### WRITTEN ARBORICULTURAL ADVICE

| <b>Site</b> | 26 Linksway, Northwood, Middlesex, HA6 2XB |
| <b>Document ref</b> | TI14012001 Rev A. |

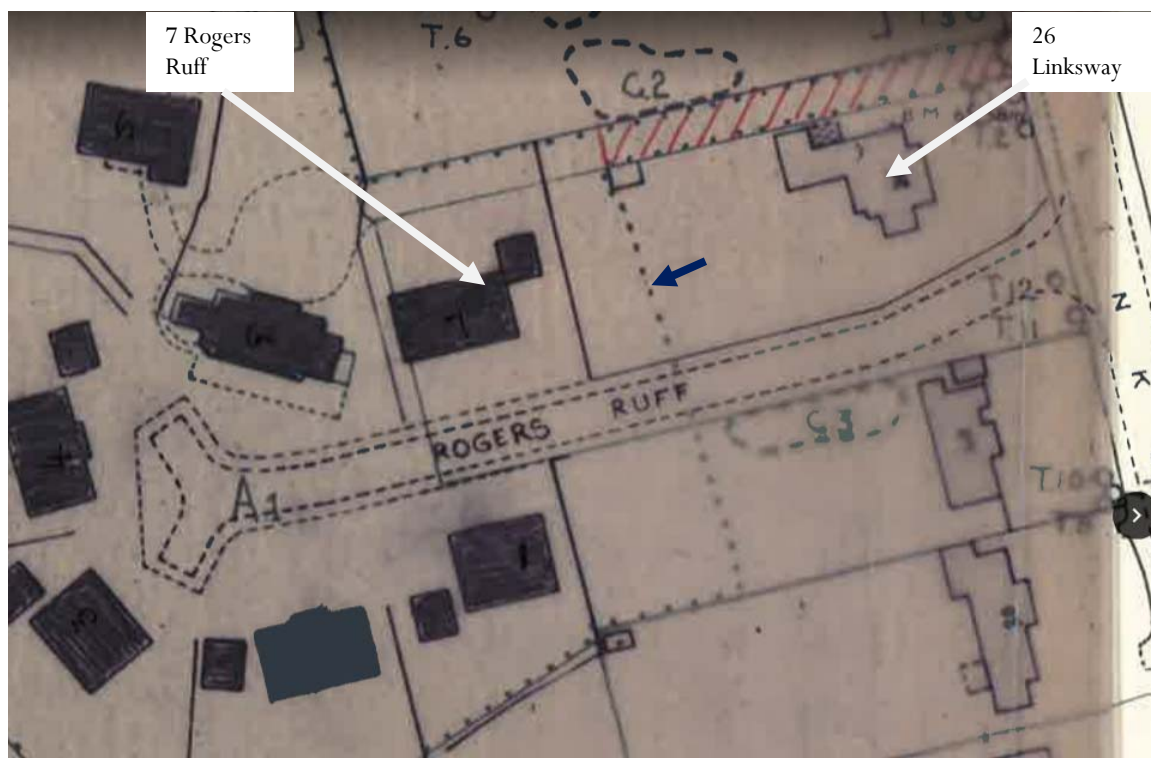
11. The London Borough of Hillingdon has a searchable GIS map on their website allowing the user to check TPOs, with helpful links enabling the user to download scanned copies of the relevant TPO documents. Using this I established that the advice in the JCA report that trees in their G3 are not protected by a TPO is not entirely correct.
12. TPO 95 (made in 1971) comprises twelve individual trees, three tree groups and one area - A1. The area element of the TPO includes 7 Rogers Ruff in its entirety, and the end section of the garden at 26 Linksway in which the whole of G3 is located. I have copied below an extract from the TPO plan which on which the dotted line shows the extent of Area A1. I have added a blue arrow to show the eastern extent by which A1 extends back into 26 Linksway.

Extract from TPO 95 plan. Blue arrow shows area A1 boundary extending into 26 Linksway

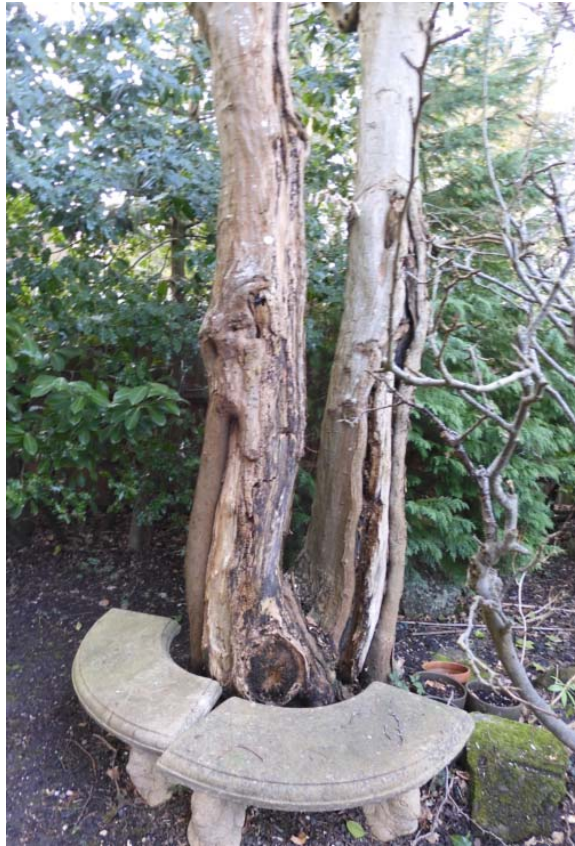
*Photograph 5*

22. **PS5.** This is a mature hornbeam with a height of 10 metres. It has two stems from ground level with diameters of 340 and 320mm. The tree has basal damage apparently caused by a historic bonfire, and significant basal decay, with extensive colonization on its west side by the fungus *Kretzschmaria deusta*. The tree has a small canopy having been subjected to heavy past reduction, and is located at a distance of approximately 6 metres from the garage at 7 Rogers Ruff. I have tagged the tree with number 133.

34. The mature hornbeam PS5 has a small crown as a consequence of past heavy reduction, and I consider it unlikely that it would be a contributory factor if vegetation is the cause of damage to the building. However, given the extent of basal decay I consider that there is a foreseeable hazard of its structural failure and I recommend that it be removed on the grounds of safety.

35. I recommend that the following trees are removed within the next three months:
- PS1 (tag 129) - aspen
  - PS2 (tag 130) - hornbeam
  - PS3 (tag 131) - pedunculate oak
  - PS4 (tag 132) - hornbeam
  - PS5 (tag 133) - hornbeam
36. I recommend that the groups PSG1, PSG2, and PSG3 are retained with no work undertaken to them at this stage.
37. Work should be undertaken by professional arboricultural contractors, ideally approved by the Arboricultural Association. <https://www.trees.org.uk/ARB-Approved-Contractor-Directory>.
38. PS5 is protected by the TPO and there is a slim chance that PS1 and PS3 are also protected by it (see 11-13). I do not consider that PS2 and PS4 are protected; however for the sake of openness, and for the avoidance of confusion I recommend that a TPO application is made to the London Borough of Hillingdon for all work recommended.

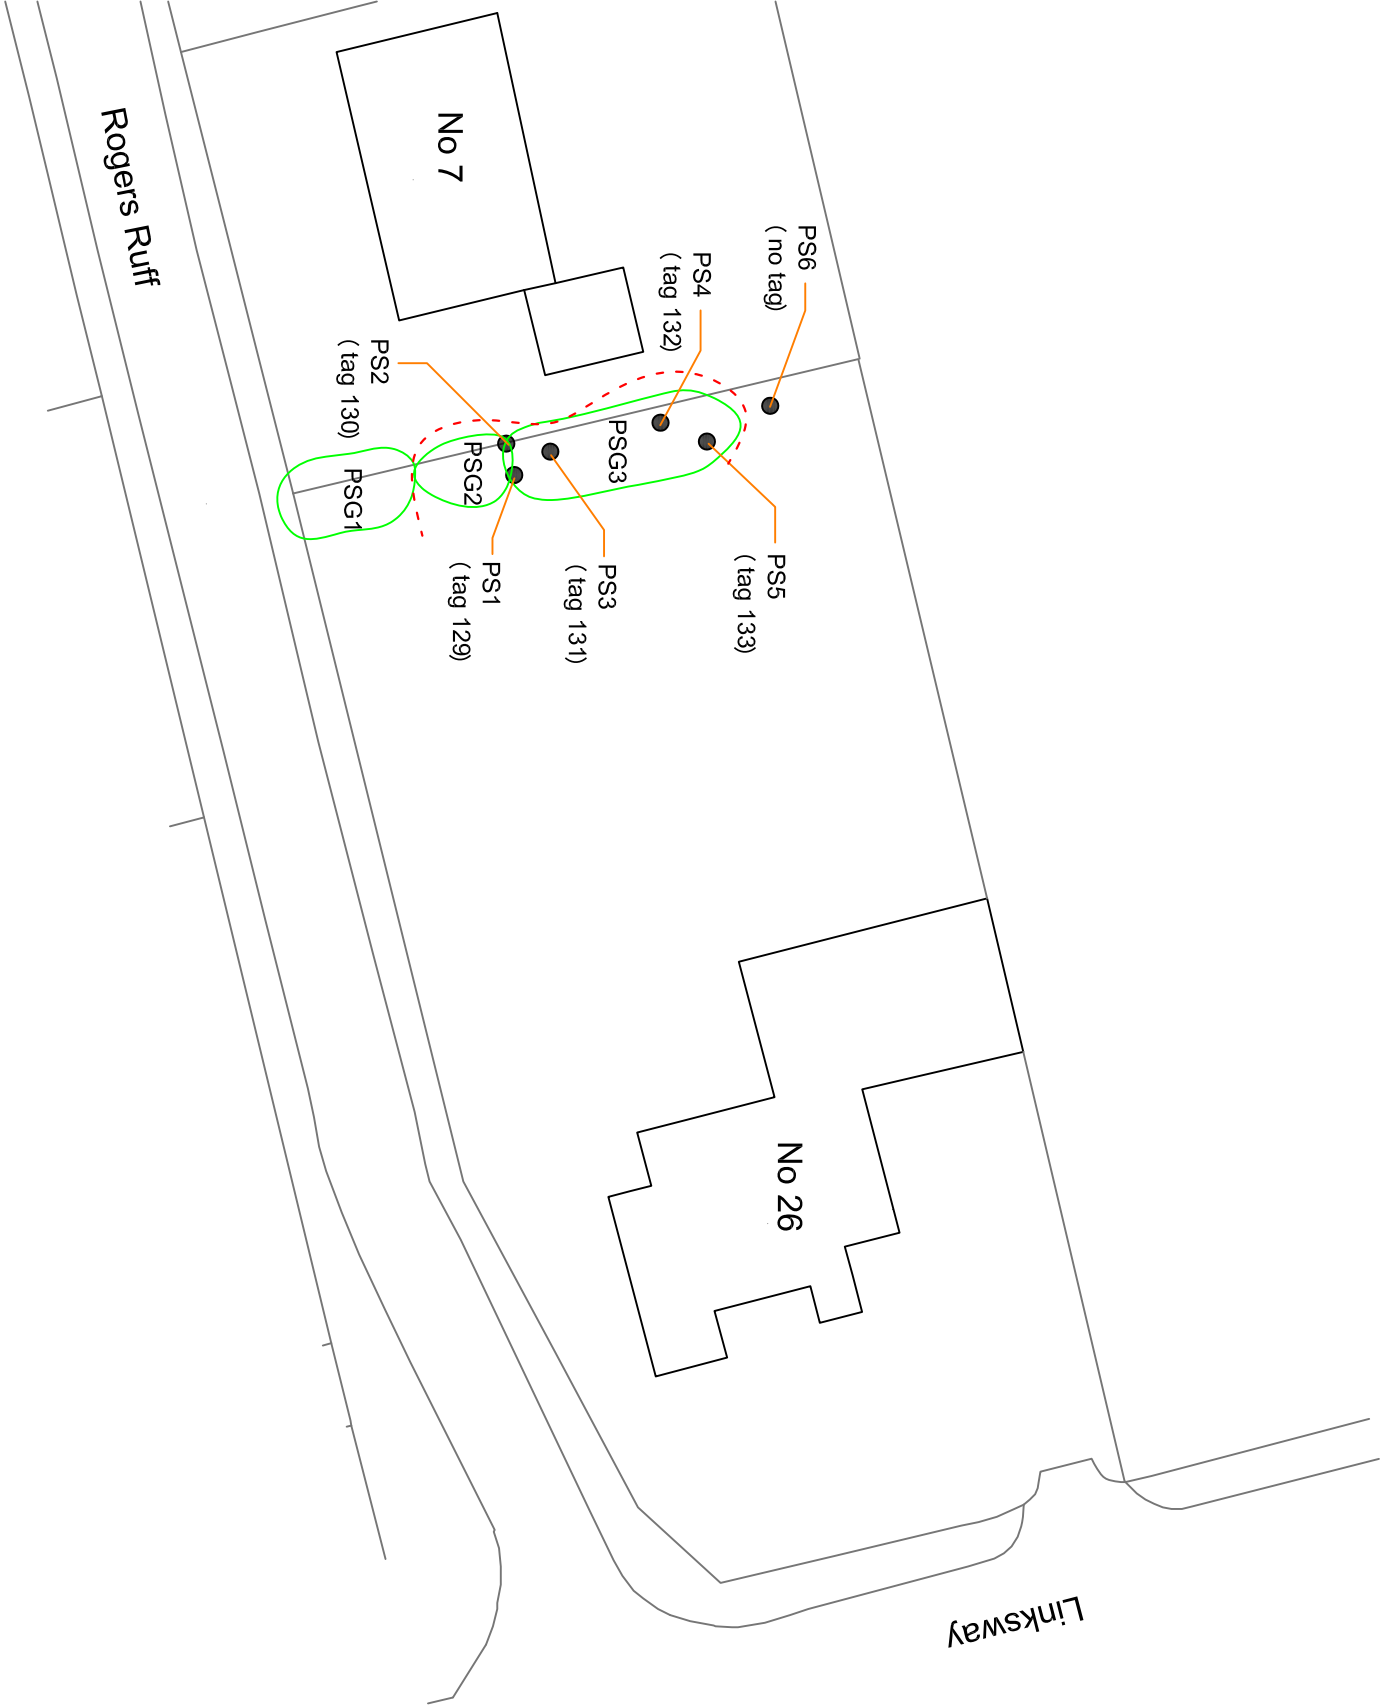
**TREE LOCATION PLAN**

14. During my site visit I recorded information relating to individual trees and groups of trees close to the western boundary of 26 Linksway, adjacent to 7 Rogers Ruff. I have shown the indicative position of these on a Tree Location Plan which I have included on Page 10. To avoid numbering confusion with the JCA report I have prefixed each individual tree surveyed with the letters PS, and each tree / shrub group with the letters PSG. Relevant details are as follows:
15. **PSG1.** This group was not included in the JCA survey and is to the south of JCA G3 (refer to Tree Location Plan on Page 10). It comprises two slender, early-mature Lawson cypress trees with heights of approximately 16 metres in addition to smaller holly and hornbeam trees. The closest tree in PSG1 to the garage at 7 Rogers Ruff is 11 metres.
