**ARBORICULTURAL SURVEY**  
**at**  
**7 Rogers Ruff**  
**Northwood**  
**Greater London**  
**HA6 2FD**

360 Globalnet,  
on behalf of Direct Line

DLG-SN-19-001049

15400/ChC

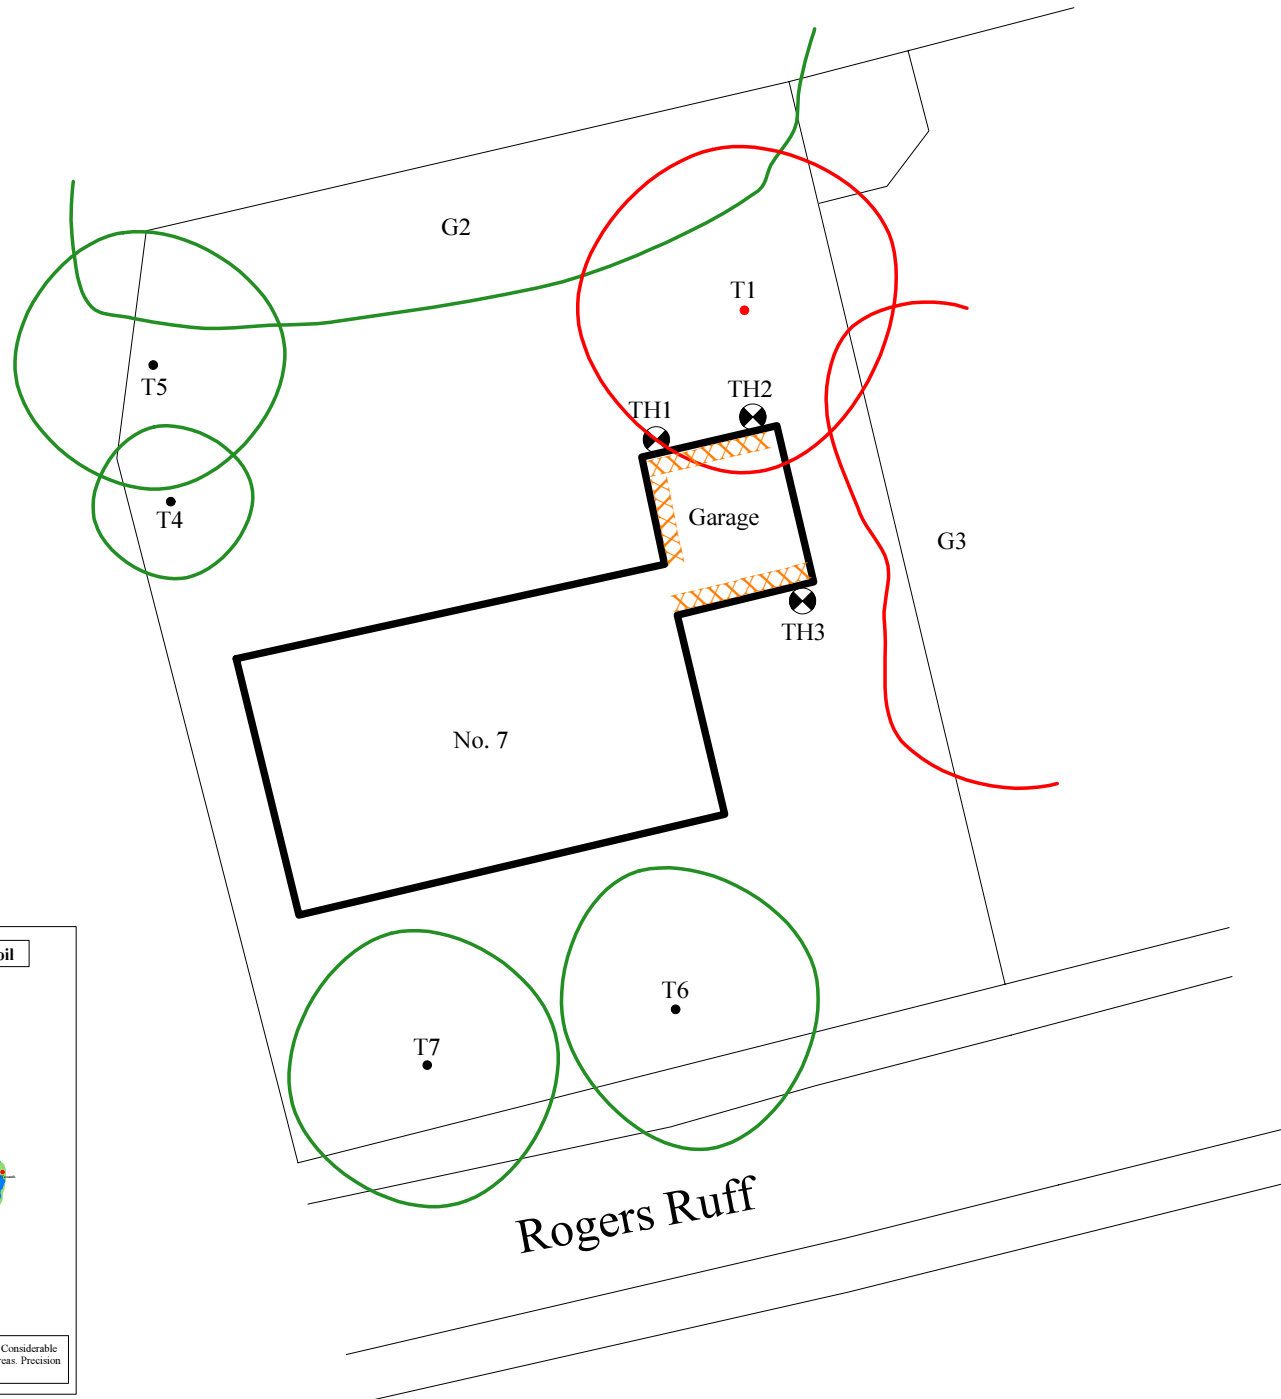
**Appendix 1: Site Plan**

- 3.2.1 Please see the attached site plan for an indication of trial pit/borehole locations.
- 3.2.2 **Trial pit/borehole 1** revealed a concrete foundation at a maximum depth of 1100mm.
- 3.2.3 **Trial pit/borehole 2** revealed a concrete foundation at a maximum depth of 1100mm.
- 3.2.4 **Trial pit/borehole 3** revealed a concrete foundation at a maximum depth of 1100mm.

- 6.2 We consider the vegetation identified as **T1** and **G3** to be contributing to the damage observed at the subject property. I have therefore recommended that these items of vegetation be removed.

| Item | Species | Recommended Action | Location/<br>Ownership | Planning<br>Restriction |
|---|---|---|---|---|
| T1 | Hornbeam | Remove and treat the stump to prevent regrowth. | Subject Property | Yes - TPO |
| G2 | Oak & Hornbeam | No action required at present. Monitor the damage following the removal of T1 and G3. | Subject Property | Yes - TPO |
| G3 | Hornbeam, Oak, Aspen, Holly and Laurel | Remove and treat the stumps to prevent regrowth. | No. 26 Linksway | Yes - TPO |
