**CCTV REPORT FOR: 7 ROGERS RUFF  
NORTHWOOD  
MIDDLESEX  
HA6 2FD**

**Insured:** Mrs B. M. Whitehead  
**Reference:** Your Ref: DLG-SN-19-001049    Ins Ref: 067361337

**Site Visit:** 14-Oct-19  
**Report Date:** 21-Nov-19

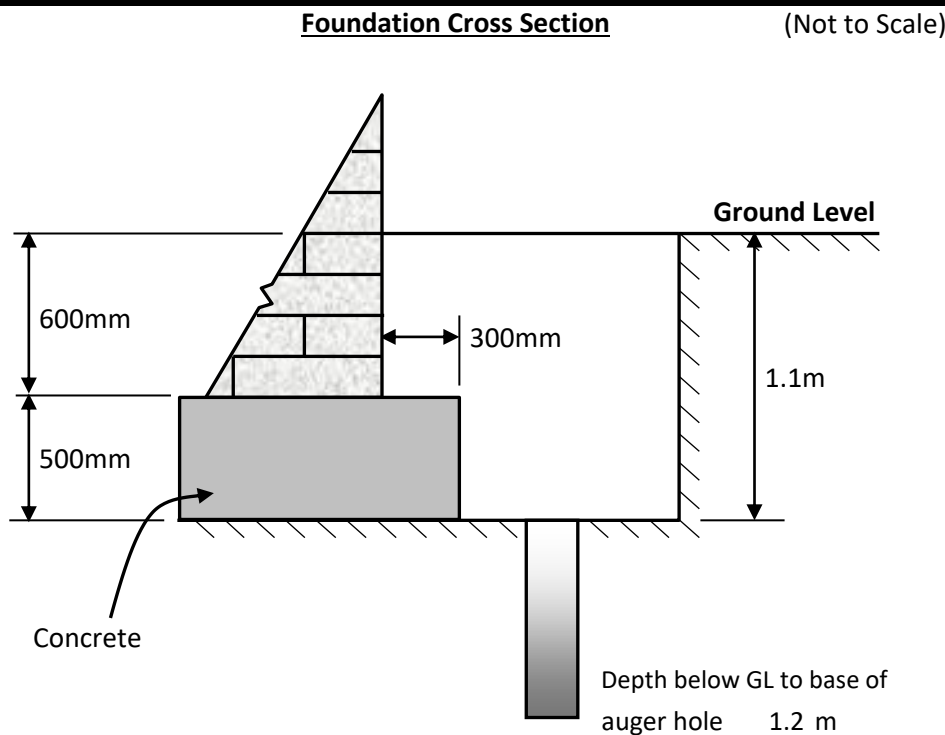
| Location: <b>Front Right Hand Corner of Garage</b> | | T/H No. <b>3</b> |

| Roots Depth & Diameter: |
| Down to 1.2m |
| up to 3mm diameter |

| <b>TP3, u/s</b> | |
| 2 no. | Examined root: similar in many ways to ILEX (Holly). |
| 2 no. | Examined root: most referable to PRUNUS species (Cherries, Plums and Damsons, Almonds, Peaches and Apricots, Blackthorn/Sloe, as well as the shrubby Cherry-laurel and Portugal-laurel). |

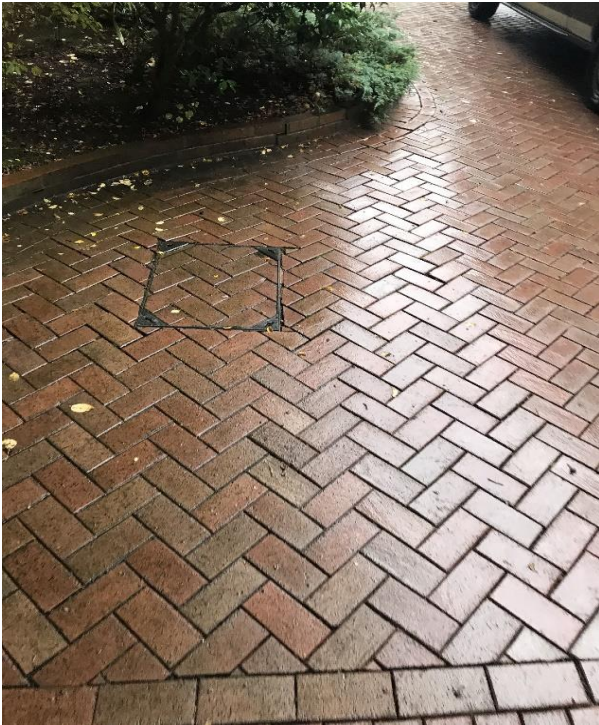
I/C3

**Run 3 - Foul - Private:**

No visible pipework defects.

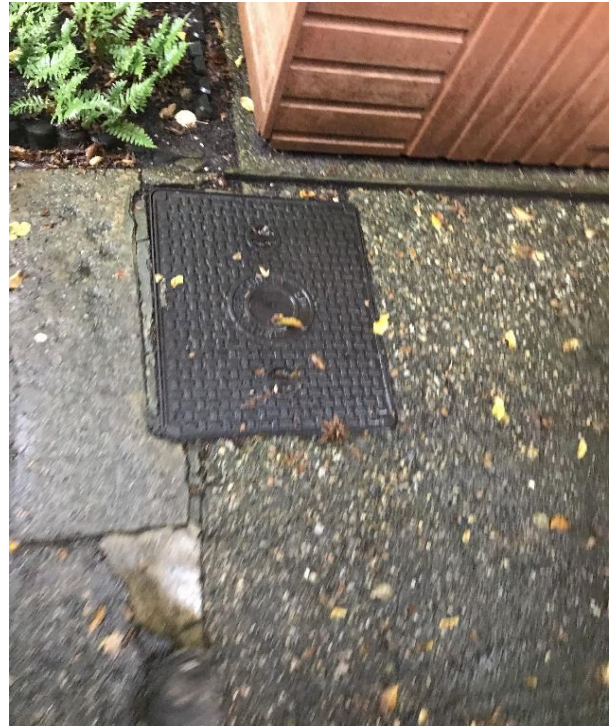
I/C1

**Run 1 - Foul - Private:**

Deformation of between 5% and 10% to pitch fibre pipework.

**Run 2 - Foul - Private:**

The WRc Drain Repair Book considers pitch fibre pipework with deformation of less than 20% to be serviceable.

As no other issues were reported to these runs no recommendations are required.

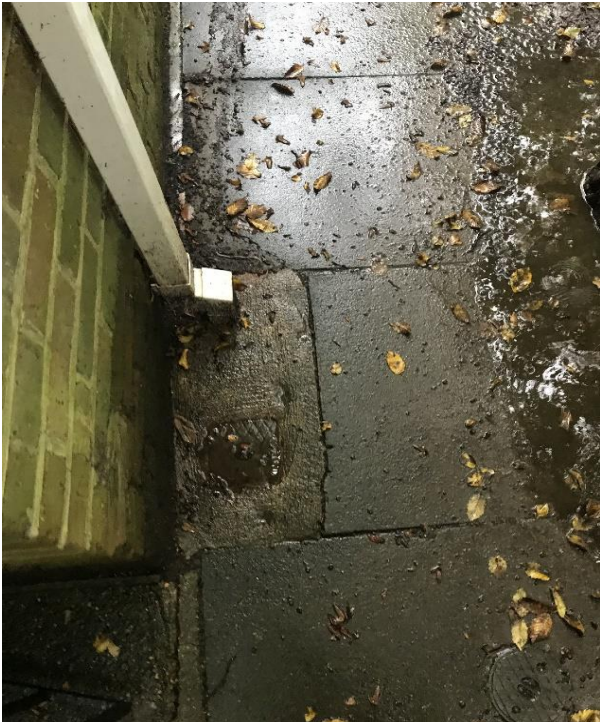
| Metres | Faults / Defects | Remarks |
|---|---|---|
| 0.70 | Debris (Silt) 100% | |
| | Root Ingress 50% | Unable to proceed |

**Run 5 - Storm - Private:**

Survey abandoned due to roots and debris.

Excavate and replace rest bend to RWP2 allowing for up to 2.0m of pipework downstream. Then carry out a further CCTV survey downstream and report findings.
