# Engineers Report

**Risk Address** 7 Rogers Ruff  
Northwood  
Middlesex  
HA6 2FD

**360 Reference** DLG-SN-19-001049  
**Claim Refence** 067361337  
**Policy Holder** Mrs. B.M. Whitehead

**Date Notified** 24.09.19  
**Date Instructed** 24.09.19  
**Report Date** 03.10.19

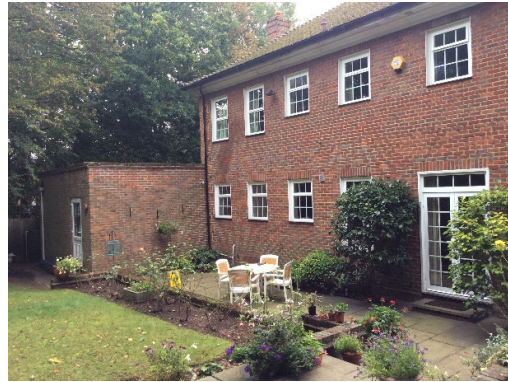
Rear View on Garage

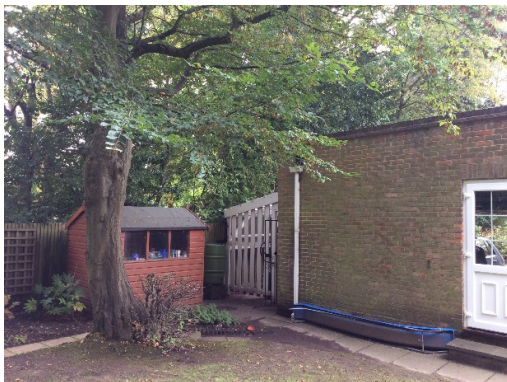
Tree in Rear Garden

The property is surrounded by numerous large trees, both within the insured's garden and also in the gardens of neighbouring properties. The closest tree to the area of damage is a 15-metre-tall Hornbeam tree approximately 3.5 metres from the rear of the garage. There is a density of trees along the right-hand boundary with 26 Links Way and these are within 3.5 metres of the garage. There are further trees along the rear boundary which is 10 metres away.

Given the sudden nature and timing of the damage, it is clear that the cause of the damage is clay shrinkage due to the moisture demand of the vegetation adjacent to the garage. The damage has occurred during a dry summer, following an extremely dry summer and winter in 2018. The trees have grown over the years and this leads to a progressive drying of the soil and then when dry summers occur, as 2018 and 2019, the tree roots will extend further to obtain moisture, desiccating the clay over a wider area. Unfortunately, this has now been sufficient to cause the rear left-hand corner to drop and cause the brickwork to rotate away from the rear personnel door.

The damage will stabilise as the clay rehydrates over the winter and spring and hopefully some of the cracking will close up. However, there is a very high risk of further damage occurring during future dry periods of weather and therefore it is recommended that the vegetation removed / reduced, subject to the agreement of the respective owners and any planning constraints. It is suspected that the dominant influence will be the Hornbeam tree at the rear of the garage, and it is likely that this will need to be removed. The influence of the other trees along the right-hand boundary is less clear and the recommendations of an arborist will be required.

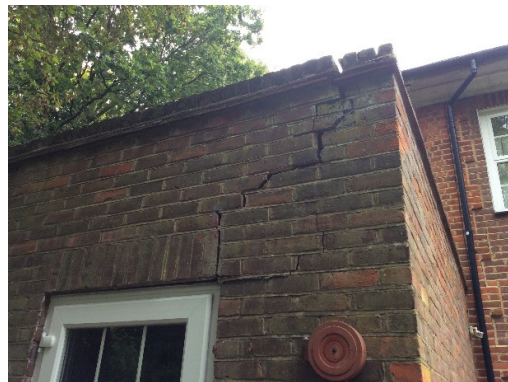
The brickwork to the rear left-hand corner has rotated significantly to the left-hand side, with severe cracking and displacement of the brickwork by up to 20mm, extending through the coping to the flat roof. The paving slabs and steps to the rear door have rotated away severely.

Cracking to Rear Left-Hand Corner

Provided that the implicated trees can be removed, the extension will stabilise over the winter / spring and repairs can be implemented in spring 2020. Some of the cracks may close up as the clay rehydrates, which will make the repairs simpler. A detailed repair schedule will be agreed at repair stage, although some localised rebuilding of the brickwork will be required.

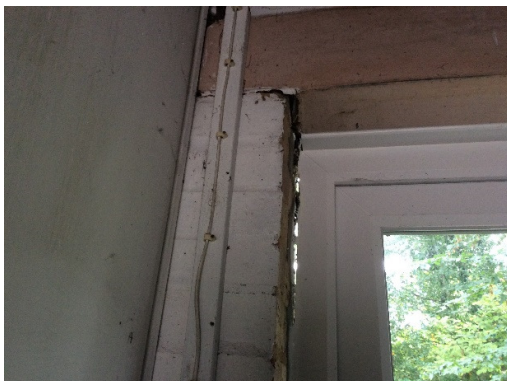
The main damage is to the rear left-hand corner where the brickwork has rotated away from the rear personnel door by around 10mm. The door frame has bowed, and the door is difficult to operate.

Movement Away from Rear Door

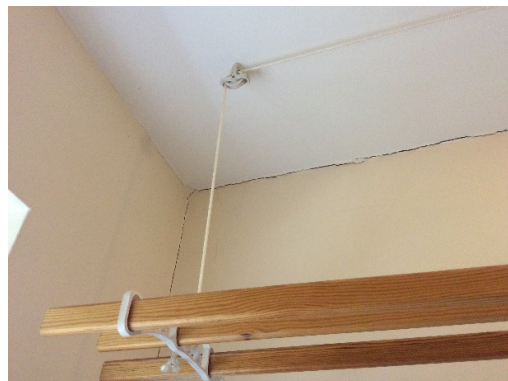
There is minor cracking along the right-hand ceiling junction, and this extends down the front and rear corners.

Cracking to Utility Room
