# ASSESSMENT OF TREES AND VEGETATION IMPLICATED IN SUBSIDENCE DAMAGE TO No. 2 Ebury Close, Northwood, Middx HA6 2PF

Assessment of Tree and Vegetation Implication in Subsidence Damage to :

No. 2 Ebury Close, Northwood, Middx HA6 2PF

Date: 26<sup>th</sup> March 2021 - Our Ref: SAL/KMA/10671

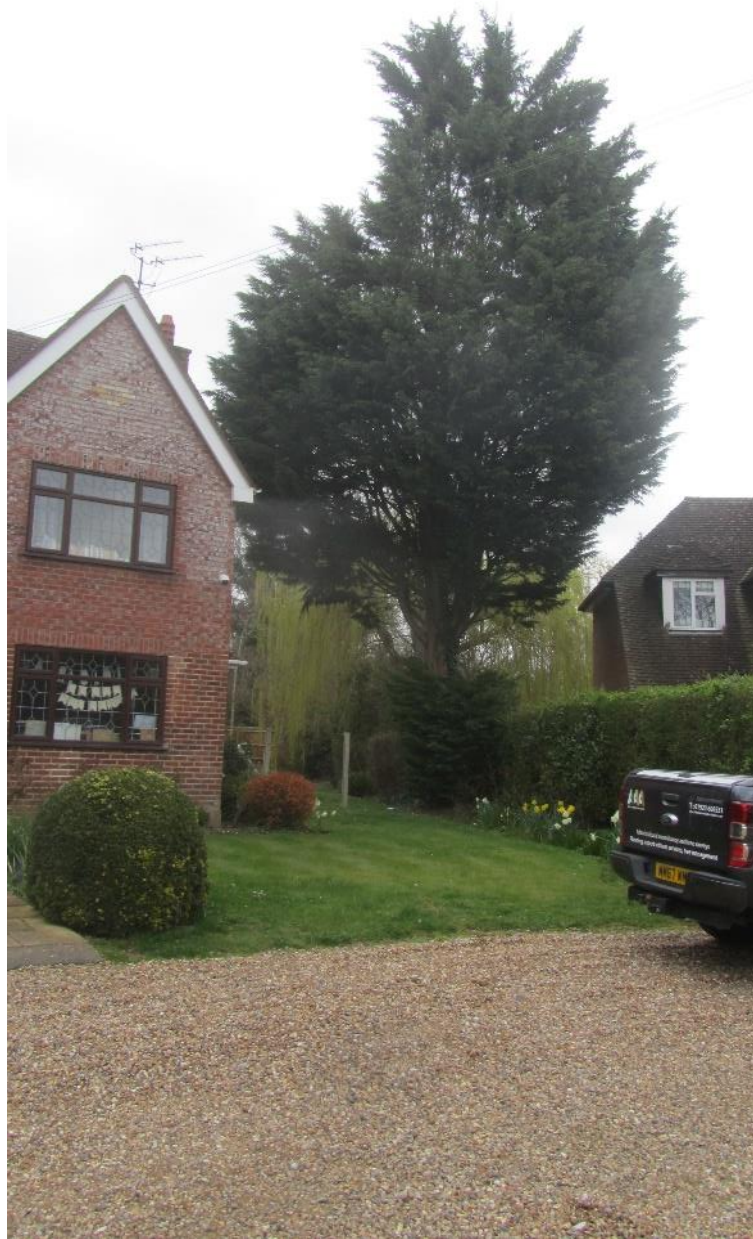
- 3.1 I inspected both trees from within the garden of No. 2 Ebury Close. The inspection was visual and from ground level only.
- 3.2 The Leyland cypress (T1) is growing within the curtilage of No. 2 close to the eastern boundary (see photograph 1, Appendix 1 at the back of this report). It is a large tree of documented high-water demand which shows high vitality and due to its widely spreading crown, 8 m north-south and 12 m west-east, has a high leaf area index. These three factors combined indicate that the tree will have a very high-water uptake, which due to the tree/building proximity will impact on soil moisture levels close to and under the built footprint. The tree has significant growth potential and will continue to increase its water usage for many years as it grows on.

- i) The Leyland cypress (T1) is a primary actor in the subsidence movement, it is a species with a documented high-water demand and has a theoretical zone of root influence that would encompass much of the footprint of the dwelling house.
- ii) It is a tree in good physiological condition showing high vitality and has a long future life expectancy. Due to its high-water demand and also the rain shadow effect of its foliage it will be contributing significantly to soil desiccation around and under the building footprint.
- iii) The subsoil on site is a shrinkable clayey loam which has likely been desiccated by the action of fine feeding roots of the cypress tree. Subsequent soil volume reduction is the probable cause of the building movement.

**PHOTOGRAPH NO. 1 - T1 - Leyland cypress tree located east of  
No. 2 Ebury Close**

6.1 **T1 - Leyland cypress** – remove tree after appropriate consultation with a structural engineer to establish the the level of heave that will occur.

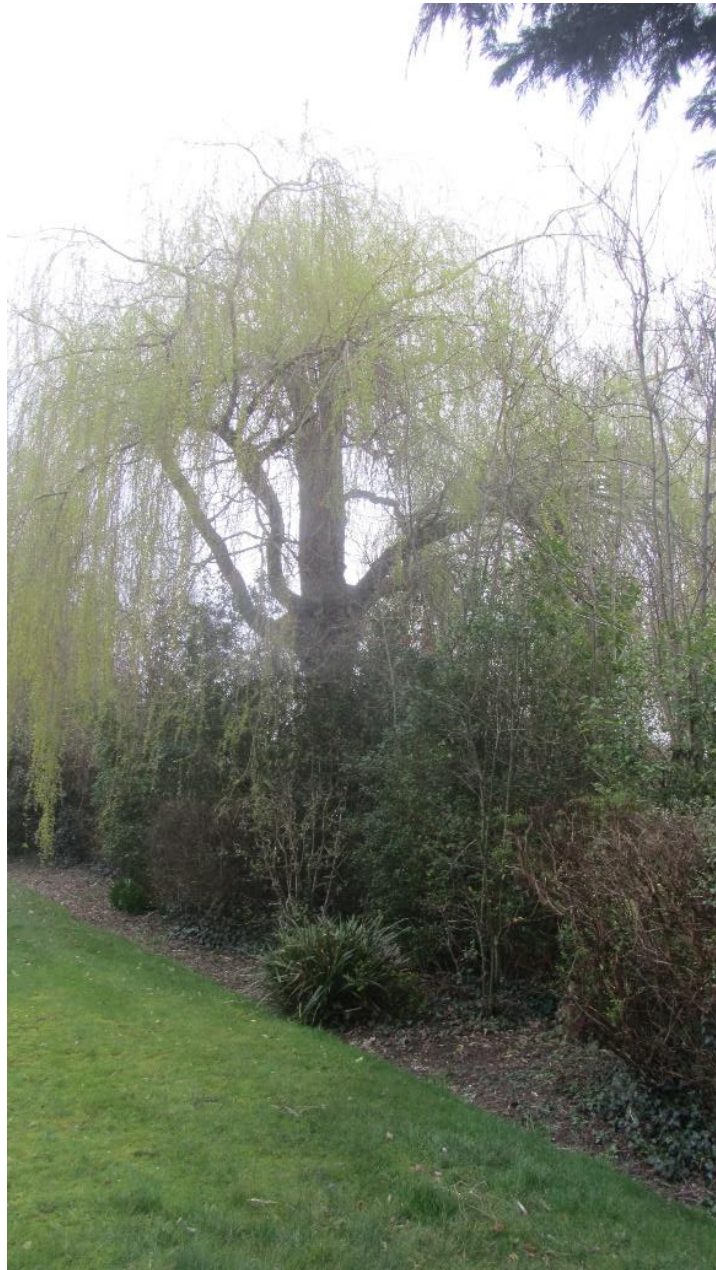
- 3.3 Tree 2, the weeping willow, is also a tree with a documented high-water demand. This is mitigated by the fact of repeated pollarding/reduction operations which have served to maintain the tree at a reduced size (see photograph 2, Appendix 1 at the back of this report). It is therefore less certain that this tree will have any detrimental effects on soil moisture levels close to the building.

**PHOTOGRAPH NO. 2 - T2 - Weeping willow located in the third-party property to the northeast of No. 2 Ebury Close**

**T2 – Weeping willow** – ensure tree is maintained at or around its current size.

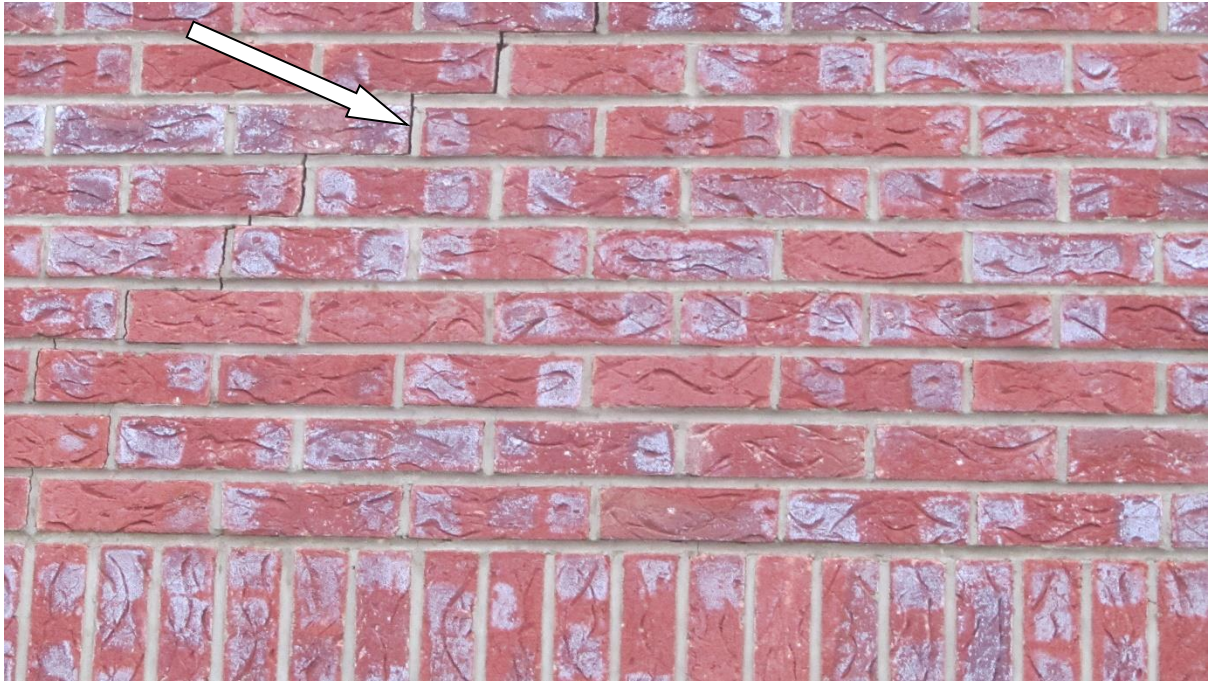
- 4.2 Structural cracking to this area of the building seems to have been noticed after the very dry summer of 2018. The Graham High Group carried out extensive investigations in 2019. These included excavation of two trial holes with boreholes extending through the bottom near the front right (eastern) end of the dwelling house. GHG found the soil beneath the foundations to be stiff and dry and concluded that the Leyland cypress tree (identified as T1 within this report) was a causal factor. Their structural engineer found the cracks to be 5-15 mm in width meaning that the extent of the damage falls within Category 3 (moderate) according to BRE Digest 251-Assessment of Damage to Low Rise Buildings (August 1990). GHG's report shows that the cracking width increases with height from approximately 1 mm to 5-6 mm. It is appreciably more by the right-hand side of the first-floor window (10 mm) (see photographs 3 & 4, Appendix 1 at the back of this report). The cracking pattern shows rotational movement and dropping of the eastern flank wall toward the cypress tree (T1). This type of movement is consistent with subsoil shrinkage caused by moisture extraction and a consequent reduction of subsoil volume.

**PHOTOGRAPH NO. 3 - Stepped brickwork cracking on the front, southern elevation near to the southeast corner (arrowed)**

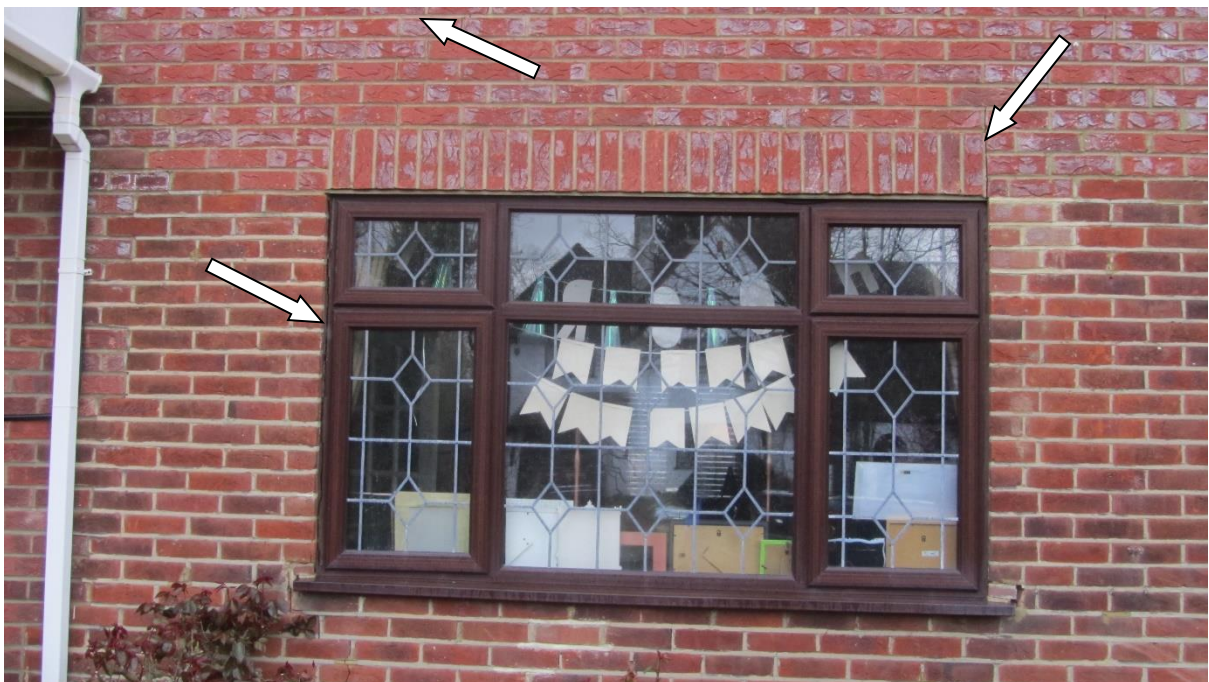
**PHOTOGRAPH NO. 4 - Brickwork cracking and window displacement on the front elevation of No. 2 Ebury Close (arrowed)**

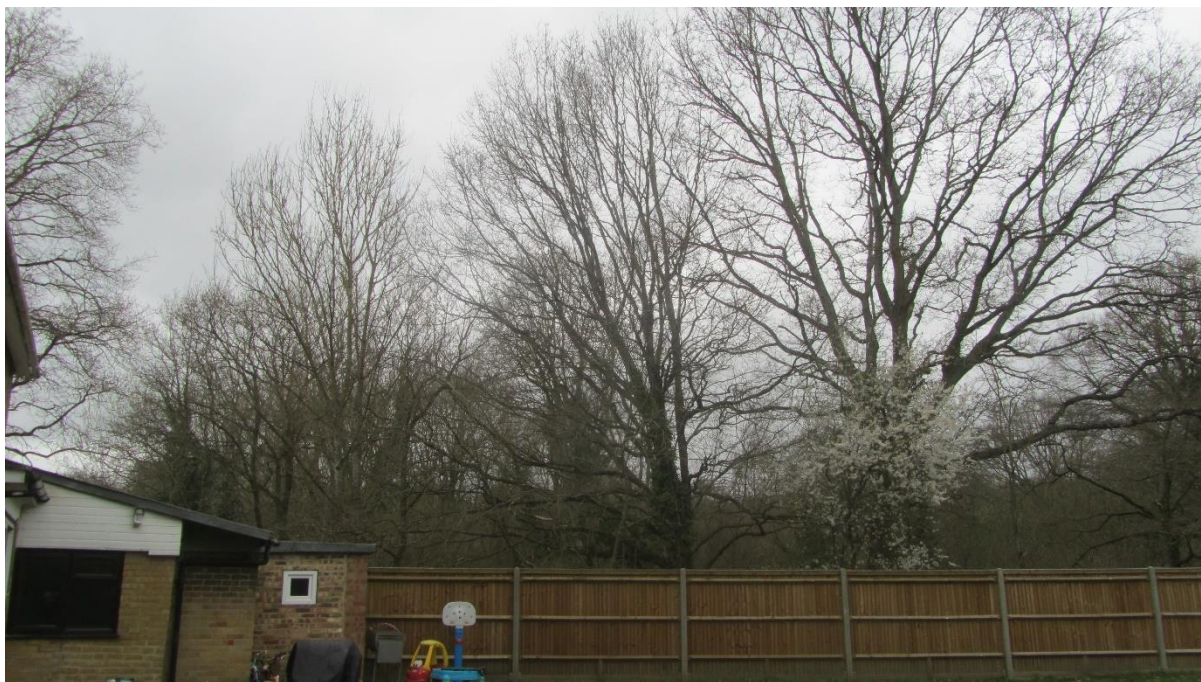
**PHOTOGRAPH NO. 4 - Wooded area to the west of No. 2 Ebury Close**
