# Site Investigation and Drainage Report

| <b>Site</b> | 2 Ebury Close<br>Northwood<br>Middlesex<br>HA6 2PF |
| <b>Our Ref</b> | 10877 |

**Project Name:** 2 Ebury Close HA6 2PE  
**Project Description:** WinCan Import in Miraculix WRc4 Standard  
**Project Status:** Complete  
**Project Date:** 19/07/2019

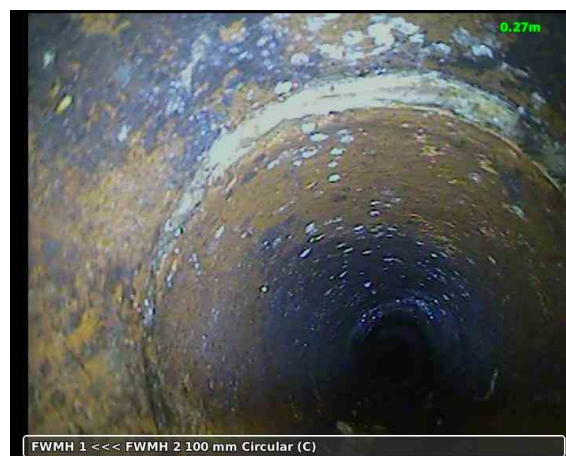
20190615-105947-snap0001.jpg, 00:00:21, 0.27 m  
Joint displaced, medium

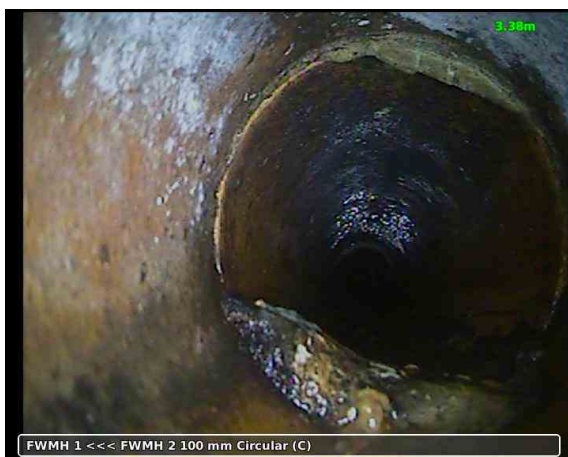
- 1) FWMH1-FWMH2: This drain is constructed from 100mm Vitrified Clay Pipe and appears to be visually in a serviceable condition and without any major structural defects. There are some attached deposits which are slightly restricting the bore and flow of the drain but it doesn't appear to have caused any blockages.

20190615-105947-snap0002.jpg, 00:00:55, 3.38 m  
Attached deposits, encrustation, from 05 to 07 o'clock, 15 %  
cross-sectional area loss

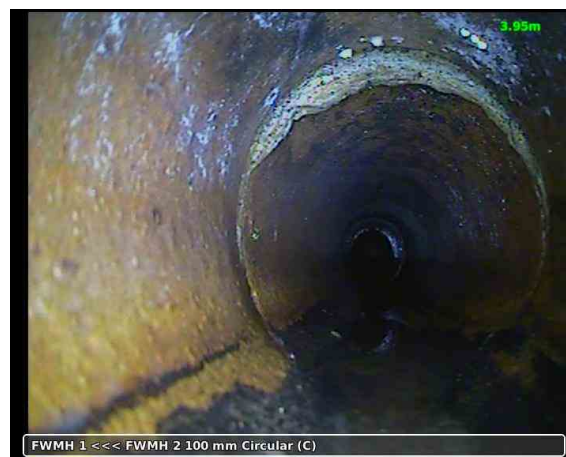
20190615-105947-snap0003.jpg, 00:01:20, 3.95 m  
Attached deposits, encrustation, from 09 to 03 o'clock, 5 %  
cross-sectional area loss

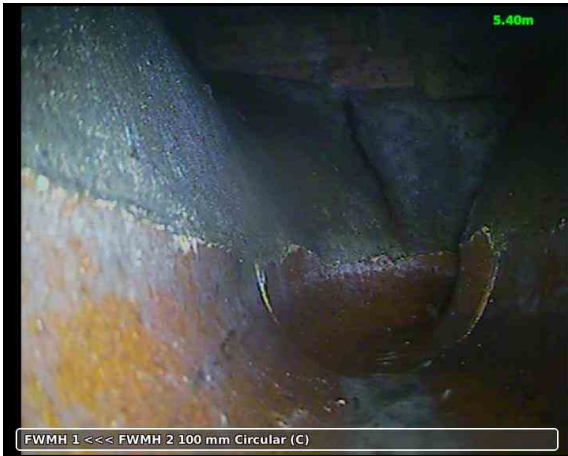
20190615-105947-snap0004.jpg, 00:01:47, 5.40 m  
 Finish node type, manhole, reference number: 2, FWMH 2  
 BURIED
