OUR REF: L/2019/57462/S/LLB/sp/BC  
REF: 35618710350  
POLICYHOLDER: Mrs D Ramaiya  
ADDRESS: 2 Ebury Close, Northwood, Middlesex, HA6 2PF

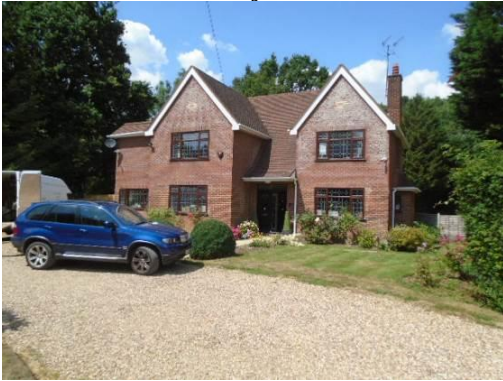
**PHOTOGRAPH 01:**

This photograph shows a general view of the front elevation of the property.

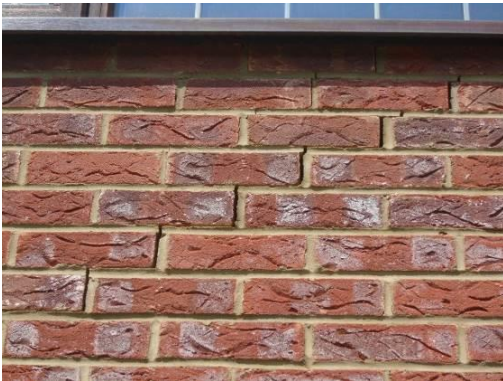
**PHOTOGRAPH 02:**

This photograph shows main stepped cracking at the right hand side of the front elevation between ground and first floor windows.

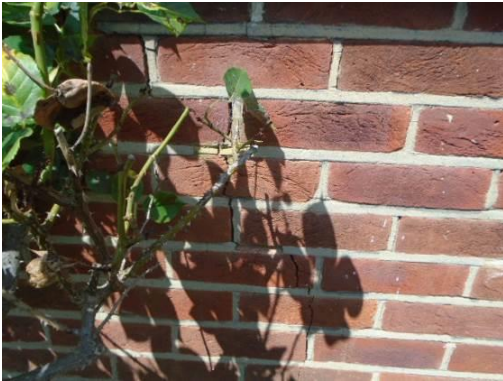
**PHOTOGRAPH 03:**

This photograph shows a crack which is tapered in nature below the left hand side of the front right hand sitting room window.

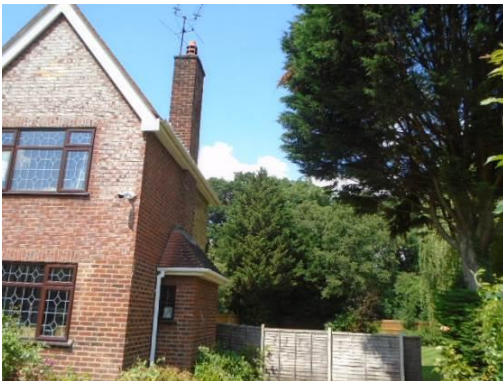
**PHOTOGRAPH 04:**

This photograph shows a general view of the right hand side elevation to the property and the Policyholder's fir tree.

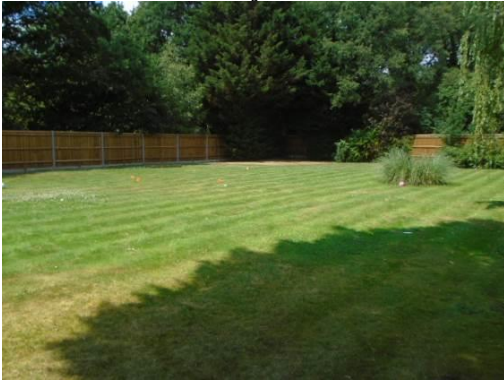
**PHOTOGRAPH 05:**

This photograph shows a general view of the rear garden.

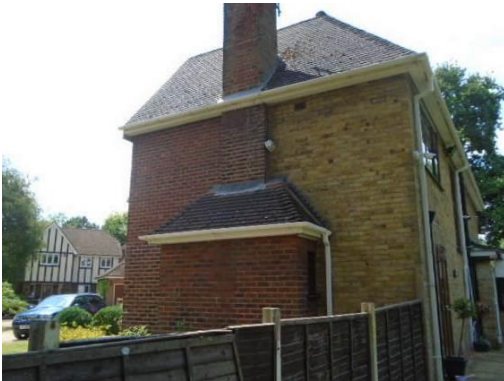
**PHOTOGRAPH 06:**

This photograph shows a general view of the right hand side elevation to the property.

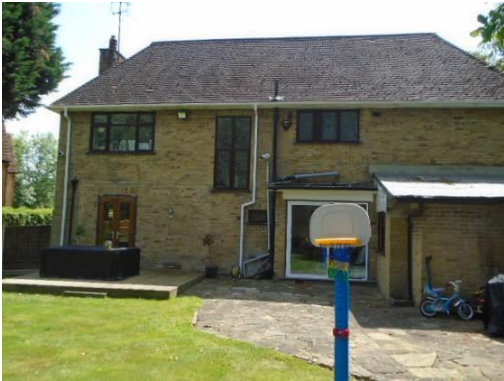
**PHOTOGRAPH 07:**

This photograph shows a general rear elevation view of the property.

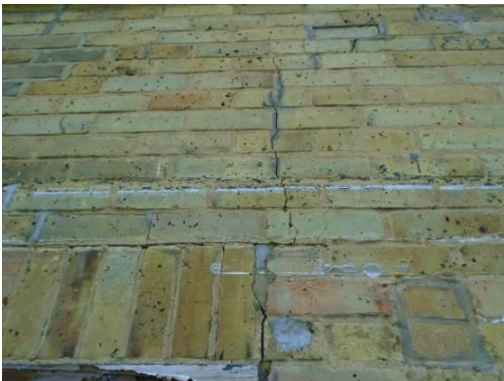
**PHOTOGRAPH 08:**

This photograph shows old cracking vertically above the right hand side sitting room on the rear elevation at the left hand side of the doorframe.

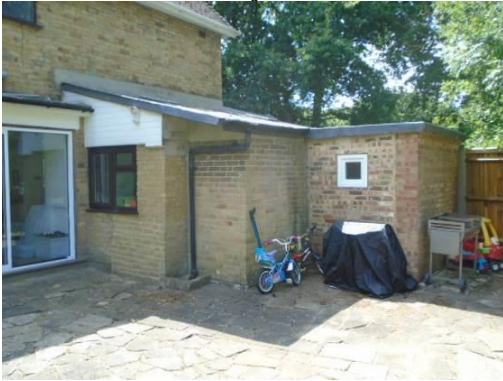
**PHOTOGRAPH 09:**

This photograph shows the right hand side elevation and view of the single storey outbuilding provision.

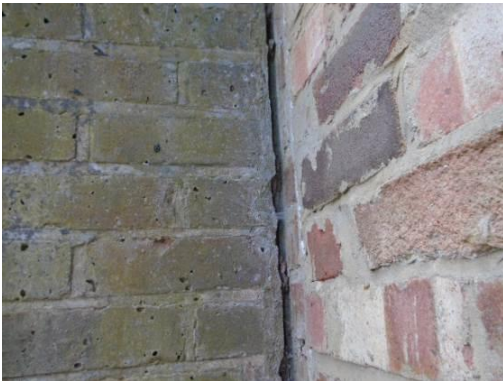
**PHOTOGRAPH 10:**

This photograph shows vertical separation midway on the rear section of the outbuilding at the junction of the right hand return walling.

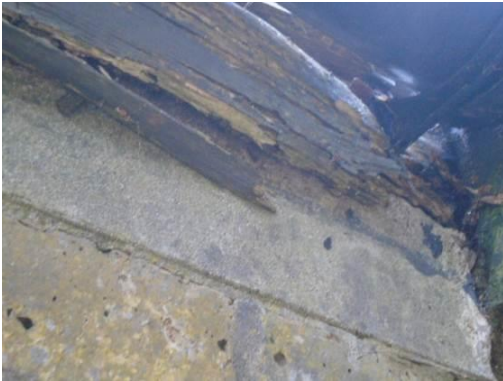
**PHOTOGRAPH 11:**

This photograph shows rotten fascia boarding above the rear central crack on the rear of the outbuilding.

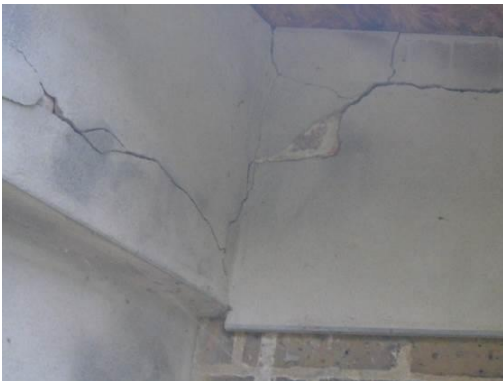
**PHOTOGRAPH 12:**

This photograph shows cracking to the right hand top rendered section on the single storey outbuilding.

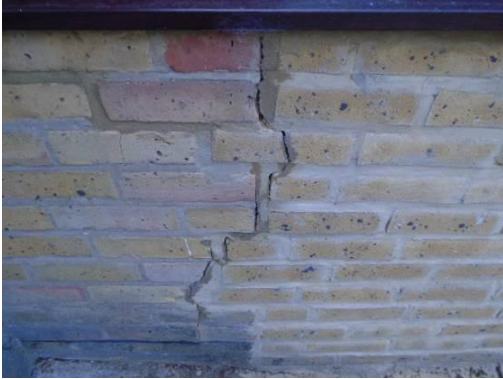
**PHOTOGRAPH 13:**

This photograph shows cracking to the right hand side of the single storey playroom extension with tapered vertical cracking centrally below the window.

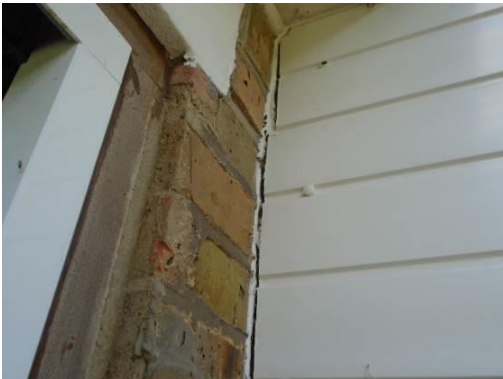
**PHOTOGRAPH 14:**

This photograph shows the right hand side wall junction to the rear single storey playroom extension with the main rear wall of the house at high level.

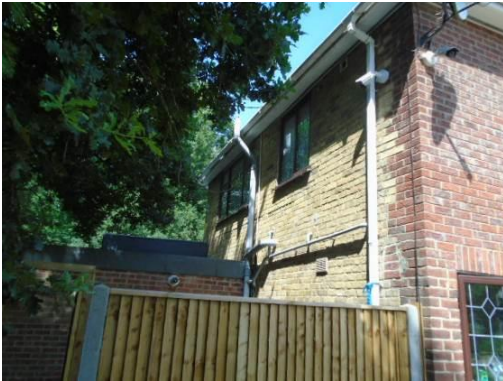
**PHOTOGRAPH 15:**

This photograph shows a general view of the left hand flank wall to the property.

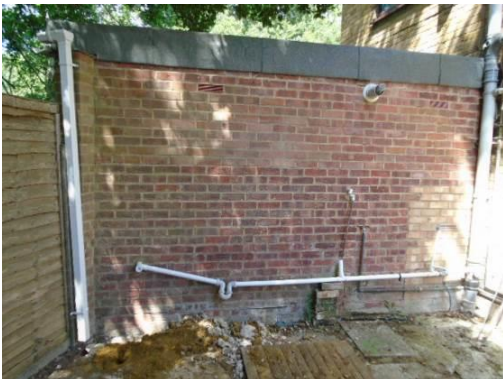
**PHOTOGRAPH 16:**

This photograph shows a general view of the left hand side elevation, Utility room.

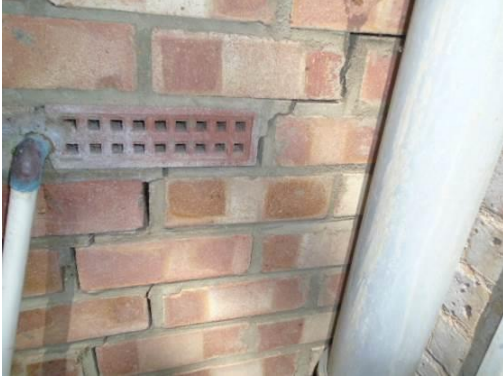
**PHOTOGRAPH 17:**

This photograph is taken to the front wall of the single storey extension, right hand side stepped cracking.

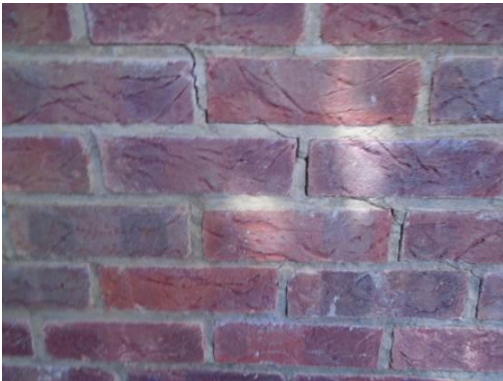
**PHOTOGRAPH 18:**

This photograph shows a stepped crack to the front wall of the single storey side extension midway on the left hand side of the wall.

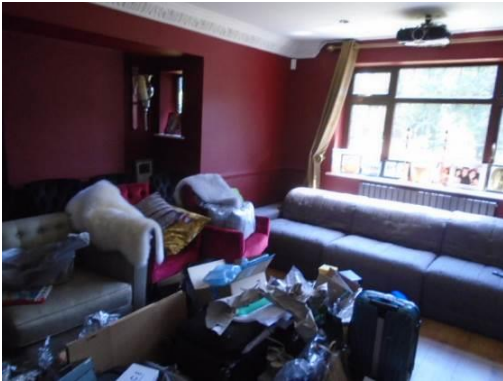
**PHOTOGRAPH 19:**

This photograph is a general view of the right hand side sitting room.

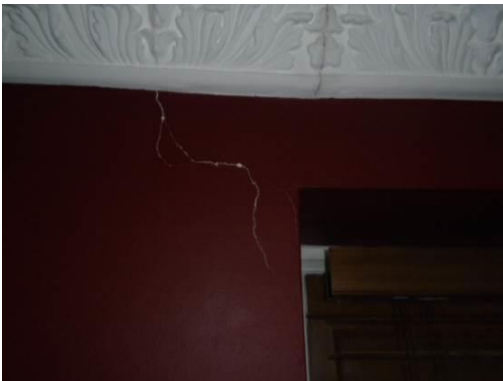
**PHOTOGRAPH 20:**

This photograph shows cracking local to the top left hand head of the rear French door opening.

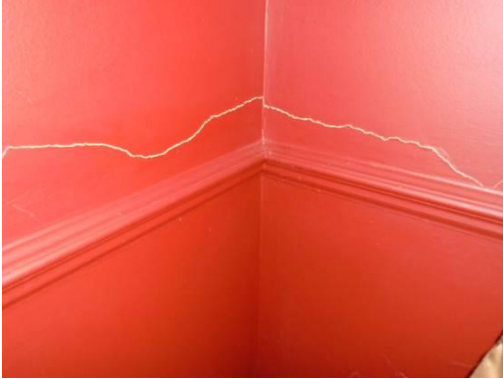
**PHOTOGRAPH 21:**

This photograph shows a horizontal fresh crack to the front right hand corner of the property approximately 1m above ground finish floor level.

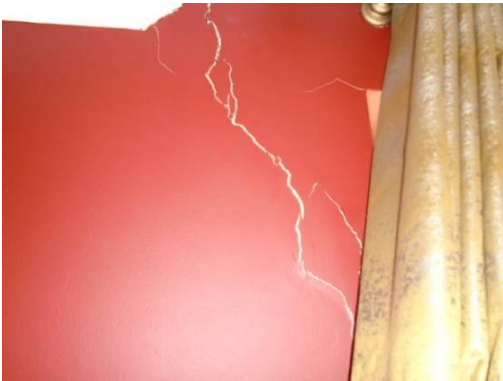
**PHOTOGRAPH 22:**

This photograph shows the main cracking in the front sitting room wall right hand head of the window.

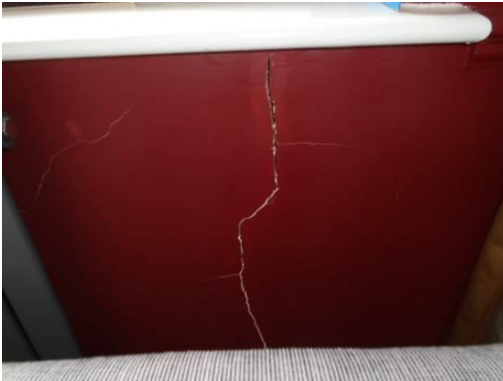
**PHOTOGRAPH 23:**

This photograph shows tapered vertical cracking below the front sitting room window left hand side.

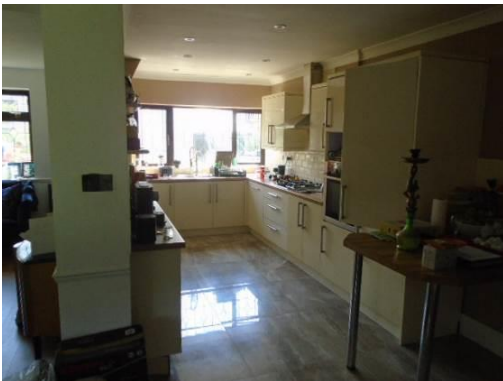
**PHOTOGRAPH 24:**

This photograph shows a general view of the kitchen area.

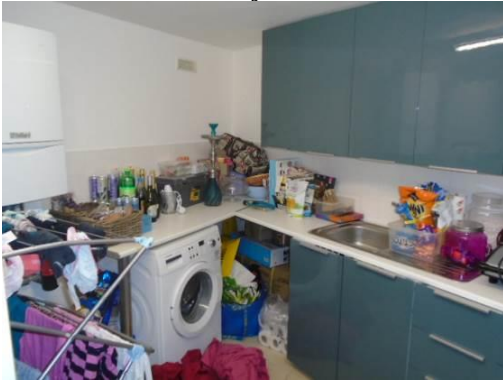
**PHOTOGRAPH 25:**

This photograph shows a general view of the left hand side utility room.

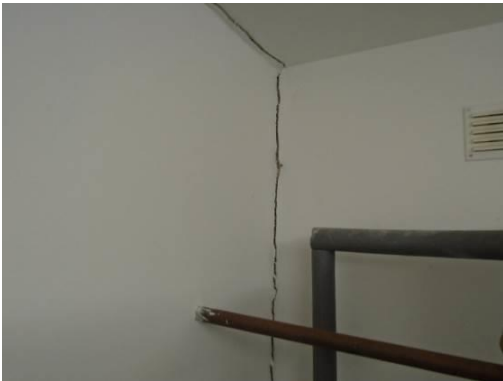
**PHOTOGRAPH 26:**

This photograph shows vertical separation in the utility room front right hand corner.

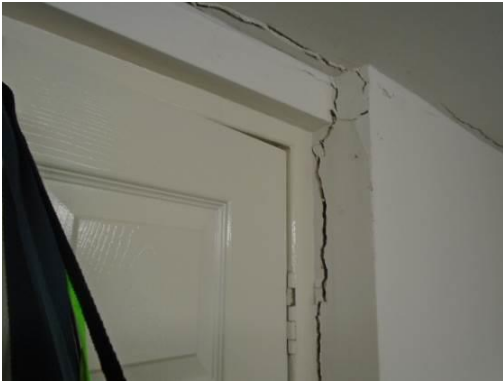
**PHOTOGRAPH 27:**

This photograph shows separation cracking in the utility room front head of the incoming door.

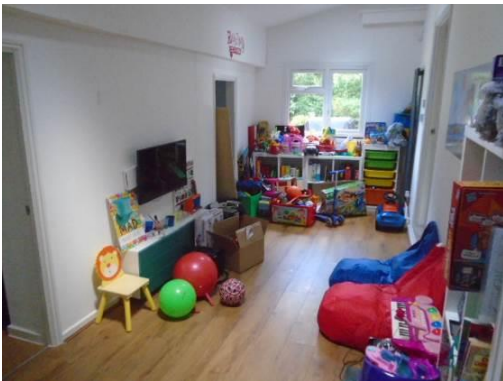
**PHOTOGRAPH 28:**

This photograph shows a general view of the rear playroom.

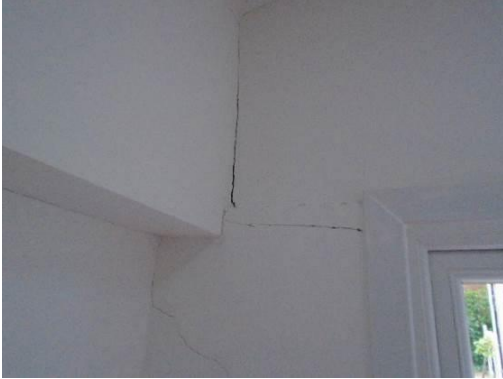
**PHOTOGRAPH 29:**

This photograph shows crack damage to the right hand side wall of the playroom to the head of the window.

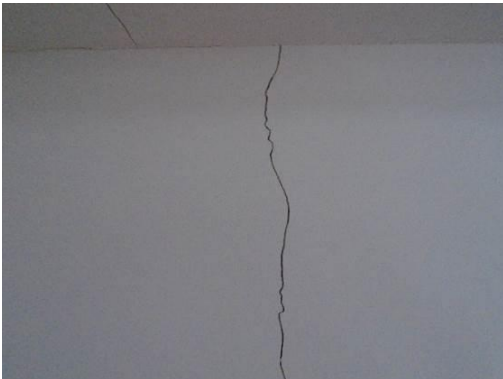
**PHOTOGRAPH 30:**

This photograph shows vertical cracking to the left hand side of the cupboard door in the playroom rear walling.

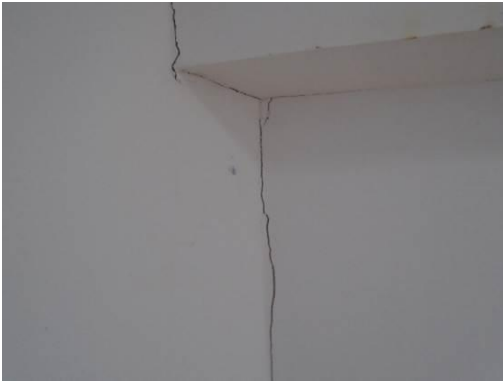
**PHOTOGRAPH 31:**

This photograph is taken of the rear left hand corner wall separation cracking in the rear playroom.

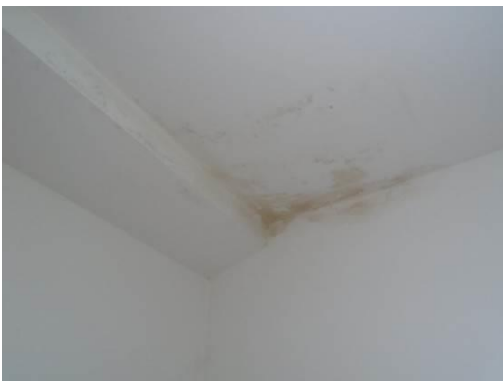
**PHOTOGRAPH 32:**

This photograph shows water staining to the front left hand corner ceiling in the playroom.

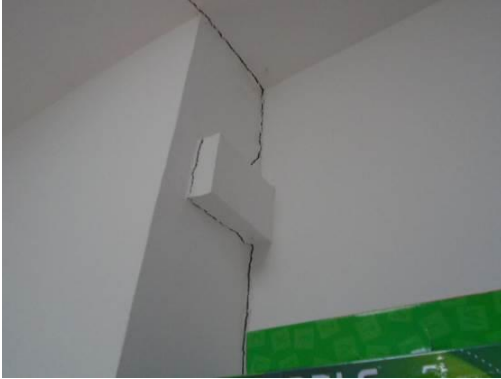
**PHOTOGRAPH 33:**

This photograph shows vertical separation cracking which is tapered in nature to the front wall of the playroom further away in from the left hand corner.

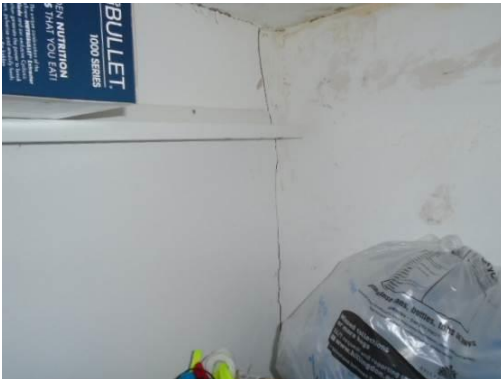
**PHOTOGRAPH 34:**

This photograph shows vertical separation cracking in the rear left hand corner of the right hand side cupboard off the rear playroom extension.

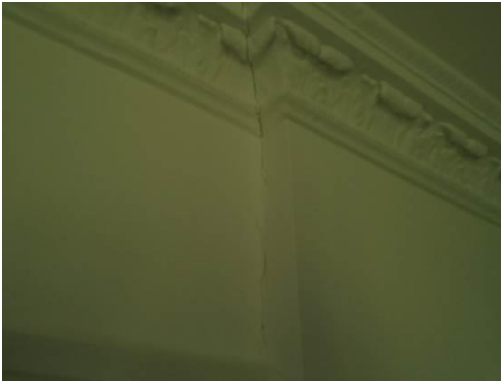
**PHOTOGRAPH 35:**

This photograph is taken at first floor level on the landing area front door opening into the central bedroom.

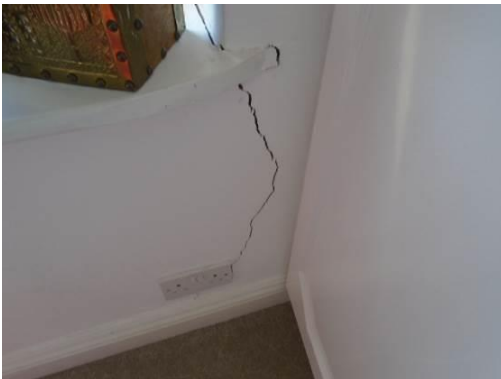
**PHOTOGRAPH 36:**

This photograph is taken in the front right hand corner bedroom showing cracking below the front left hand side of the window.

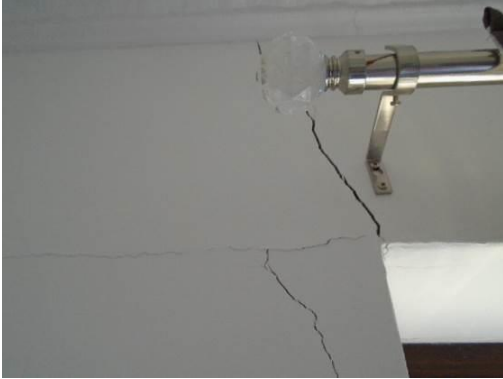
**PHOTOGRAPH 37:**

This photograph shows cracking in the front right hand bedroom top right hand corner of front window.

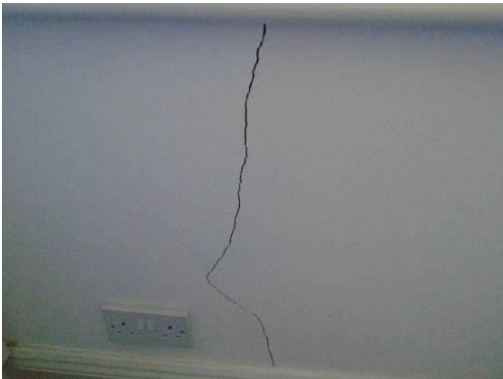
**PHOTOGRAPH 38:**

This photograph shows cracking to the rear wall in the rear right hand bedroom below the left hand side of the window.

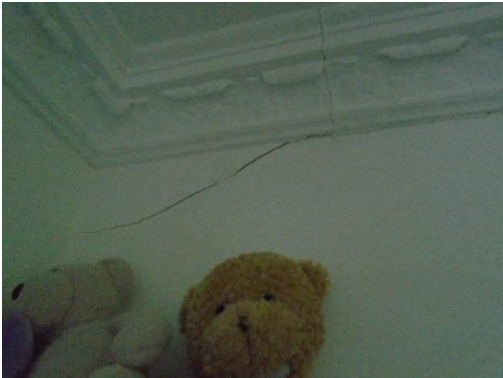
**PHOTOGRAPH 39:**

This photograph shows localised cracking to top right hand corner of walling within the rear right hand corner bedroom.

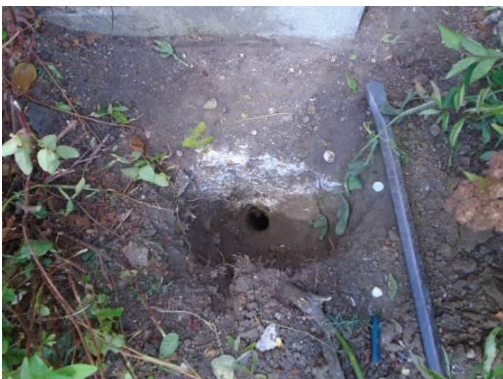
**PHOTOGRAPH 40:**

This photograph shows the location of trial pit/borehole 01 to the front right hand corner of the property.

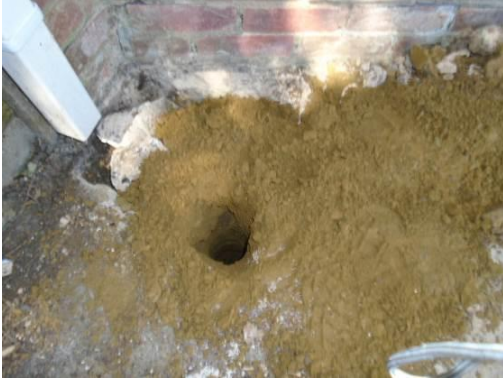
**PHOTOGRAPH 41:**

This photograph shows the location of trial pit/borehole 02 standing to the left hand side front corner of the single storey side extension.

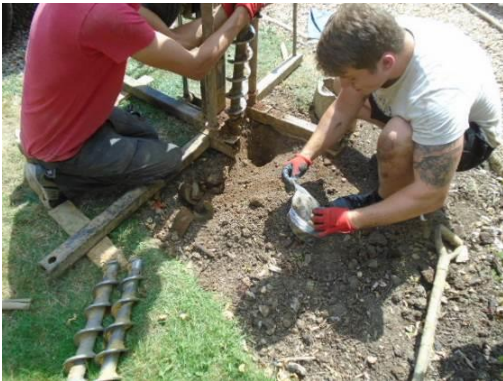
**PHOTOGRAPH 42:**

This photograph shows borehole 03 standing midway in the front garden to the property.
