**DESIGN AND ACCESS STATEMENT
FOR THE FORMER REGAL CINEMA, UXBRIDGE**

Jun 2022

- 1.1. This Design and Access Statement has been prepared to support a Listed Building Consent application to re-roof the flat roof areas of The Former Regal Cinema, Uxbridge.

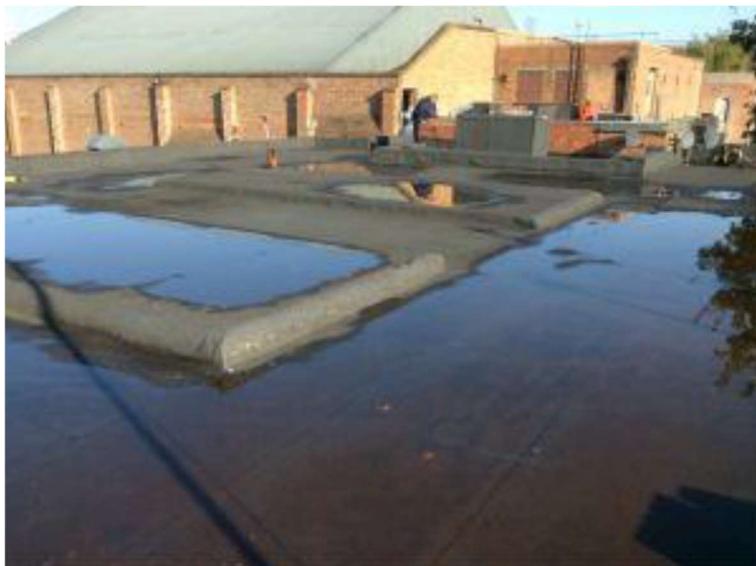
Img 2 Main roof area overview as above showing severe ponding indicating poor falls and place additional load the roof area as well as presenting a severe slip hazard if maintenance is required in ice cold weather conditions.

- Remove existing felt overlays back to mastic asphalt.
- Upon completion of the preparatory works, install a Langley TA-25W warm roof high performance elastomeric membrane system incorporating tapered Parafoam Ultra insulation to achieve compliance with the part L2b threshold of 0.18W/m²K.
- Replace rainwater goods with new cast iron to match existing. It is considered that this element will not require Listed Building Consent but is noted for completeness.

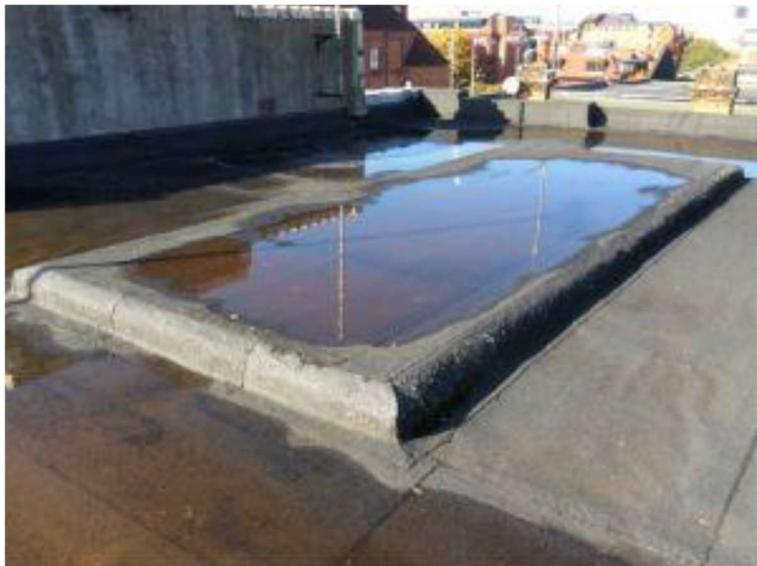
Img 3 Standing water on decked over rooflight aperture to main roof area.

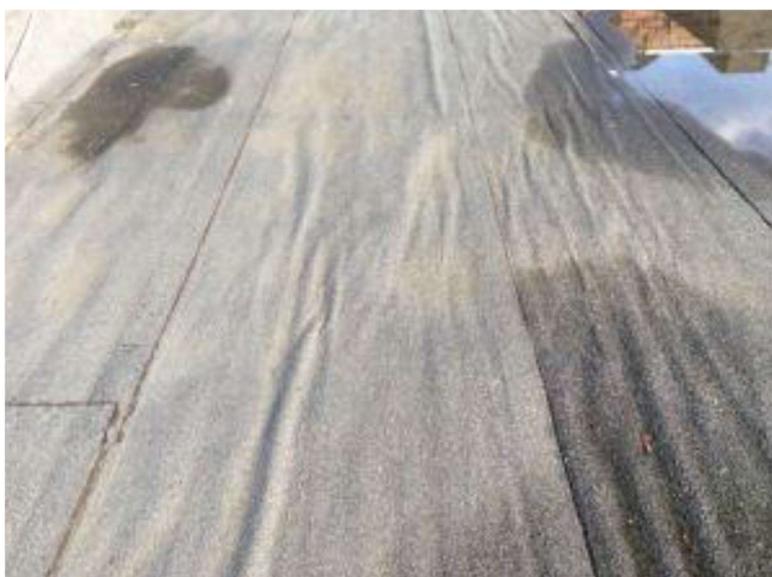
Img 4 Rucking due to trapped moisture vapour to main roof area.

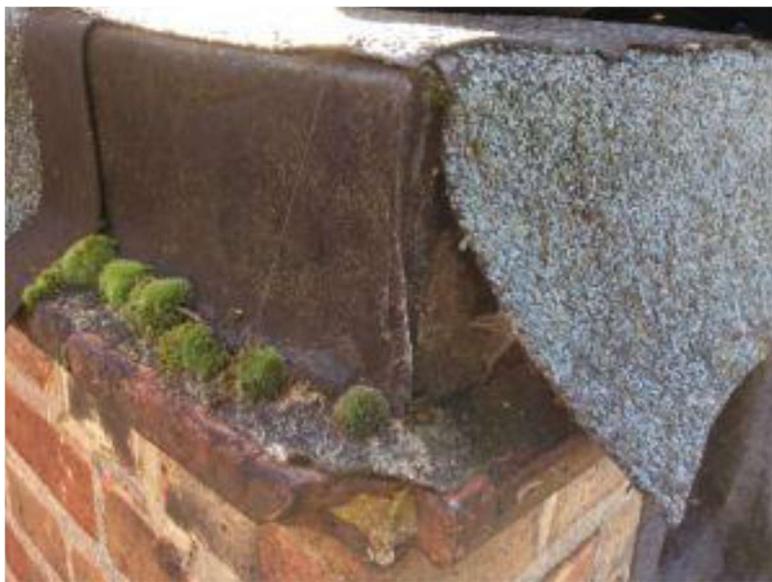
Img 5 Poor termination of waterproofing to outer of edge of parapet wall. Note: organic growth indicating areas of standing water.

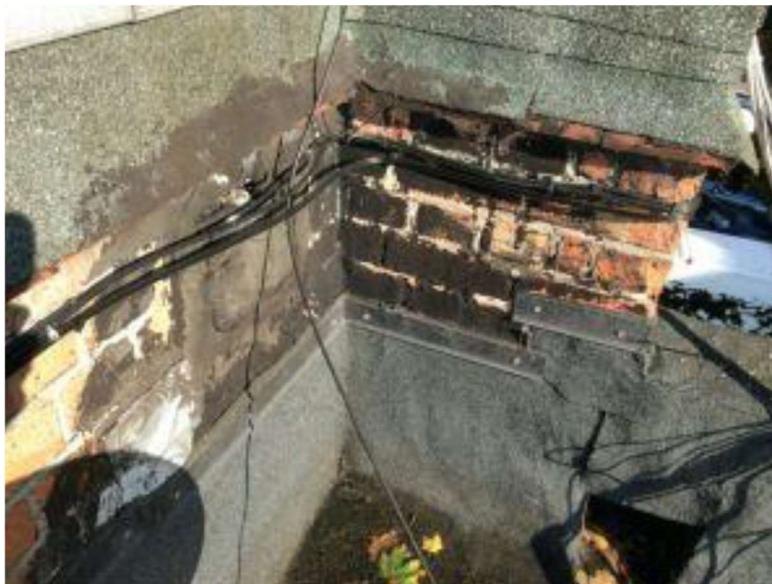
Img 6 Bituminous liquid patch repairs to brick upstands on main roof area. Despite mineral felt termination bar detail there are still ongoing moisture ingress problems. Note electrical cabling fixed to parapet wall.

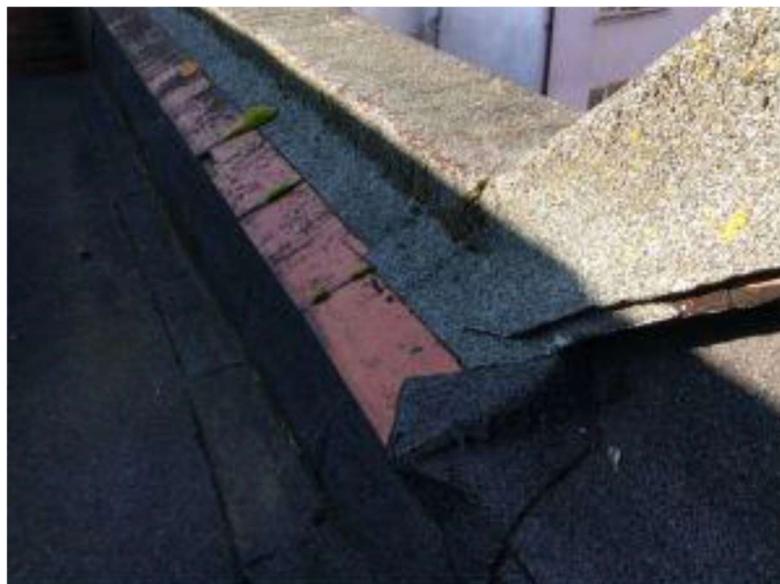
Img 7 Parapet walls have been partially encapsulated with felt to the inner leaf and top without terminations.

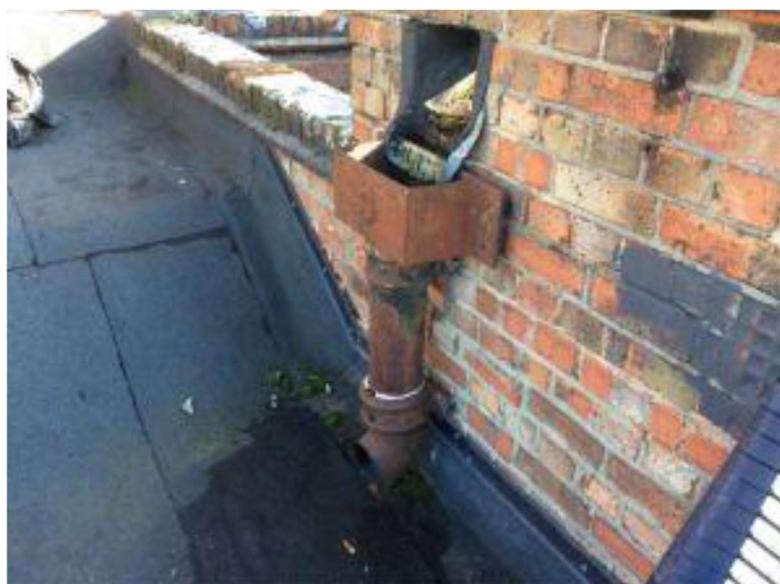
Img 8 Example of corroded cast iron hopper and downpipe

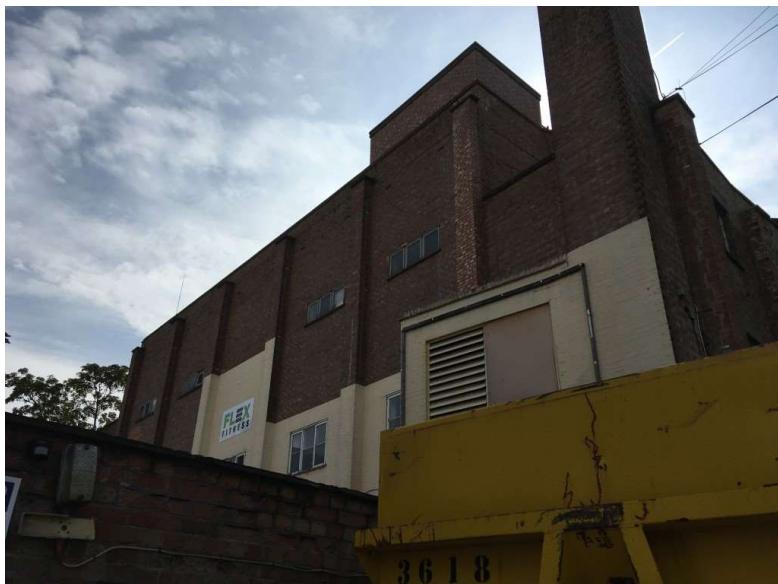
Img 10 View of high level parapets to rear of building
