Watching brief report - Mezzanine areas

Regal Cinema building
233 Uxbridge High Street
Uxbridge

January 2025

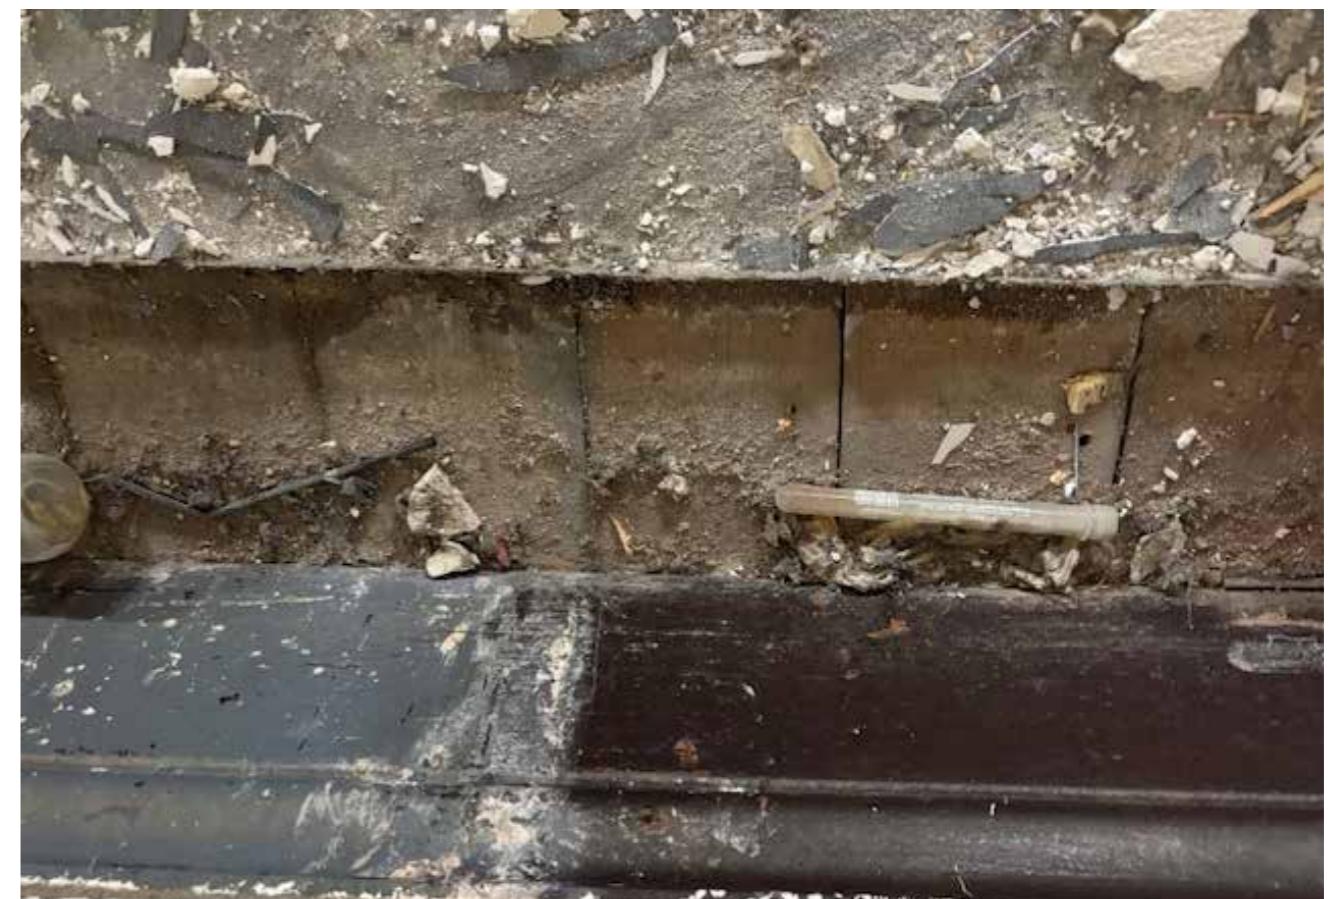
Original mezzanine timber floor exposed.

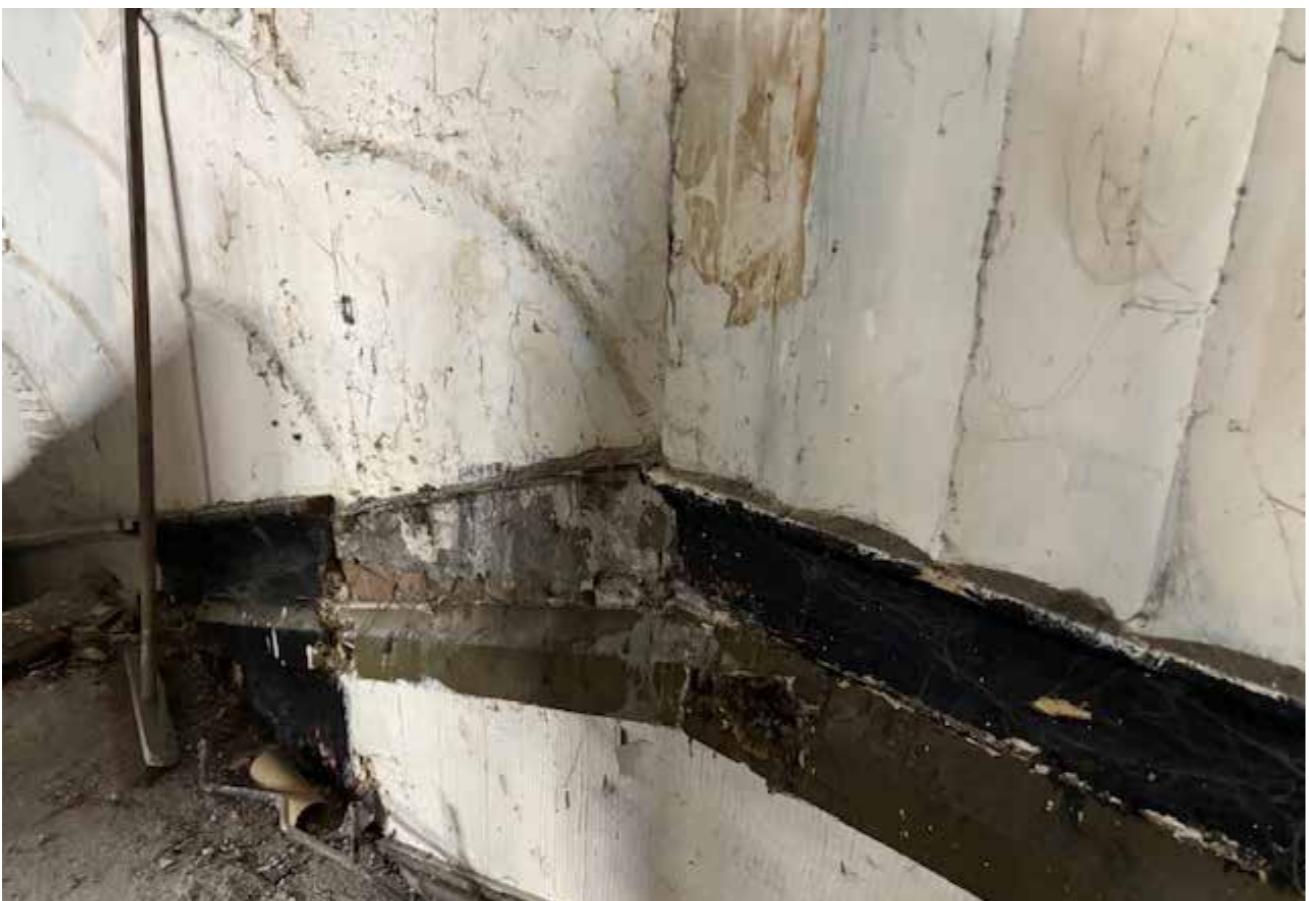
Original plaster work exposed to side walls.

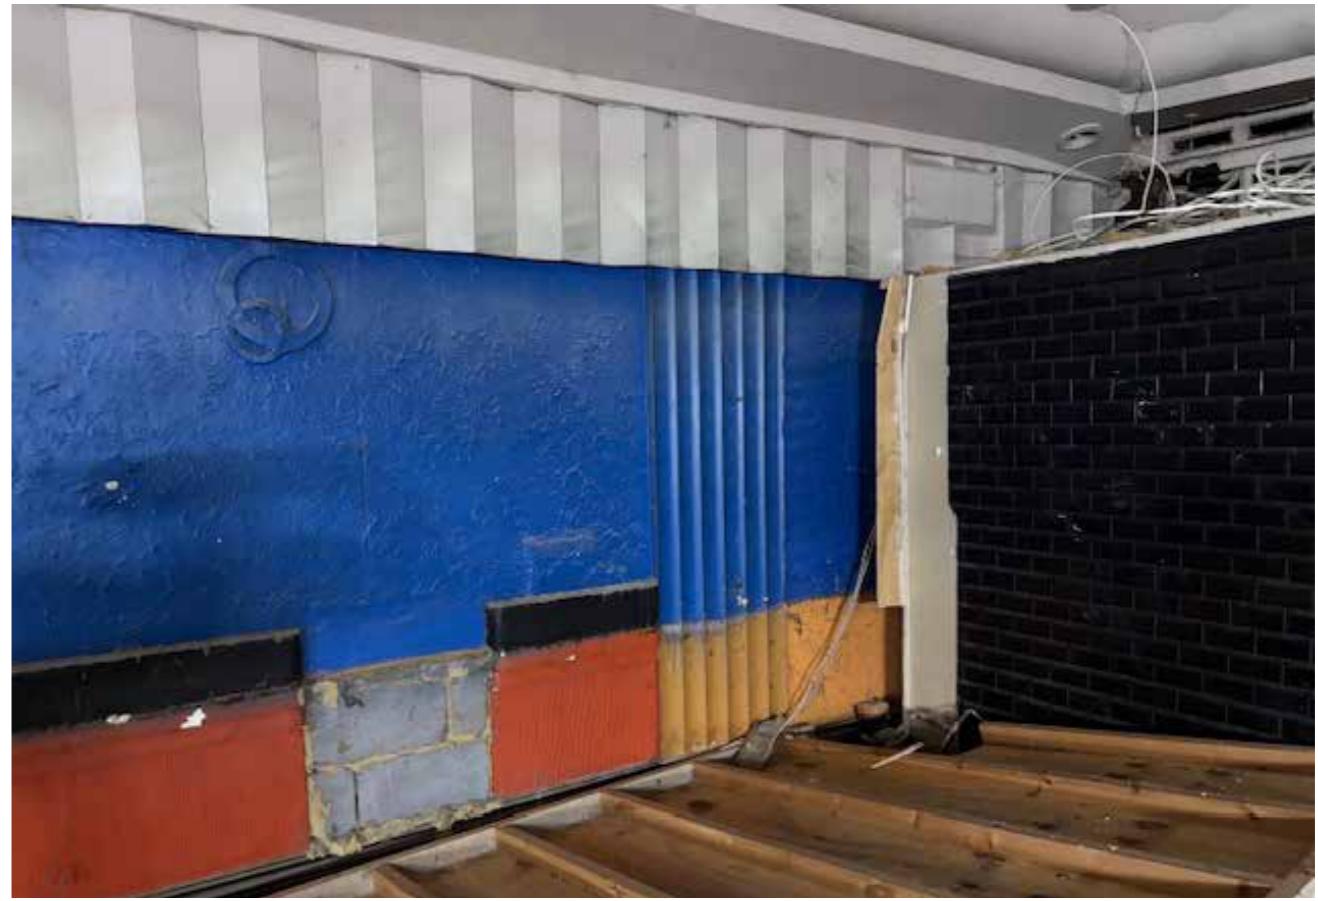
Original rear wall and plaster work exposed.

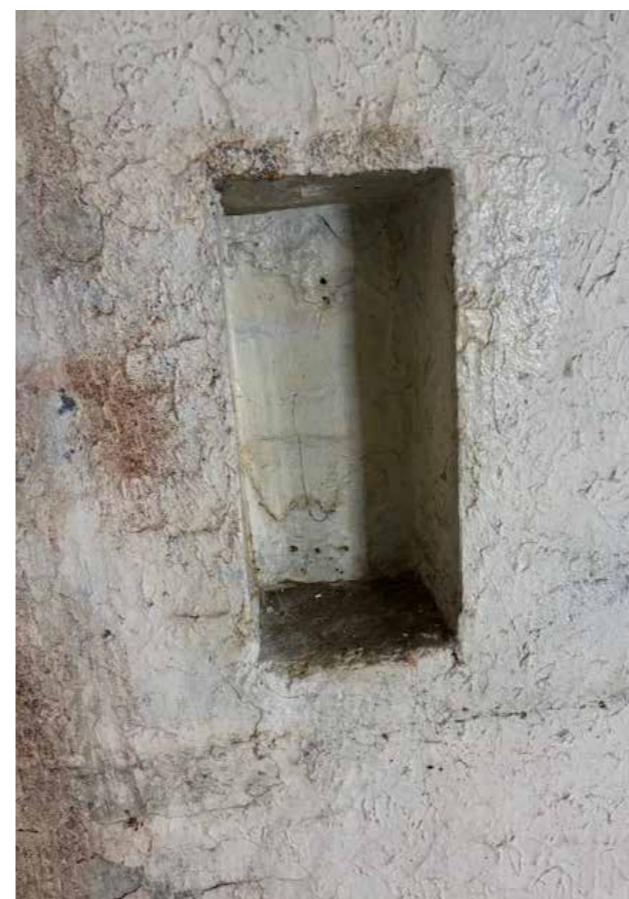
Original Niche and fire hose exposed.

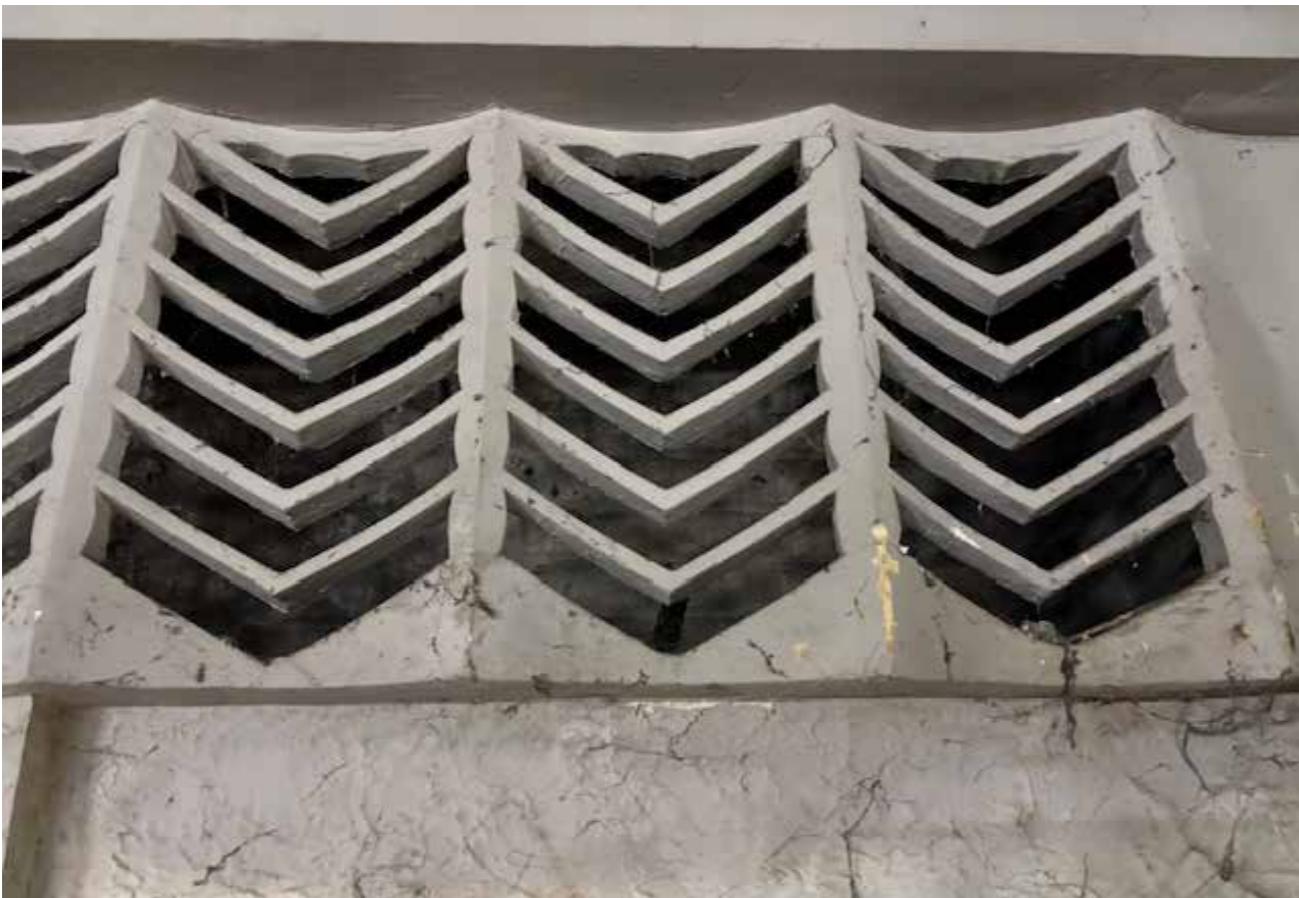
Original heating vents exposed in plaster work.

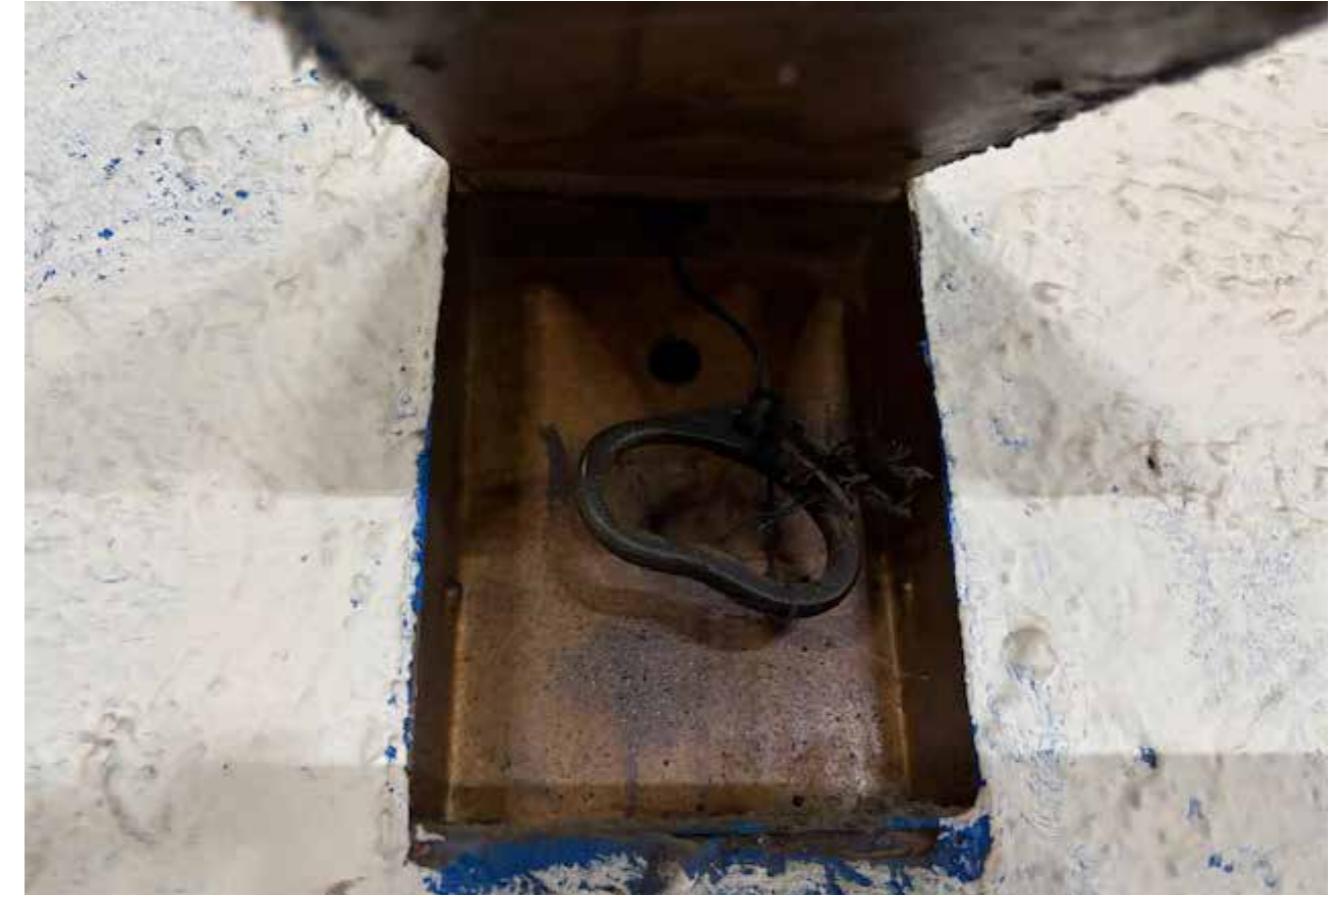
Possible original smoke vent pulley handle.

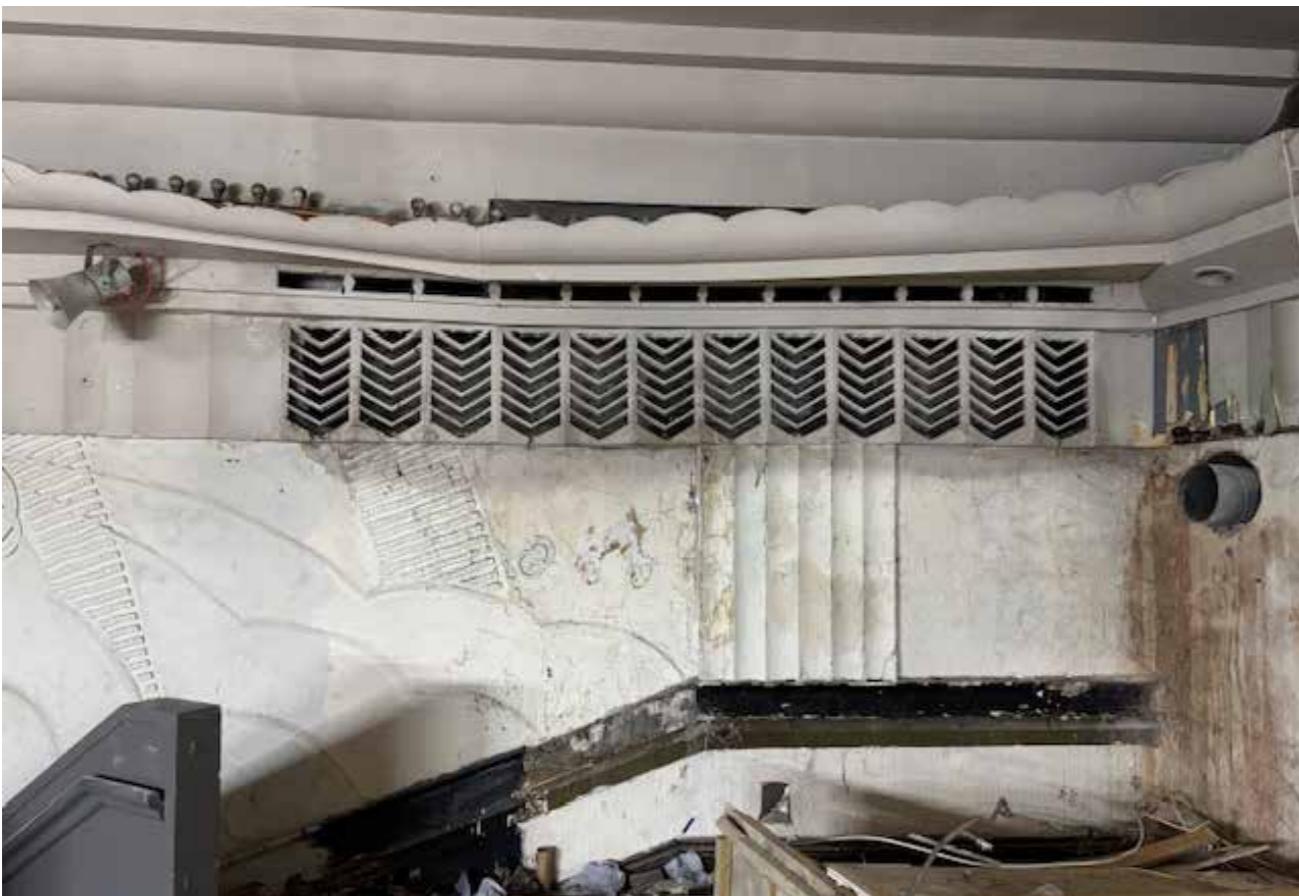
Original plaster work to upper side wall and damage caused prior to demolition of nightclub features.

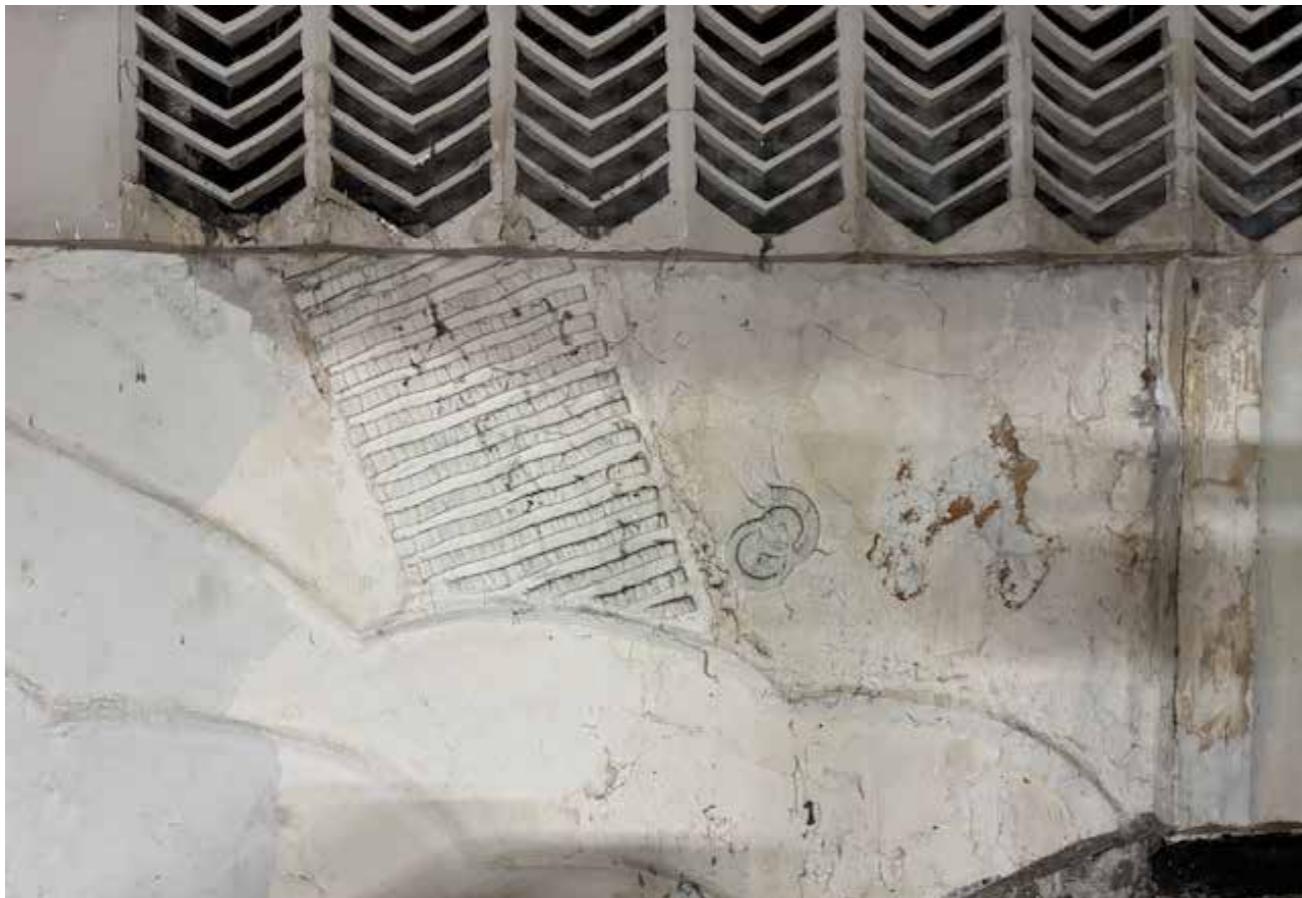
Original vents and plaster features revealed.

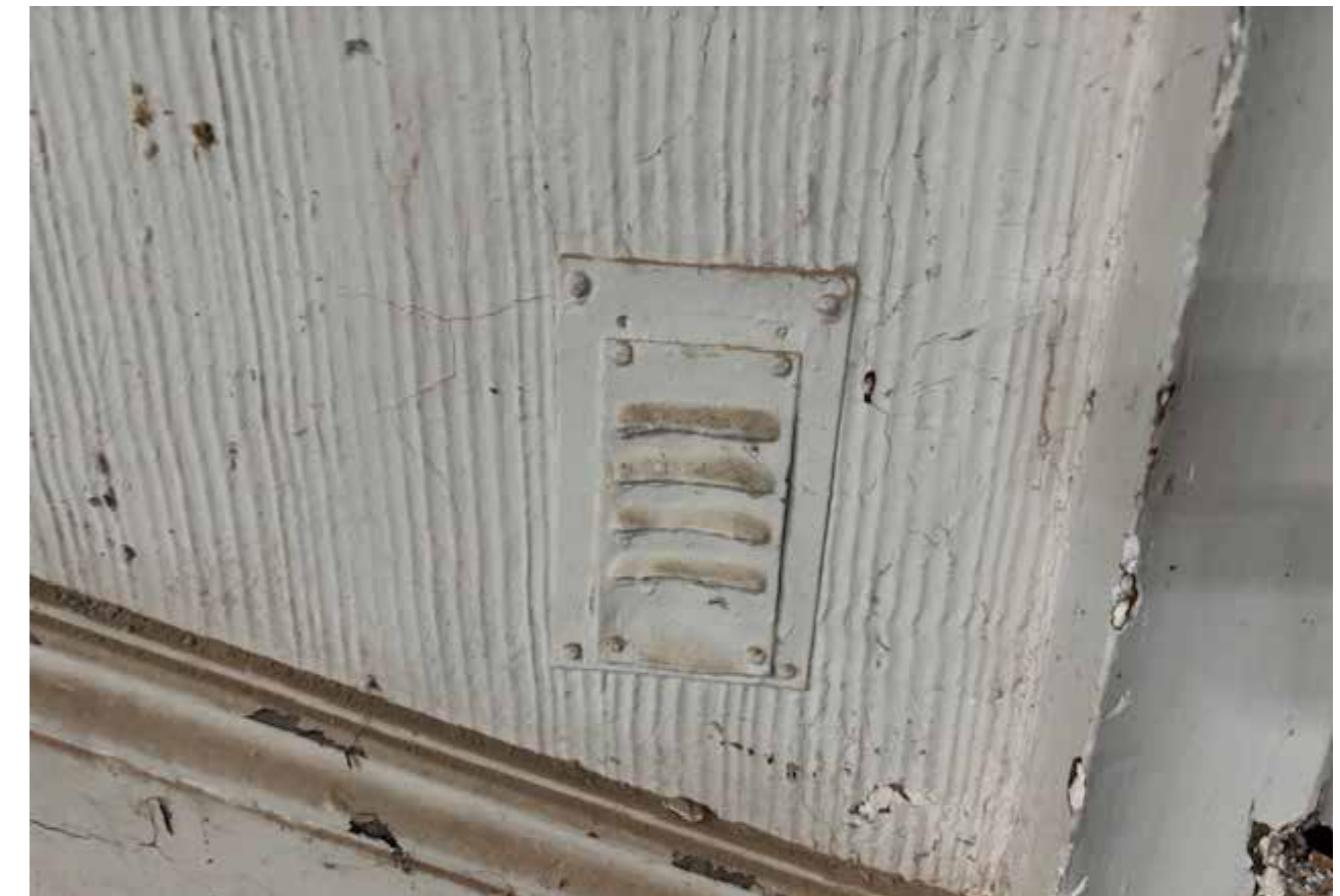
Original moulding, skirting and lighting revealed.

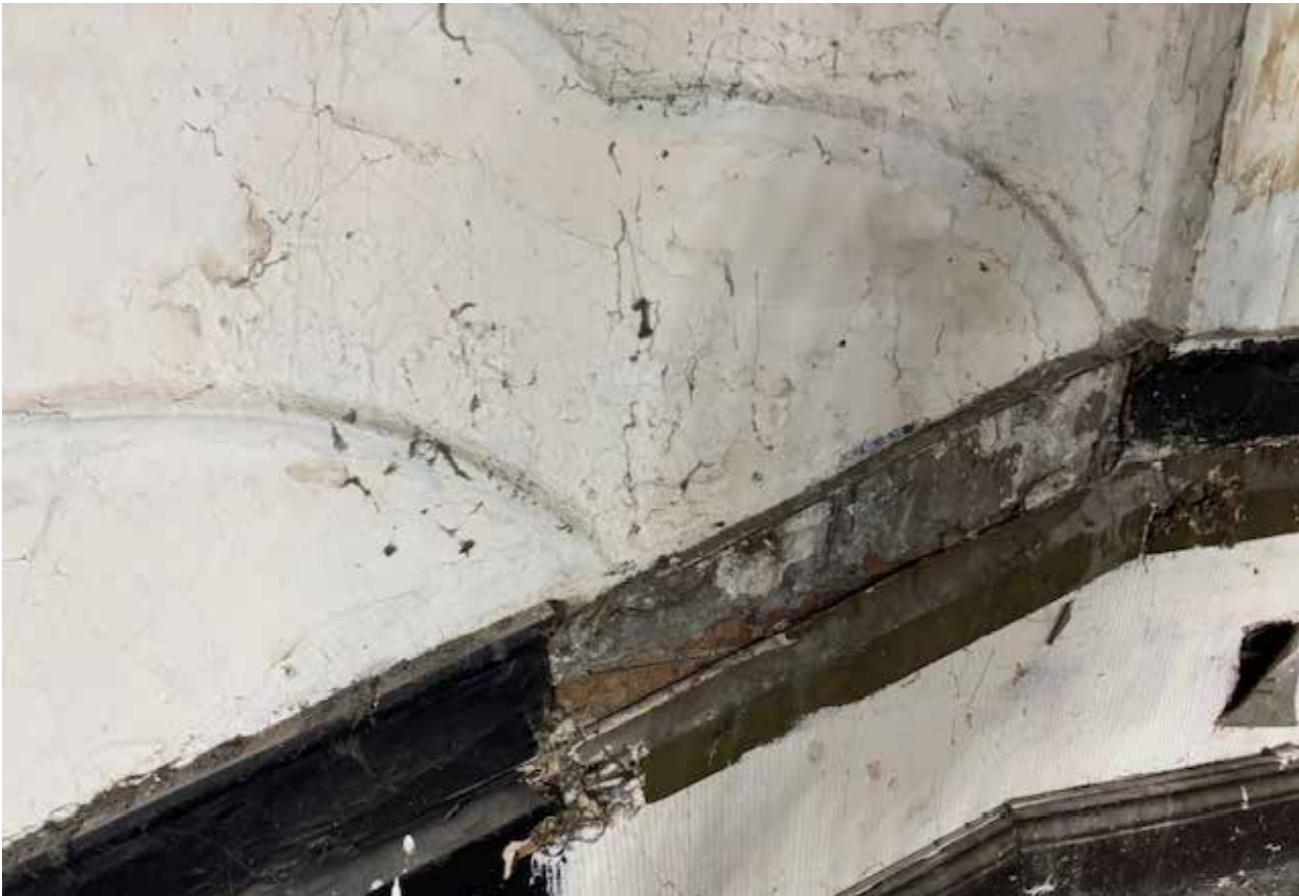
Damage to moulding and plaster revealed behind nightclub walls.

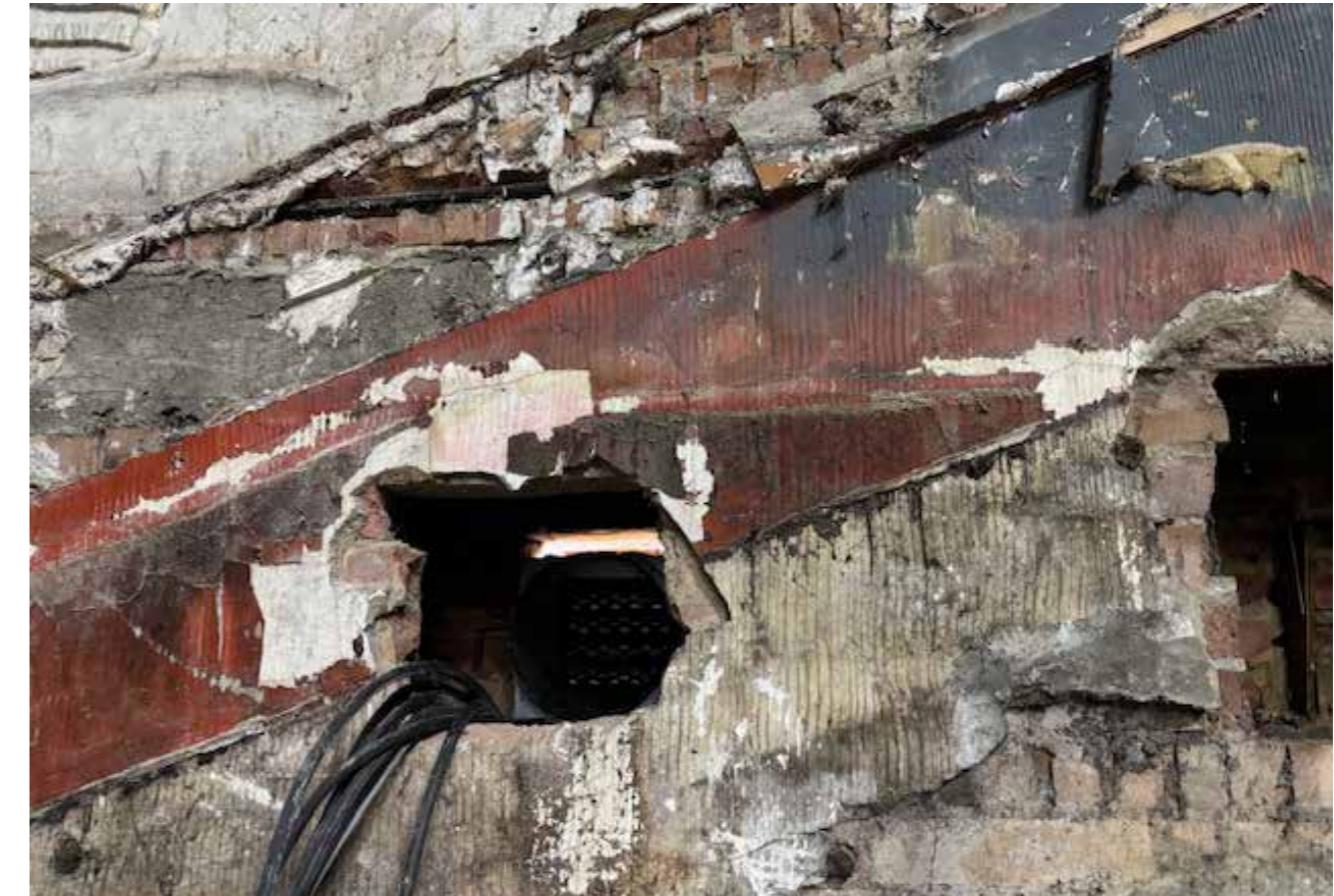
Damage to moulding and plaster revealed behind nightclub walls.

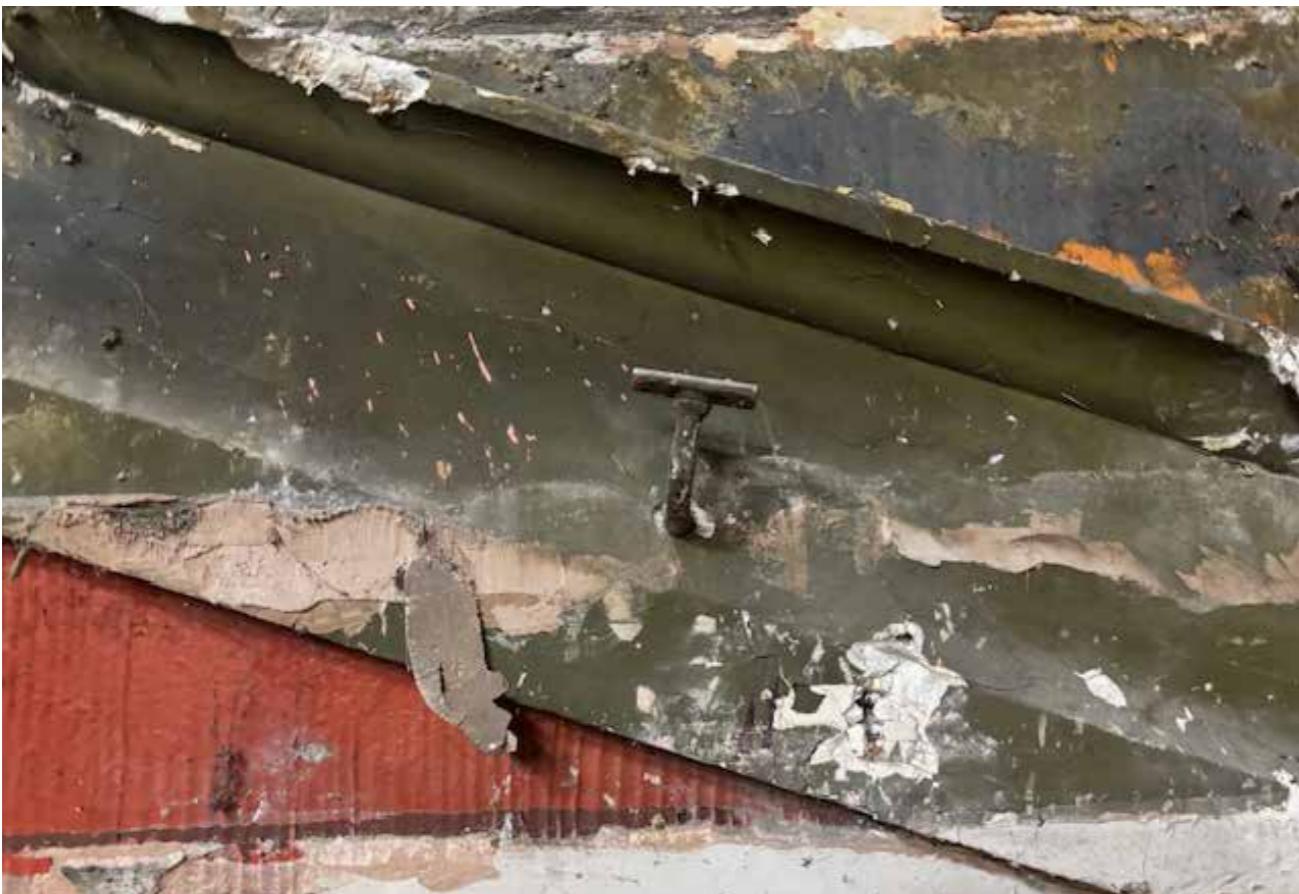
Exposed moulding to side walls and mezzanine seating handrail bracket.

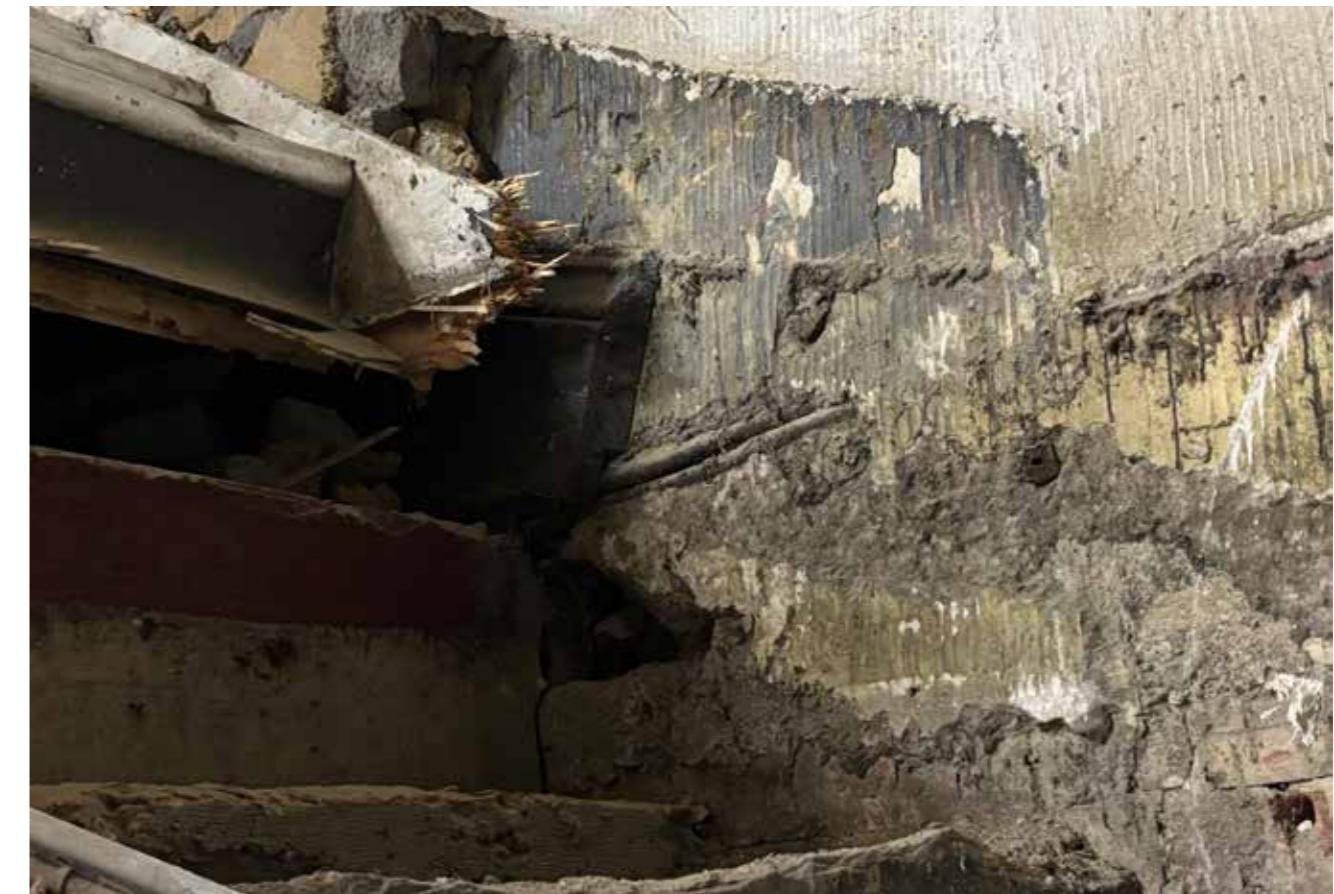
Original skirting and line of original mezzanine seating revealed.

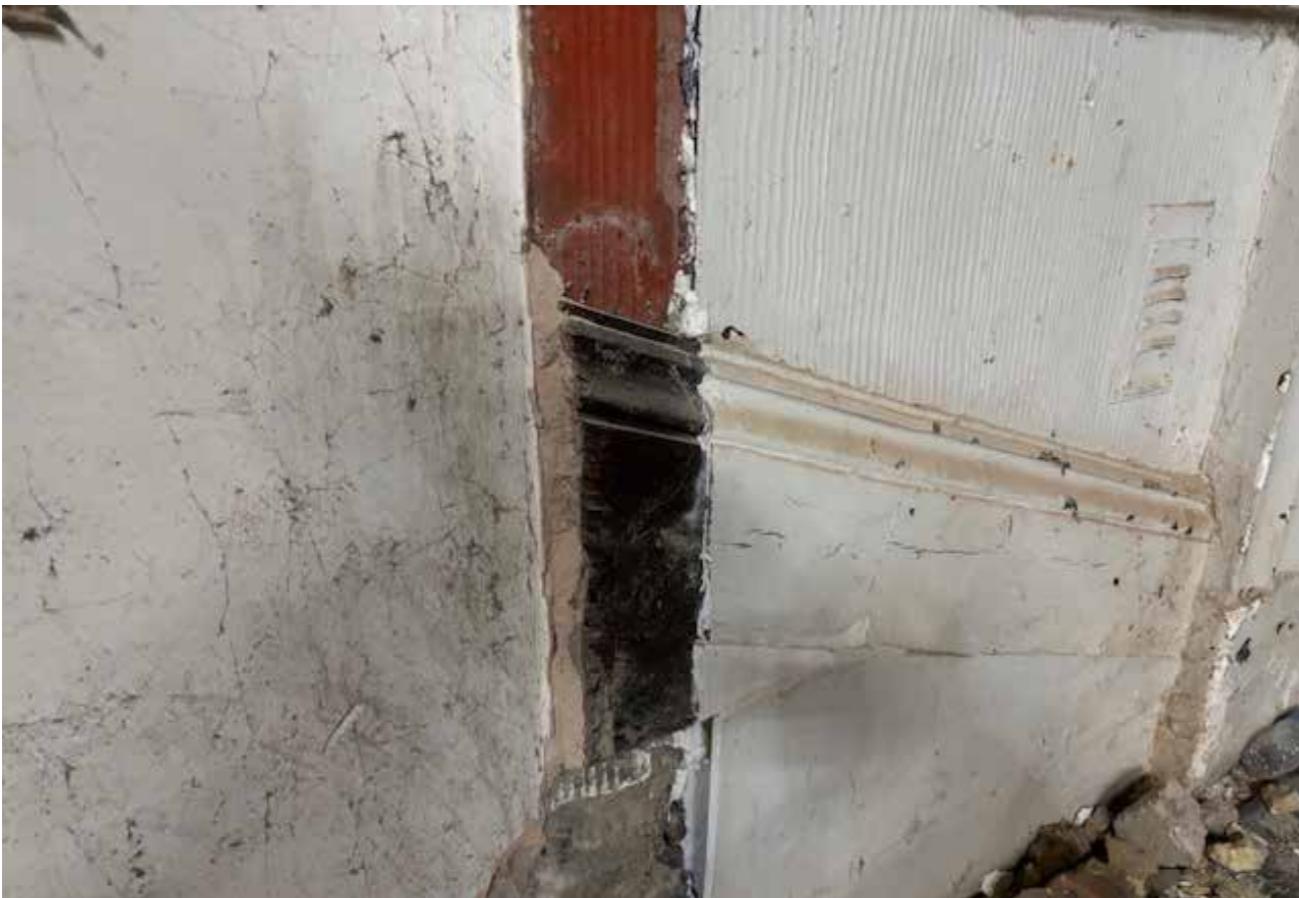
Original sloped seating line revealed.

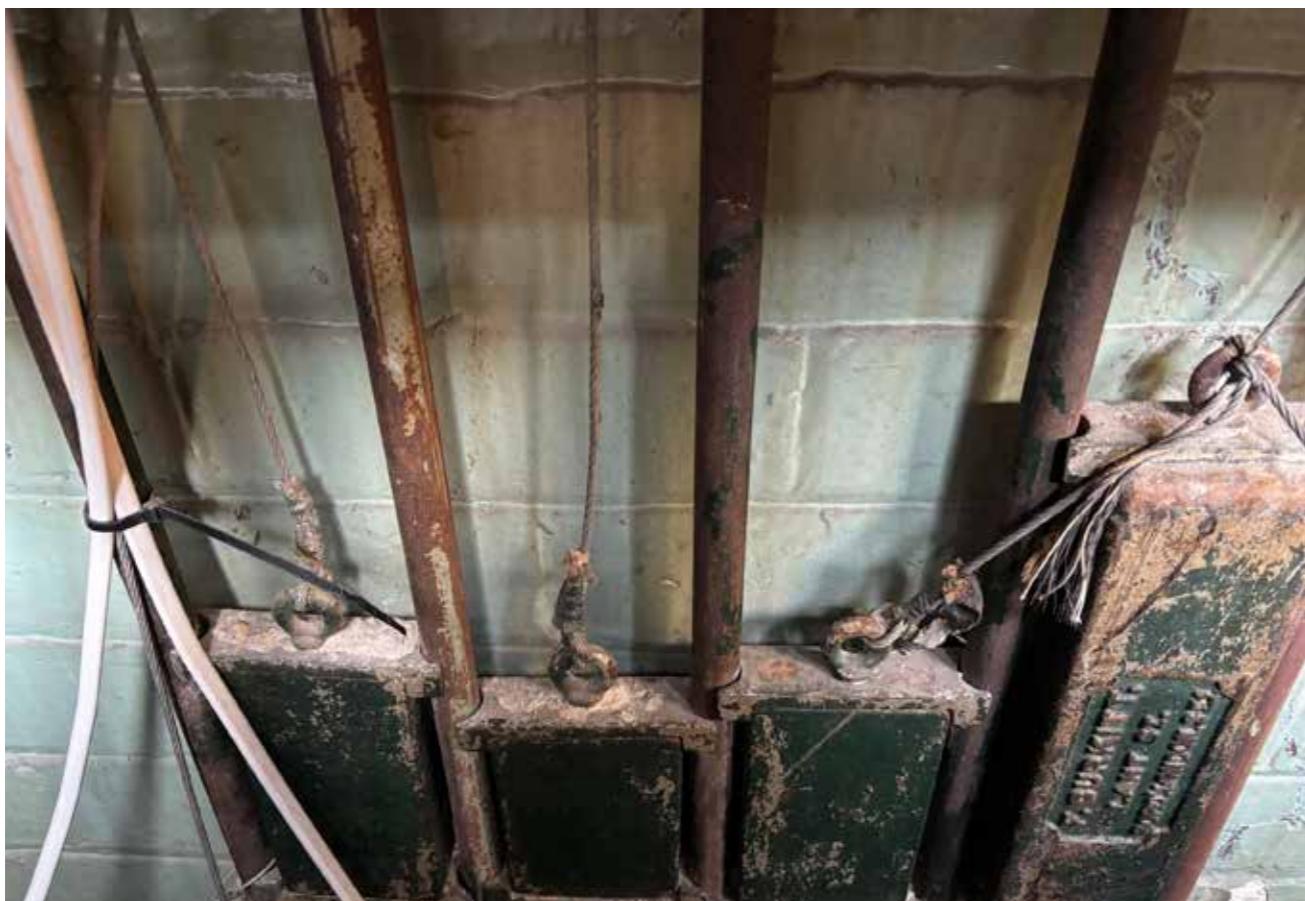
Original weight and pulley system revealed - possible smoke extraction vents.

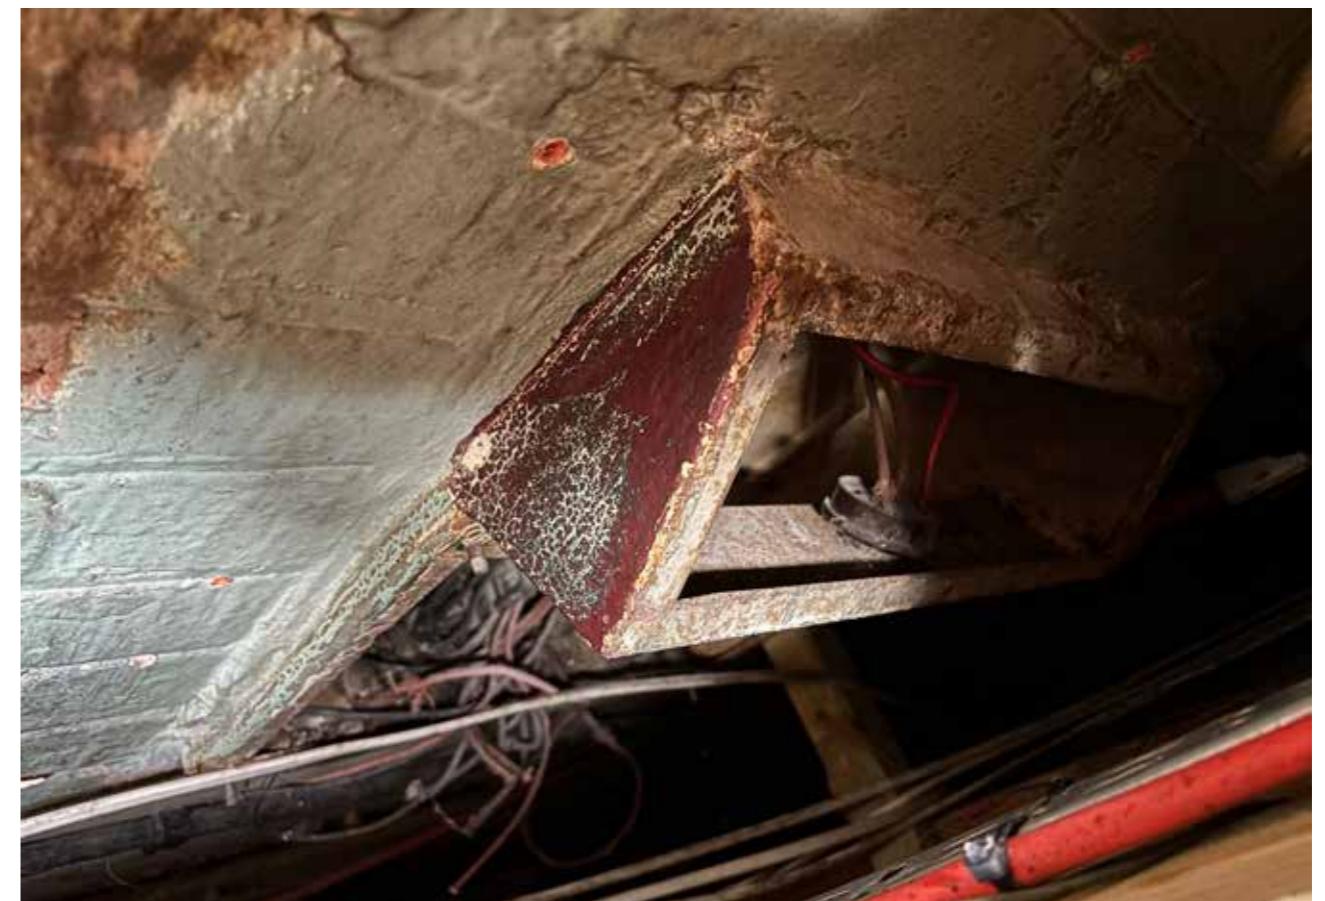
Original terrace external light revealed.
