DISCOTHEQUE ROYLE

233 High Street | Uxbridge | Hillingdon | UB8 1LD

HISTORIC FIBROUS PLASTER INSPECTION & CONSERVATION METHODOLOGY

Locker & Riley (L&R) Inspection & Conservation methodology for historic fibrous plaster interior fabric to the main auditorium of Discotheque Royel

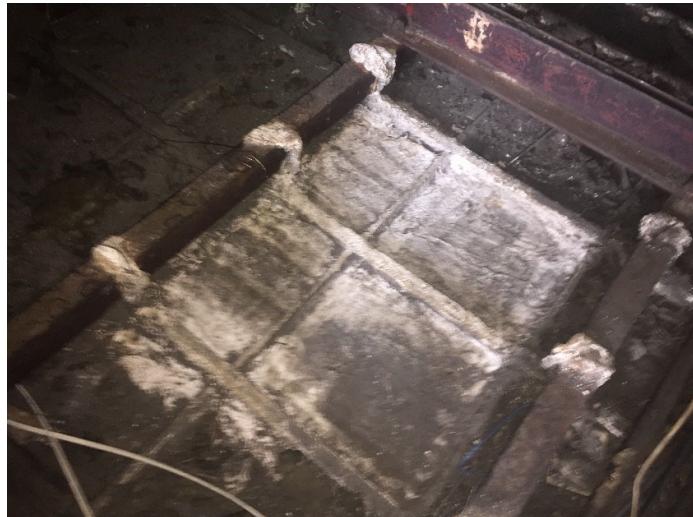
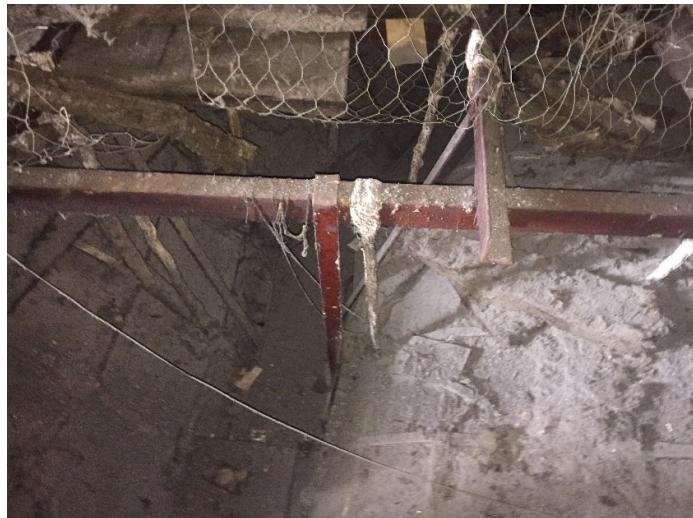
(1 above)-(2 below) cleaning of back of ceiling in progress for ABTT GN20 ceiling inspection-2018-(above and below) for assessment of stability & Integrity-Duty Holder C2018-Duty Holder removed all dangerous asbestos from the main auditorium ceiling void under instruction from previous duty holder.

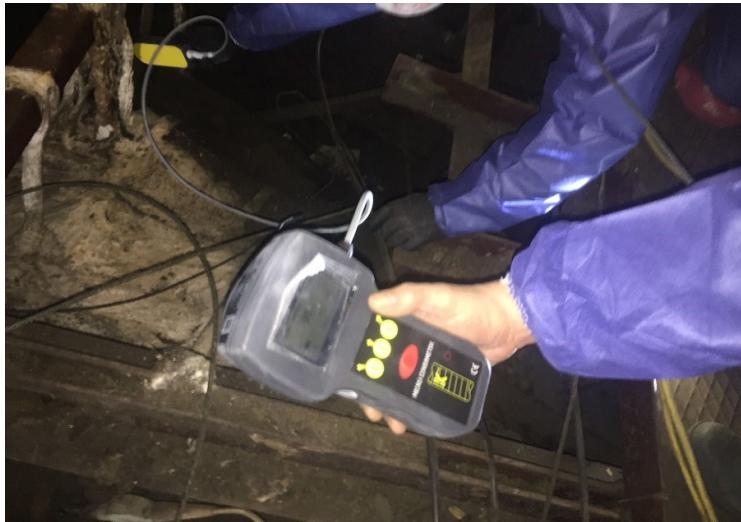
(3)-Inspection of plaster hessian wadding in main auditorium ceiling void with metal detector (Koltec Cover Meter)-ABTT GN20 inspection-further details of inspection report to be reviewed in 2018 Locker & Riley ABTT GN20 report-The back of ceiling of the main auditorium consists of 5no distinct bays-Duty Holder instructed 1no bay to be fully cleaned with all obstructions fully removed (insulation & chicken wire)-Remaining 4no ceiling bays have not received any formal ceiling inspection-Duty Holder to review compliance with Building Safety Act 2022 before opening main auditorium to general public.
