Taylor-Hammond Associates Ltd

Client: The London Empire, Formerly the Regal Cinema, Uxbridge

Project: Restoration of the Compton cinema organ pipe chamber contents and reconnect the console

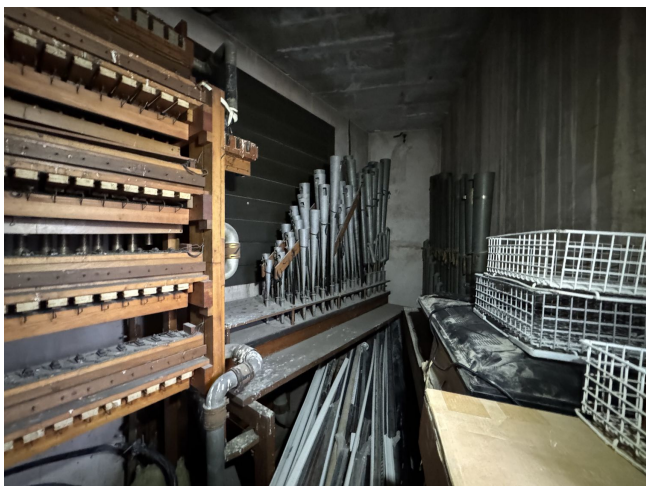
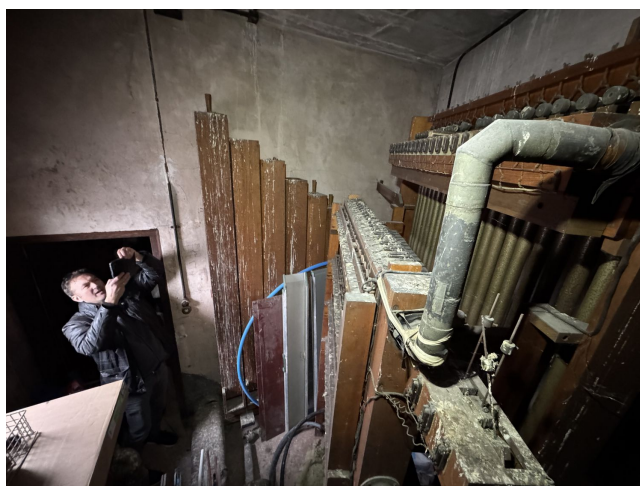
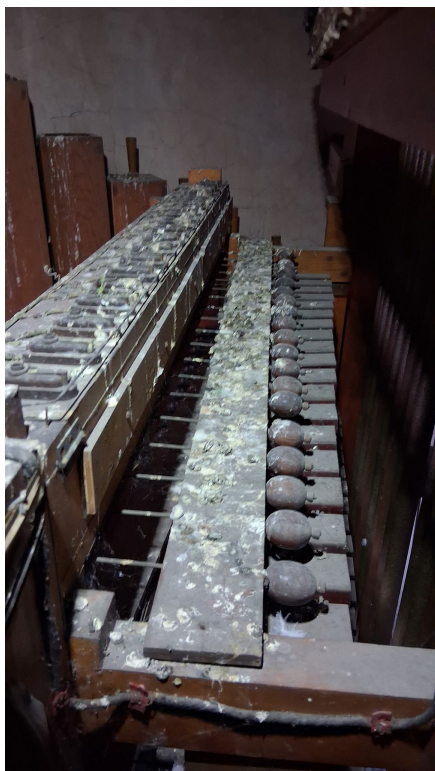
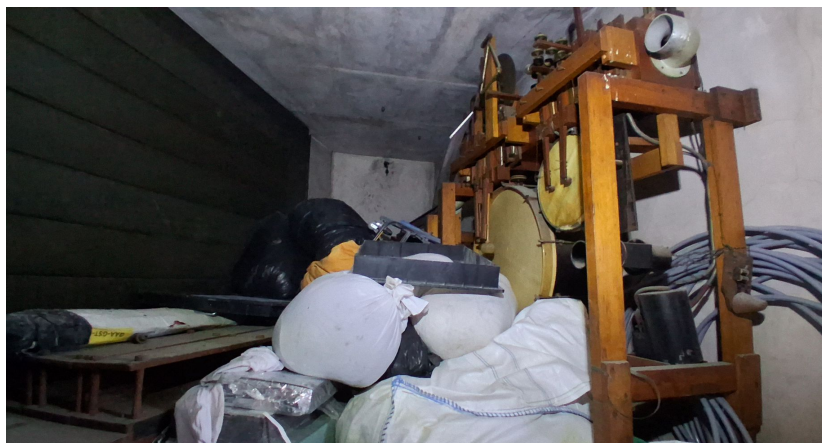
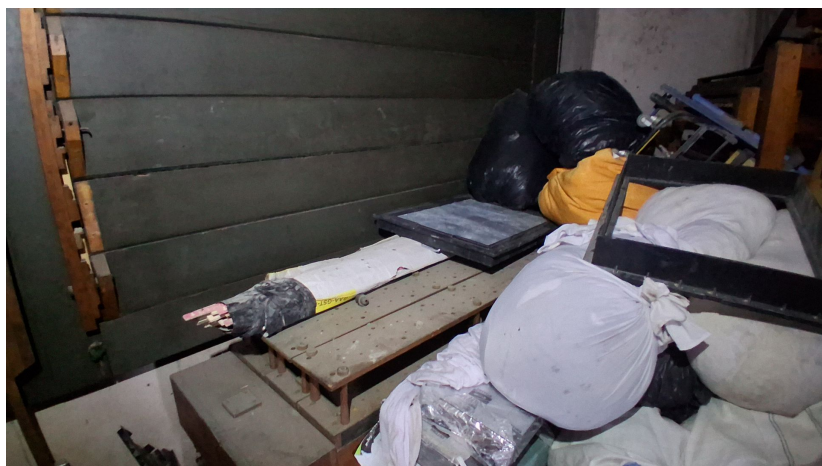
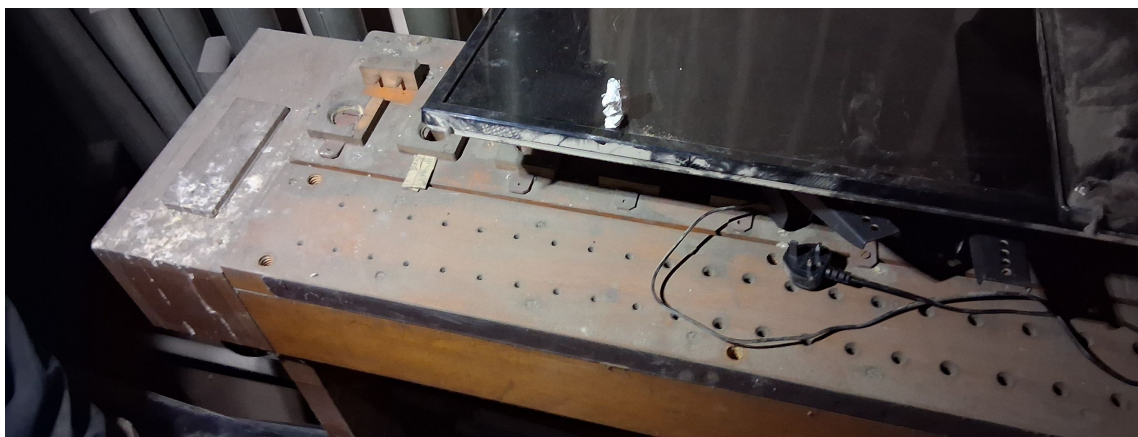
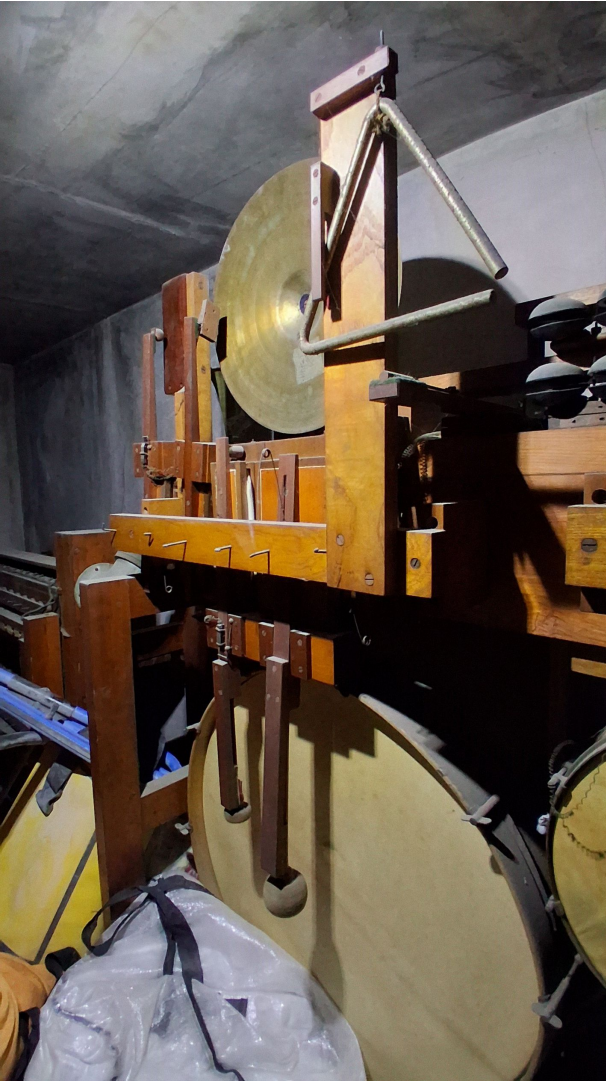
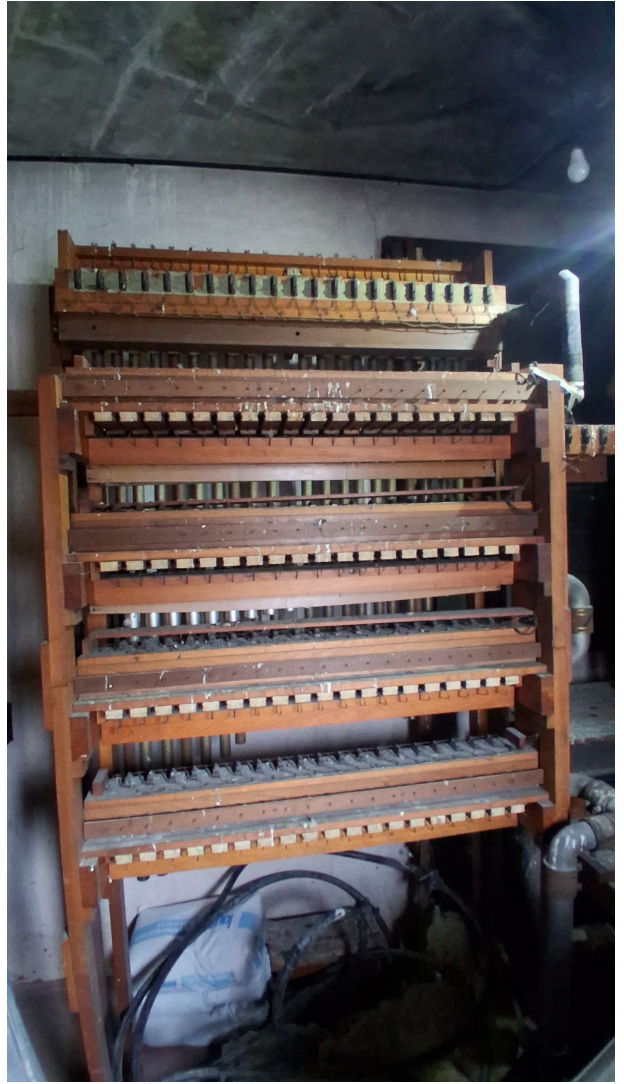
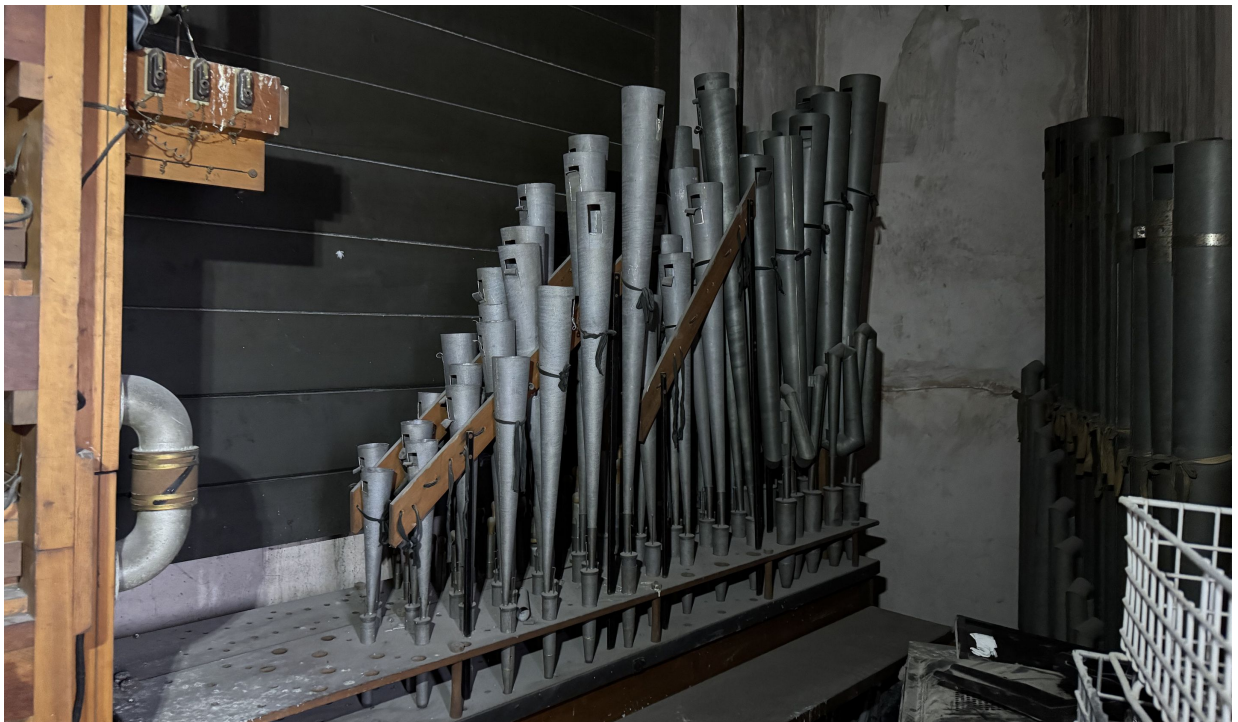
The photos below illustrate the current condition of the organ chambers:

One thing that would be hugely beneficial to the organ components in the chambers and blower room is to remove all the 'stuff' that's been put in there over the years. I strongly suggest that we are booked for a day's work to do this, plus a skip provided at the rear of the building to dump it all in (unless of course any items are required to be kept by the owner). We noted that new windows have already been installed at the chamber external window openings, which is very good and which increases general security, and I suggest that a new lockable door is put on the blower room entrance once the chambers have been cleared out.
