TREE SURVEY - HEALTH & SAFETY

Proj. No 9736	8 Ravenscourt Close, Ruislip, Middlesex, HA4 7PP	
Client:	Pat Taverner	
Date of Report:	23/09/2022

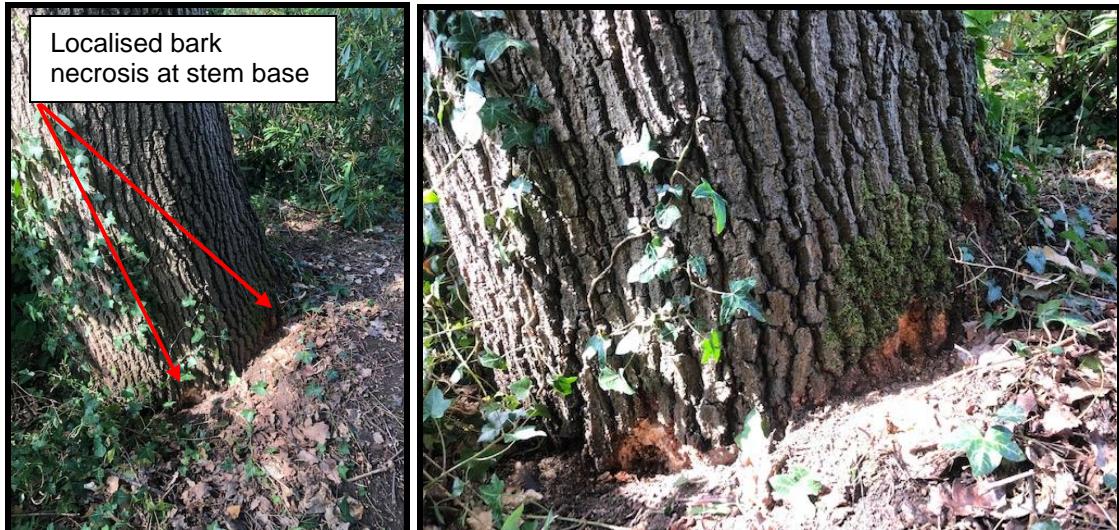
3.9 Tapping the lower stem with a sounding hammer did not reveal the presence of any notable decay and there was no visual evidence of any fungal pathogens around the base, or on the lower stem. However, located at the base of the stem on its eastern aspect are two areas of necrotic bark, beneath which localised decay is present that is likely to adversely affect the tree's vascular system. The affected areas are identified in the photographs below.

- 3.12 Given the above, whilst (T001) it is not considered to pose an imminent risk, it is recommended the deadwood is removed and a minor reduction and reshaping of its crown undertaken. The reduction should not exceed two metres on any aspect and its final dimensions following the works should be no less than 14m in height with a crown spread of 6m to the north, 6.5m to the east and 7.5m to the south and west. It is also recommended the lowest primary branch extending south that has an old rope swing encased within it is removed

- 3.14 It is also recommended that secondary investigations with a Resistograph Microdrill and/or PICUS are undertaken to ascertain the extent of decay within the stem. These investigations can then be repeated during the annual re-inspection, which will enable an objective assessment of the progression of decay to be quantified.

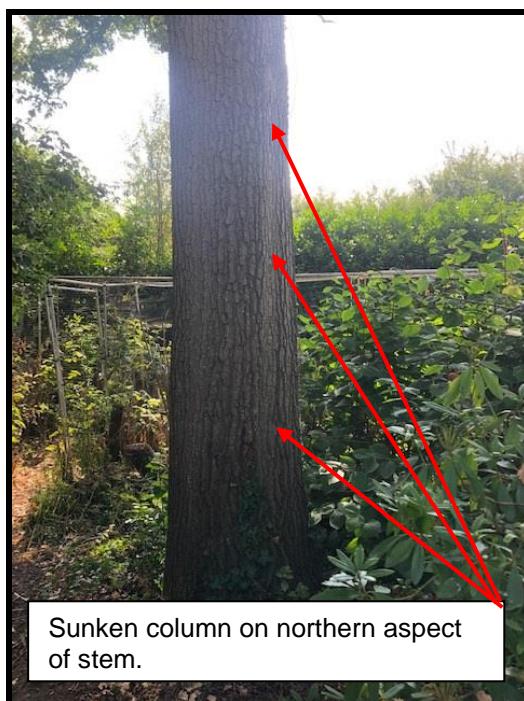
3.10 On the stem's northern aspect is a sunken column of wood, up to 0.3m in width that extends from its base to circa. 2m above ground level. Whilst tapping the stem around the sunken area with a sounding hammer did not reveal the presence of notable decay, this growth characteristic is often associated with localised root decay and / or death. The sunken column is identified in the photograph below.

- 3.13 Subsequent to the works being undertaken, the tree should be inspected annually for the following 5 years to assess whether the bark necrosis and associated decay is continuing to progress around the base of the stem. It will also enable its vigour to be closely monitored and thereby ascertain if further areas of branchtip dysfunction and dieback are occurring throughout its crown.
