CCTV Inspection Report

Metro Rod (London North West)

Job Number 919711	Surveyed by (Operator) MR MARTIN DOLLING	Base Unit XGFC6NDUIN	Date 25/03/2024
-----------------------------	--	--------------------------------	---------------------------

28 MOOR PARK ROAD
NORTHWOOD
HA6 2DJ

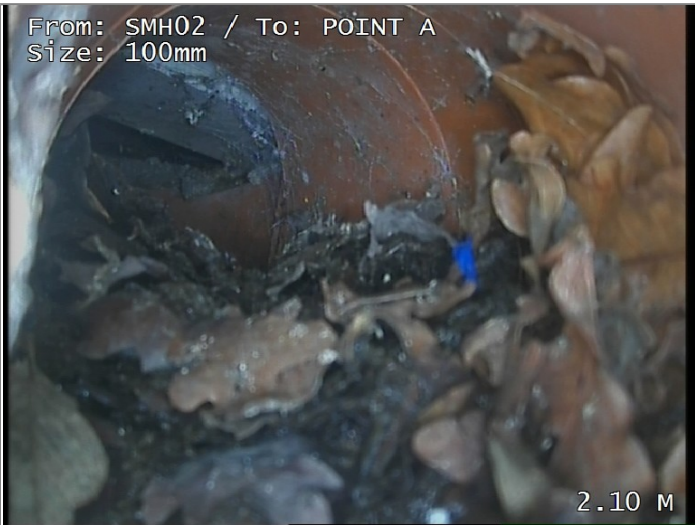
<p>2.10 M</p> <p>Settled deposits fine 50% cross-sectional area loss - Remark: LEAVES</p>

Service Defects			
Section	PLR	Grade	Fault Description
5	POINT A X	4	Settled deposits fine 50% cross-sectional area loss - Remark: LEAVES
6	SMH02 X	4	Settled deposits coarse 25% cross-sectional area loss, Start
13	FMH06 X	4	Attached deposits, encrustation from 12 to 12 o'clock 30% cross-sectional area loss

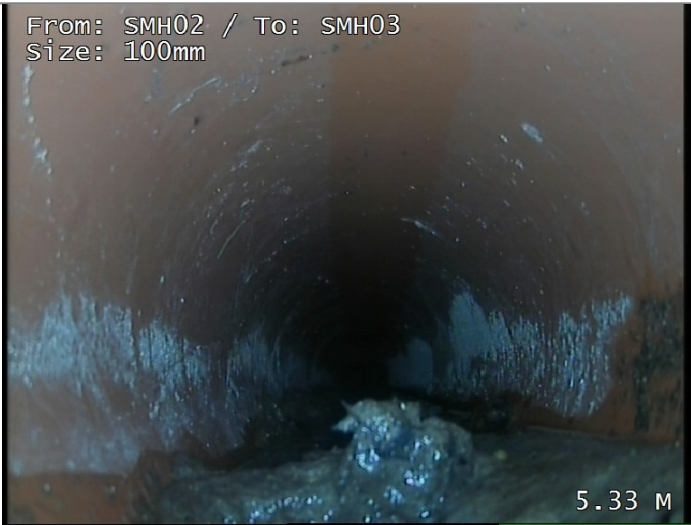
<p>5.33 M</p> <p>Settled deposits coarse 25% cross-sectional area loss, Start</p>		<p>From: SMH02 / To: SMH03 Size: 100mm</p>

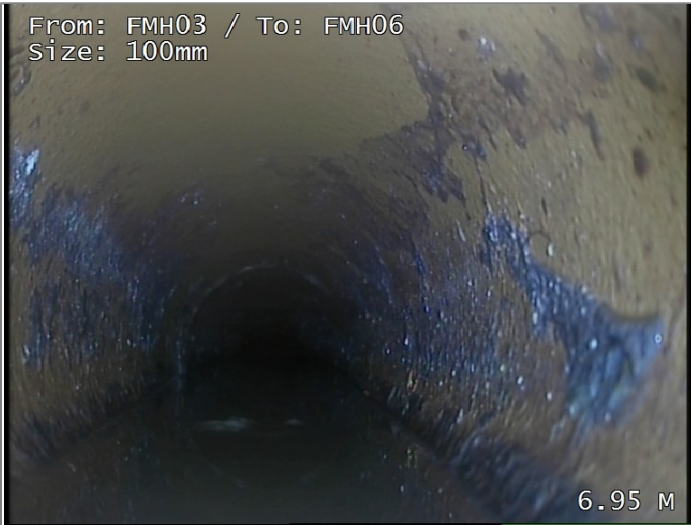
<p>6.95 M</p> <p>Turbid water level 25% height/diameter - Remark: CAUSE BY BLOCKED IC POSSIBLE CONCRETE</p>	
<p>From: FMH03 / To: FMH06 Size: 100mm</p>

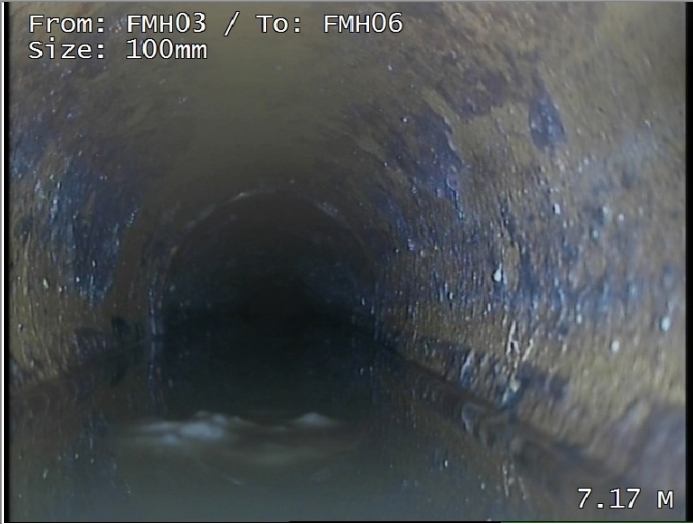
<p>7.17 M</p> <p>Turbid water level 25% height/diameter, Start</p>		<p>From: FMH03 / To: FMH06 Size: 100mm</p>

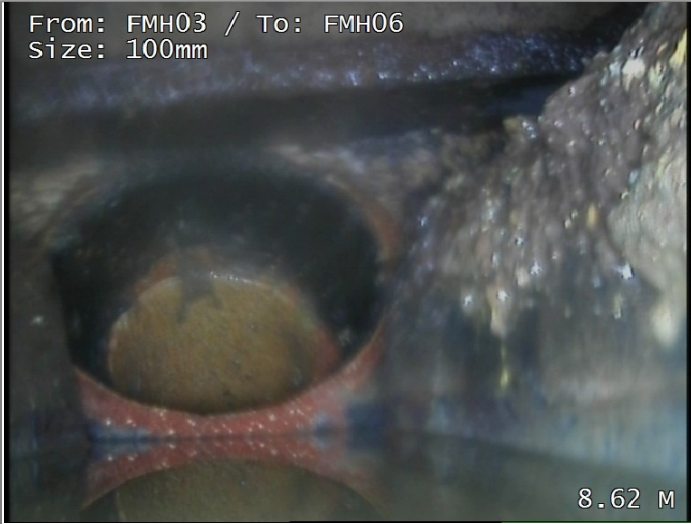
<p>8.62 M</p> <p>BLOCKED IC POSSIBLE CONCRETE CANT CLEAR</p>	
<p>From: FMH03 / To: FMH06 Size: 100mm</p>

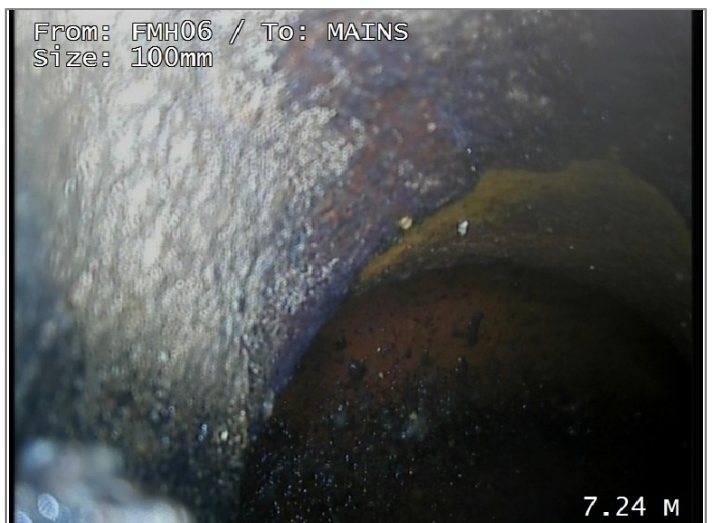
Attached deposits, encrustation from 12 to 12 o'clock 30% cross-sectional area loss
