Arboricultural Appraisal

28 Moor Park Road, HA6 2DJ

Report Reference: 211770r_AA001_25-26

Date of inspection: 10/02/2026

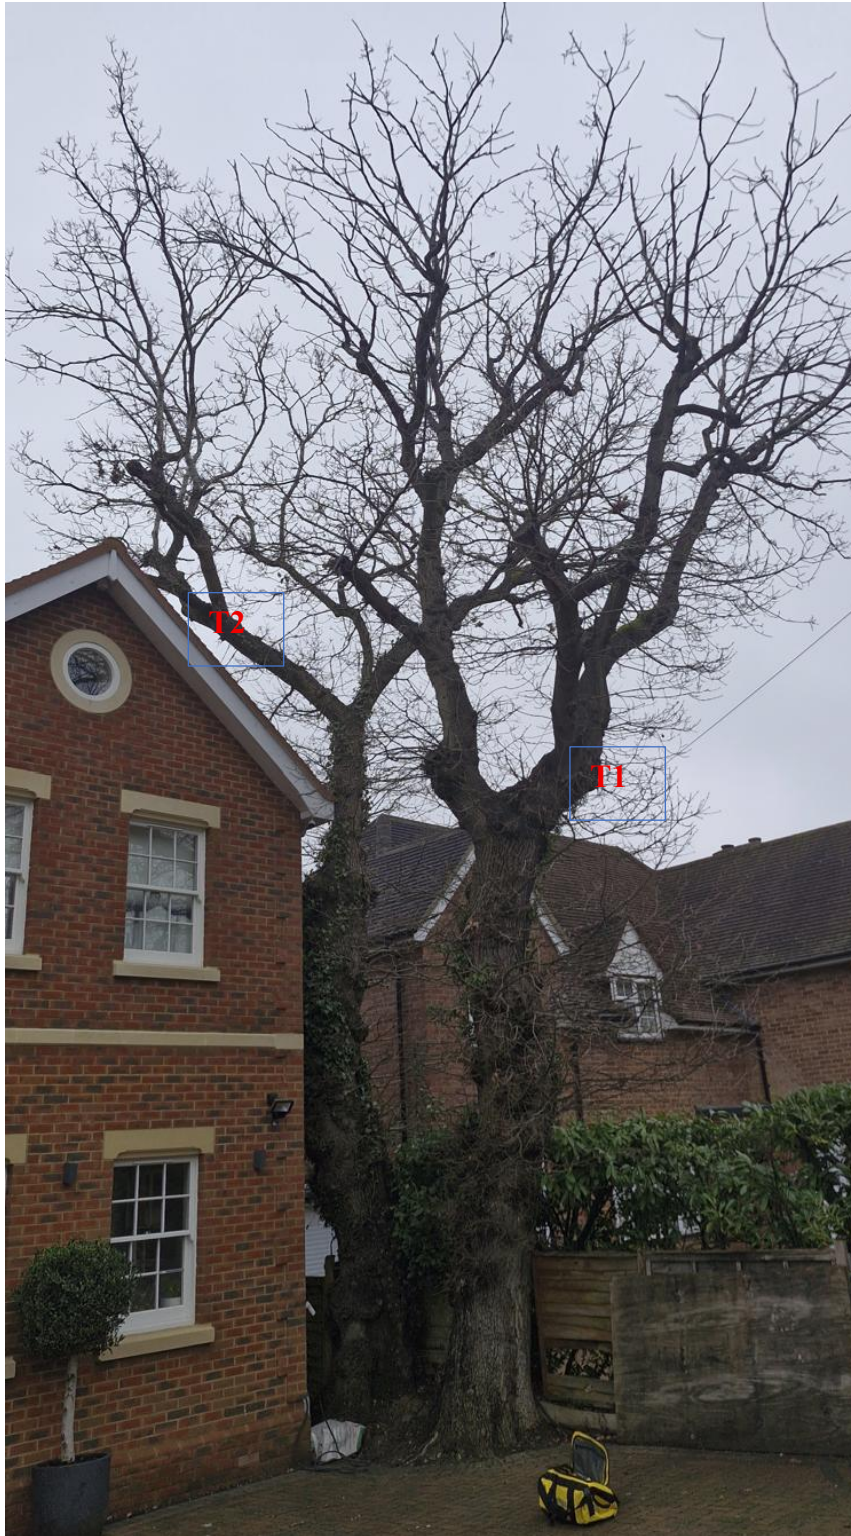
- 5.1 T1 and T2 are located adjacent to 28 Moor Park Road. There is obvious die-back within the upper crown of T1

Fig 2) T1 and T2 within 1.5m of property

Fig 2) T1, T2 and T3 with the collapsed Poplar in the background

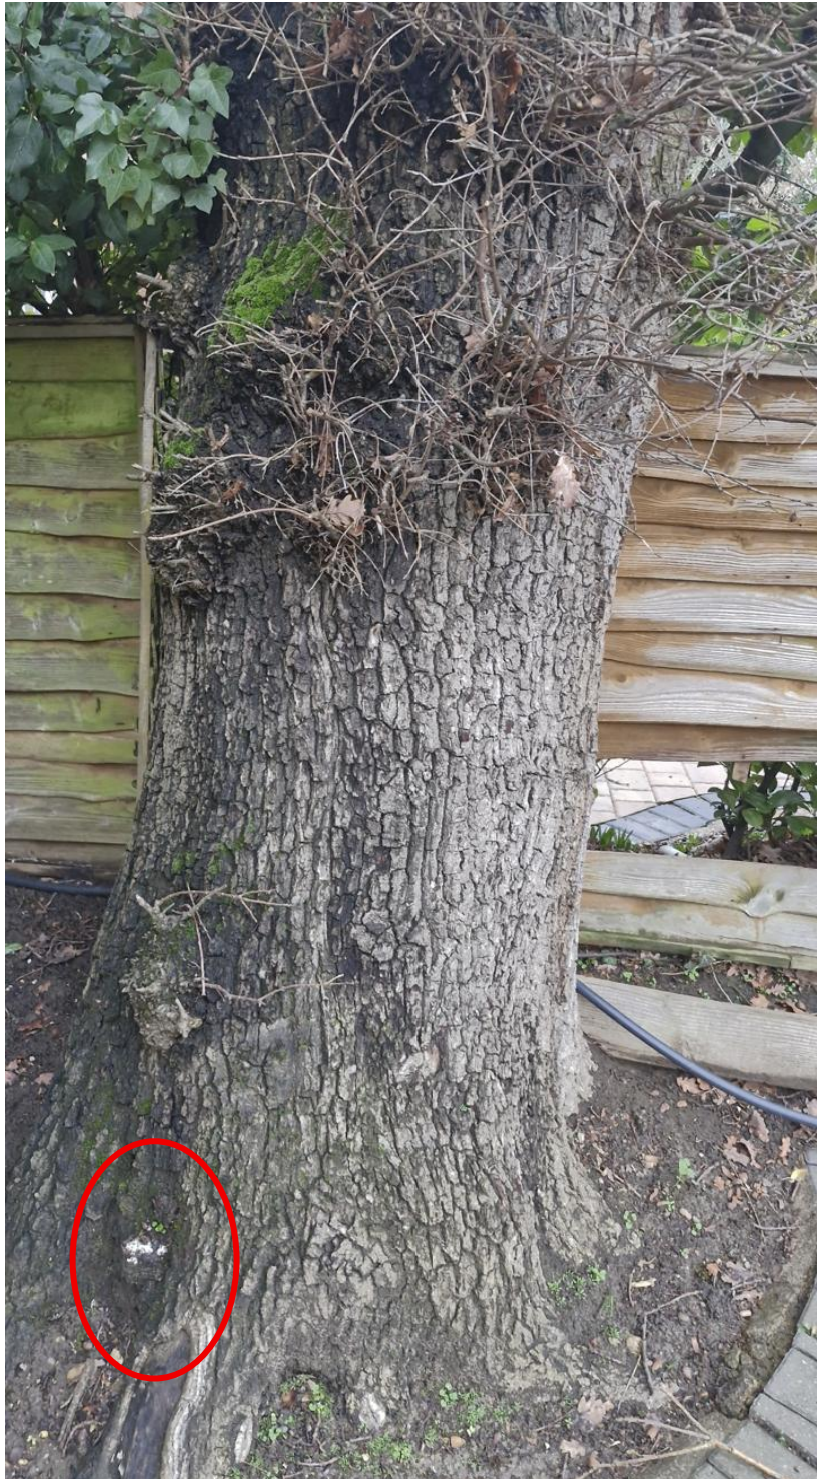
- 5.2 There is an obvious fungal fruiting body present at the root crown of T12, there is also the production of lower stem epicormic growth, consistent with a stressor such as a poor rooting environment and/or the presence of a physiological issue such as what a fungal fruiting presence could result in. Sounding mallet revealed a localised pocket of decay.

Fig 3) T1 Lowe stem, fungal fruiting body and epicormic growth

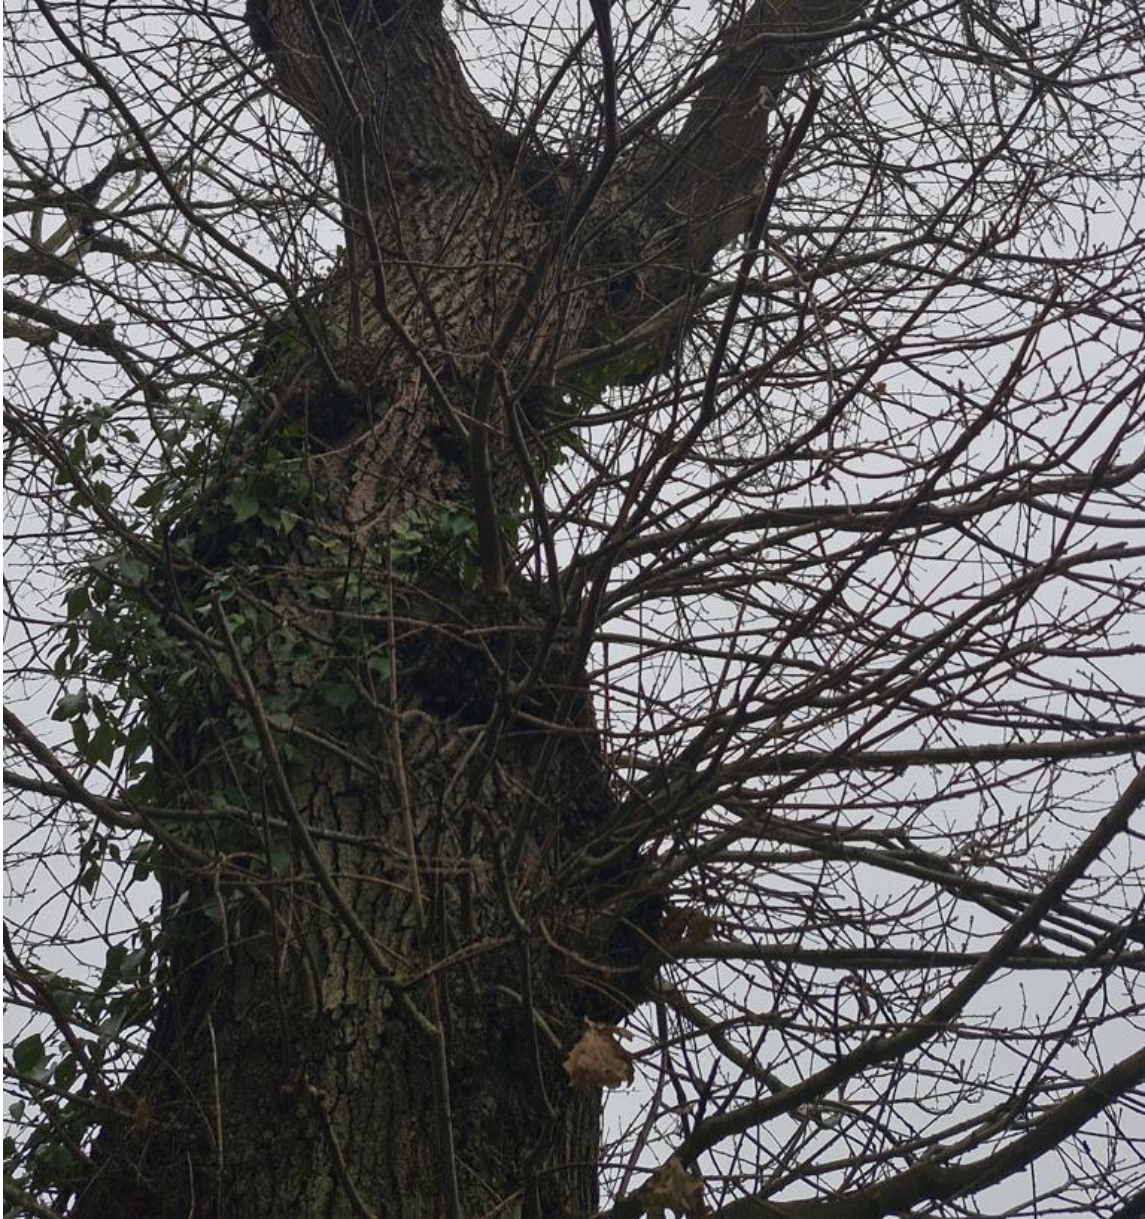
- 5.3 The upper stem of T1 has also generated prolific epicormic growth, consistent with a stressor such as a poor rooting environment or the presence of a physiological issue.

Fig 4) T1 upper stem and crown break

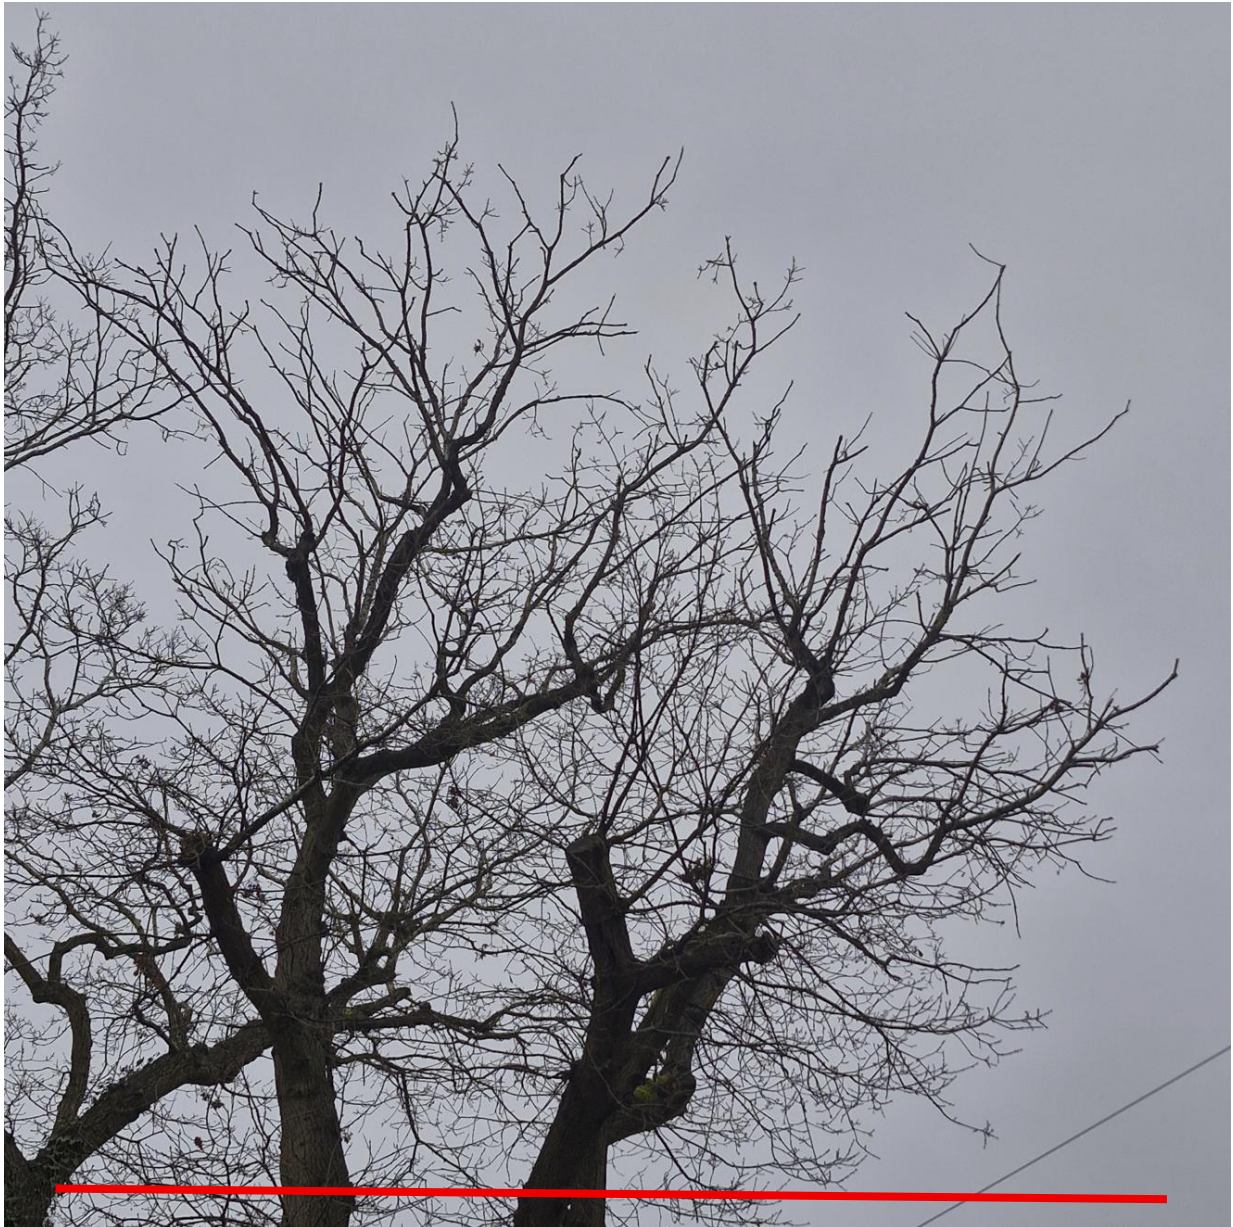
- 5.4 The upper crown of T1 is entrenched to the point of no bud production. The top 5m of T1 no longer has the capacity to stabilise itself through physiological processes feeding biomechanical tolerance to strong weather events. Without proactive works there is a likelihood of failure beyond any risk tolerance parameters set out by VALID or other risk models such as QTRA. All bud production that can be seen within fig 5 is from the adjacent tree T2, which in itself is not prolific and consistent with a healthy tree.

Fig 5) T1 upper crown. Lack of bud production leaving the entire top 5,m of this tree dead with little to no biomechanical tolerance towards strong winds or other extreme weather events.

- 8.1 The upper crown of T1 is dead action is required.
- 8.2 The lateral growth from T2 extending over the property is regressing and entrenching action is required.
- 8.3 Ownership of both T1 and T2 is in question. This should be verified though the use of the deeds and measuring out property boundaries. The place from which the tree originates and/or where the greater part of the root crown resides is the place of ownership.

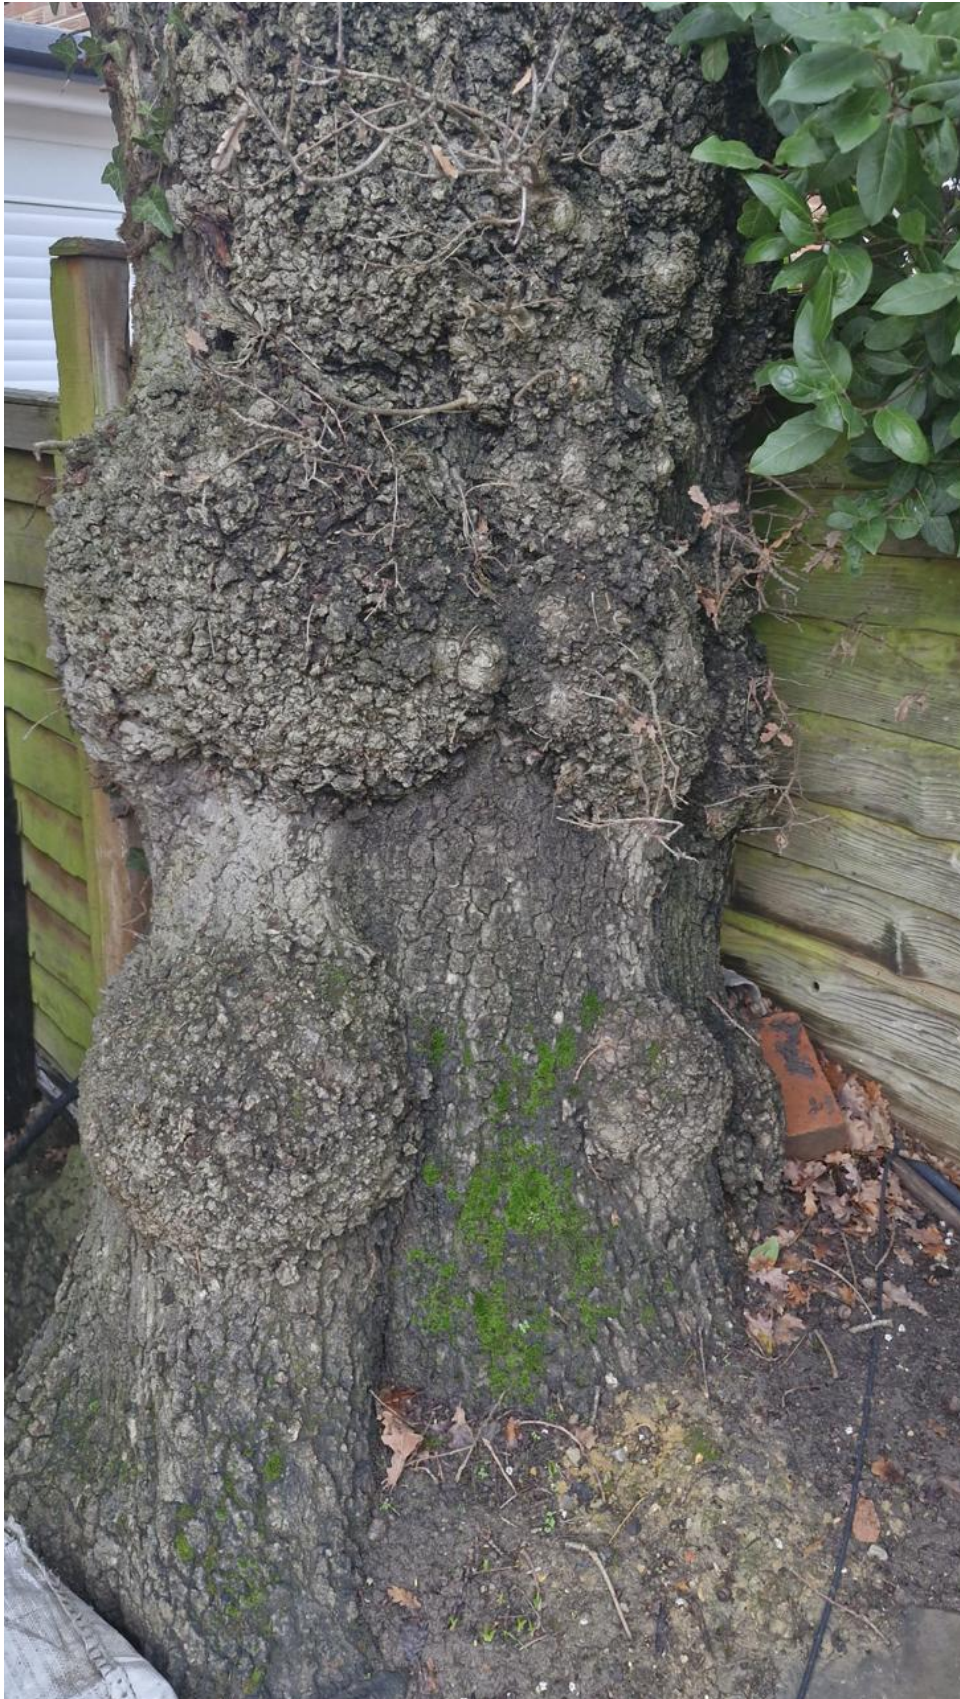
5.5 The lower stem of T2 is in relatively good condition. There is some wood cankering, but that is consistent with Oaks that are both in good condition and those that are suffering. The sounding mallet revealed no reason for structural concern at this level of the tree. This specimen has obvious proximity issues and has displaced the adjacent fenceline and is within 0.7m of the main structure of the property. This raises longevity concerns that whilst are not present now will required consideration in the future.

Fig 6) T3 Lower stem of T2. Proximity to structure. Mild epicormic response.

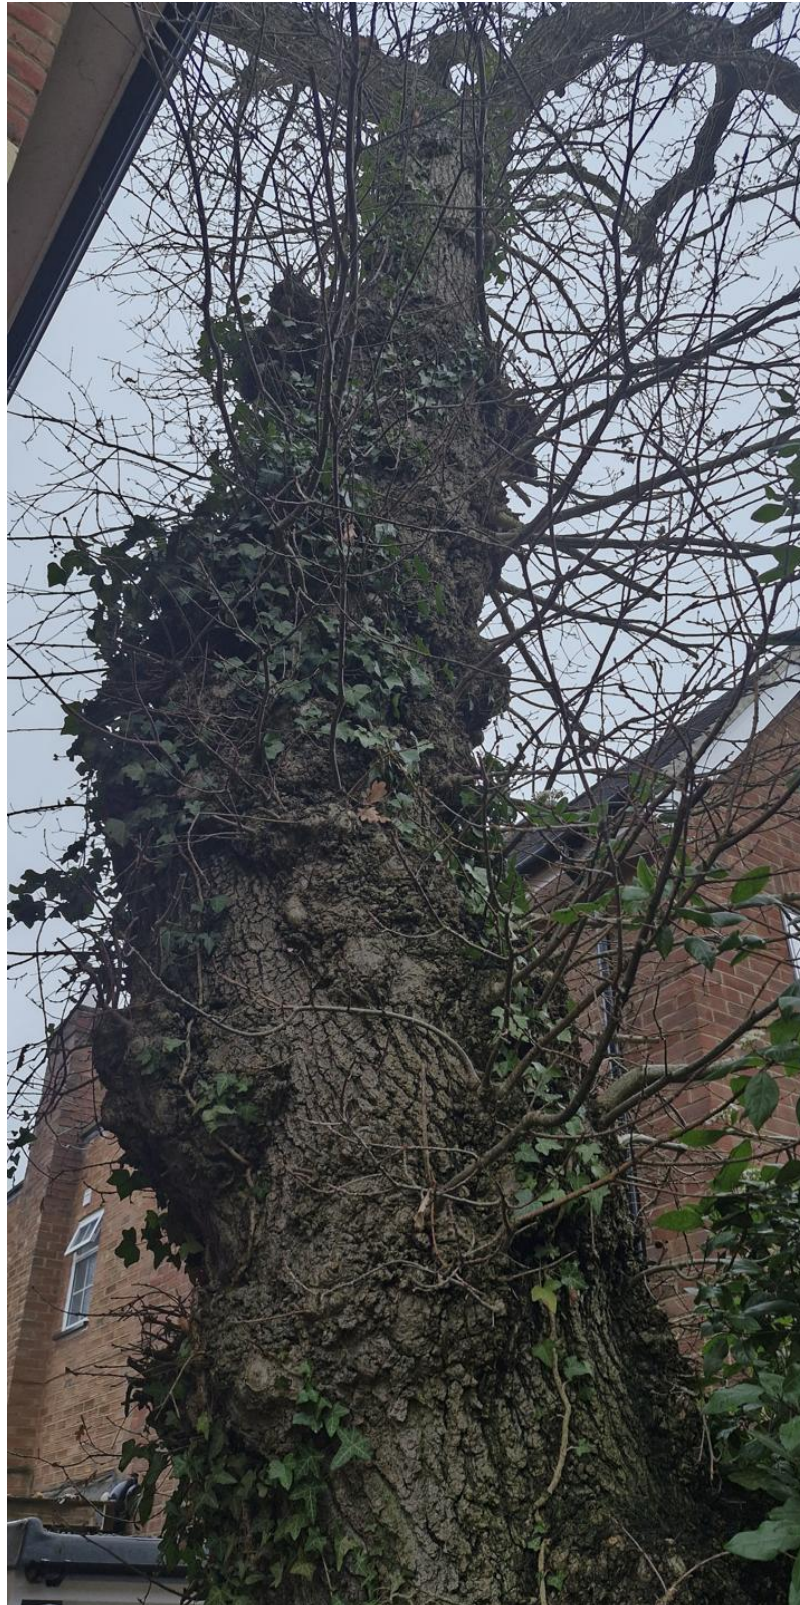
5.5 The stem of T2 is producing more epicormic growth than you would expect from a healthy specimen. There is a leaver to its growth habit that takes it within 0.5m of the property,

Fig 6) T2 upper stem

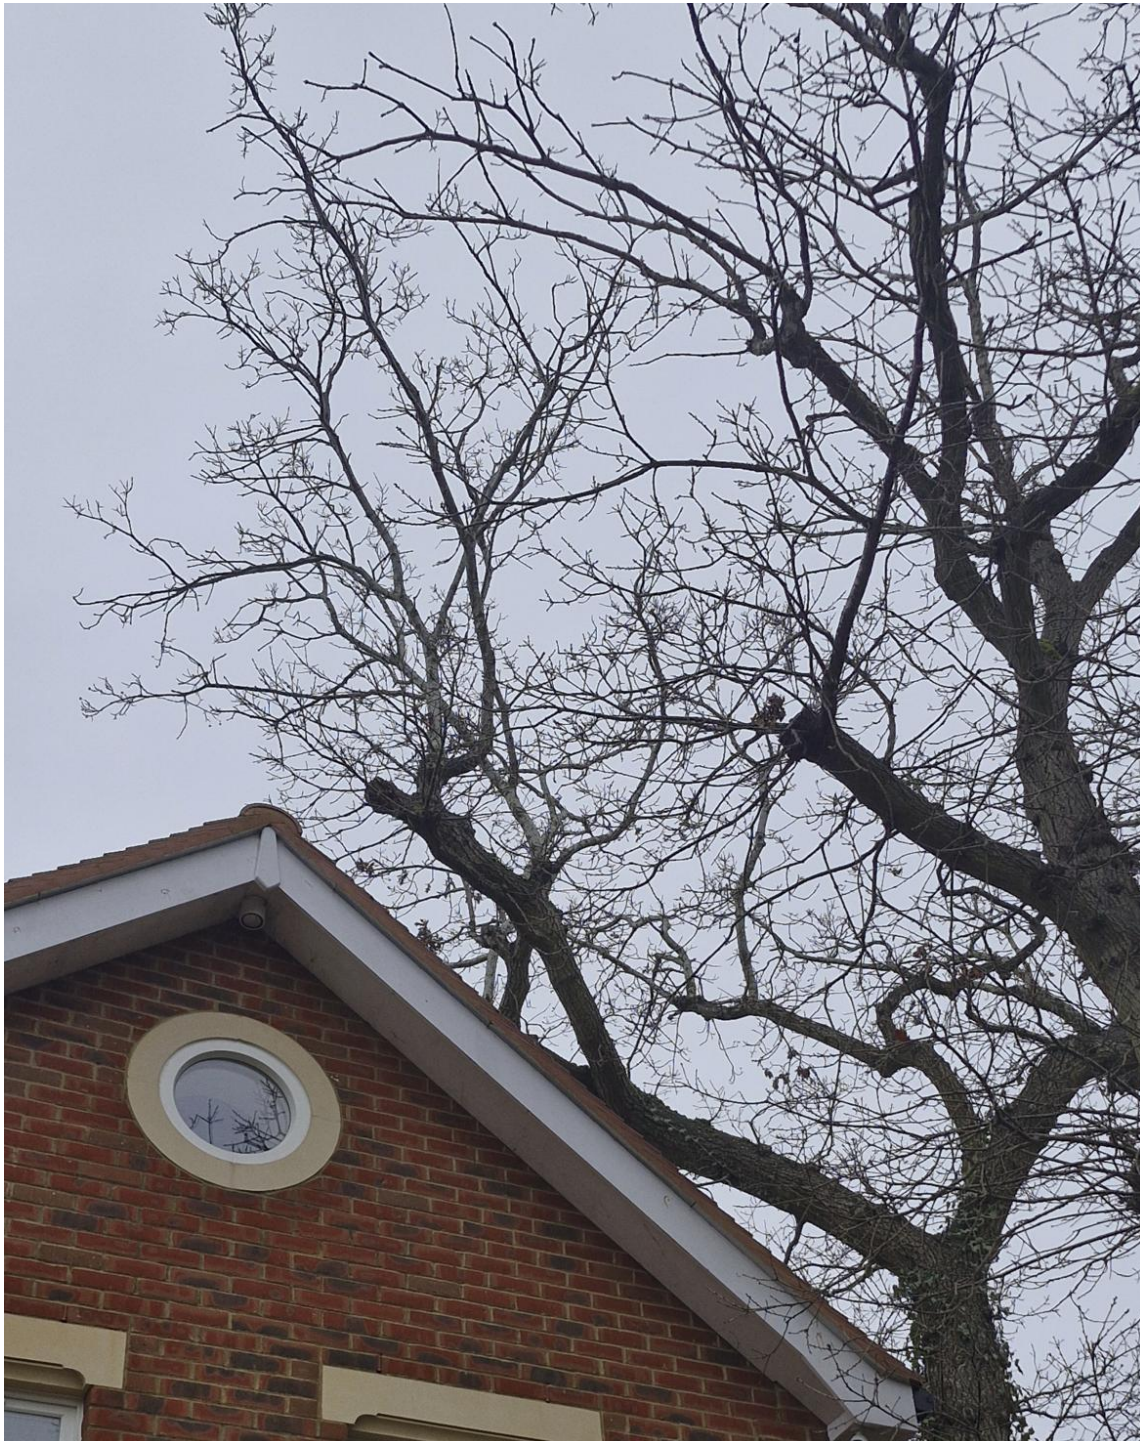
5.6 The upper crown of T1 would be considered of a *fair* condition, though the bud production is not consistent with an Oak at this stage of its life cycle. There is a lateral limb that overhangs the property which imbalances the upper crown, this also happens to be the rea which has the least amount of viable buds, and therefore the point of most concern.

Fig 7) T2 upper crown overhang of property. More prolific bud production | central areas of growth. The tips of branch extension display entrancement.
