Simon Pryce Arboriculture

Report

Subject: **Row of red cedars in front of the house**

Reference: **21/082/2**

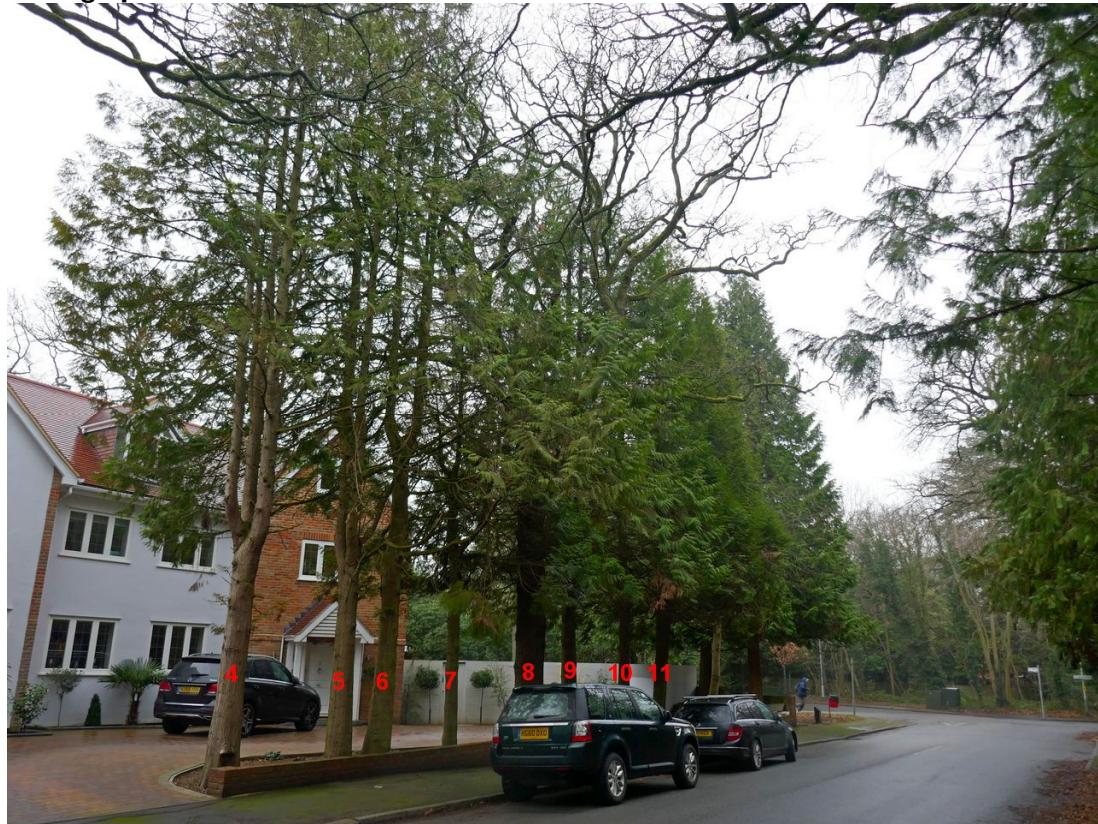
1) From Linksway - tree 8 is the oak

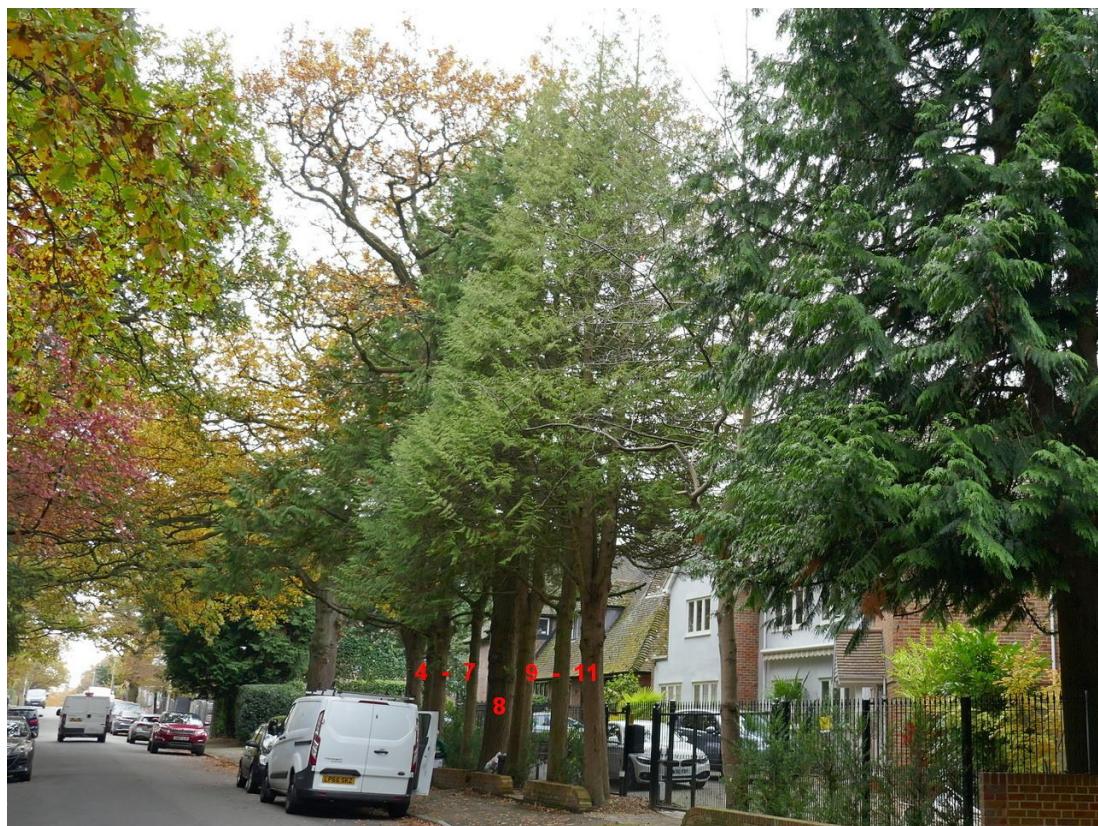
2) From the other direction

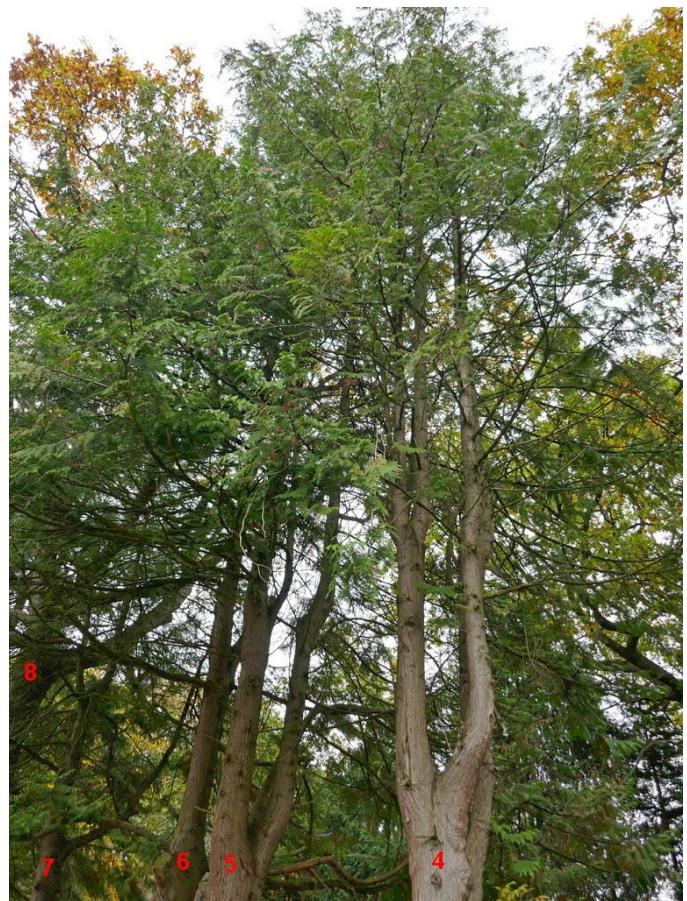
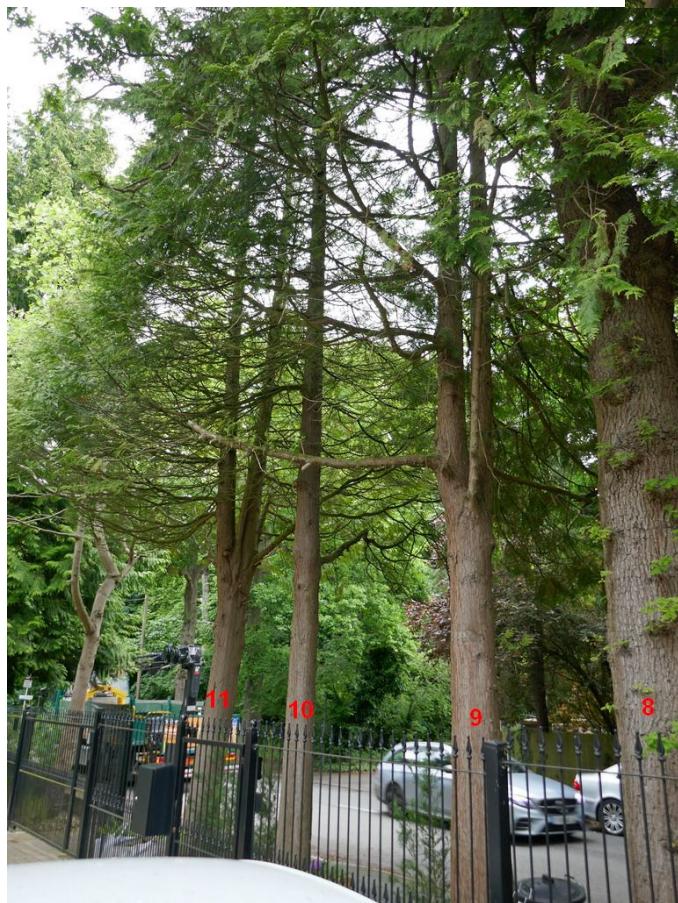
3+4) From the front garden of no.2, showing former topping points and sparse foliage

Tree no.	Species	Ht	Dia	Comments
The trees are described in sequence from left to right as seen from the road in front.				
4	Red cedar	18	400	Has previous topping points at about 3.5m and 6m which, together with the close planting distances between the trees, confirms that the line has been maintained as a hedge. There is also a bulge just above ground there the trunk had deformed and developed a pressure pad where it was in contact with the previous wall. Crown spread is less restricted to the left than in the other trees, as it is growing next to the entrance, but the foliage is very sparse.
5	Red cedar	16	380	Has topping points at the same heights as tree 4. Very close to tree 6, so the crown is flattened that side and on the other side due to proximity to tree 4.
6	Red cedar	16	370	Has the same topping points as the others and a laterally flattened crown due to growing very close to tree 5.

7	Red cedar	10	240	Smaller than the others due to growing under the oak and being suppressed by it and the other red cedars.
9	Red cedar	15	370	Same topping points as the others, close to the oak, but not as suppressed as tree 7.
10	Red cedar	14	300	One of the smaller trees due to growing close between 9 and 11 as well as beneath the oak and has sparse foliage.
11	Red cedar	15	350	Crown spreads farther to the right than the others due to being next to the entrance, but mid and upper level foliage is sparse. Narrow potentially weak fork at the lower topping point.

3.3 If these trees were retained, it would be almost impossible to establish a hedge beneath them, due to the shade and competition for water from the red cedars. One attempt to do so has already failed and the plants had to be removed. Selective removal of the worst suppressed red cedars might help by admitting more light and reducing competition, but they are all declining and the only viable option is to remove all of them in order to plant a new hedge.
