# GEOSHIELD Verification Report

PROJECT REFERENCE: GEO100209

PROJECT: Prologis Park

AREA SURVEYED: Lift Pits 3A and 3B

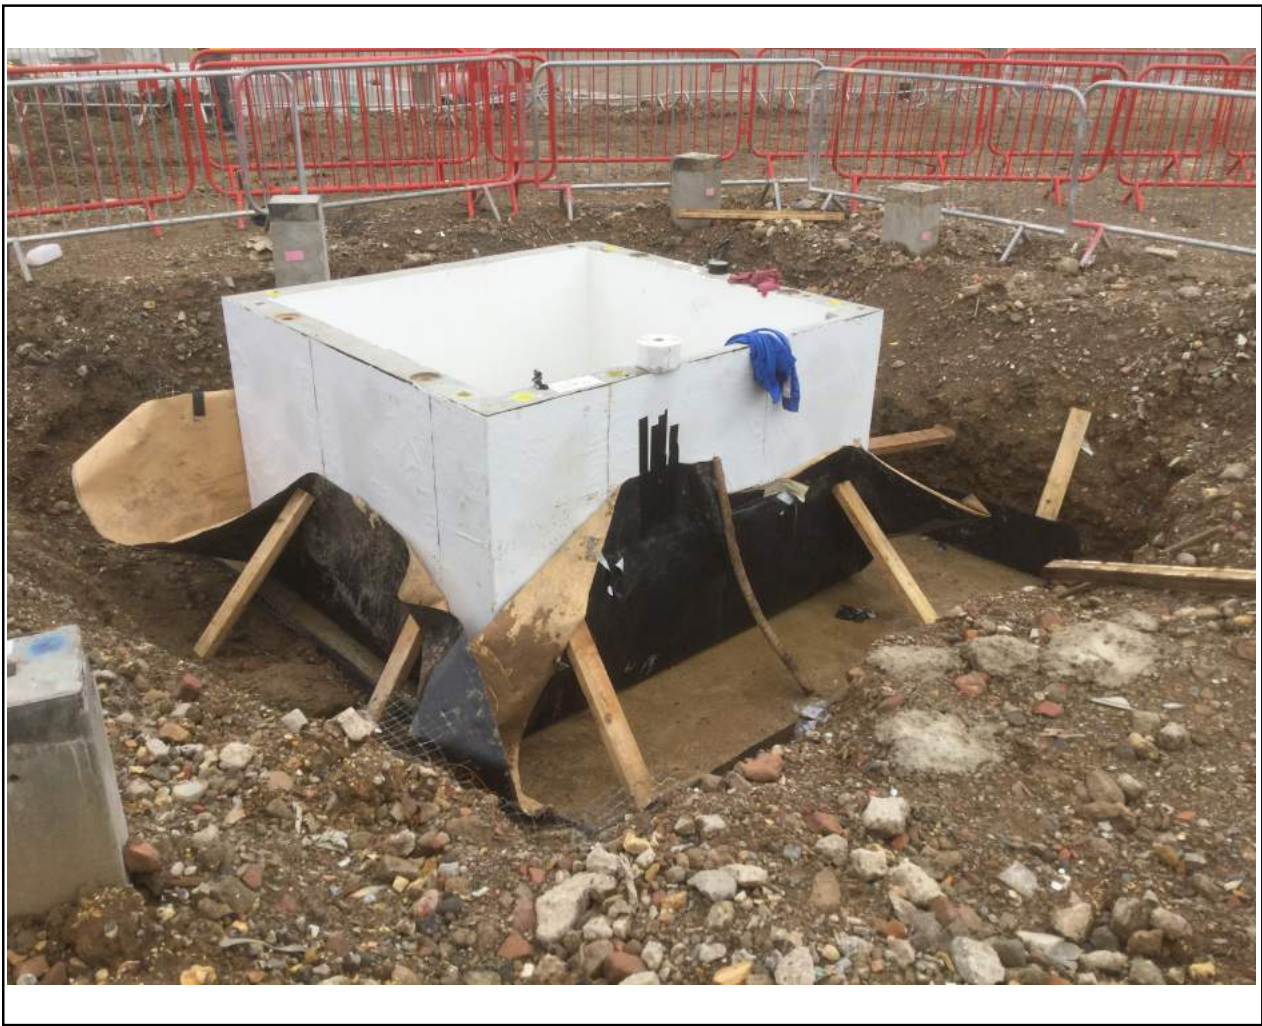
Overview of Verification Area - Lift Pit 3B

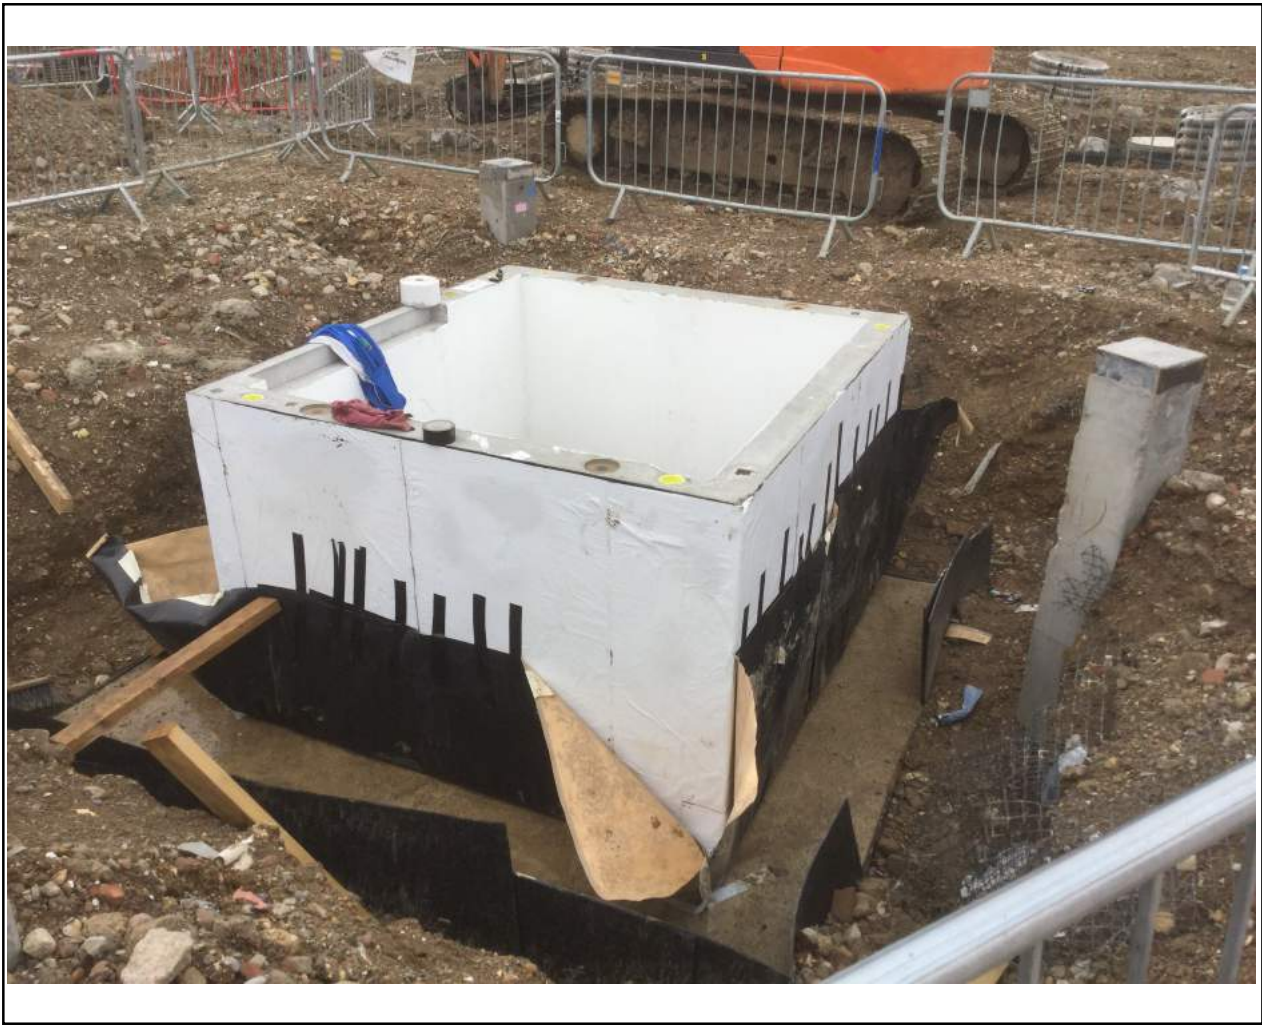
Alternative Overview of Verification Area - Lift Pit 3B

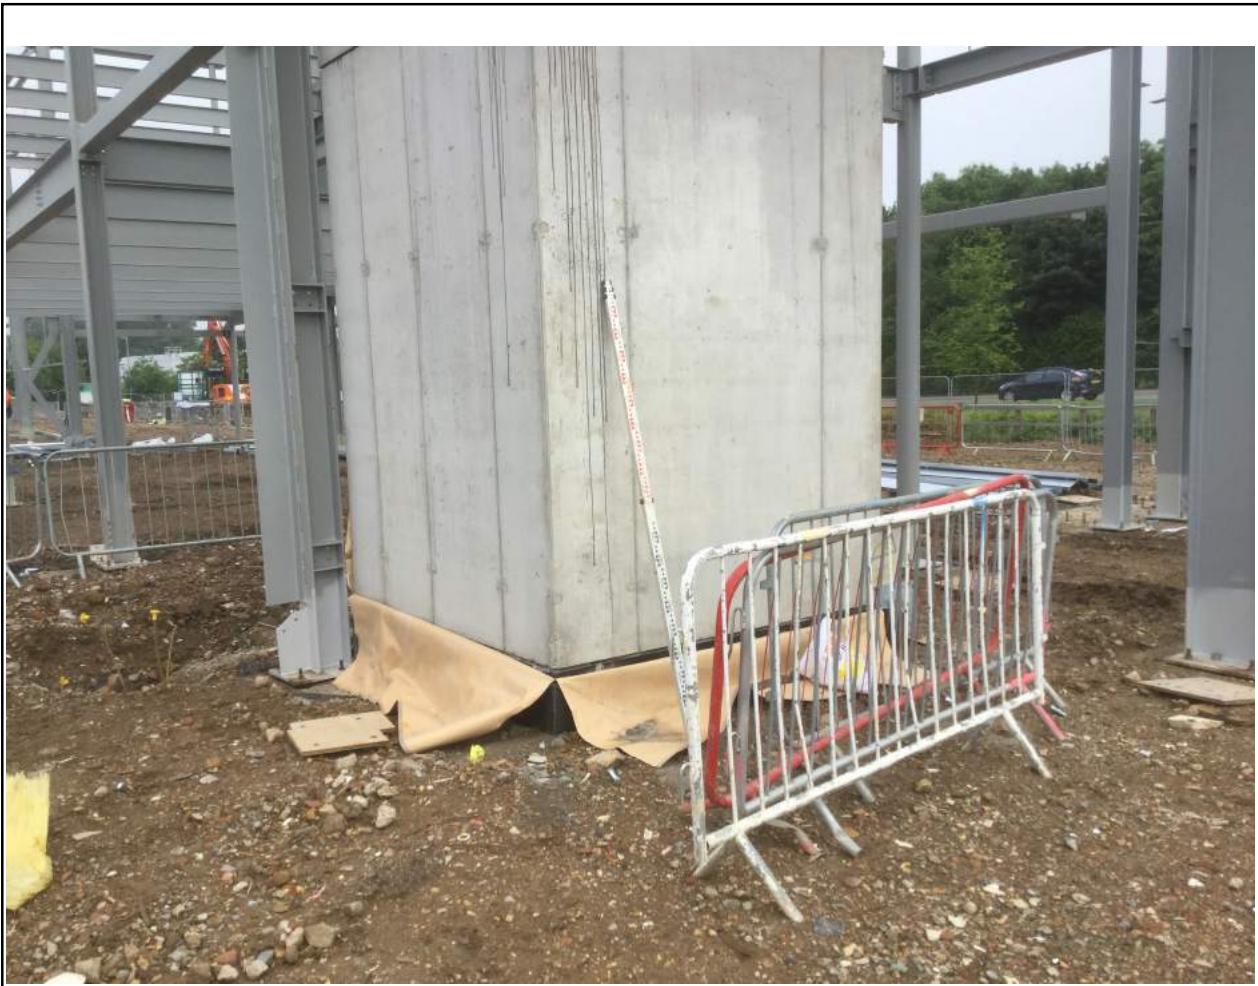
Overview of Verification Area - Lift Pit 3A

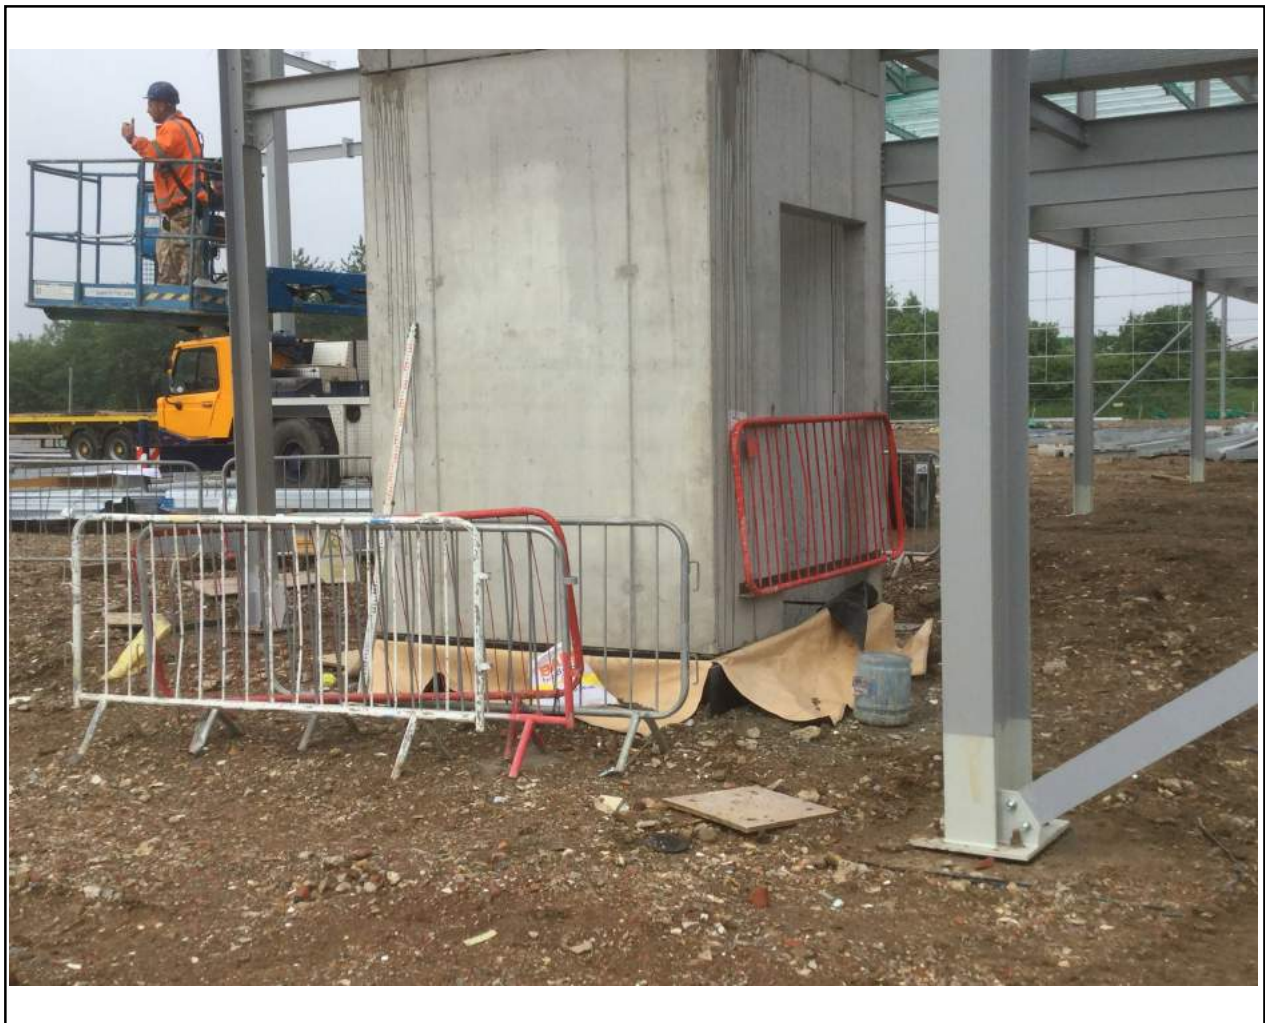
Alternative Overview of Verification Area - Lift Pit 3A

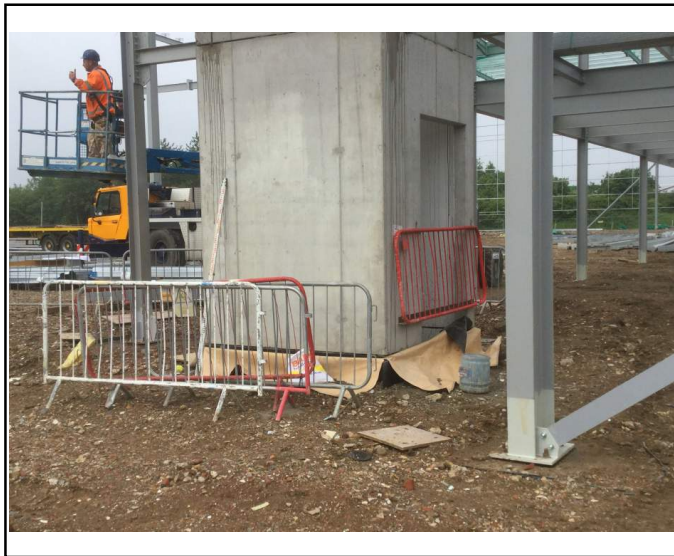
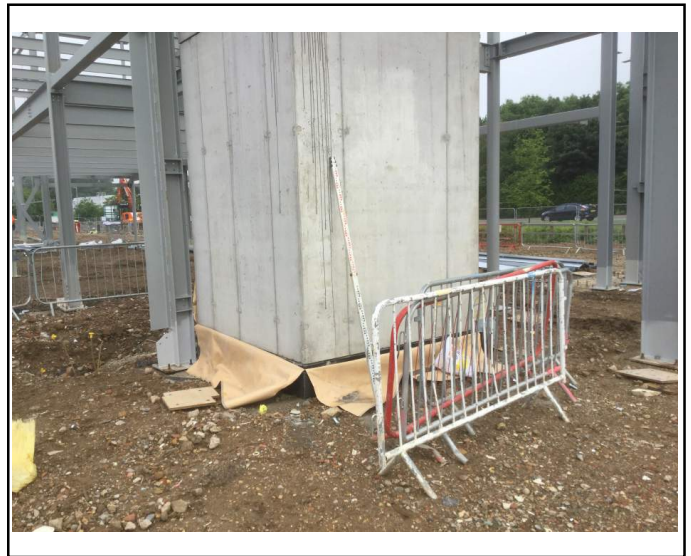
Lift Pit had been previously wrapped in

Monarflex Super as opposed to an appropriate Self Adhesive Gas Resistant Membrane

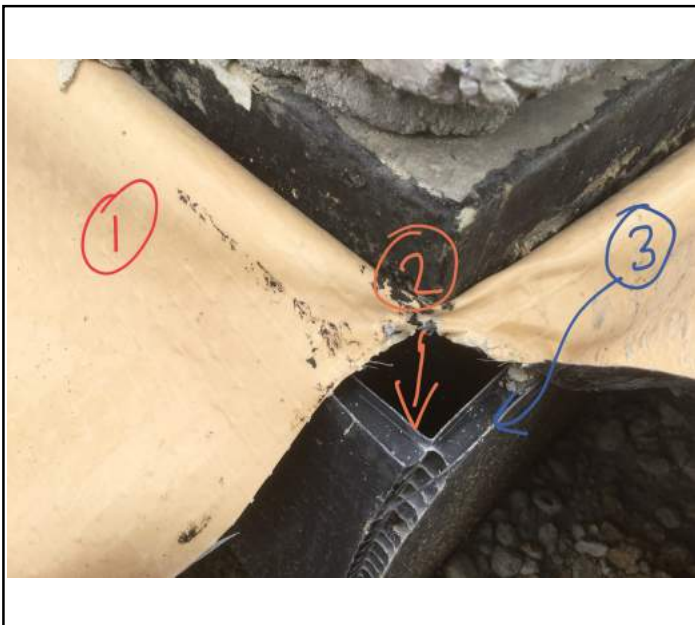
Photo 1 - showing the PAG Monarflex Reflex Super (1) being wrapped around the corner of the Lift Pit. This was typical to all four corners and therefore a complete seal at (2).

The PAG Monarflex Reflex Super was projected prior to backfilling with Protection Board.

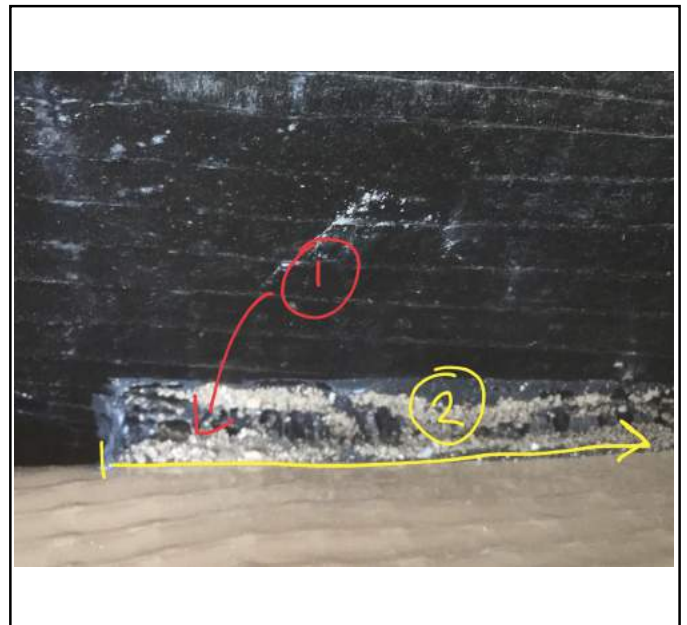
Photo 2 - showing Double Sided Butyl Tape sealing the Membrane - minimum lap 150mm

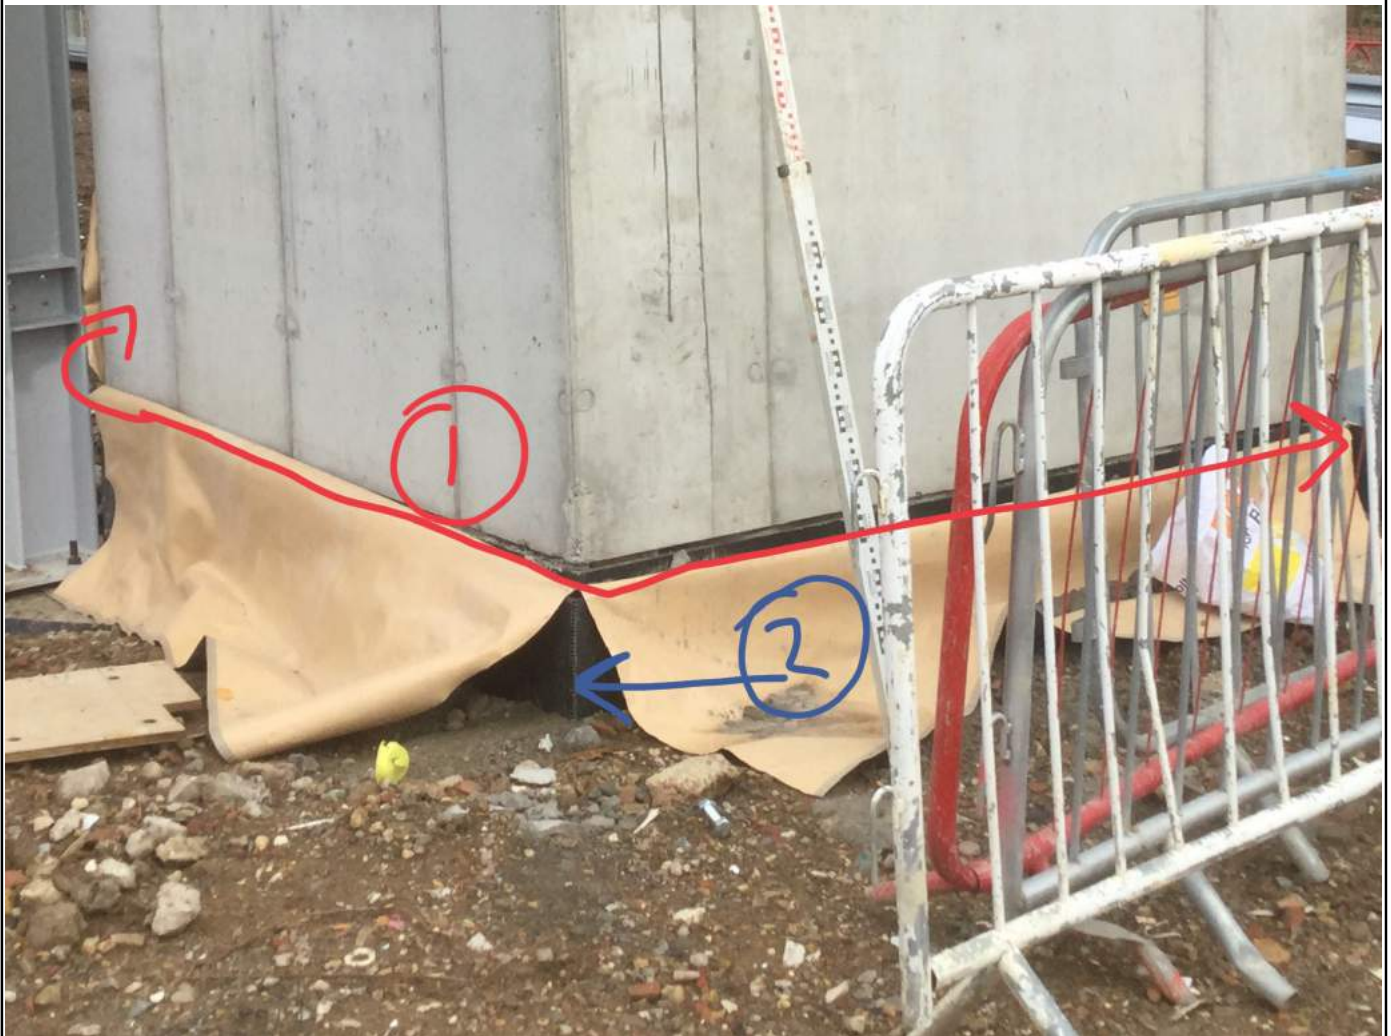
Overview of Lift Pit 3A where the PAG Monarflex Reflex Super proved to have been fully wrapped at (1). PAG Monarflex Reflex Super was protected with Protection Board at (2) prior to backfilling.

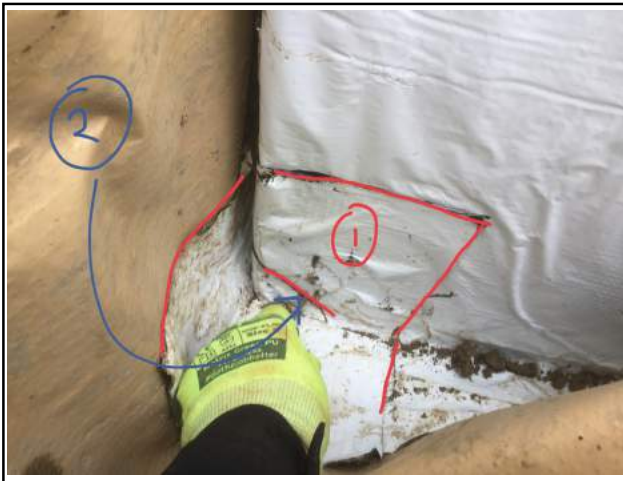
Photo 1 - showing the Pick & Probe Test (2) being undertaken along one of the four available GRSA Membrane Corner Lap Joints - all proved to be fully sealed

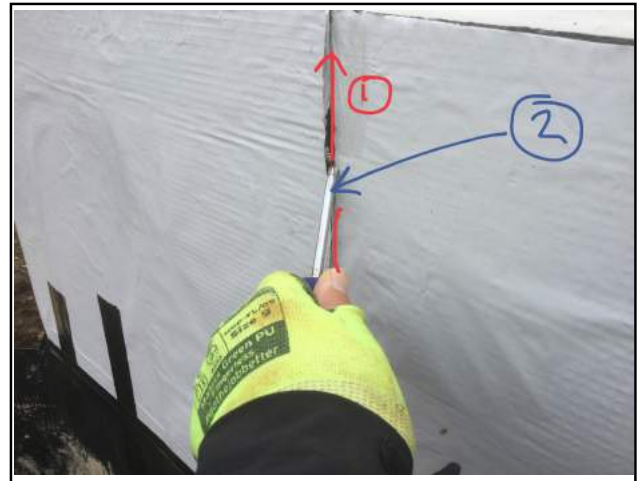
Photo 2 - showing the Pick & Probe Test being undertaken along a typical GRSA

Membrane Lap Joints proving all had a good seal.

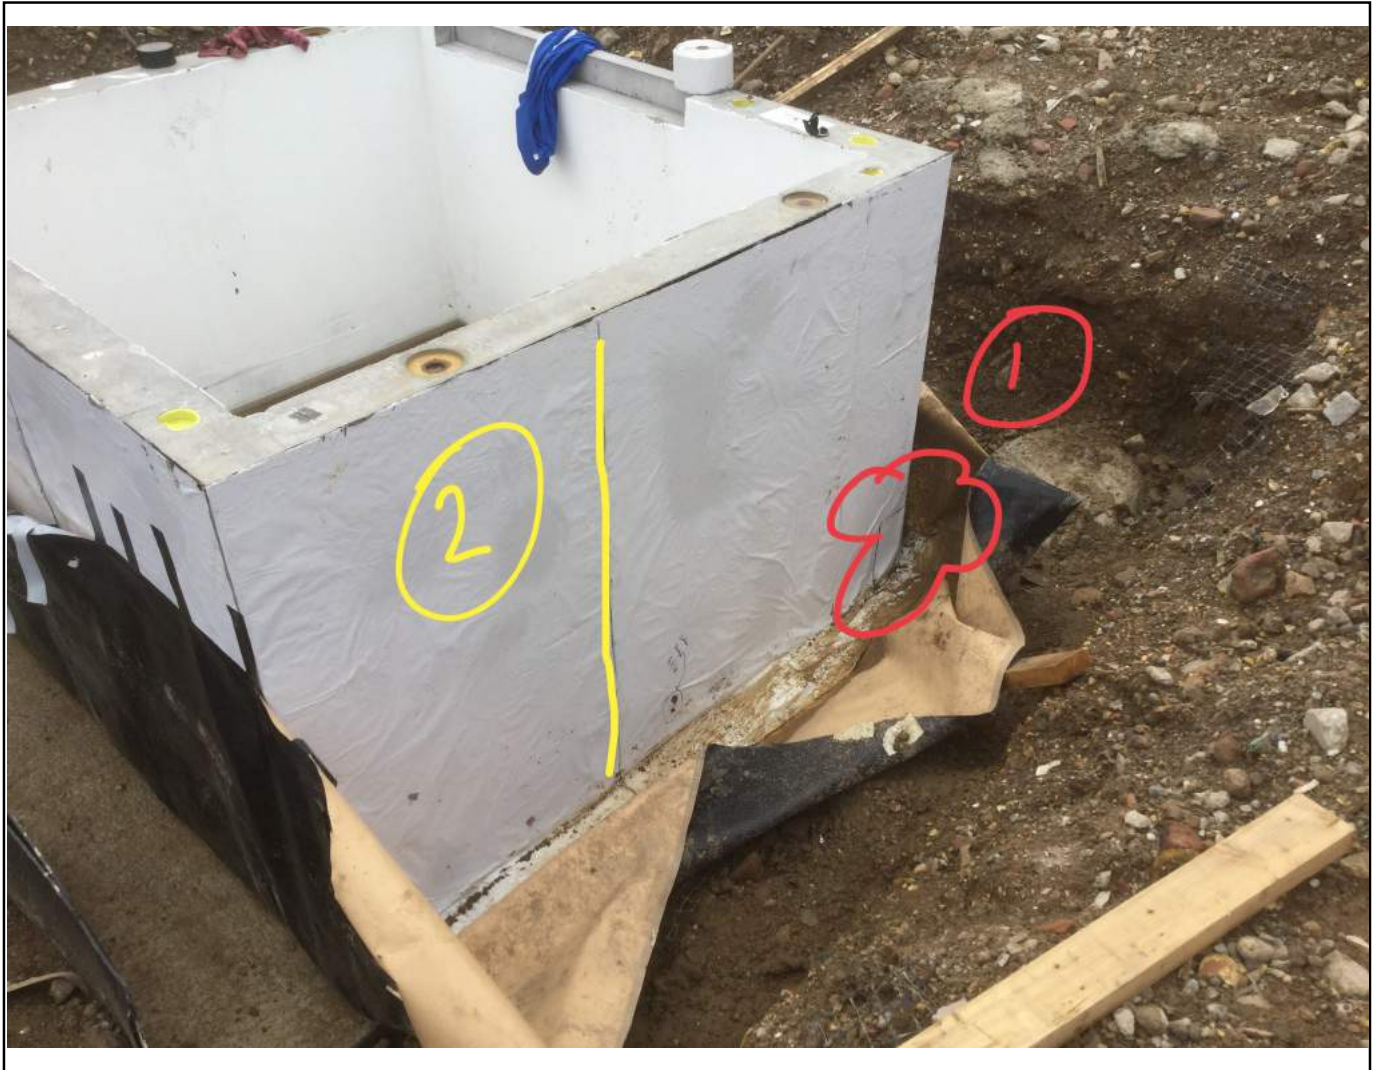
Overview of the Verification Area where (1) is showing one of the four Corner Lap

Joints and a typical Lap Joint at (2) where the Pick & Probe Test was undertaken

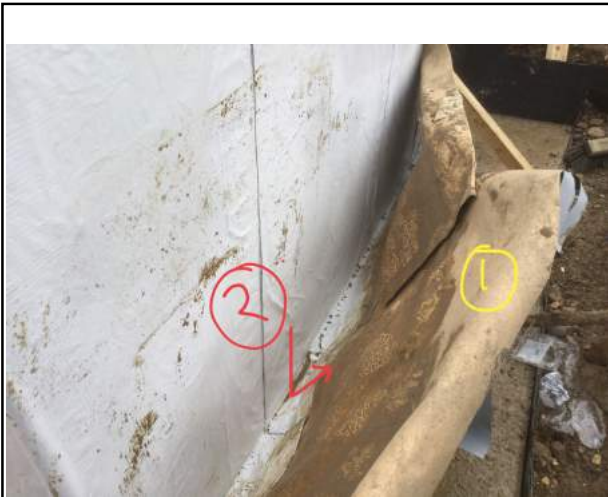
Photo 1 - showing the GRSA Membrane sealed (2) with the previously installed

PAG Monarflex Reflex Super (1) completely sealing the Lift Pit.

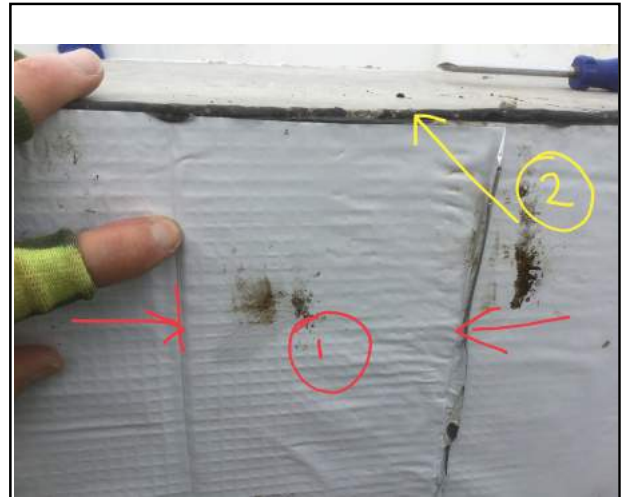
Photo 2 - showing the GRSA Membrane has been sufficiently lapped at (1). The

surface of the concrete had been previously primed and evidence seen at (2).

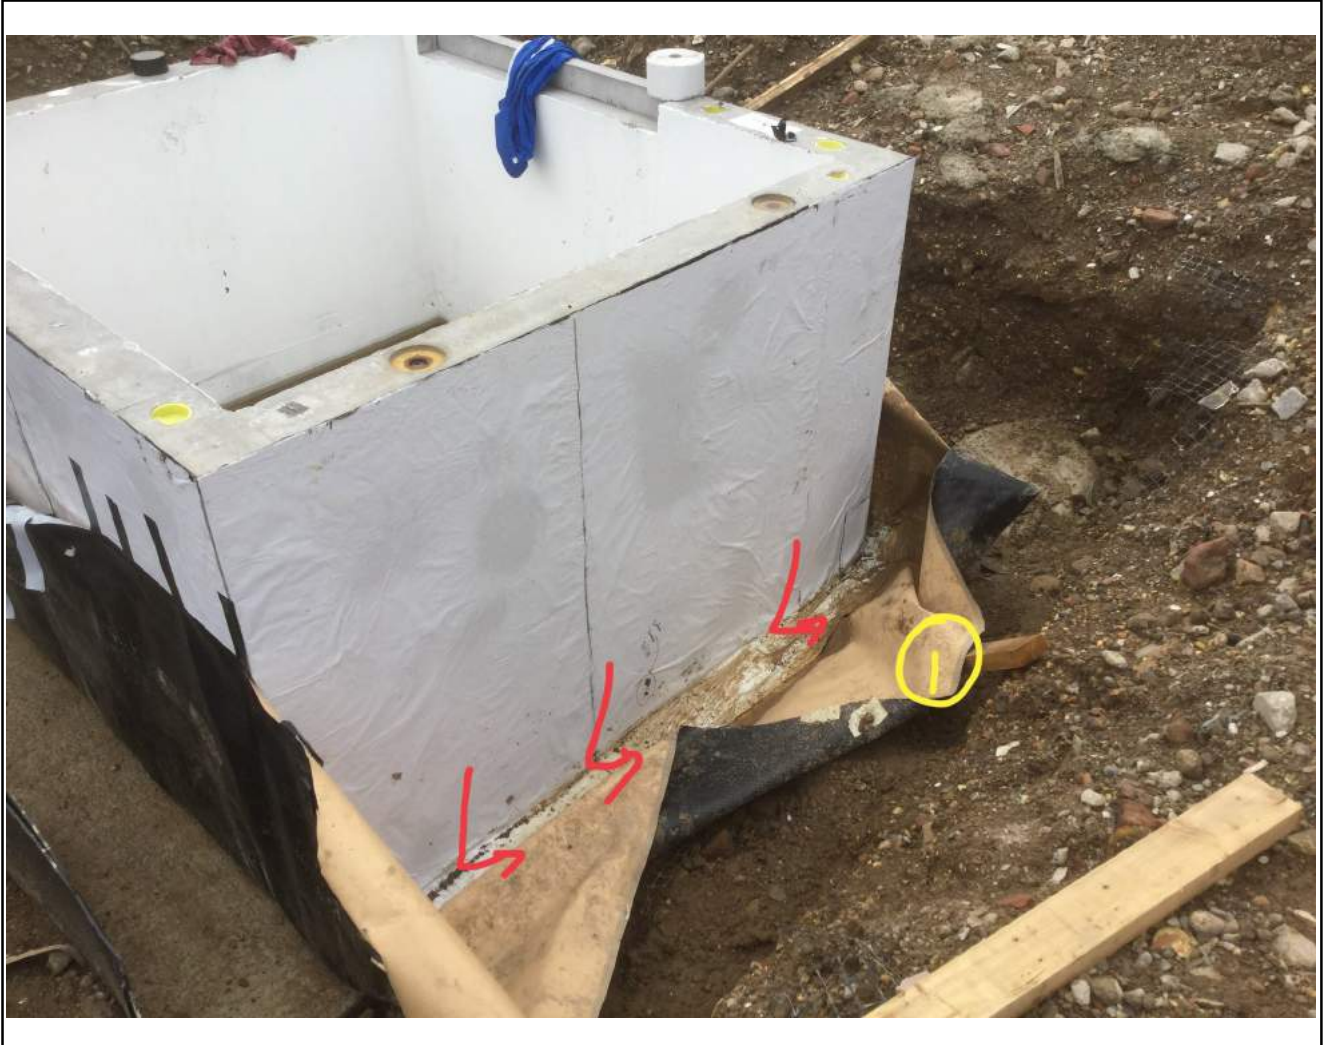
Overview of Verification Area showing one of the four sides to the Lift Pit

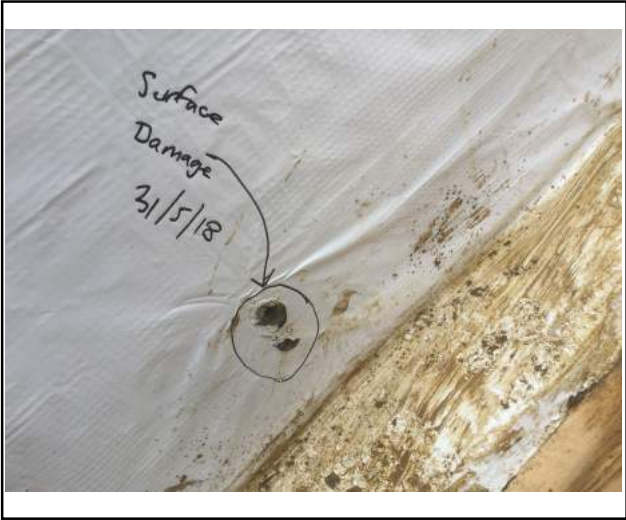
| Date | Nr | Remediation Description | Y/N |
|---|---|---|---|
| | 001 | Damage to GRSA Membrane at Lift Pit 3B | ✓ |

Damage to GRSA Membrane - Lift Pit

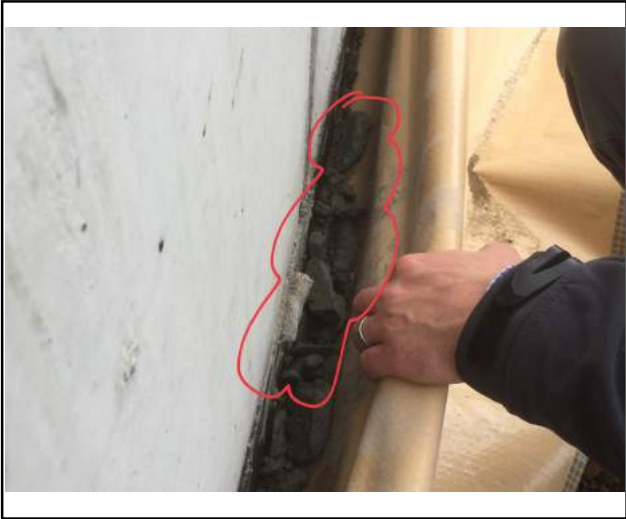
| Date | Nr | Remediation Description | Y/N |
|---|---|---|---|
| 31st May 18 | 001 | Three areas of debris trapped between Lift Pit 3A wall and the | |
| | | PAG Monarflex Reflex Super - potential puncture damage. | ✓ |

Debris trapped requiring removal

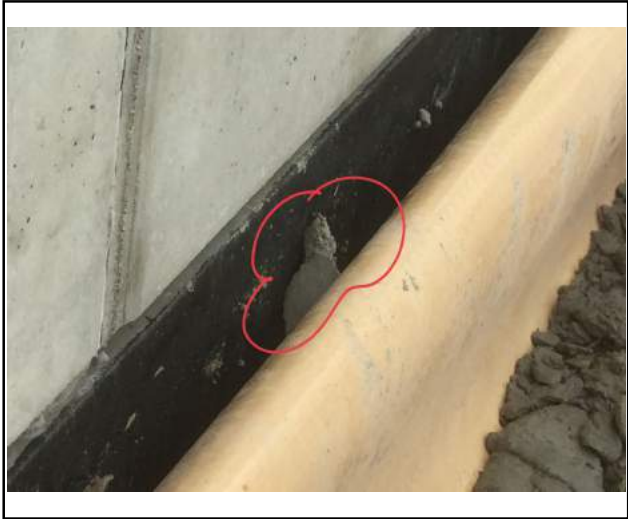
Debris trapped requiring removal
