# GEOSHIELD Verification Report

PROJECT REFERENCE: GEO100209

PROJECT: Prologis Park

REPORT NUMBER: 003

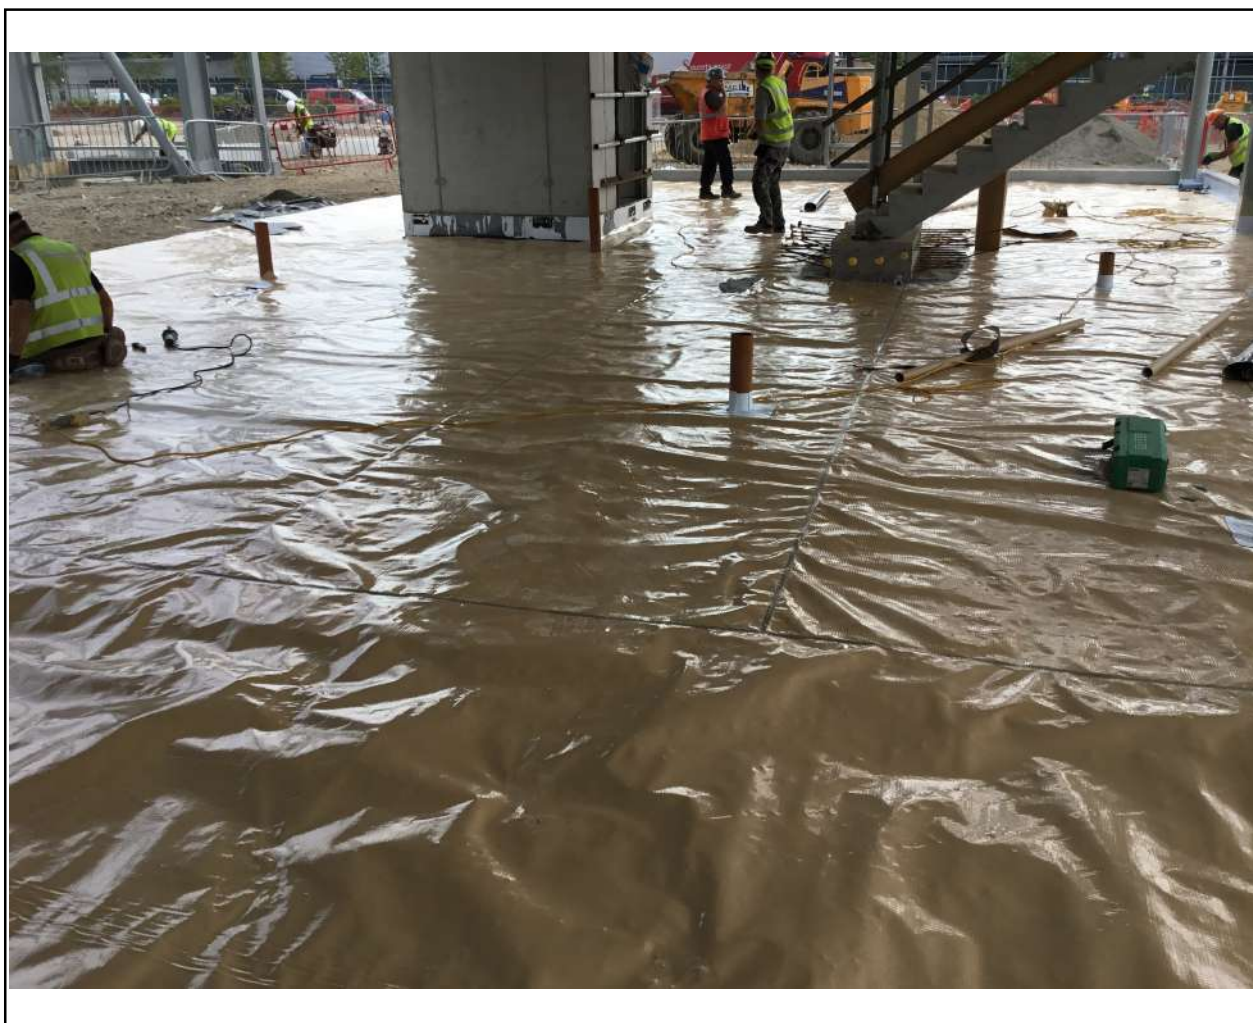
Shows overview of membrane layer during placement

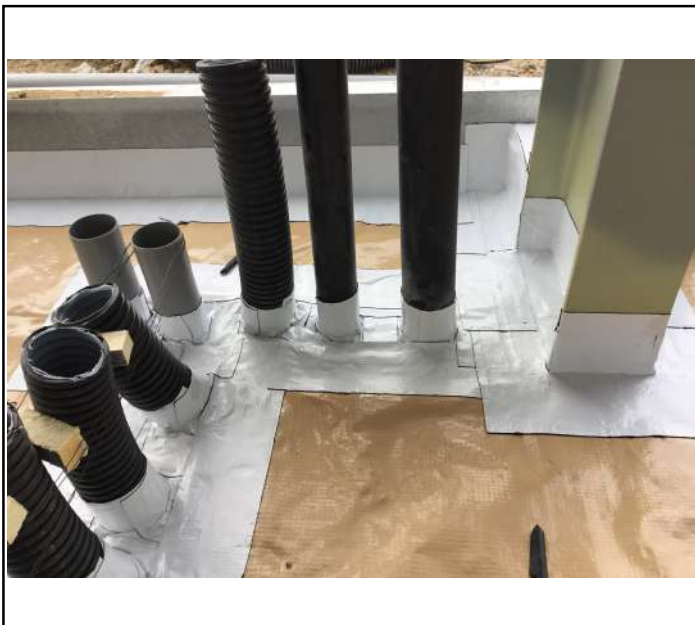
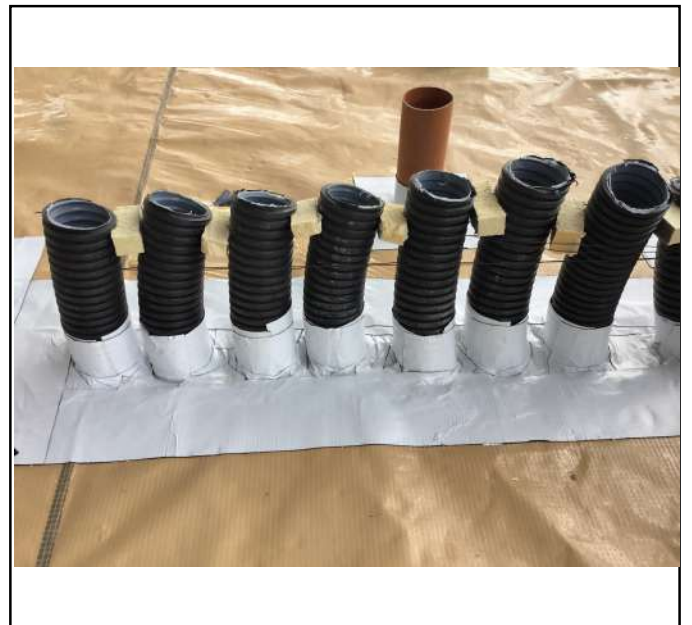
LOCATION/GRID LINE: E1 -K x 16 -17

NOTES: Pipe sealing

Both pictures show close ups of good practice pipe sealing

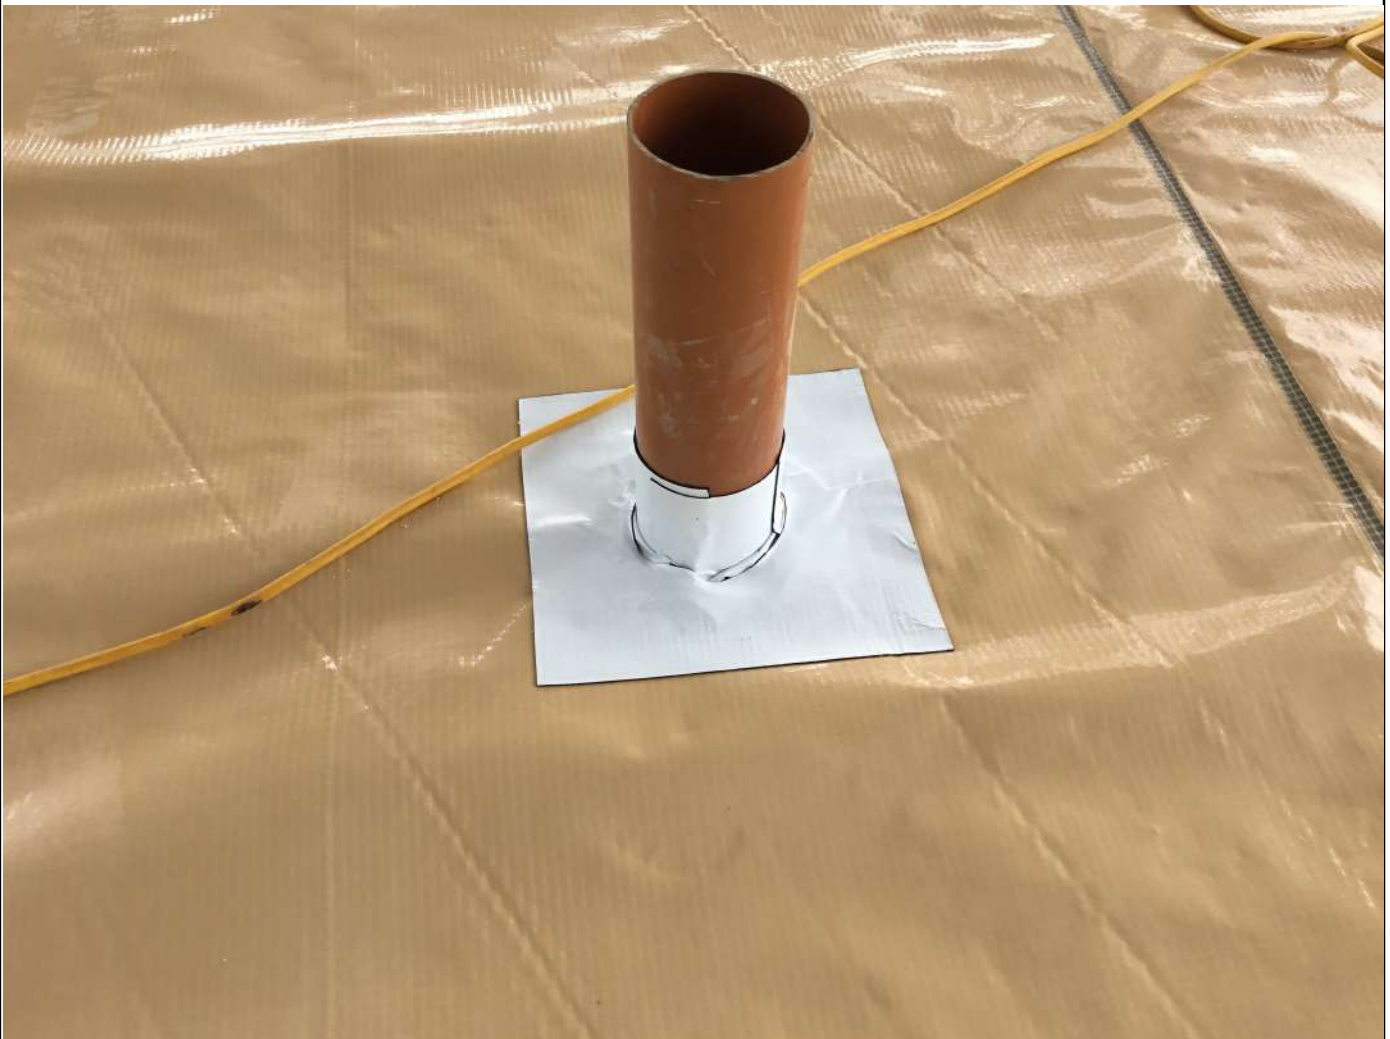
Very tidy and clean finished work around the pipe work

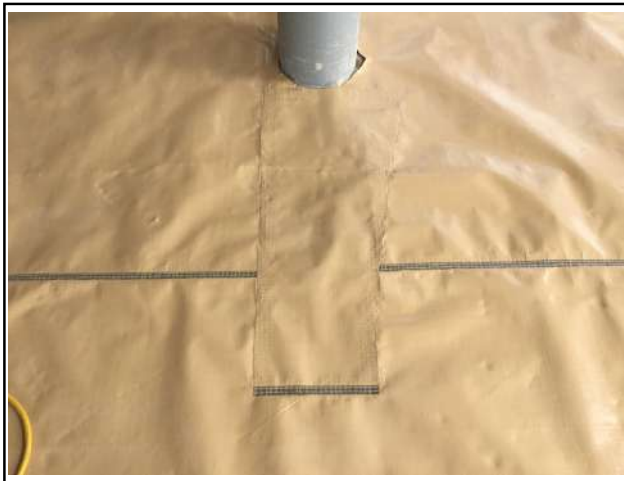
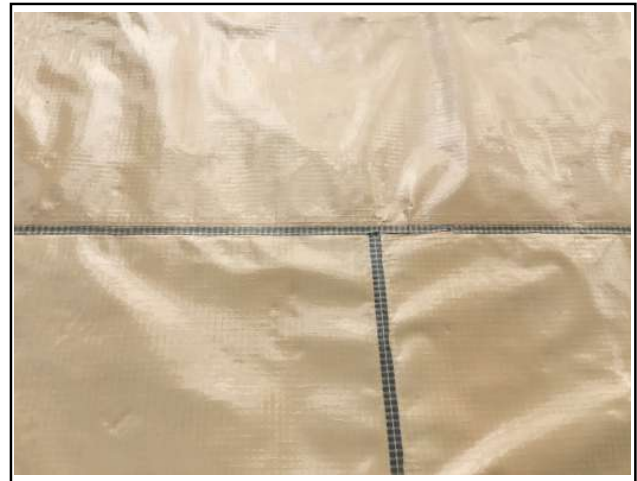
LOCATION/GRID LINE: E1 -K x 16 -17

NOTES: Welded joints

Both photos show seams that have been air tested to 50psi

Very good workmanship

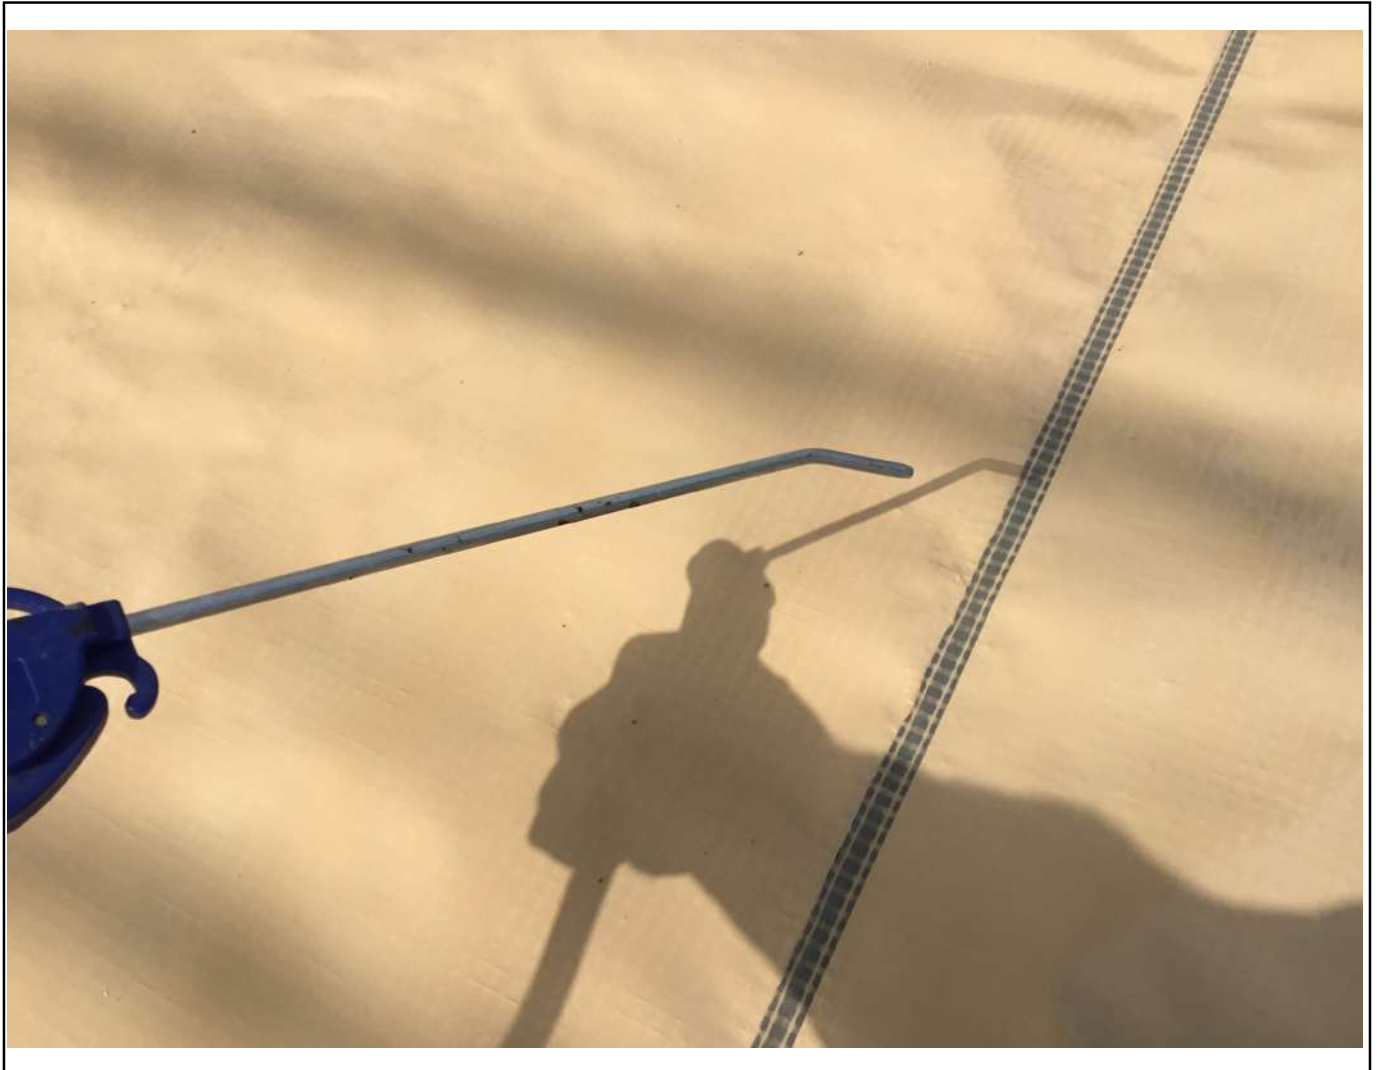
Airtest being carried out on welded joints

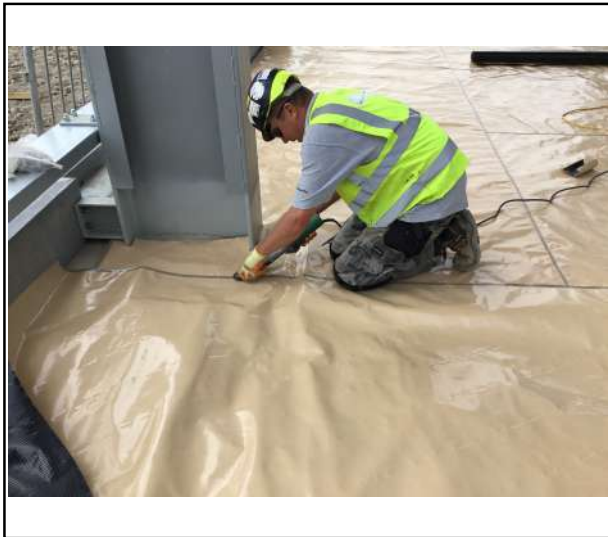
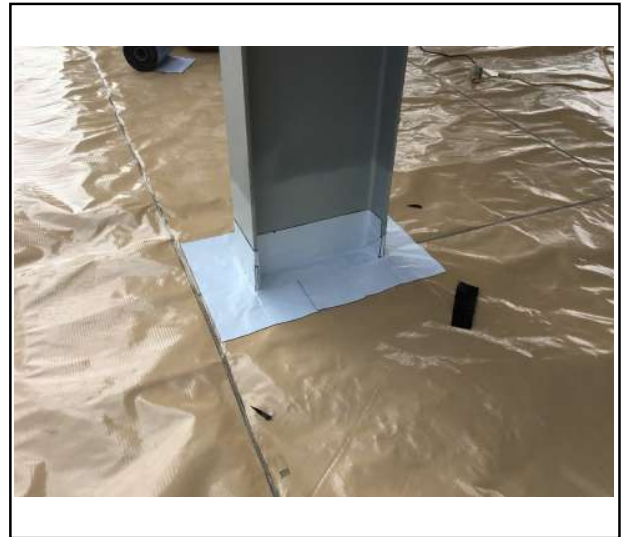
LOCATION/GRID LINE: E1 -K x 16 -17

NOTES: Upstands around steel work

Dressing being applied to steel upstands

Very neatly done

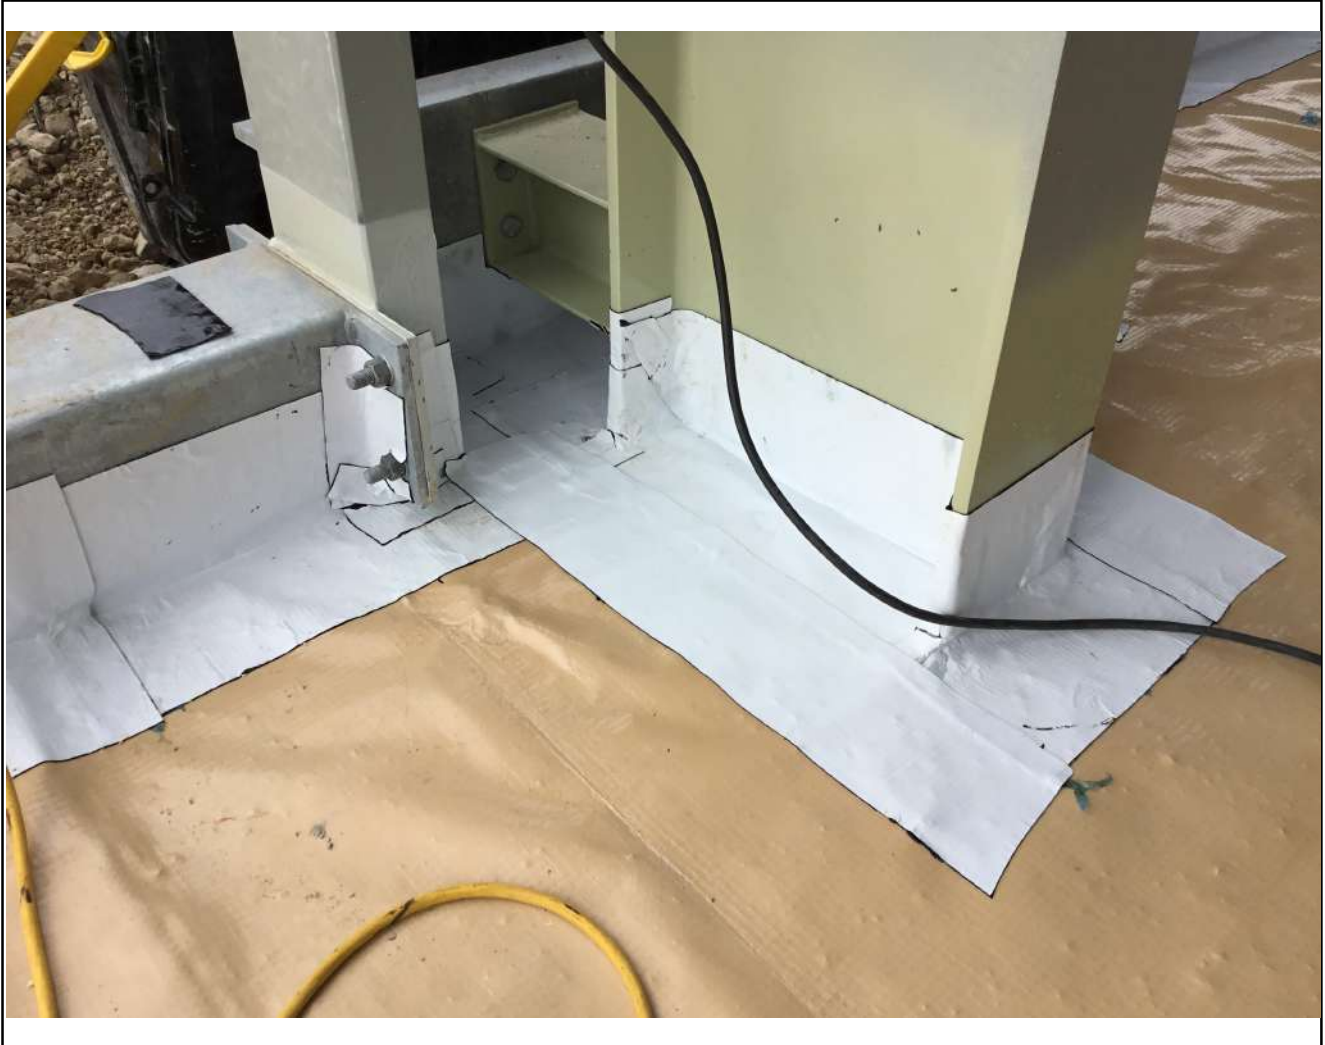
Further sealing to upstands

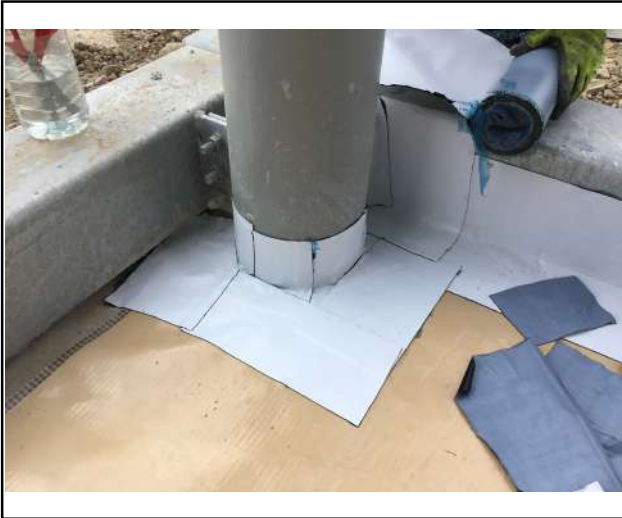
Pipe work in awkward position

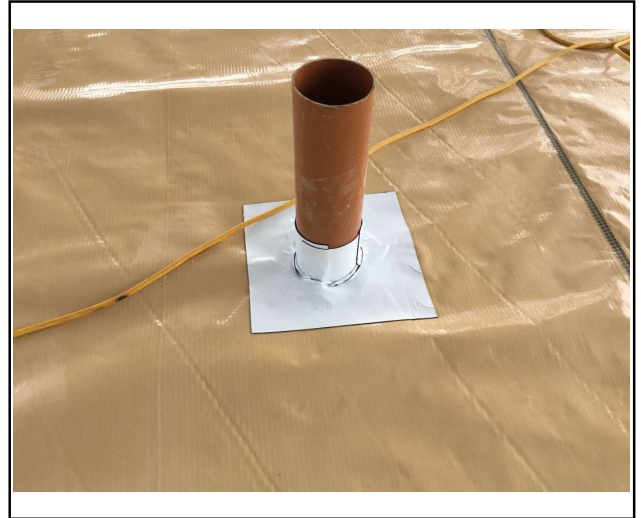
Tidy workmanship

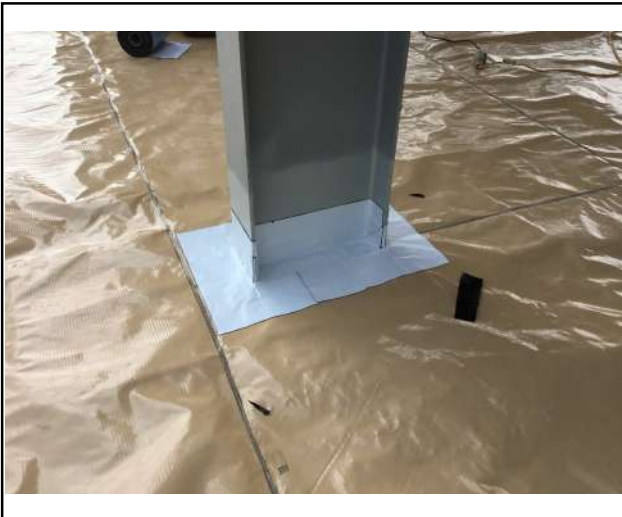
Upstands

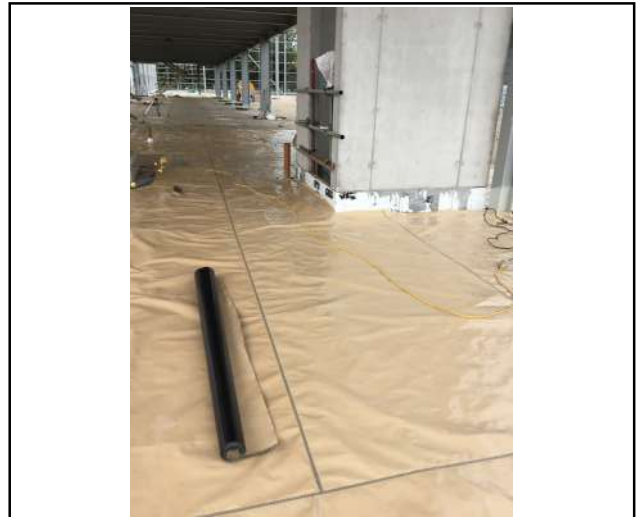
Joint sealing

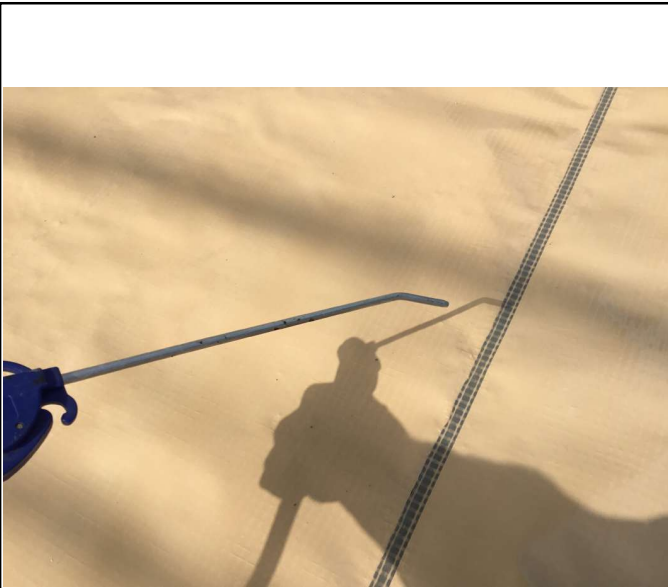
Testing seams

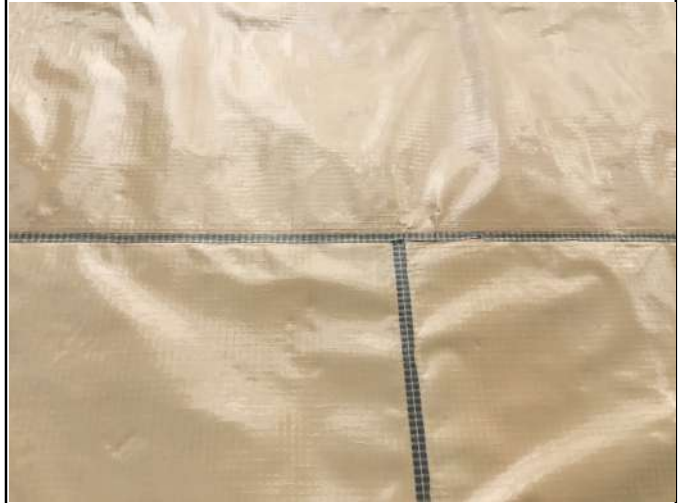
Tested seams
