ADDENDUM ARBORICULTURAL REPORT

SUBSIDENCE CLAIM

Crawford Reference: SU1903345

Uplands Court

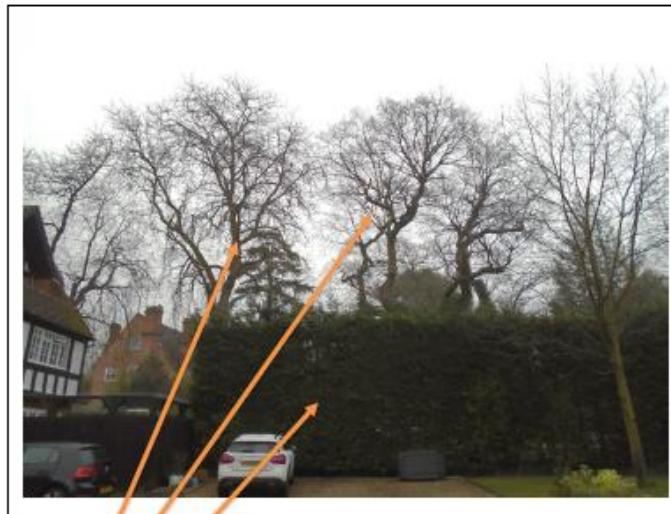
View of T2, T1 and H1

T1 Oak – Fell to ground level

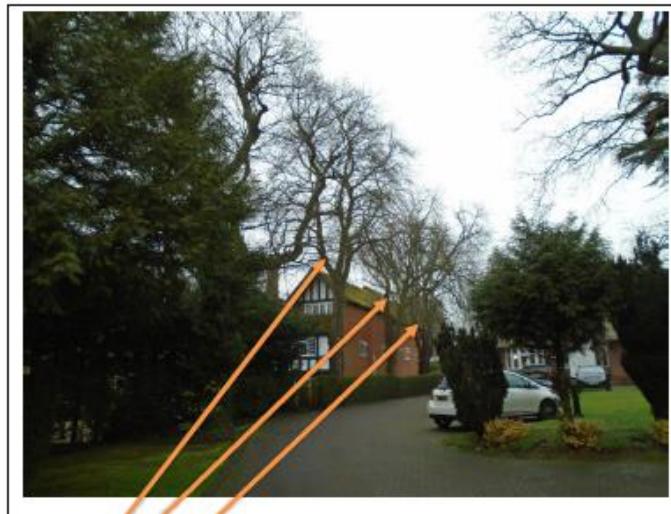
View of T2, T3 and T4

T3 Horse Chestnut – Fell to ground level

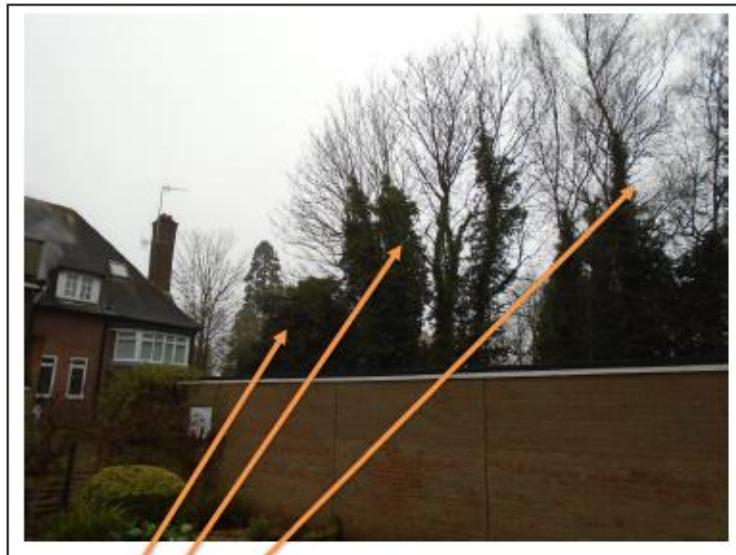
View of TG1, TG2 and TG3

TG1 Prunus – Fell to ground level

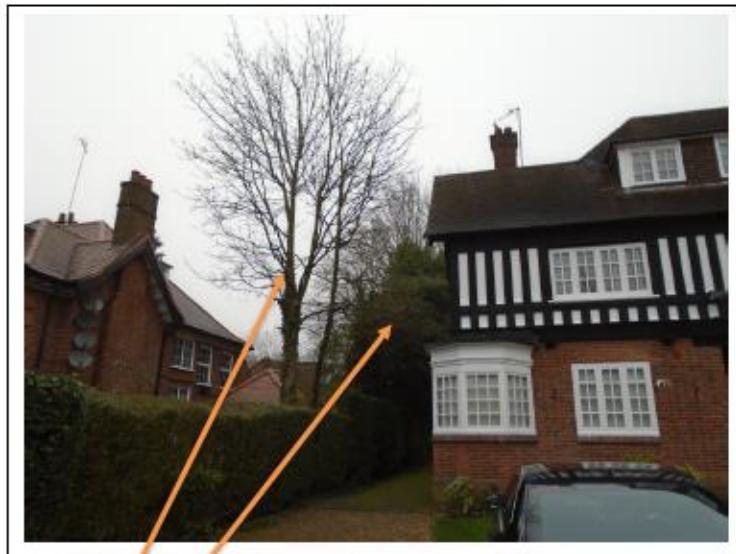
View of T5 and TG1

As a result of the above, T5 and TG2 were removed during 2020.

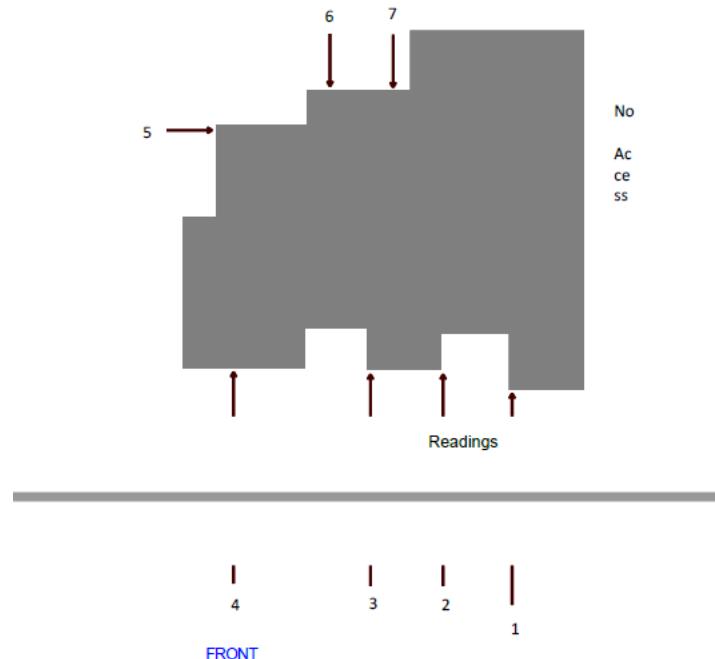
The results are as follows:

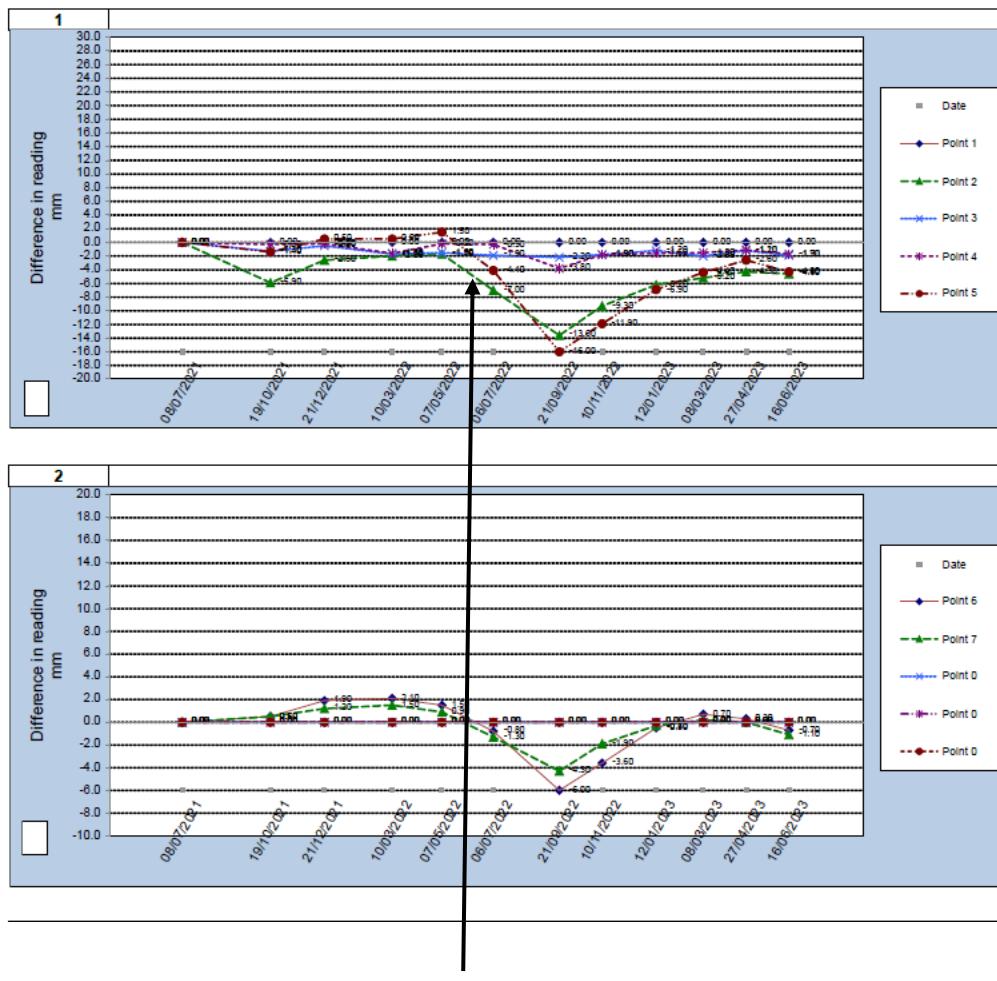
T1 reduced and T2 removed June 2022

The level monitoring indicates a clear seasonal and cyclical pattern of movement consistent with root induced clay shrinkage with the greatest amplitude of movement being consistent with the locations of the subject trees and after the works to T1 & T2 were completed, this confirms the ongoing influence of T1, T3, T6 and TG1.
