ADDENDUM TECHNICAL REPORT

Crawford Reference: SU1903345

**Uplands Residents Management Company
Flats 1 & 3
Uplands Court
19 Frithwood Avenue
Northwood
HA6 3LY**

SUBSIDENCE CLAIM

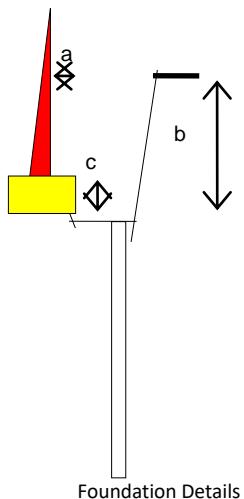
No.	Borehole Depth	Footing (a)	Underside (b)	Thickness (c)
TH1	3.00 m.	200 mm.	1,000 mm.	700 mm.

Trial hole 01 was completed to the front right corner of the building in September 2019. The trial hole revealed a concrete trench fill foundation bearing on to a dry very stiff brown fine to medium gravelly CLAY.

- The foundations are at a depth of 1,000mm which is below the level that normal seasonal movement would occur.
- The moisture content profile indicates a reduction in moisture content at 1,000mm below ground level and using Driscoll's rule ($0.4 \times LL$) the moisture content reading of 21% does indicate desiccation at this level. This is also co-incident with the depth of root activity.
