TECHNICAL REPORT ON A SUBSIDENCE CLAIM

Crawford Reference: SU1903345

Flats 1 & 3 Uplands Court,
19 Frithwood Avenue
Northwood, HA6 3LY

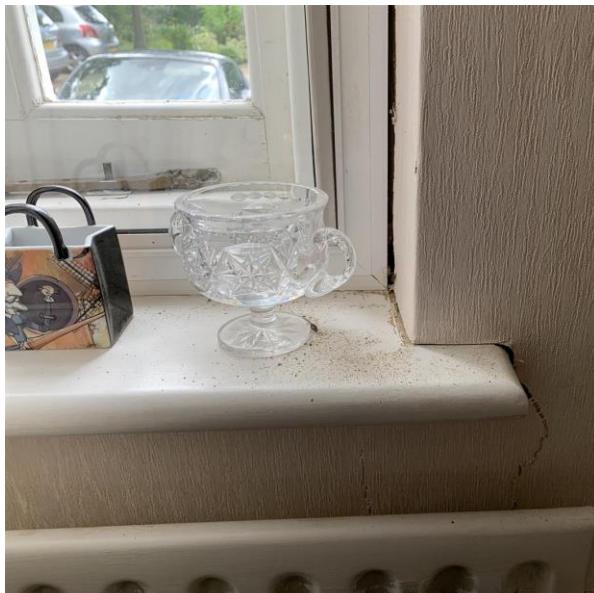
Lounge - Flat 1 - front window

Diagonal cracks below right side of front window.

Vertical crack below left side of front window.

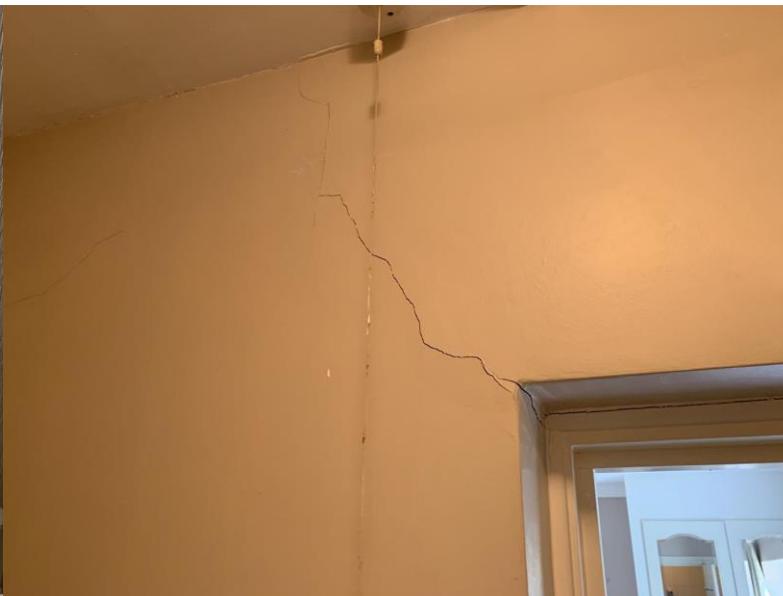
En-Suite - Flat 1

Diagonal crack above door to bedroom

Diagonal and stepped cracking above and below rear window including through wall tiles.

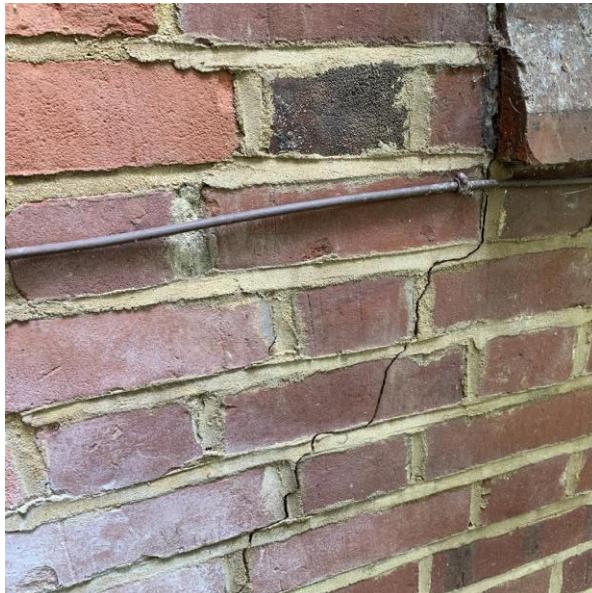
Below En-Suite window

Stepped crack below En-Suite window, open 2-3mm.

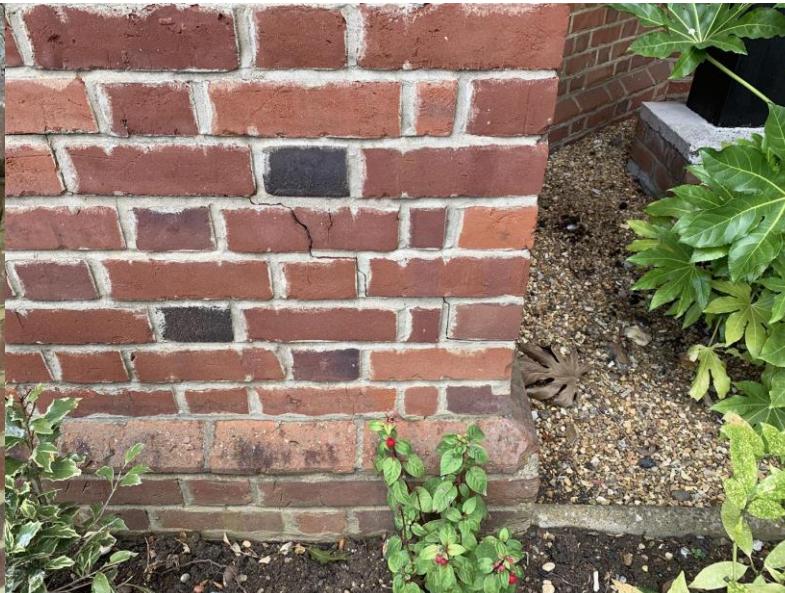
Stepped crack below Lounge window

Stepped vertical crack below left and stepped crack below right of Lounge window (Flat 1). Cracks above both sides of window extending up to Flat 3 bedroom window above.

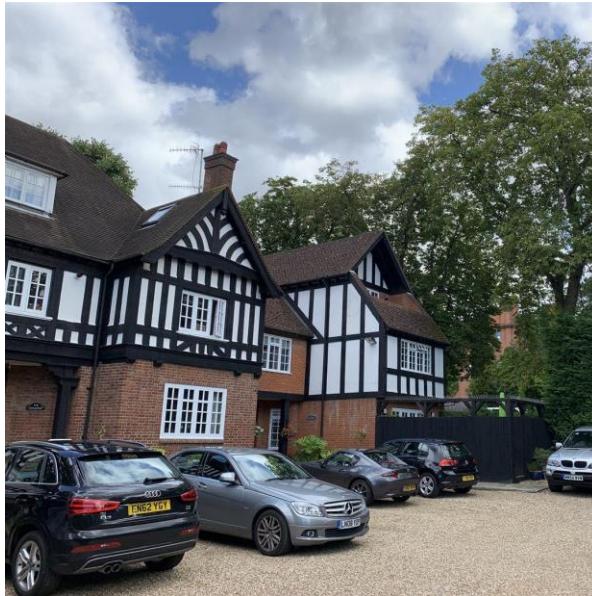
Horse Chestnut tree on right

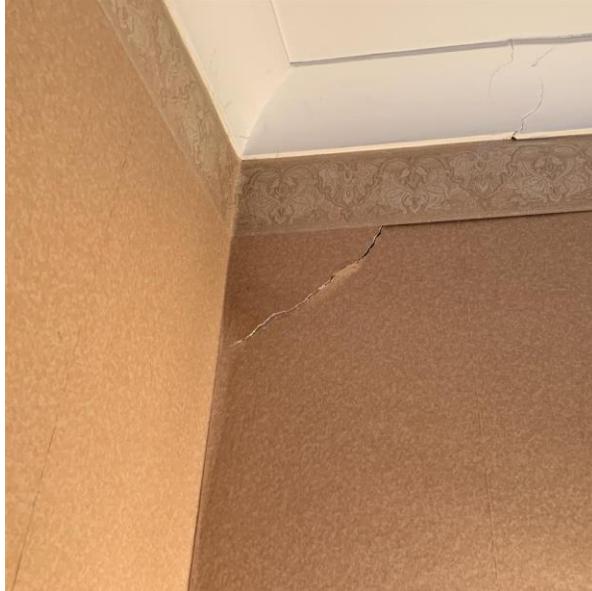
Hall - Flat 1

Diagonal crack above front door.

Diagonal crack adjacent to rear bedroom wall and associated crack to coving and across ceiling.

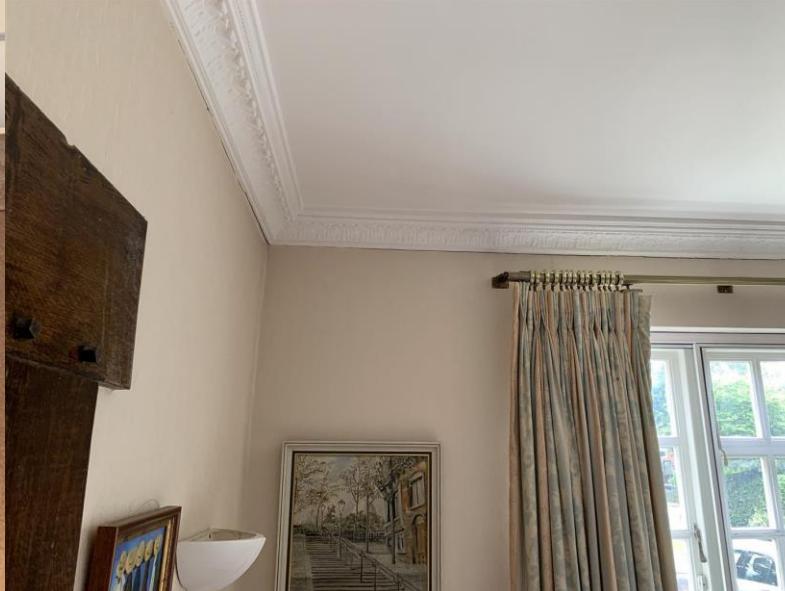
Lounge coving - Flat 1

Separation of coving with wall at front right corner and along right wall.

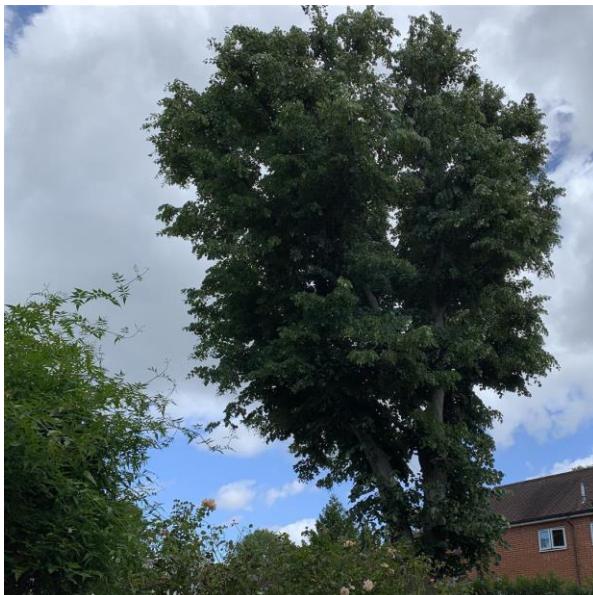
Poplar Tree

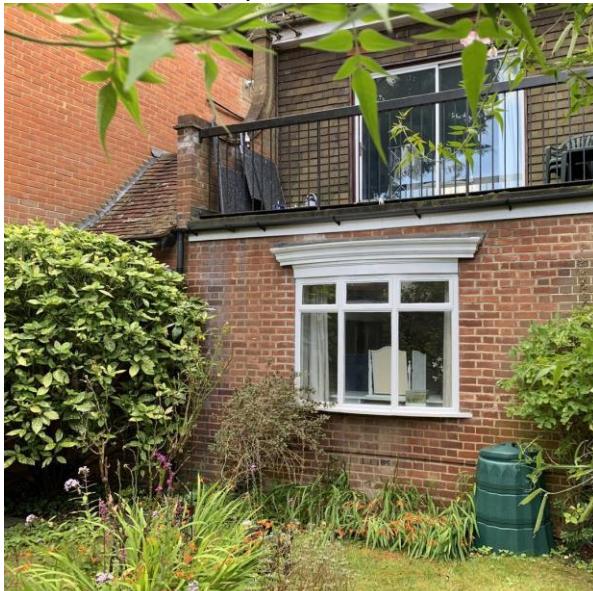
Rear elevation

Vertical crack below Flat 1 rear bedroom bow window - not reflected internally.

Laser level survey shows rear elevation is dropping towards the rear left corner. The left elevation is relatively level.

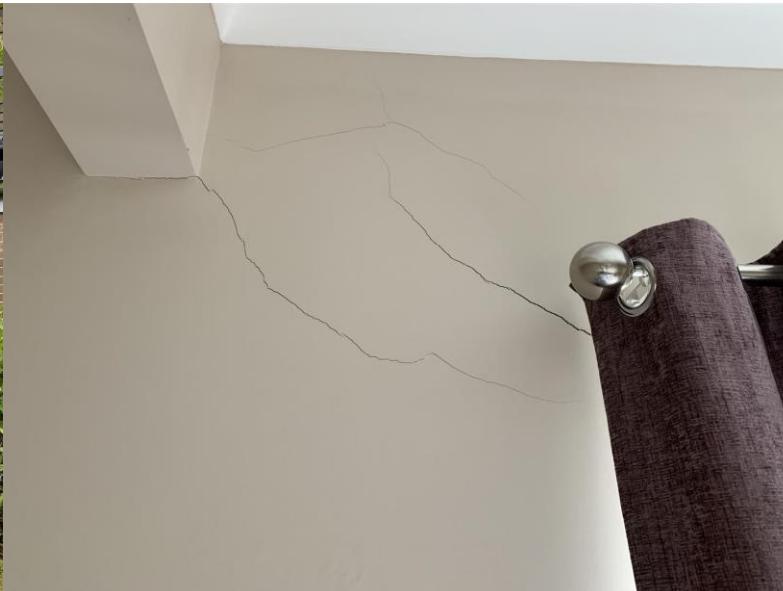
Diagonal stress cracks above either side of front window.

Flat 3 - Bedroom above front window
