**TECHNICAL REPORT ON A SUBSIDENCE CLAIM**

**Crawford Reference: SU1903345**

**Flats 1 & 3 Uplands Court,  
19 Frithwood Avenue  
Northwood, HA6 3LY**

23<sup>rd</sup> August 2019

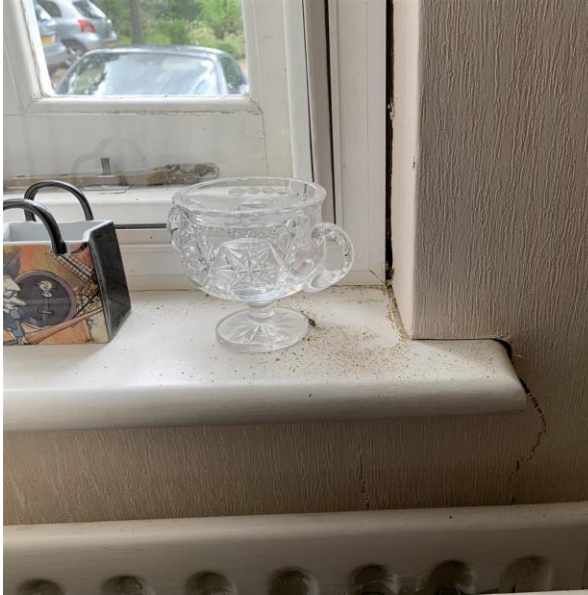
Lounge - Flat 1 - front window

Diagonal cracks below right side of front window.

Separation of coving with wall at front right corner and along right wall.

Vertical crack below left side of front window.

Vertical crack at external splay junction in alcove area and cracks at wall/ceiling junction

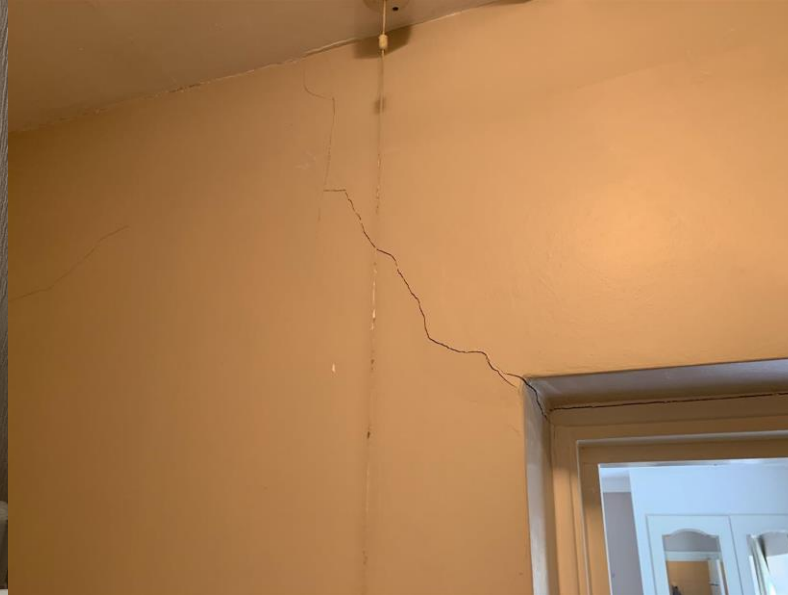
En-Suite - Flat 1

Diagonal crack above door to bedroom

Diagonal and stepped cracking above and below rear window including through wall tiles.

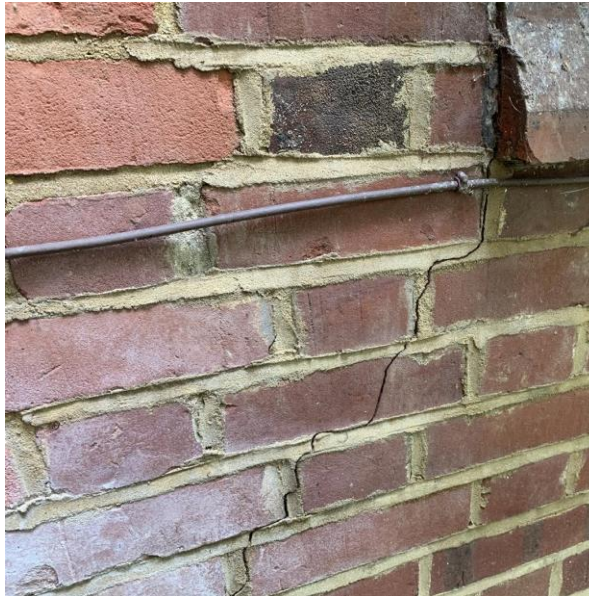
Below En-Suite window

Stepped crack below En-Suite window, open 2-3mm.

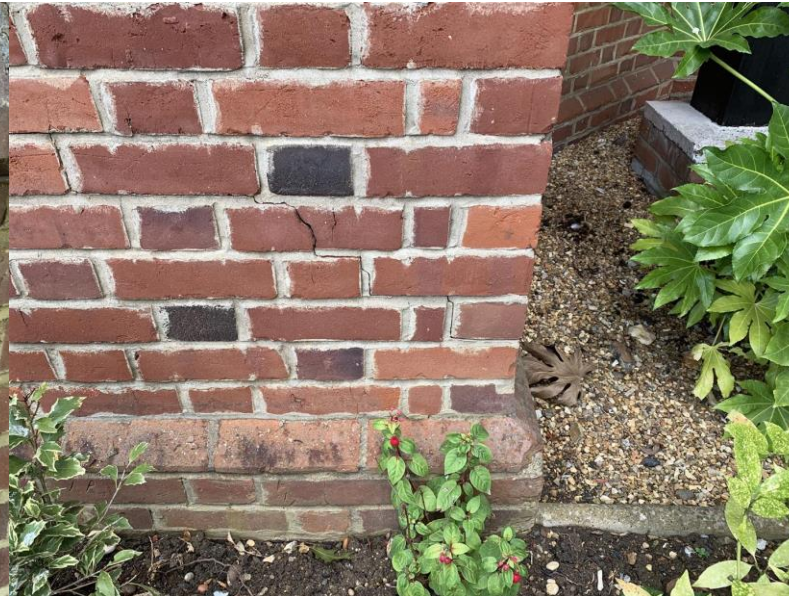
Stepped crack below Lounge window

Stepped vertical crack below left and stepped crack below right of Lounge window (Flat 1). Cracks above both sides of window extending up to Flat 3 bedroom window above.

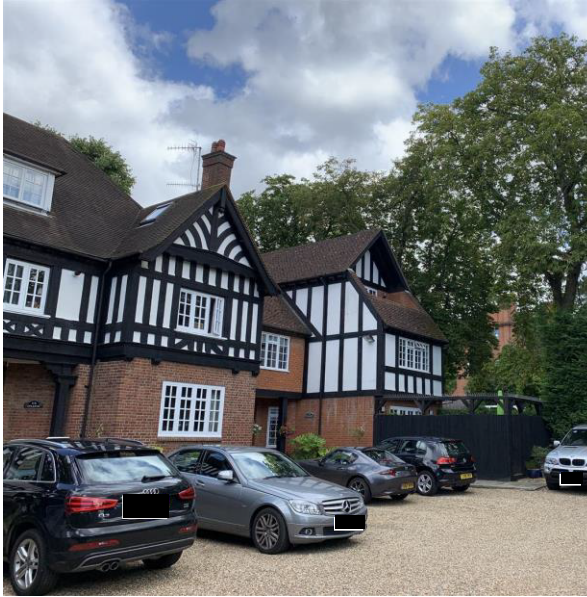
Horse Chestnut tree on right

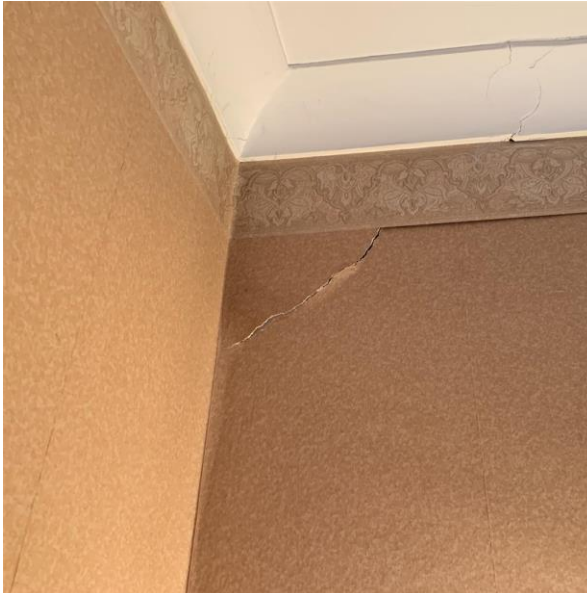
Hall - Flat 1

Diagonal crack above front door.

Diagonal crack adjacent to rear bedroom wall and associated crack to coving and across ceiling.

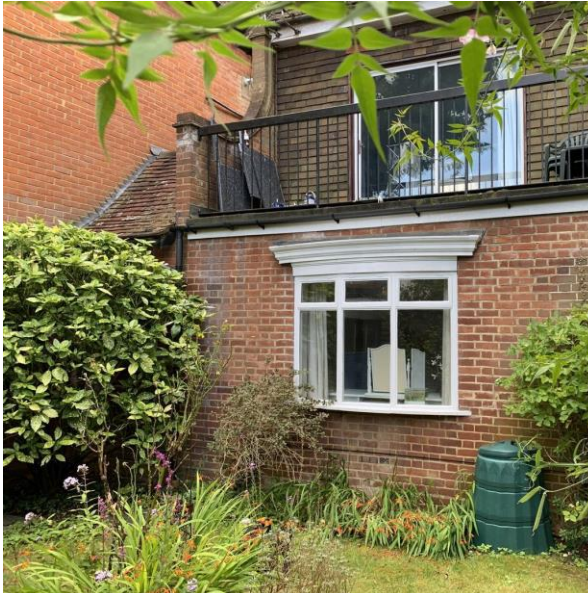
**Rear elevation**

Vertical crack below Flat 1 rear bedroom bow window - not reflected internally.

Laser level survey shows rear elevation is dropping towards the rear left corner. The left elevation is relatively level.

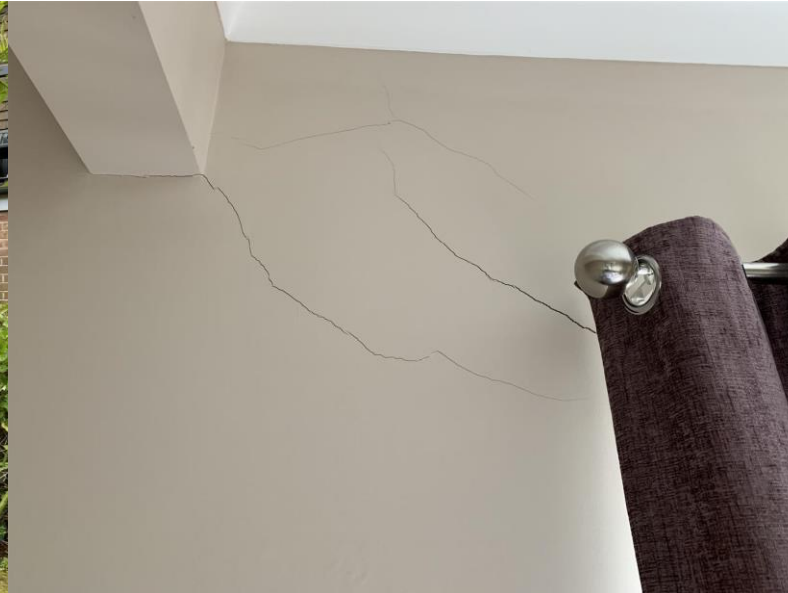
**Flat 3 - Bedroom above front window**

Diagonal stress cracks above either side of front window.
