## Addendum Arboricultural Report

### Subsidence Damage Investigation at:

Flats 1 & 3 Uplands Court  
 19 Frithwood Avenue  
 Northwood  
 HA6 3LY

CLIENT: Crawford & Company  
 CLIENT REF: SU1903345  
 MWA REF: SUB200116-6580Rev02  
 INITIAL REPORT DATE: 12/02/2020  
 1<sup>st</sup> ADDENDUM REPORT DATE: 28/09/2021  
 2<sup>nd</sup> ADDENDUM REPORT DATE: 16/02/2023

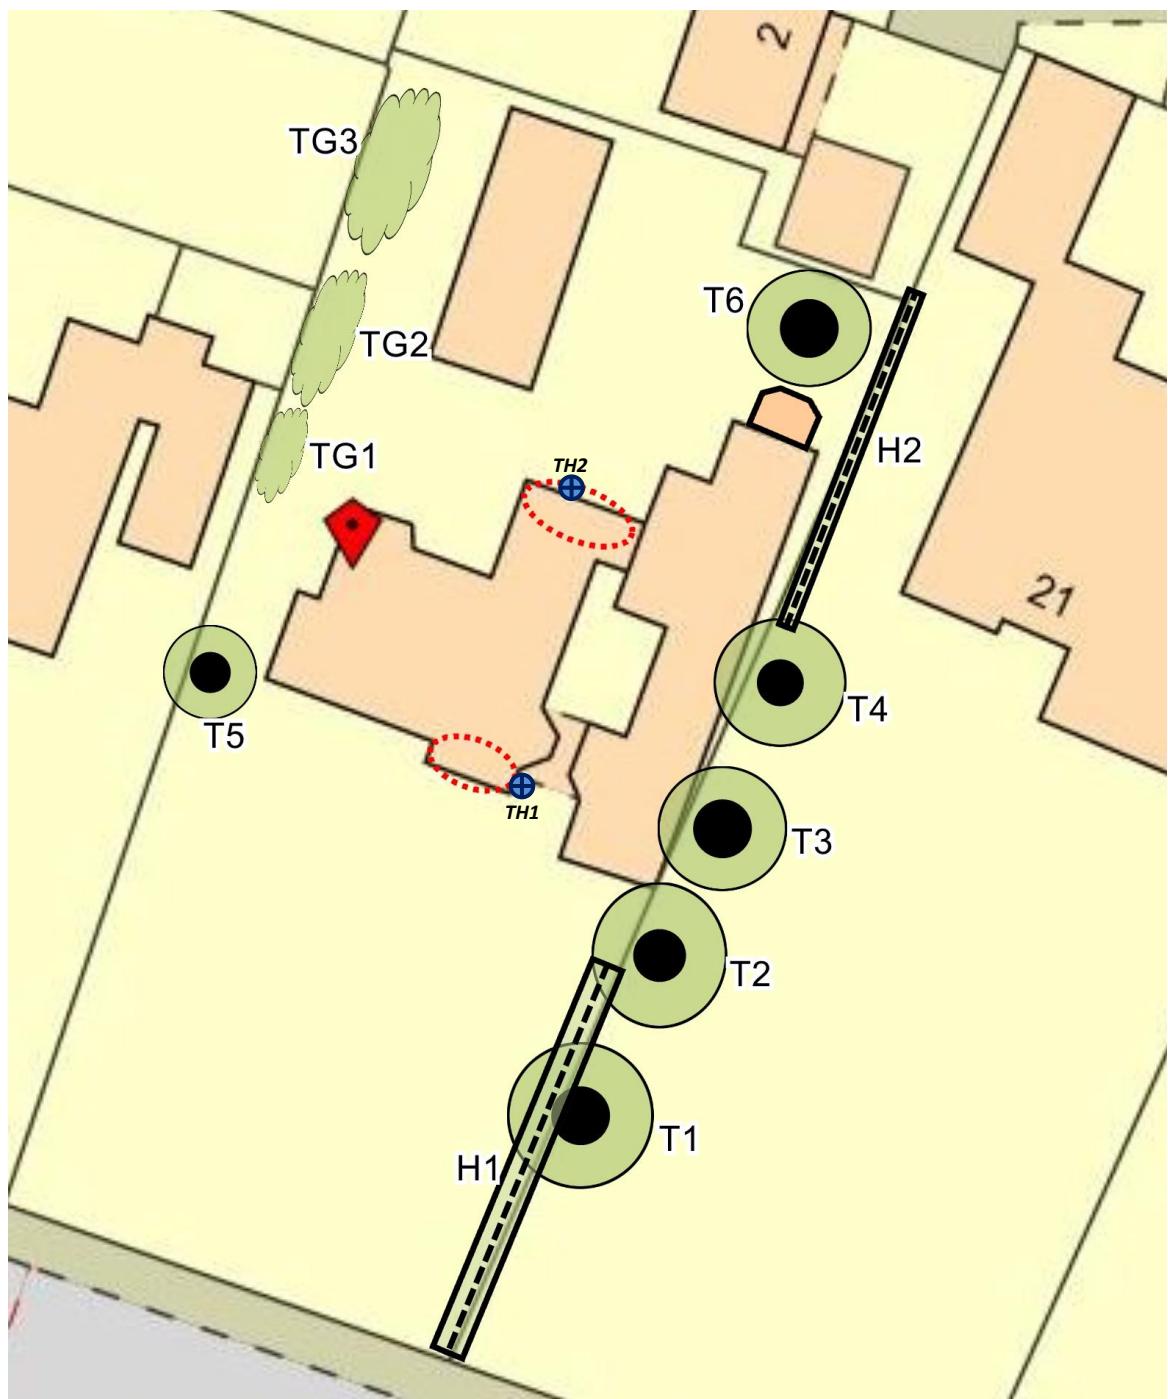
## Site Plan

Approximate areas of damage

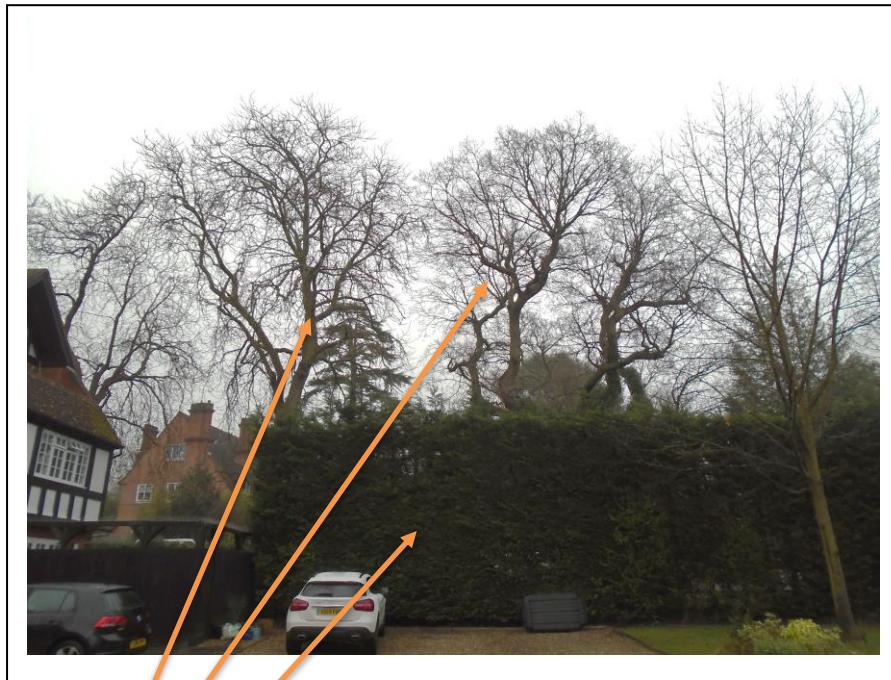
Our initial report noted that despite no positive identification of roots from T2, due to its size and proximity to the area of damage, its roots were also likely to be present below foundation level in proximity to the area of movement/damage and influencing soil moisture and volumes. The second site investigation recovered Aesculus roots to 2.1m depth and whilst the borehole was slightly offset from the building, we considered it highly likely that the roots from this tree are present below the foundations.

The oak roots recovered in the second site investigation will have originated from T1. This tree was originally recommended for reduction as a future risk. In view of the positive root identification works to this tree were moved to current claim works (REV01 report). The was subsequently reduced in June 2022.

View of T2, T1 and H1

Level monitoring has demonstrated ongoing movement at the front right (pin 2) and rear left (pins 5, 6, 7) of the building and on this basis the removal of T1, T3, T6 and TG1 are recommended.

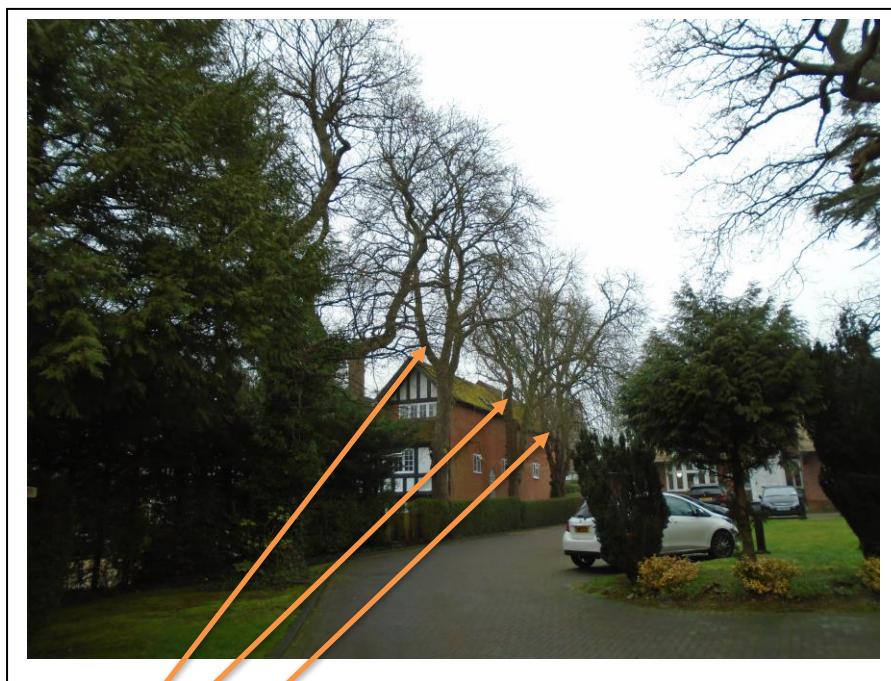
Trees T3 and T4 (chestnut) are also within influencing distance of the original house and the Aesculus roots identified may originate from one or both these trees. However, on balance we considered it likely that T2 to be the most significant of the chestnuts with respect to the damage at the front right of the original house. T2 was removed in June 2022.

View of T2, T3 and T4

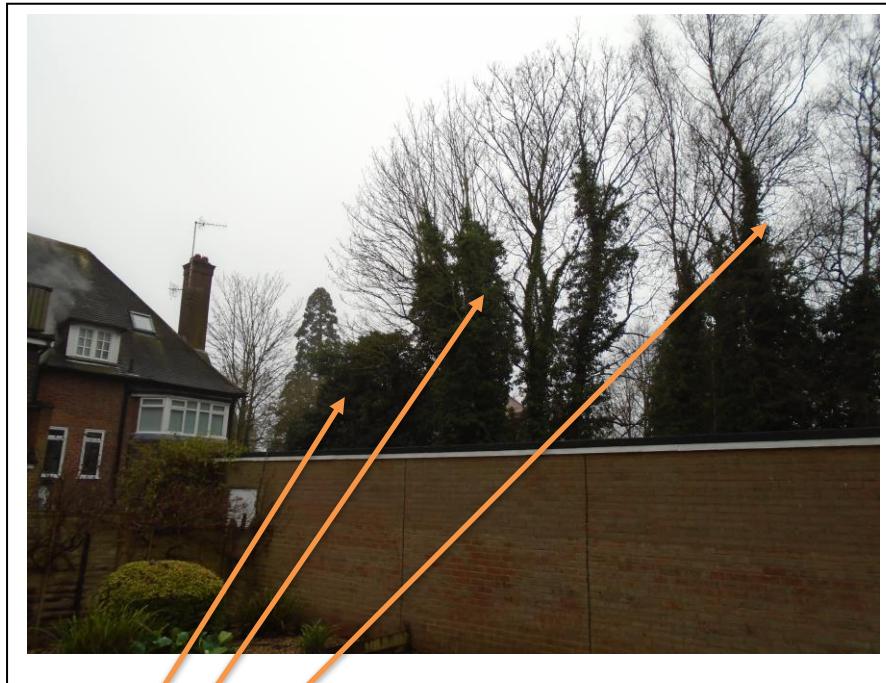
The Acer roots noted at a depth of 1m in TH2 (first site investigation) will originate from the trees within TG2.

View of TG1, TG2 and TG3

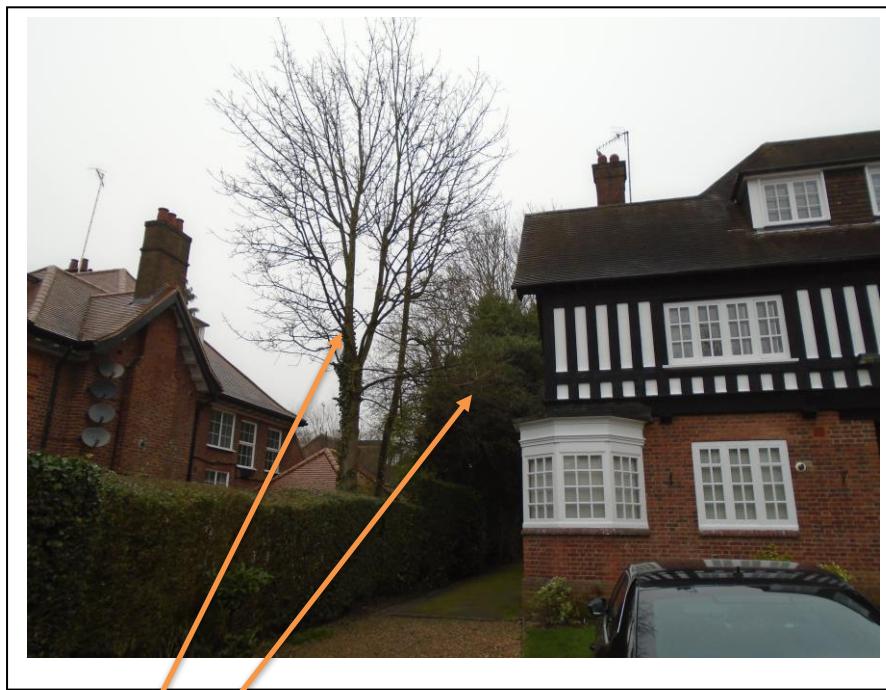
Due to previous monitoring readings, T5 and TG2 were removed in 2020.

View of T5 and TG1
