# **Simon Pryce Arboriculture**

## **Report**

**Site:** Kaduna Close, Pinner, HA5 2PZ

**Subject:** Tree survey to update previous report

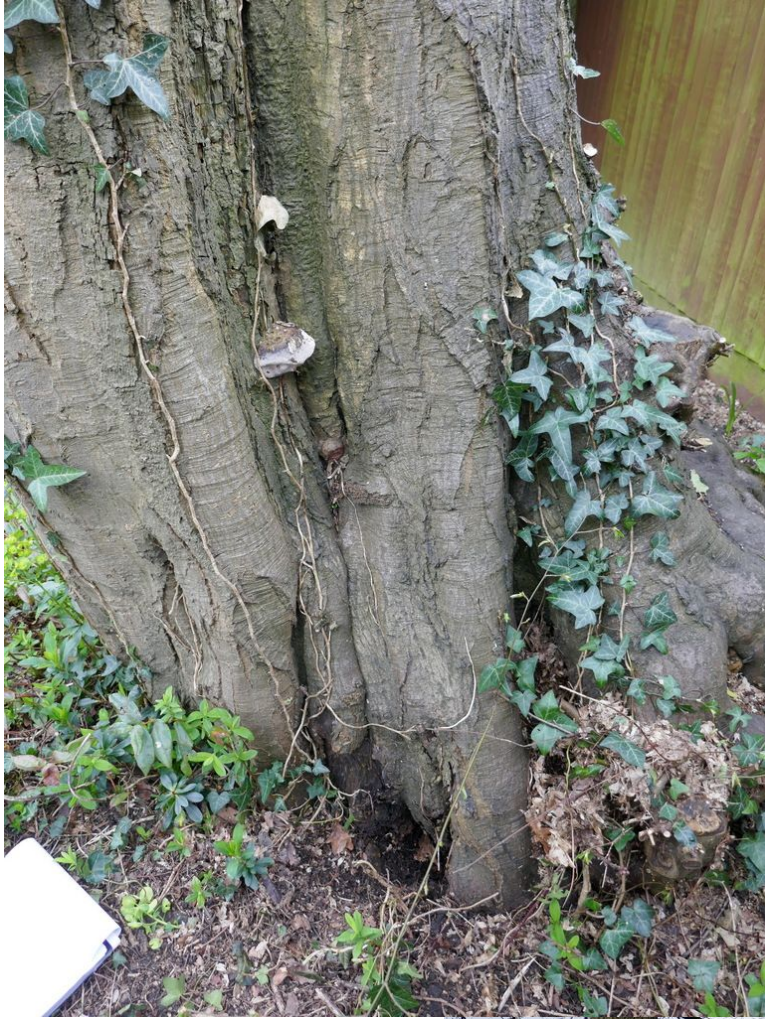
- 3.1 The hornbeam, tree 2, now has a bracket of one of the *Ganoderma* decay fungi growing on the lower trunk and probing at the base revealed decay at ground level (photo 1). The tree is in reasonable health otherwise and the root buttresses, which bear most of the load are sound. Hornbeams are naturally resilient, but it would be advisable to reduce it more severely than it has been to date and to trim the regrowth regularly, as specified in the schedule.

| Tree / TPO no. | Species | Distance | Height | Trunk dia. | Est. age | Comments and recommendations |
|---|---|---|---|---|---|---|
| 2/T11 | Hornbeam | 9m | 16m | 710mm | 100+ | Mature specimen that was crown reduced in about 2015 then pruned again under consent ref 2017/61 and the regrowth since then is healthy looking. There are some old wounds at the base and some large pruning cuts. In 2016 there were no signs of decay, but since then several fruiting bodies of one of the <i>Ganoderma</i> decay fungi have appeared on the trunk (photo 1). This indicates active internal decay and it is possible to push a blunt steel probe up to about 0.5m under the tree's base. The root buttresses are still reasonably sound but the tree leans towards the buildings and it would be advisable to reduce the crown further.<br><ul style="list-style-type: none"> <li><i>Reduce height and spread by 3 - 4m, reshape and trim new growth every 2 - 3 years.</i></li> </ul> |
