Overview of Repairs and Works

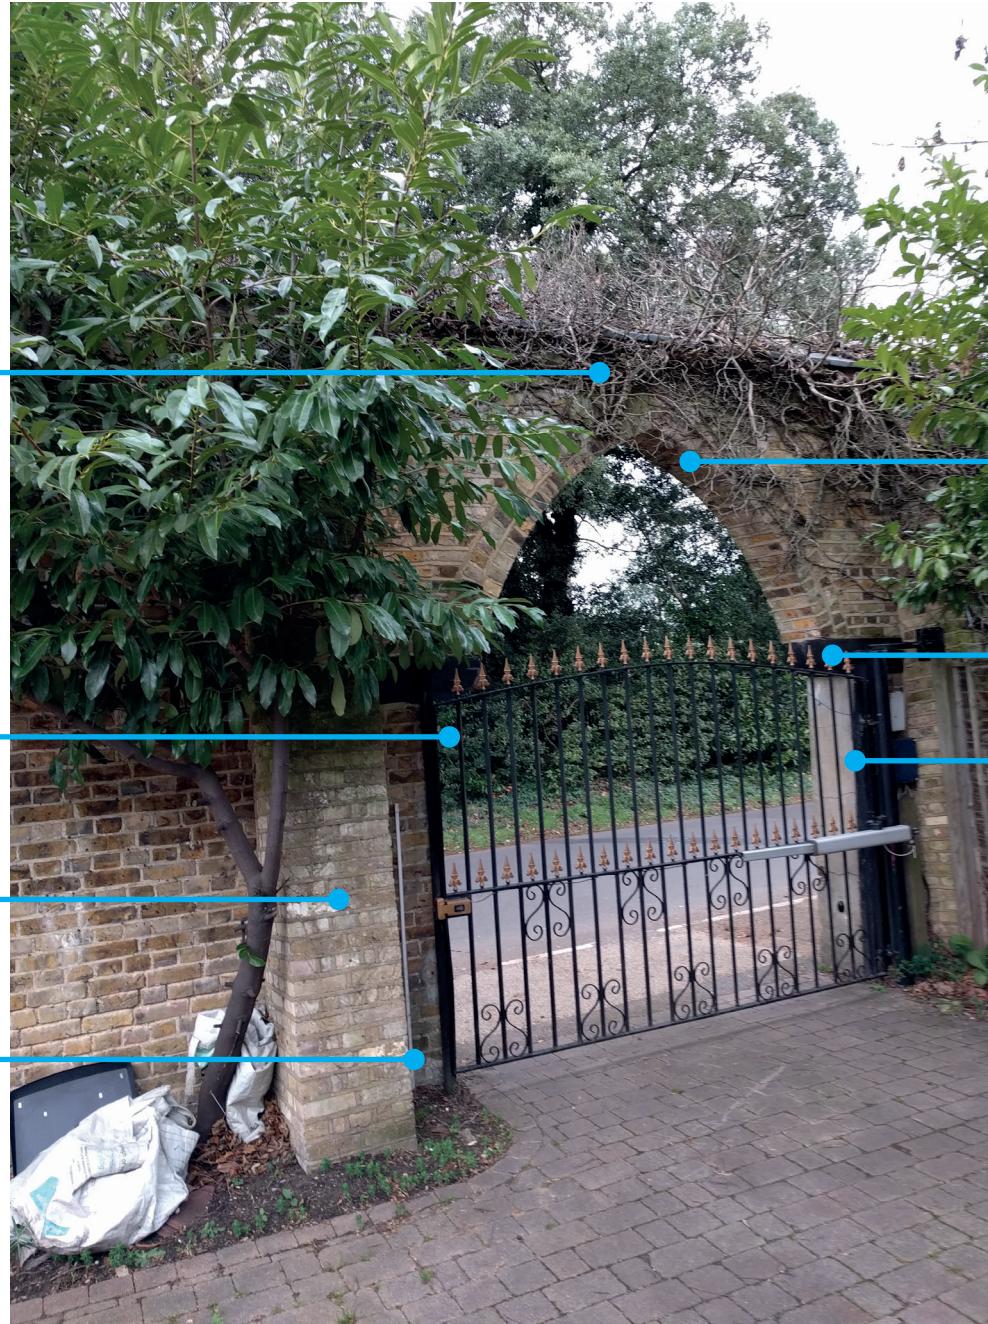
Dead vegation removed to prevent future damage

Timber support in need of replacement - to be removed

Brickwork to be re-pointed were in poor condition - to match apperance of existing

Wall is locally listed but not nationally protected

Head of arch remove and re-built to allow timber support below to be replaced

Gates removed and refurbished

Render to inside of pier renewed

Side pier removed and re-build upto butress
