Arboricultural Consultancy for Aviva / Barclays / Woolwich

1. Case Details

Insured	Mr Amit Karia	Address	16 Deerings Drive, Pinner, HA5 2NZ		
Client	Subsidence Management Services	Contact	Ian Domigan	Claim No.	IFS-AVI-SUB-22-0101567
ES Ref	SA-250316	Consultant	Giles Mercer	Contact No.	0330 380 1036
Report Date	26/09/2022

16 Deerings Drive, Pinner, HA5 2NZ

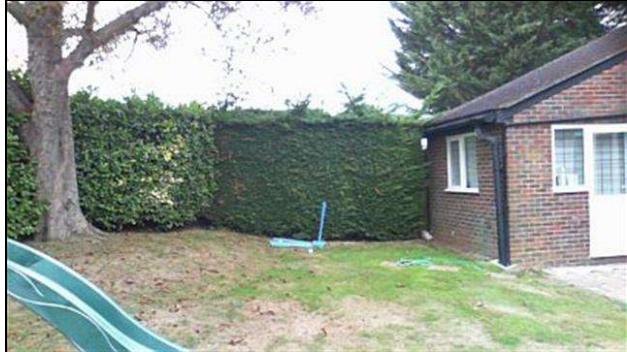
H1 - Mixed species hedge

With due regards to species profile, size and proximity, the Red Oak (T3 & T4), the Horse Chestnut (T1) and the mixed species hedge (H1) are considered the dominant features proximate to the focal area(s) of movement and accordingly, where vegetation is confirmed as being causal, we have identified them as the primary cause of the current subsidence damage.

Consequently, we have advocated the complete removal of, the Red Oak (T3 & T4) and the Horse Chestnut (T1) in conjunction with management, to include partial removal of a section of the mixed species hedge H1 (as detailed) as it will offer the most certain arboricultural solution likely to restore long-term stability.

Tree No.	Species	Age Cat	Approx. Height (m)	Distance to Building (m) *	Ownership	Action	Requirement
H1	Mixed species hedge	1	3	0.6	C - Insured	Maintain as detailed	Remove section of hedge/group to achieve a minimum clearance of 2m to the insured property; do not treat stumps due to translocation risk. Where such a risk exists, we advise that any emergent regrowth is removed annually. Maintain retained section thereafter at broadly current dimensions by way of regular pruning.
T1	Horse Chestnut	1	13.1	6.25	C - Insured	Remove	Remove close to ground level and treat stump to inhibit regrowth.
T3	Oak (Red)	3	24.5	6	C - Insured	Remove	Remove close to ground level and treat stump to inhibit regrowth.
T4	Oak (Red)	3	20	13.75	A - Third Party	Remove	Do not allow to exceed current dimensions by way of regular pruning.

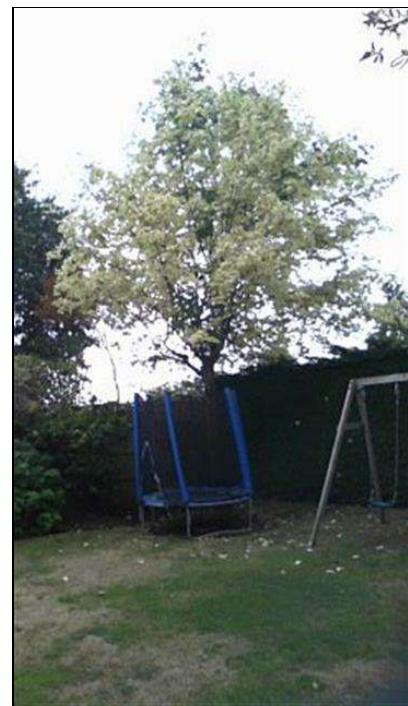
T2 - Maple (Norway)

Please note that the footing of the insured property fall within the anticipated rooting distance of additional vegetation which we believe presents a foreseeable risk of future damage and accordingly we have made recommendations in respect of this.

Tree No.	Species	Age Cat	Approx. Height (m)	Distance to Building (m) *	Ownership	Action	Requirement
T2	Maple (Norway)	1	8.5	9.4	C - Insured	Action to avoid future risk	Maintain at broadly current dimensions by way of regular pruning.
T5	Birch	3	3.6	4.8	C - Insured	Action to avoid future risk	Do not allow to exceed current dimensions by way of regular pruning.
T6	Cypress	2	15	7	A - Third Party	Action to avoid future risk	Do not allow to exceed current dimensions by way of regular pruning.
T7	Holly	1	7	4.6	A - Third Party	Action to avoid future risk	Do not allow to exceed current dimensions by way of regular pruning.

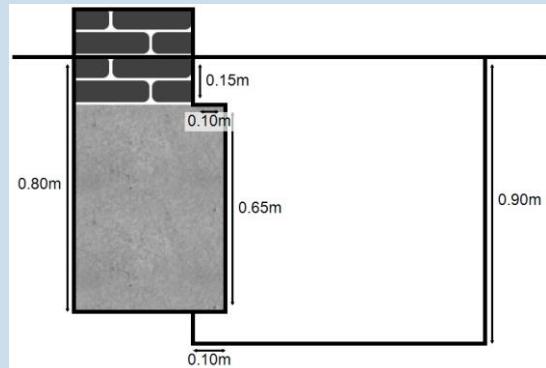
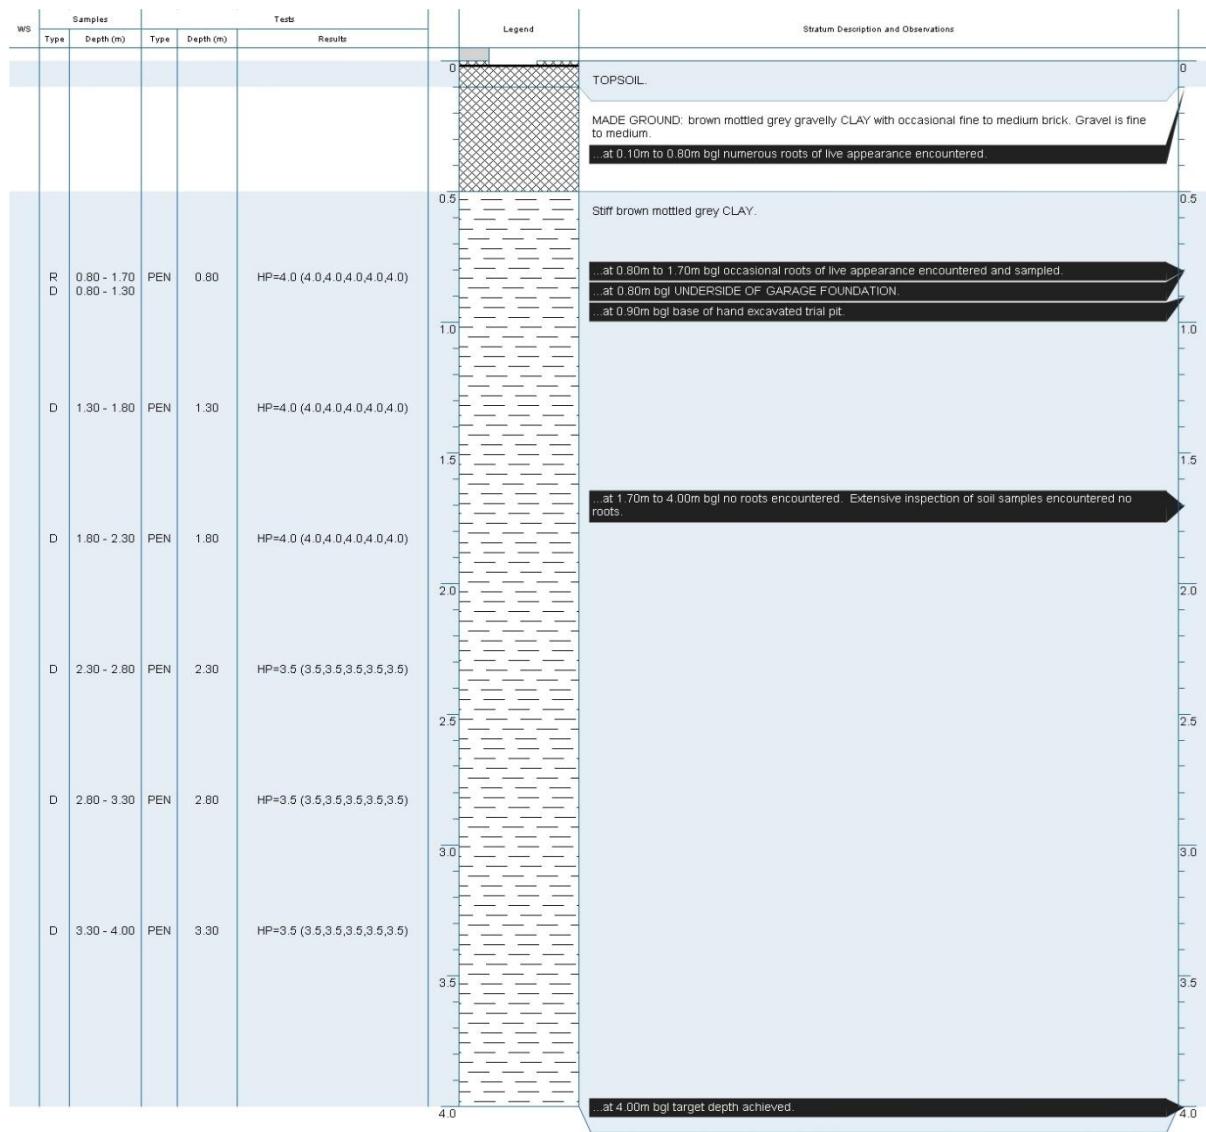
TP/BH1 Foundation Detail and Borehole Log

Garage foundation comprised of brick wall to 150mm bgl, bearing on concrete to 800mm bgl with a total projection of 100mm from the elevation. Underside of foundation (USF) was exposed to 100mm back from the face of the foundation and probed 400mm back from the face of the foundation.

At 0.10m to 0.80m bgl numerous roots of live appearance encountered in TP/BH1.

At 0.80m to 1.70m bgl occasional roots of live appearance encountered and sampled in TP/BH1.

At 1.70m to 4.00m bgl no roots encountered. Extensive inspection of soil samples encountered no roots in TP/BH1.

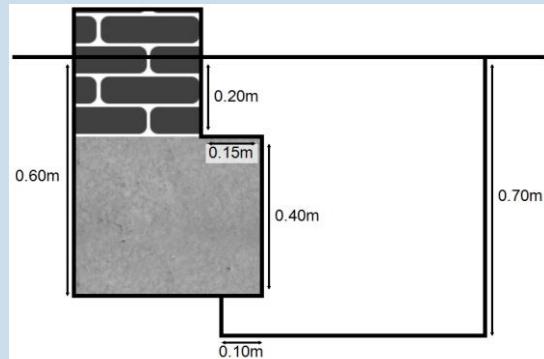
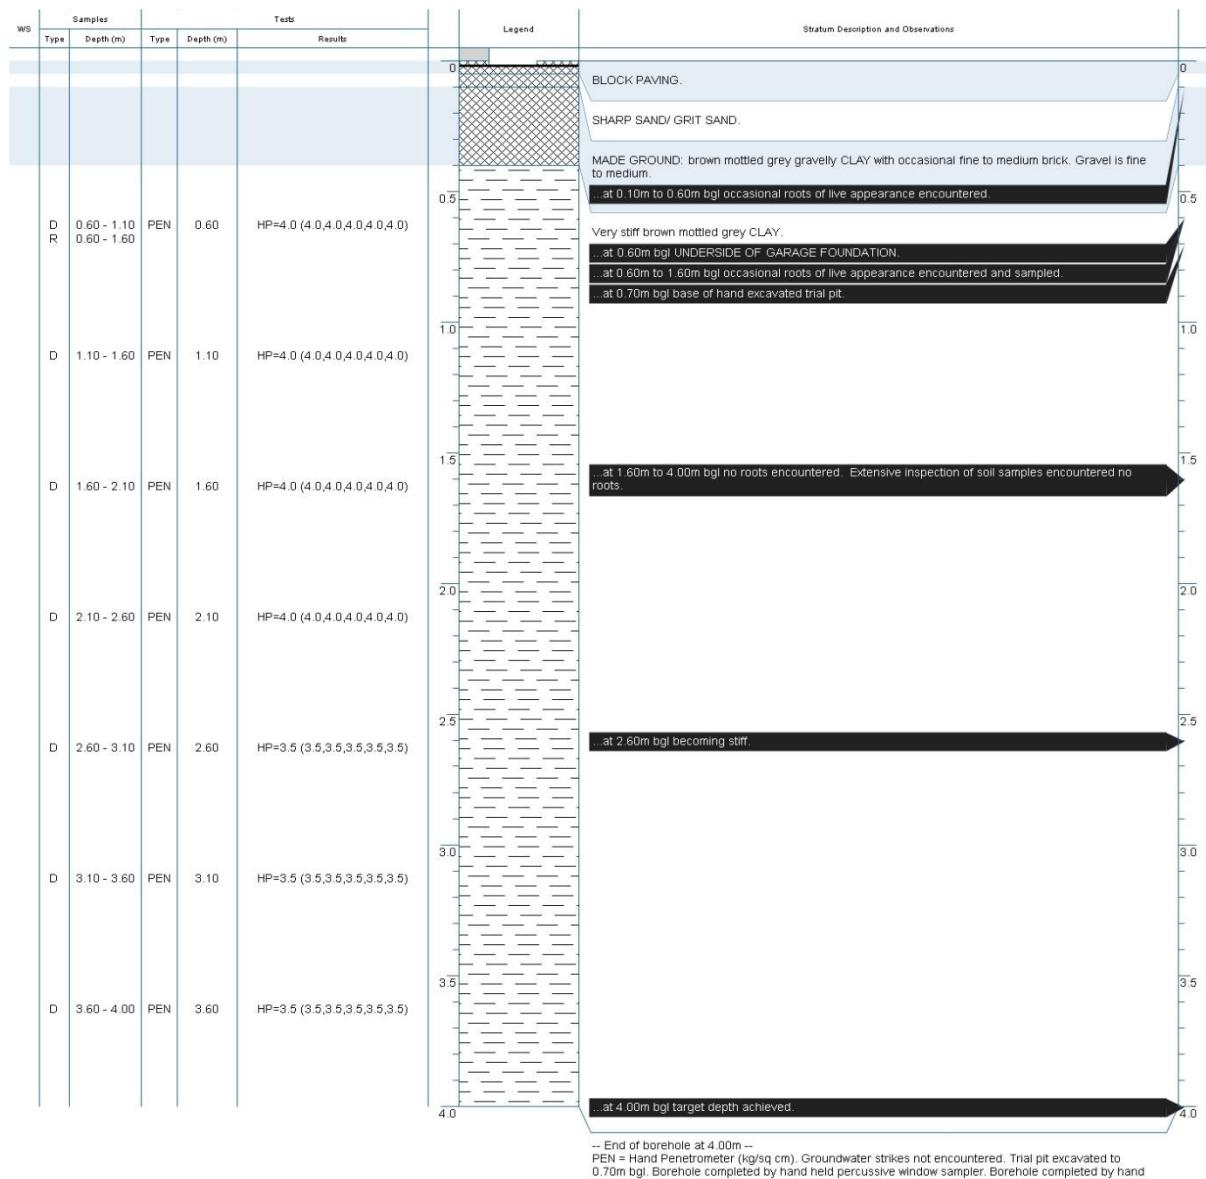
TP/BH2 Foundation Detail and Borehole Log

Garage foundation comprised of brick wall to 200mm bgl, bearing on concrete to 600mm bgl with a total projection of 150mm from the elevation. Underside of foundation (USF) was exposed to 100mm back from the face of the foundation and probed 400mm back from the face of the foundation.

At 0.10m to 0.60m bgl occasional roots of live appearance encountered in TP/BH2.

At 0.60m to 1.60m bgl occasional roots of live appearance encountered and sampled in TP/BH2.

At 1.60m to 4.00m bgl no roots encountered. Extensive inspection of soil samples encountered no roots in TP/BH2.

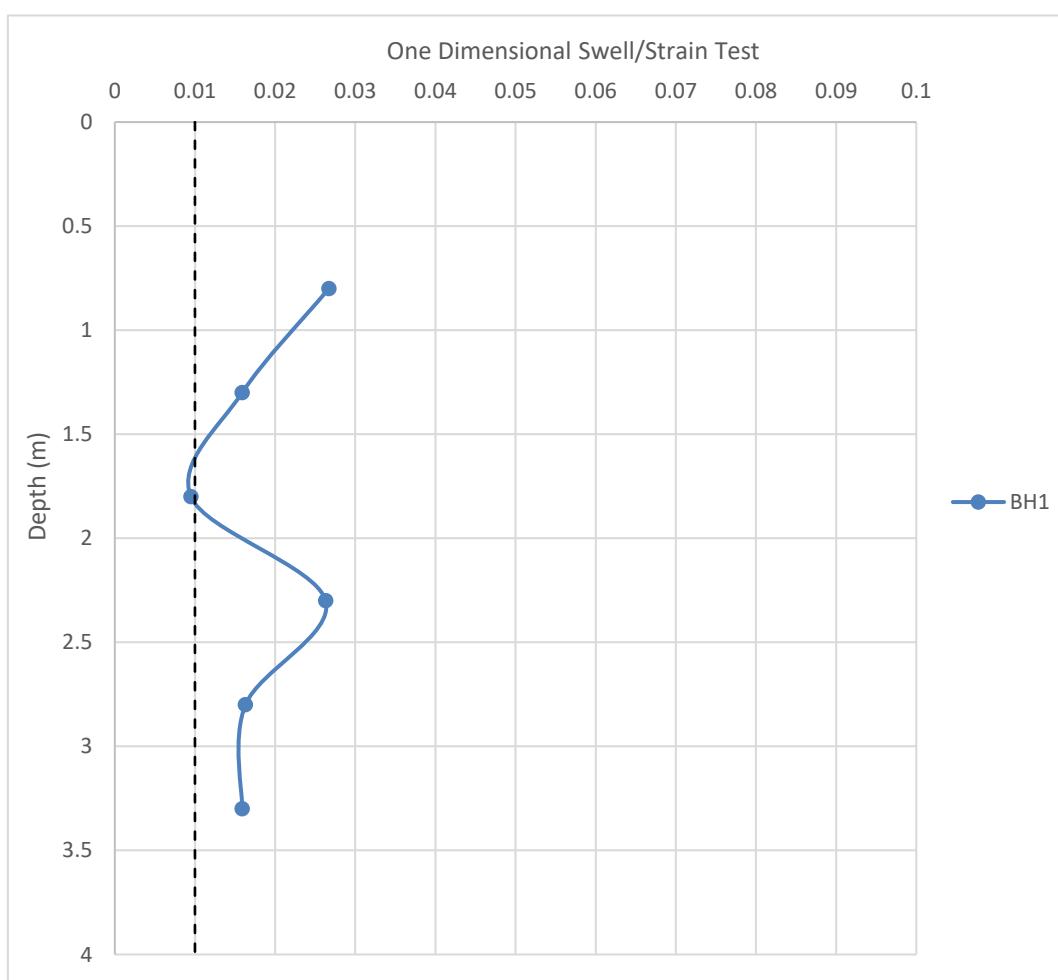
BH 1 estimate of heave

29mm

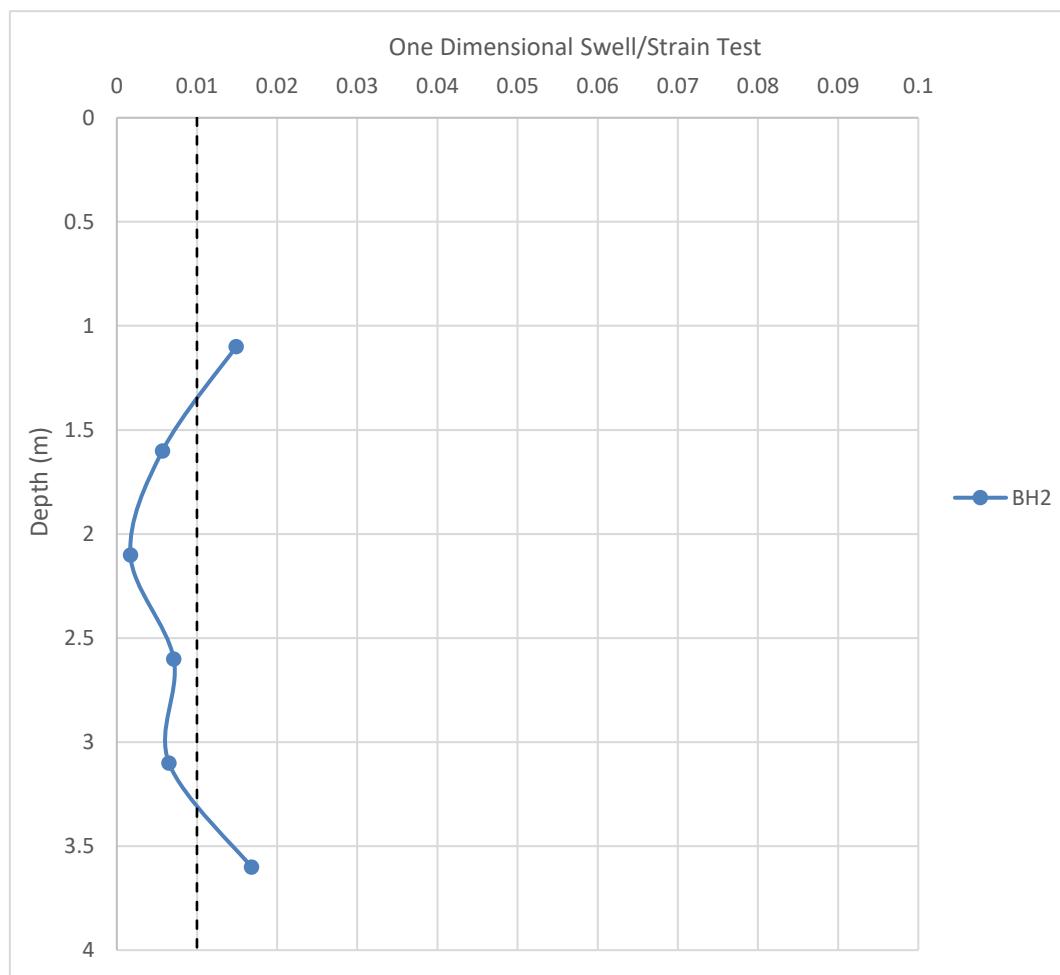
Summary of Oedometer Testing for BH2

7	0.6		
8	1.1	0.0149	8.2
9	1.6	0.0057	0
10	2.1	0.0017	0
11	2.6	0.0071	0
12	3.1	0.0065	0
13	3.6	0.0168	4.2

BH 2 estimate of heave	12mm
------------------------	------
