Reference No: PS - 1386

# Roof Condition Report

The Furze – External

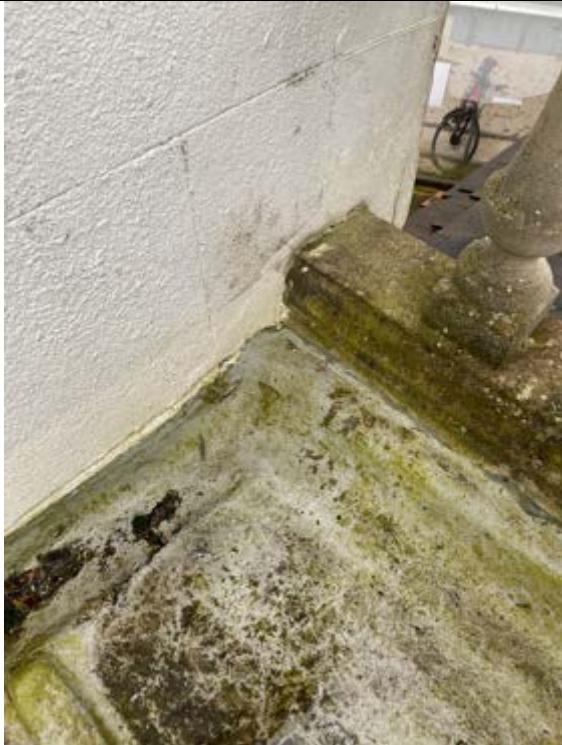
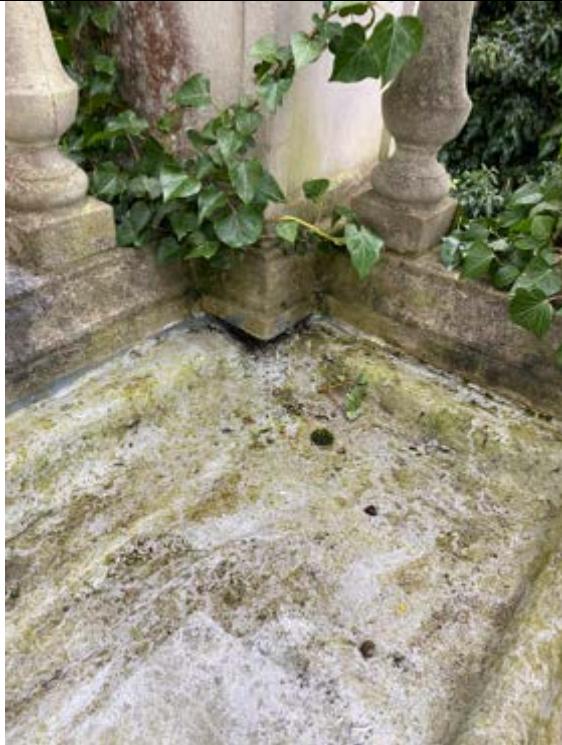
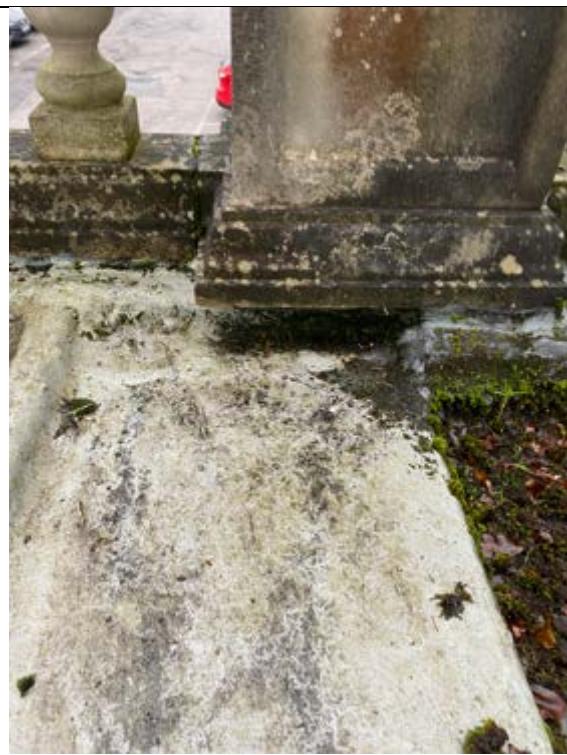
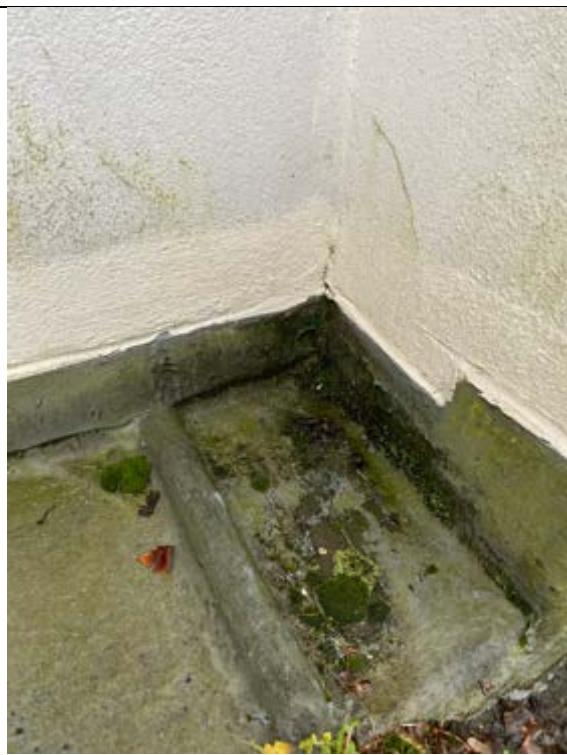
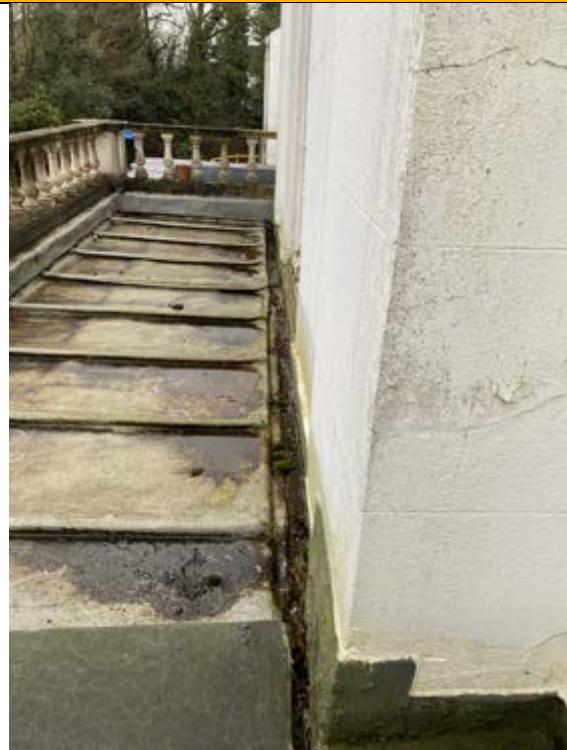
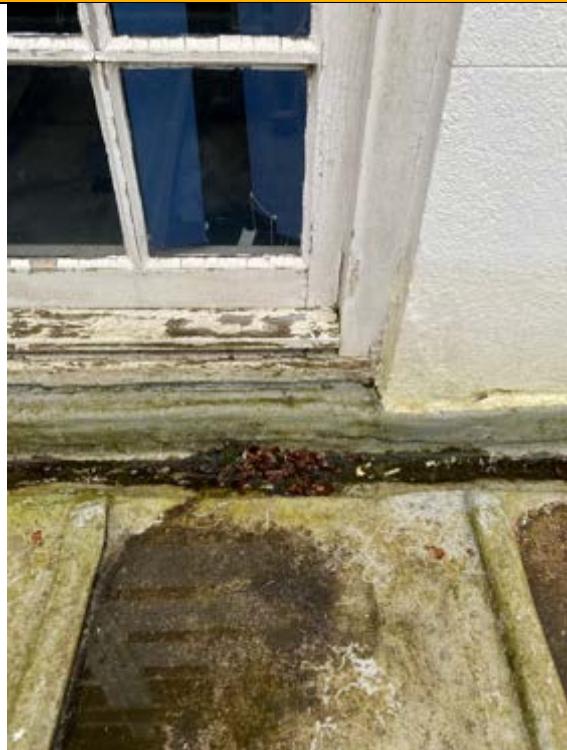
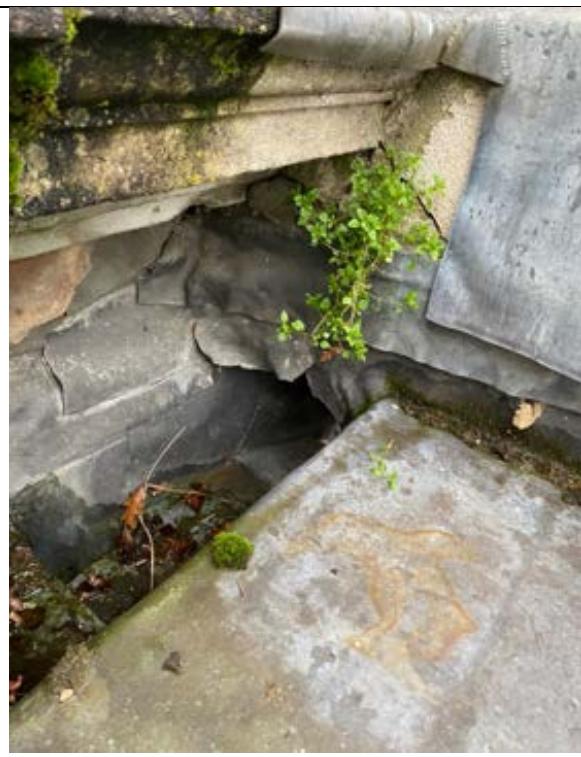
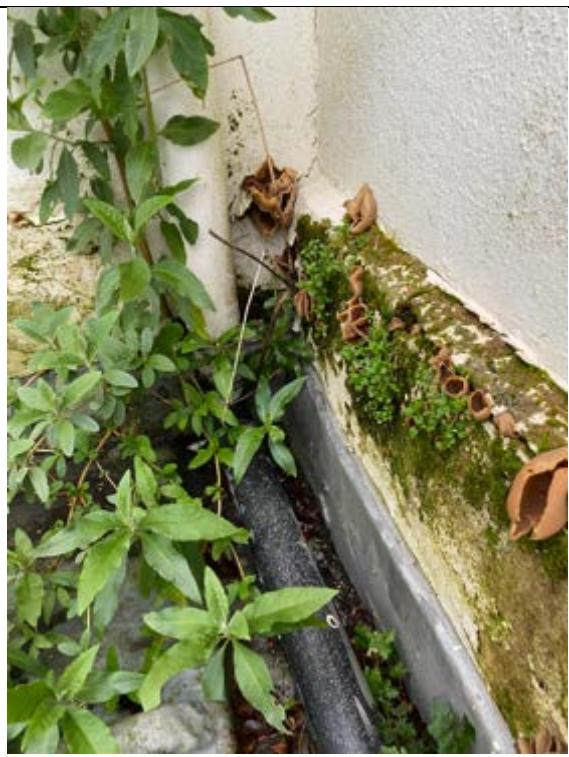
Number	Action/Cause	Appendix B
1.	<p>Painted Lead Roof Terrace 01C:</p> <p>The lead roof terrace has been subject to remedial works over time and been painted with a fibreglass reinforced liquid membrane. Cracking and splits can be viewed on the upstands/terminations and at points of the door thresholds along the terrace. This would lead to water travelling behind the liquid membrane and this product is incompatible with lead due to the thermal expansion and contraction which occurs with lead at different temperatures. The terrace falls back towards the building and the rain water gully appears to be flat with one outlet leading on to Flat Roof 01A. The gully could not be fully inspected due to debris however assumption would be significant rainfall would result in the gully overflowing and the thresholds would be compromised and appear to show historic signs of this.</p>	1 - 12

Number	Recommendations
1.	<p>Painted Lead Roof Terrace 01C:</p> <p>Allow to strip back the liquid membrane that has been applied to the lead roof and the upstands taking back to the lead finish.</p> <p>Allow to remove all flashing detailing into the upstands and replace with new ensuring accordance with current building standards for upstand/threshold allowances. Ensure all mortar and lead sealant replaced and chased out to provide a watertight seal between the mortar of the parapet and the lead roof.</p> <p>Allow to clear out the gully and inspect for defects and replace where necessary.</p>

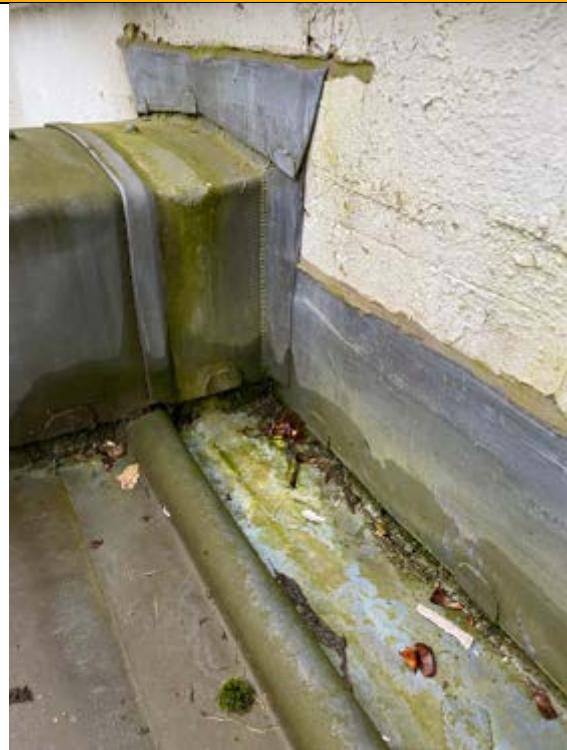
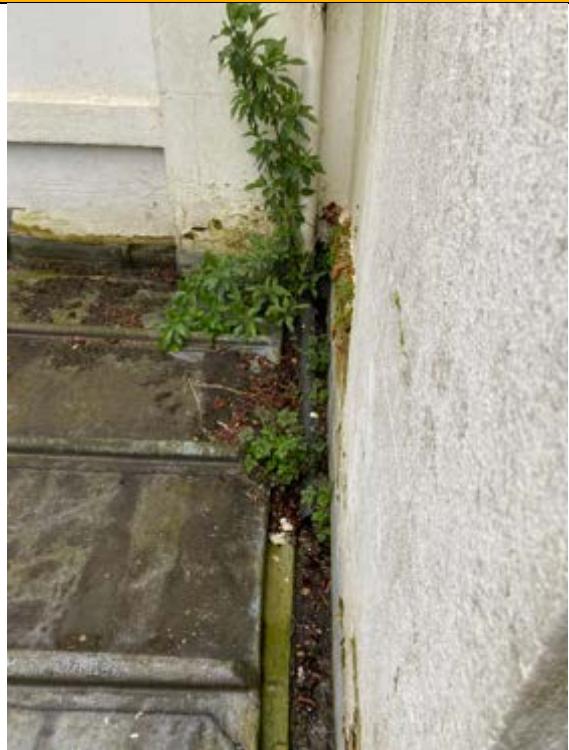
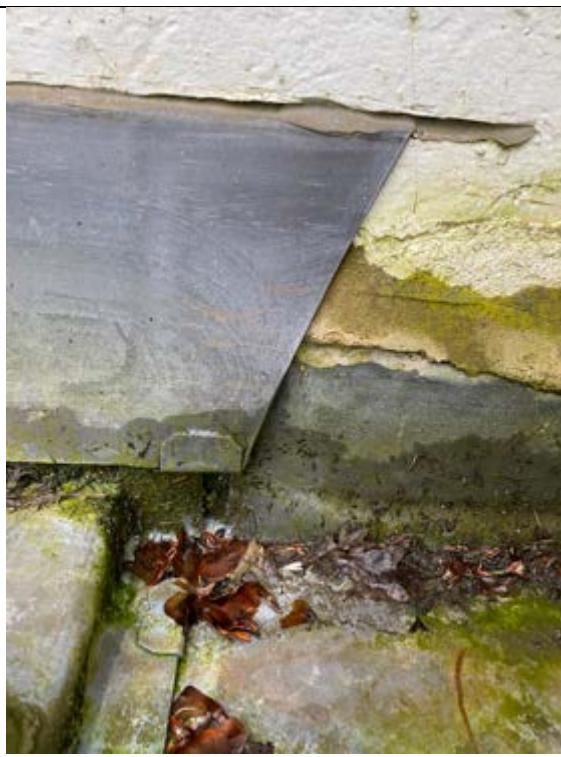
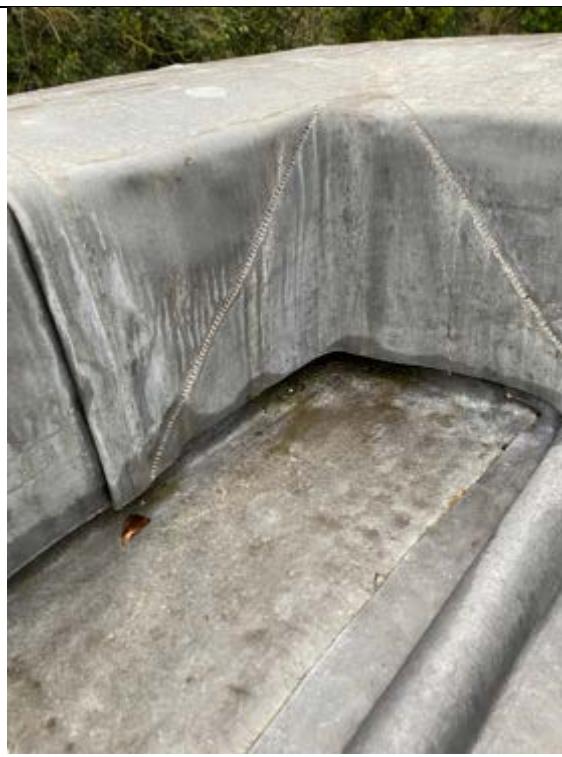
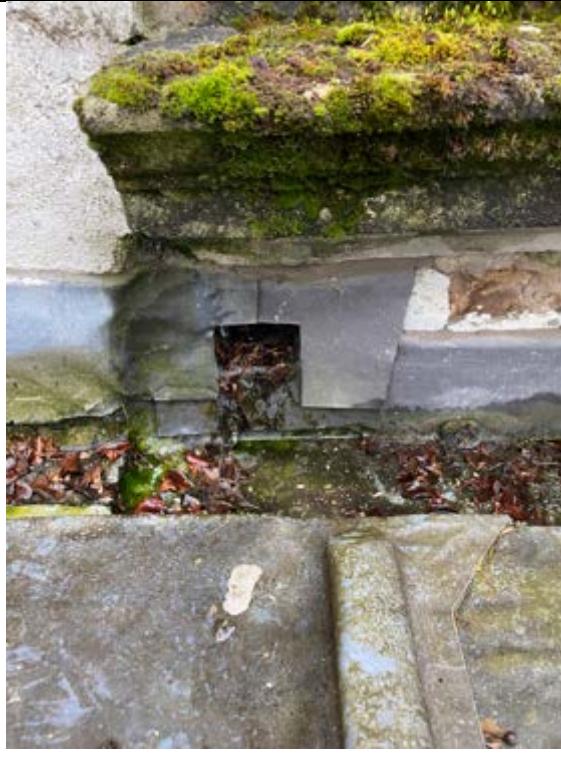
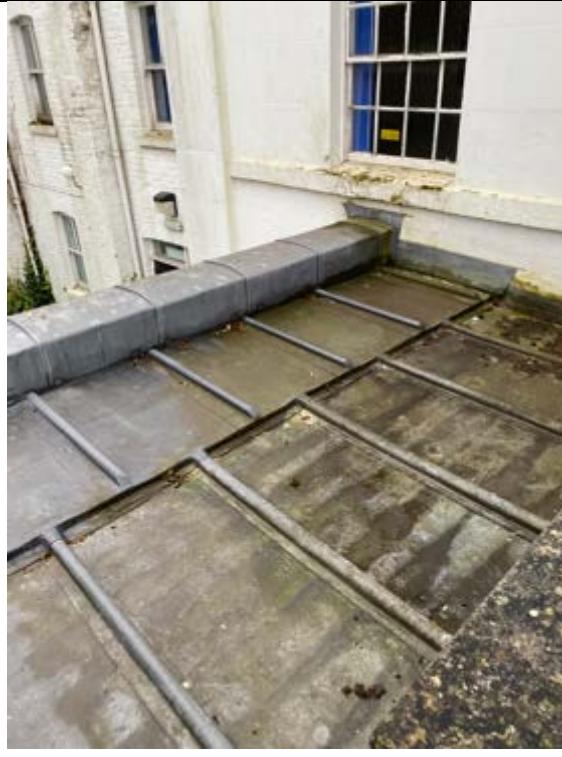
2.	<p>Flat Roof 01A:</p> <p>The lead roof has had repairs conducted over time to the detailing and flashings around the masonry, presumably in an effort to prevent future ingress as this has been the source of historic ingress into room 9.4, however the raised section has not been coated with any other product. We were unable to determine if the lower section falling back towards the painted roof terrace had been coated due to the build up of lichen present.</p>	13 - 20

2.	<p>Flat Roof 01A:</p> <p>Allow to strip back the internal ceiling in room 9.4 to allow substrate inspection from under the roof to allow for a decision to either, remove and replace the roof entirely due to water damage on the substrate or repair the substrate from underneath and preserve and repair the current lead roof.</p> <p>Allow to thoroughly clean down the lower section to determine if there is a coating present on the lead roof or it is simply a build up of debris. If a coating is found to be present allow to remove entirely back to the original lead roof.</p> <p>Allow to remove all flashing detailing into the upstands and replace with new ensuring accordance with current building standards for upstand/threshold allowances. Ensure all mortar and lead sealant replaced and chased out to provide a watertight seal between the mortar of the parapet and the lead roof.</p>

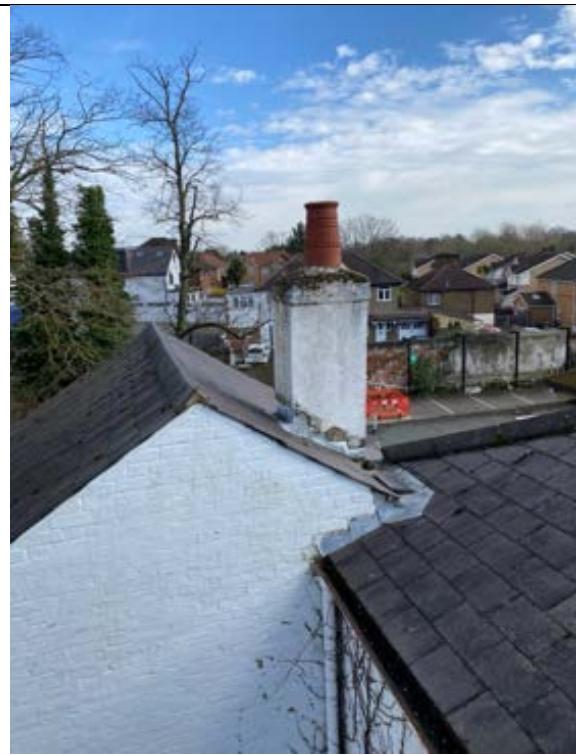
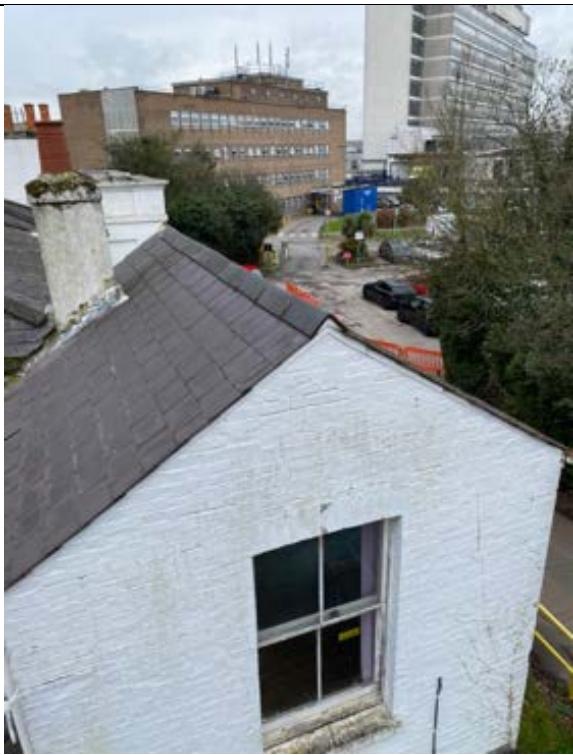
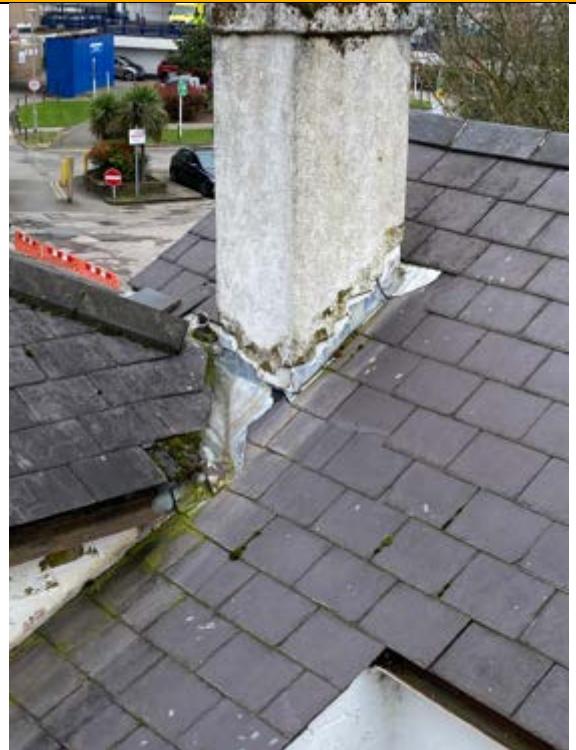
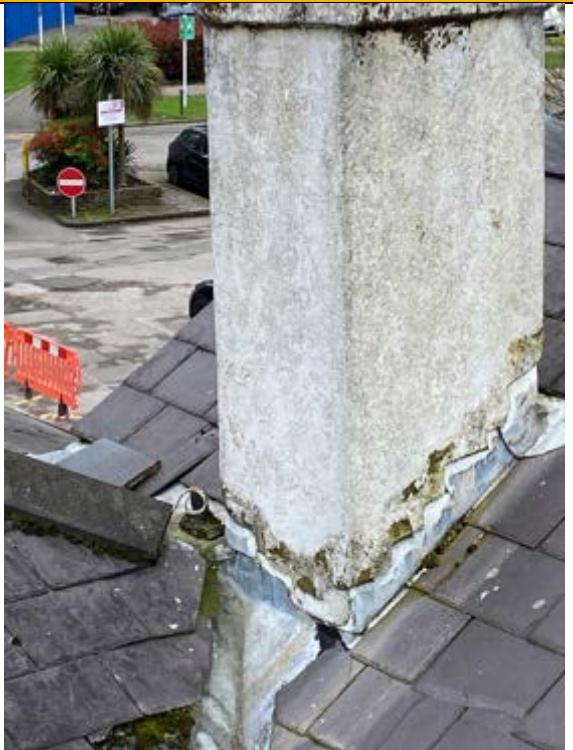
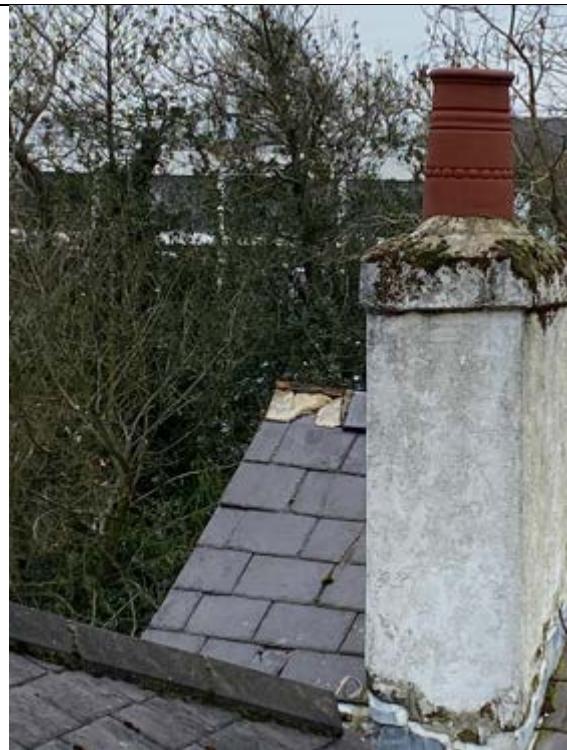
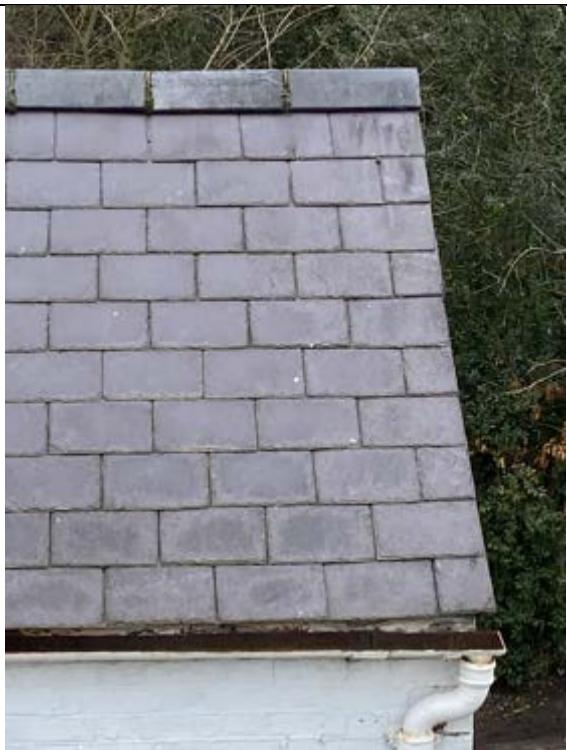
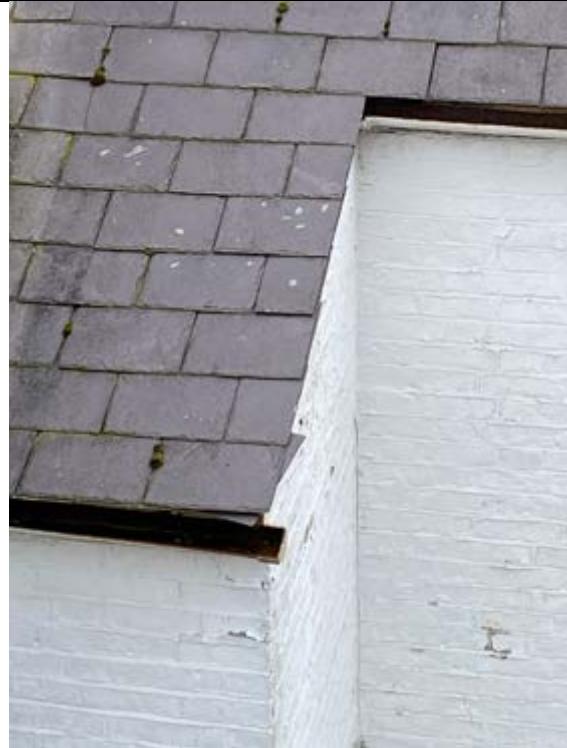
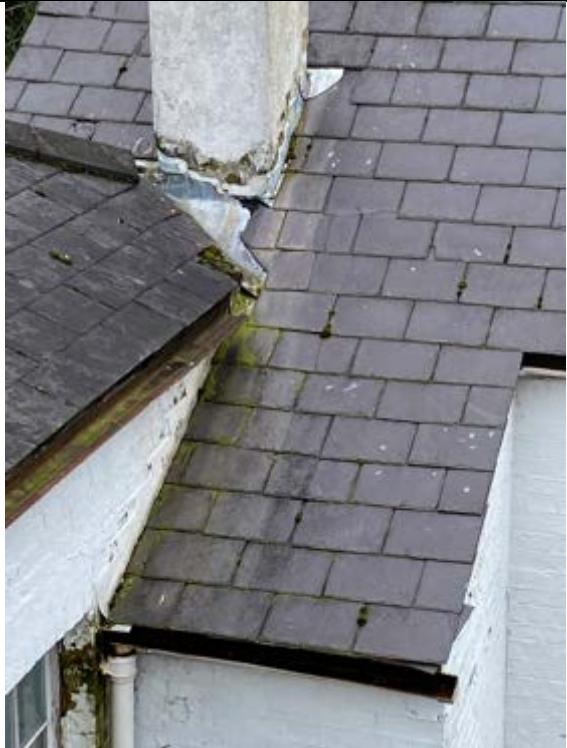
4.	<p>Slate Roof 02:</p> <p>There is a missing ridge slates at the gable end which will be allowing water to traverse under the slates, the slate is in the lead gully at the bottom of the roof therefore poses a risk of falling off in high winds.</p> <p>There are a number of loose, cracked and broken slates visible.</p> <p>The lead flashing around the chimney stack and the masonry at the base require attention, they appear at the end of their natural lifespan and it is assumed it is some time since they were installed, these should be replaced during roofing works.</p> <p>The cast gutters are sagging and in need of replacement, internal corrosion is visible from above.</p>	39 - 46

4.	<p>Slate Roof 02:</p> <p>Allow to replace all broken slates and inspect the sarking felt and baton underneath to determine if they also need to be stripped back and replaced due to damage from ingress.</p> <p>Allow to replace the cast guttering to the front and rear with compatible guttering in line with listed building status guidelines.</p> <p>Allow to strip back slates, lead flashings and broken mortar around the base of the chimney stack and replace with new.</p>

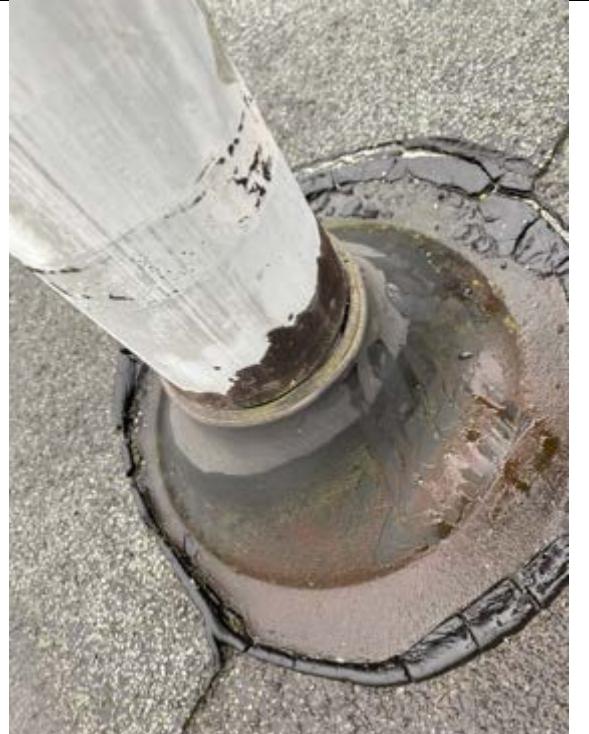
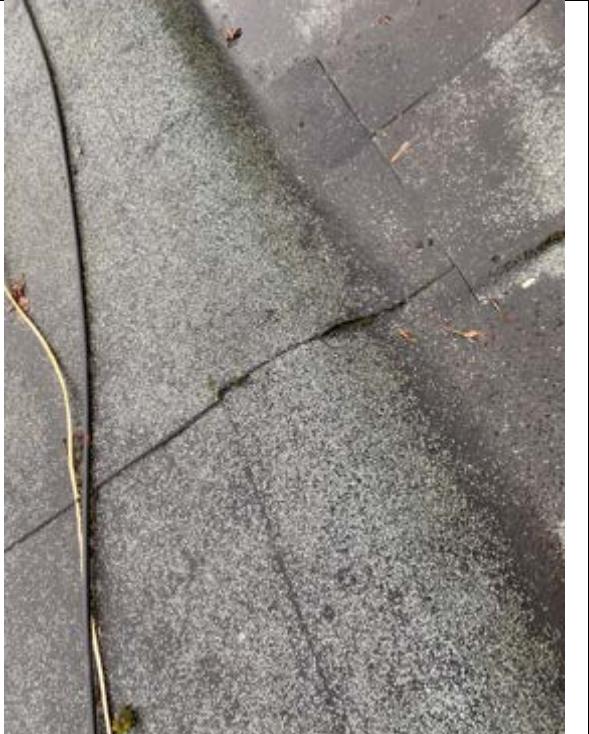
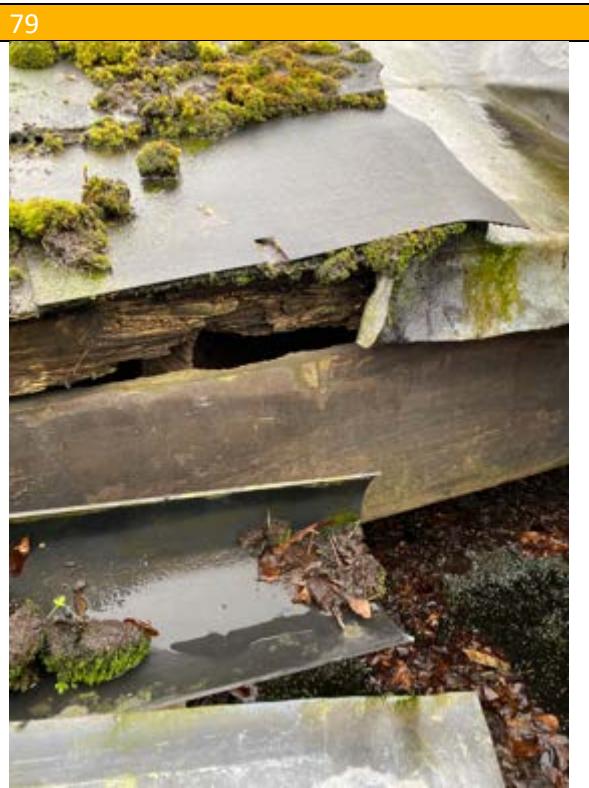
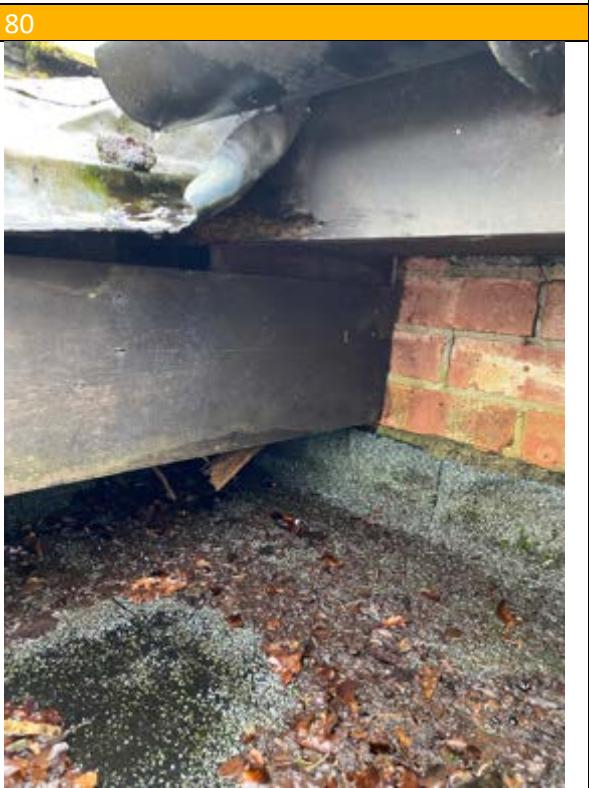
5.	<p>Flat Roof 02A:</p> <p>The roof is constructed of a bituminous membrane assumed on a timber deck. It is at the end of its normal lifespan and severe cracks and defects are visible throughout. The roof appears to have some damage to the substrate due to undulations and it is assumed at some point water have penetrated the system resulted in damage to the substrate beneath. There are defective laps on the upstands of the sides of the valley gutters in</p>	47 - 82

<p>the centre of the roof and these defects will also allow rainwater to penetrate beneath the membrane.</p> <p>The roof is heavily soiled with moss, debris, redundant plant and the rainwater goods appear blocked as a result.</p> <p>The cappings and upstand are split and cracked in various places also allowing ingress.</p> <p>Numerous repairs appear to have been undertaken over time to lead flashings on upstands and liquid repairs to the flat areas around the outlets. Repairs have been carried out to a vent pipe which the rubber has degraded and cracked and will be a point of ingress.</p> <p>The grp rooflight covering the void below has been replaced in time however has been cracked in various places and requires replacement.</p>

5.	<p>Flat Roof 02A:</p> <p>Allow to fully strip up and replace all areas of the flat roof in line with current building regulations, ensuring a fall is designed in the roof for effective drainage and replace all rainwater goods internally and externally.</p>

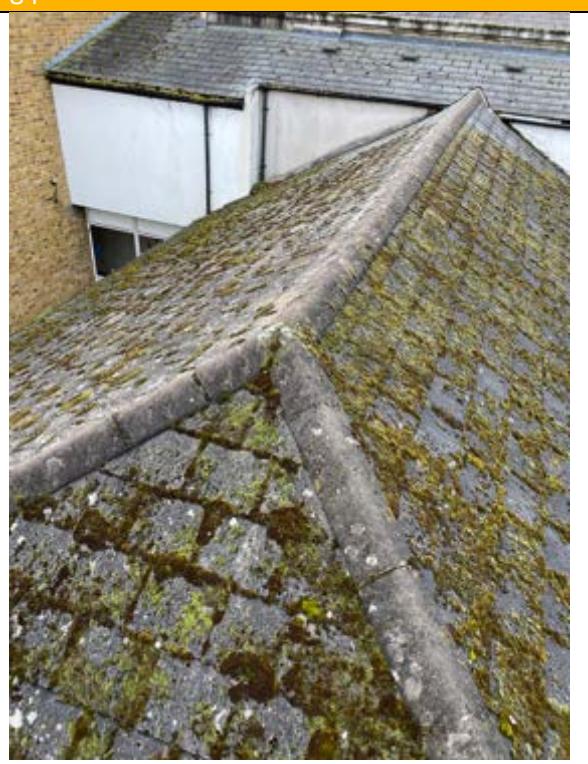
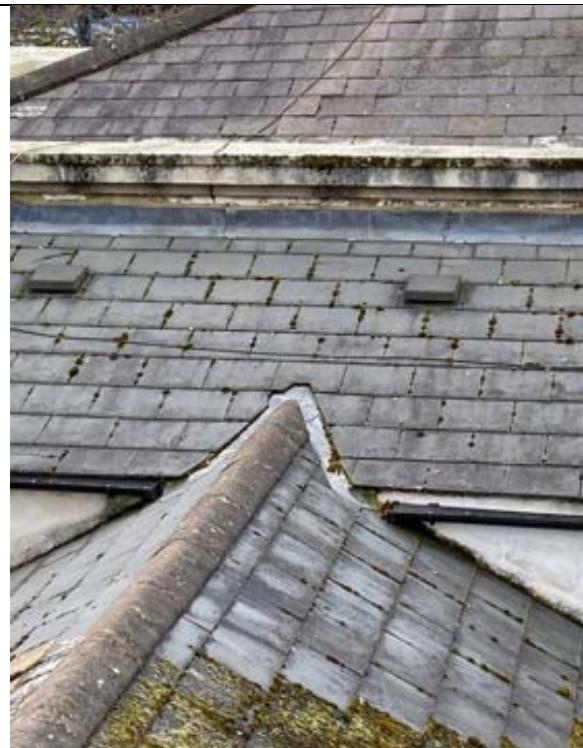
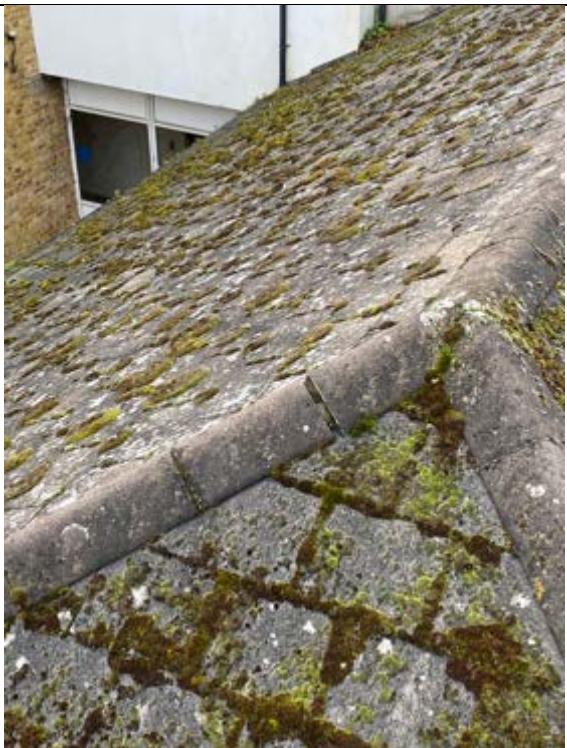
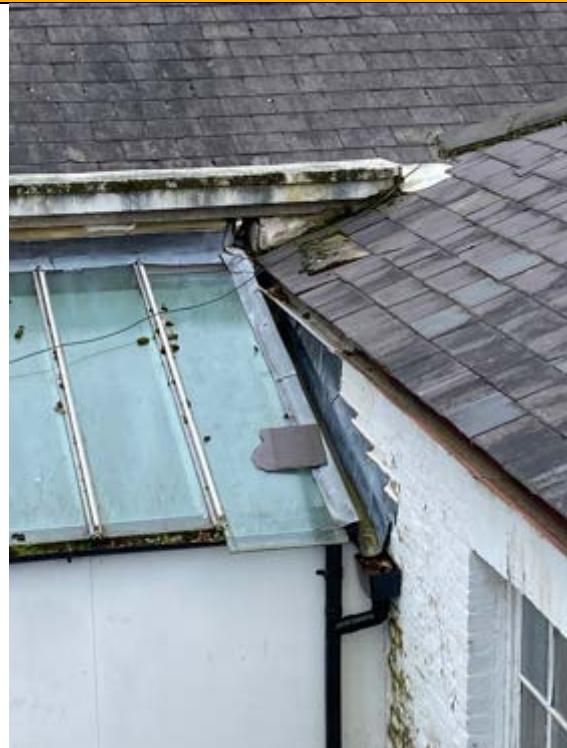
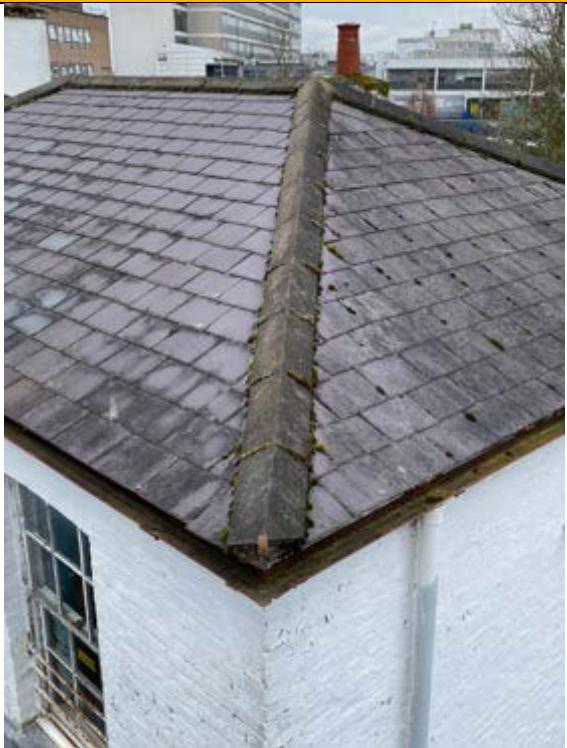
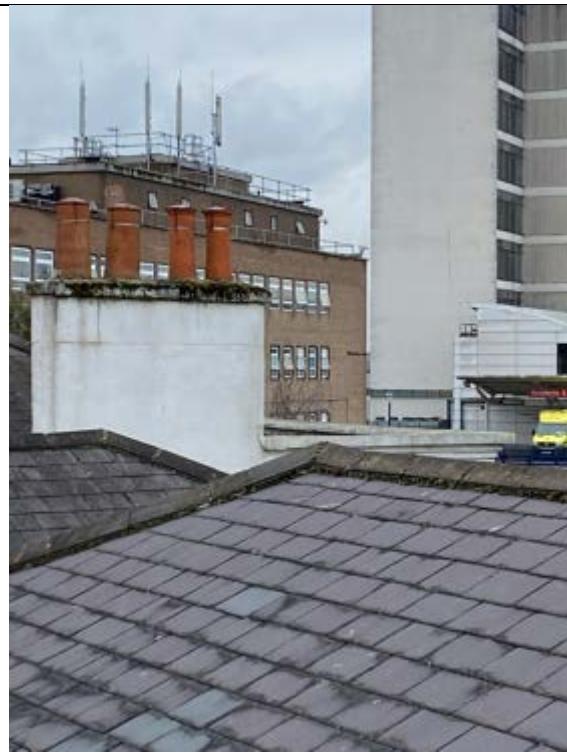
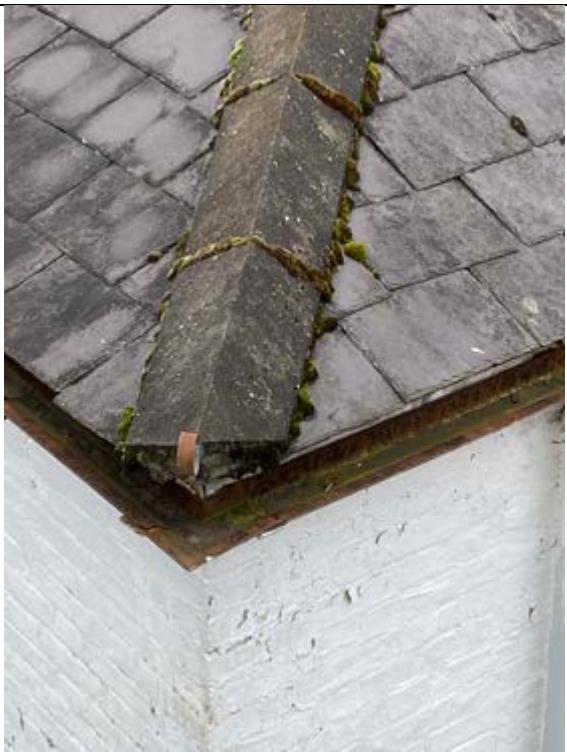
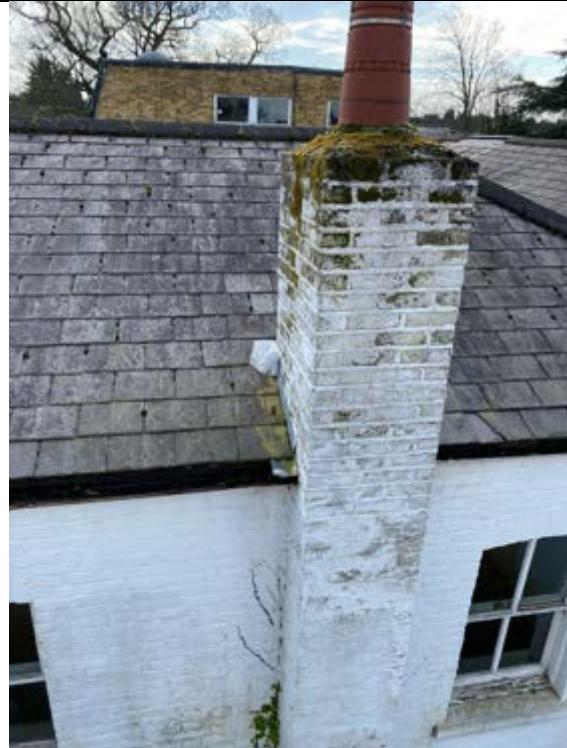
6.	<p>Slate Roof 03:</p> <p>A number of hip slates have slipped and require replacing, these can become dislodged over time and is a sign the mortar had failed and is no longer supporting them.</p> <p>There are areas of concern on the lead flashings in the gully's between this roof and Slate Roof 07 and remedial works should be undertaken.</p> <p>There are a number of damaged slates that require replacing near the eaves</p> <p>The guttering requires replacing due to damage as a result of the weight of the moss and debris currently in the guttering.</p> <p>All of the fascia boards and soffits need to be removed and replaced with new.</p> <p>The masonry supporting the eaves of this roof is in extremely poor condition and it appears has been constructed on top of the old flat roof, this is the audiology suite underneath where the old flat roof is visible.</p>	83 - 88

7.	<p>Slate Roof 04:</p> <p>There have been a number of slates replaced on this roof over time, however at the rear of the roof bordering the adjacent glass roof, a replacement slate has become dislodged entirely and is on the glass roof. It is unclear whether this slate has caused the glass to slip down or something else has caused this yet the glass appears to have been completely dislodged from its support above and is protruding over the guttering. This will result in rainwater entering the building at the top of the glass pane.</p> <p>Despite the replacement slates installed there are still damaged and broken slates visible on the roof.</p>	89 - 95

<p>The guttering is suffering from extensive corrosion internally and appears to be sagging at the rear.</p> <p>The hip and ridge slates appear to be in reasonable condition.</p>

6.	<p>Slate Roof 03:</p> <p>Allow to fully clean down the roof slates and hip/ridge slates and reinspect when clear to determine which slates require replacement, refixing or realignment.</p> <p>Allow to replace all broken slates and inspect the sarking felt and baton underneath to determine if they also need to be stripped back and replaced due to damage from ingress.</p> <p>Allow to strip off the fascias and soffits on all sides and replace with new and replace all guttering.</p> <p>Allow to replace the lead gullies between roof 03 and 07.</p> <p>Allow to fully overhaul the masonry supporting the eaves leading onto the flat roof and replace if necessary during roofing works.</p>

7.	<p>Slate Roof 04:</p> <p>Allow to fully clean down the roof slates and hip/ridge slates and reinspect when clear to determine which slates require replacement, refixing or realignment.</p> <p>Allow to replace all broken slates and inspect the sarking felt and baton underneath to determine if they also need to be stripped back and replaced due to damage from ingress.</p>

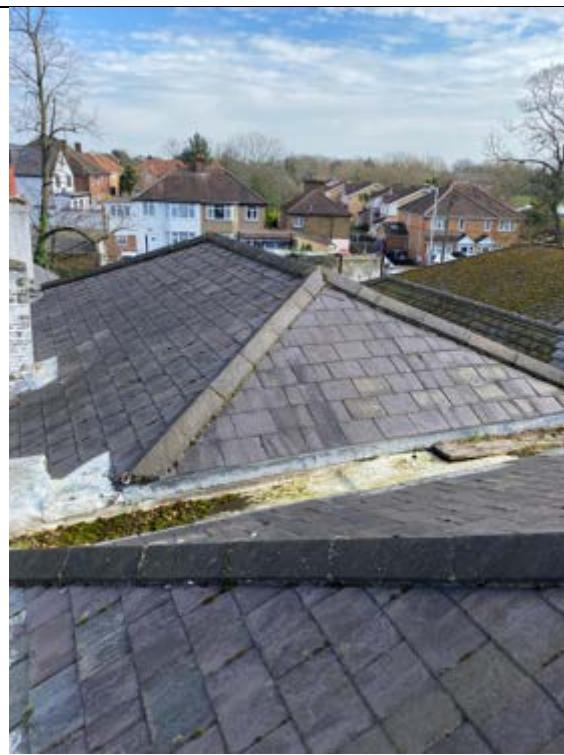
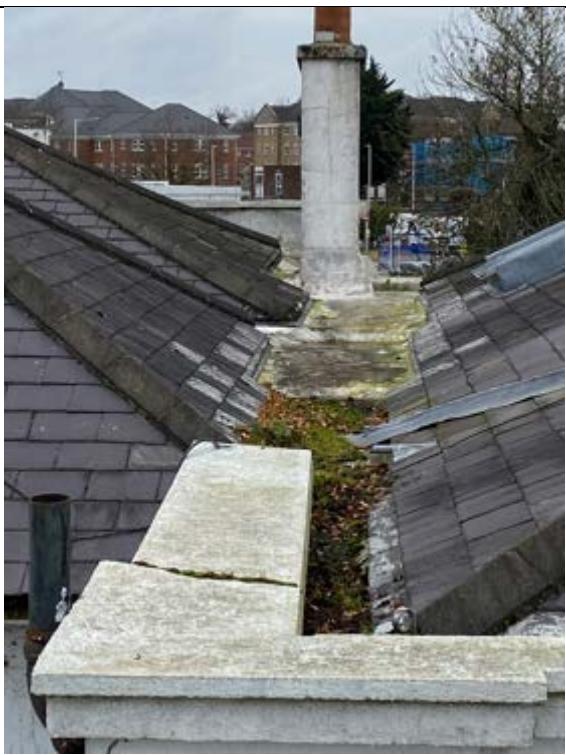
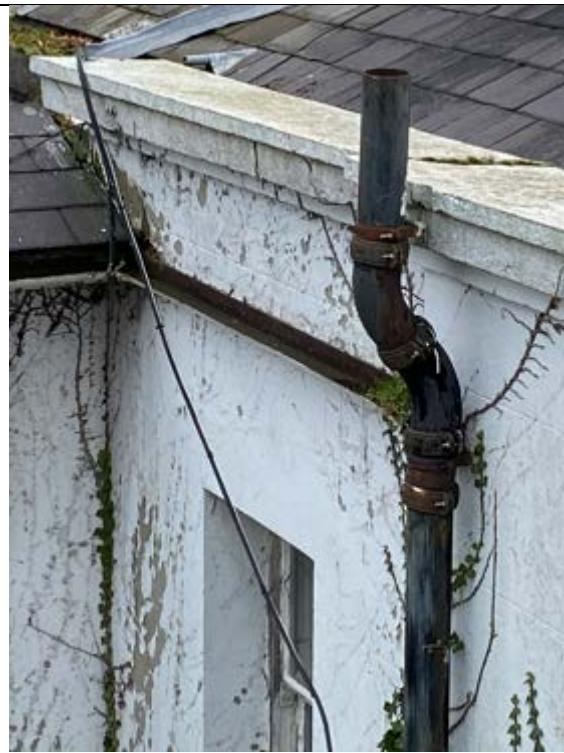
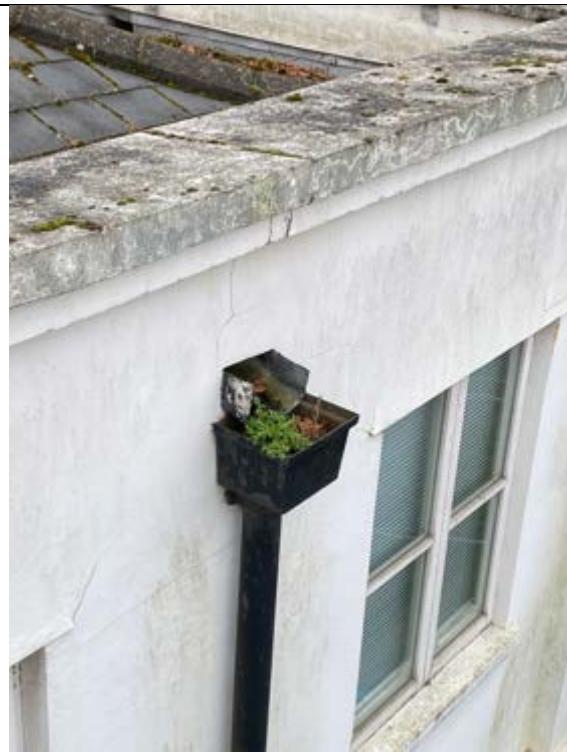
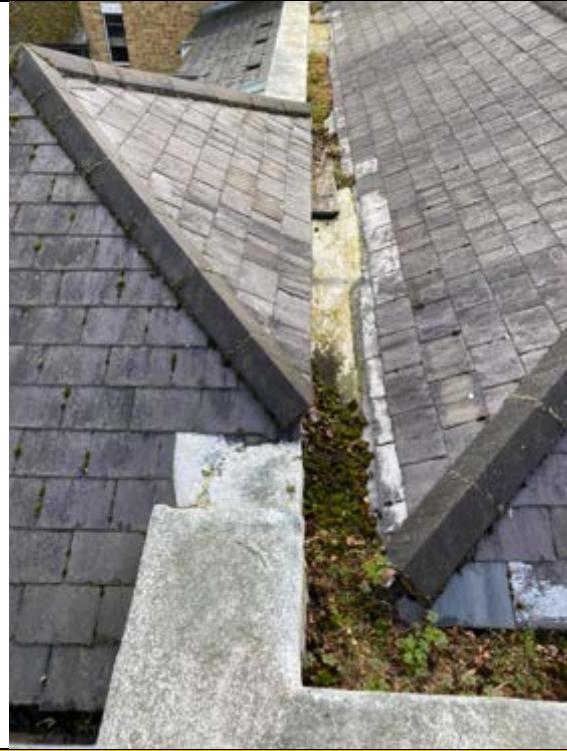
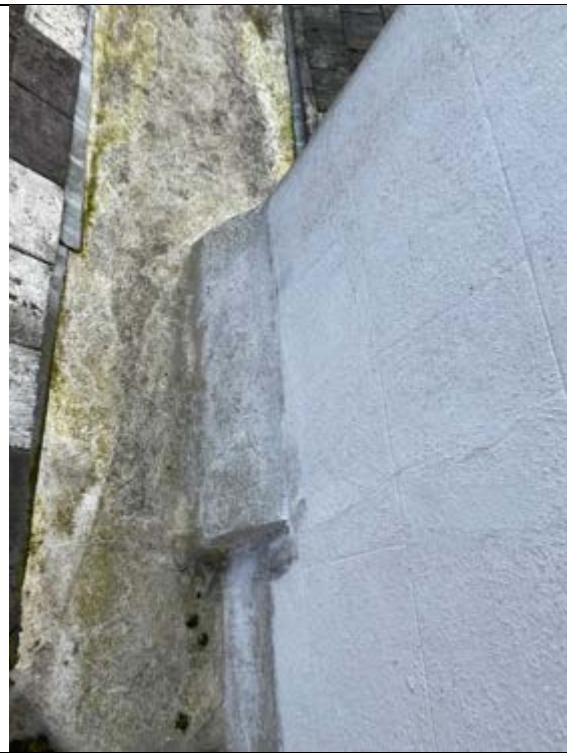
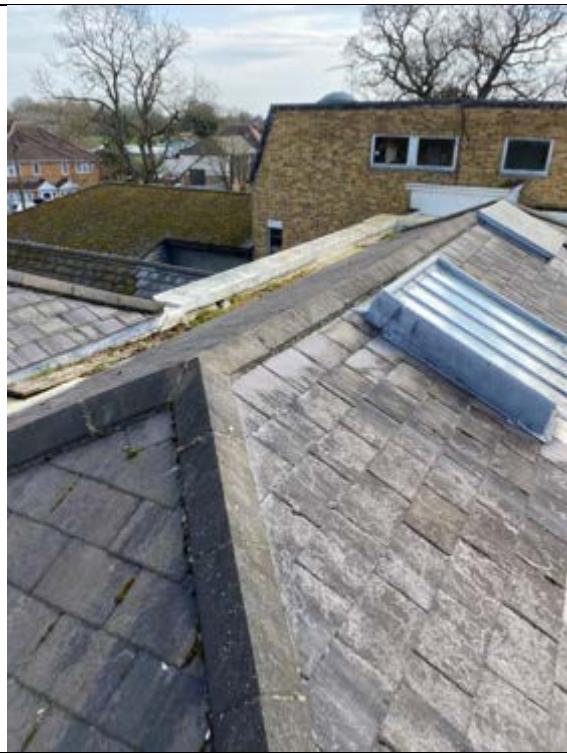
8.	<p>Slate Roof 05:</p> <p>There have been extensive repairs on this roof over time to the slates, the upstands onto the parapet, the parapet themselves and also the perimeter which frames the slate roof down onto the parapet.</p> <p>There is considerable build up of moss and debris in the valleys surrounding the entire roof which is blocking the flow of rainwater through the outlets into the hoppers.</p> <p>The lead flashings on the skylights appear in order however the flashing to the canopy adjacent has become completely dislodged at the bottom and is hanging down into the valley, in adverse weather conditions this may result in ingress at the base of the canopy.</p> <p>The ridge and hip slates appear in reasonable condition.</p>	96 - 108

<p>Allow to replace the cast guttering on all elevations with compatible guttering in line with listed building status guidelines.</p>
8.	<p>Slate Roof 05:</p> <p>Allow to fully clean down the roof slates and hip/ridge slates and reinspect when clear to determine which slates require replacement, refixing or realignment.</p> <p>Allow to replace all broken slates and inspect the sarking felt and baton underneath to determine if they also need to be stripped back and replaced due to damage from ingress.</p> <p>Allow to strip perimeter of slate roof back to original substrate and treat with a compatible waterproof membrane in line with listed building regulations. Allow to treat upstands of perimeter to coping stones to allow a watertight gully for rainwater to flow freely to external drainage and hoppers.</p> <p>Allow to strip back the base of chimney stacks adjoining roof 01 and refurbish the termination between the chimney stacks and the flat roof area gully.</p> <p>Allow to repair the damaged lead flashing on the canopy to ensure watertightness.</p> <p>Allow to repair or where necessary replace, the external cast hoppers and downpipes at the front and rear in line with listed building status guidelines.</p>

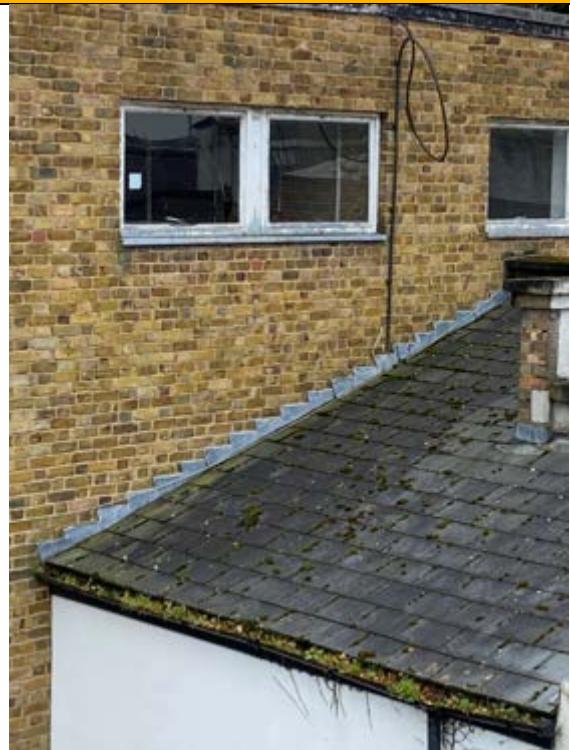
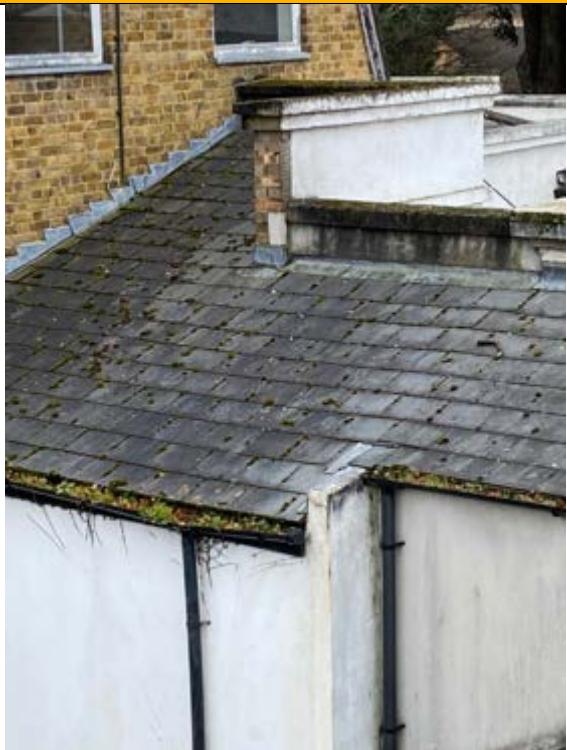
9.	<p>Slate Roof 06:</p> <p>The lead flashing under the parapet onto the roof appears to have had the mortar replaced and the lead looks to be in fair condition.</p> <p>The first glass roof panel has slipped and become completely dislodged from its support above and is protruding over the guttering. This will result in rainwater entering the building at the top of the glass pane.</p> <p>The guttering is full of moss and debris and consideration will need to be given to replace if the weight of the debris has caused damage beyond repair.</p> <p>The slates appear to be in good condition however once the moss is cleared completely will have to be reinspected to determine if any are cracked, broken or have become dislodged.</p>	85/87/89 109 - 110

9.	<p>Slate Roof 06:</p> <p>Allow to fully clean down the roof slates and reinspect when clear to determine which slates require replacement, refixing or realignment.</p> <p>Allow to replace all broken slates and inspect the sarking felt and baton underneath to determine if they also need to be stripped back and replaced due to damage from ingress.</p> <p>Allow to replace the damaged guttering on front elevation.</p> <p>Allow to replace or repair the glass roof panel that has become dislodged/damaged.</p> <p>Allow to inspect the lead flashing on the abutment to roof 05 and replace where necessary.</p>
