Reference No: PS - 1386

# Roof Condition Report

The Furze – External

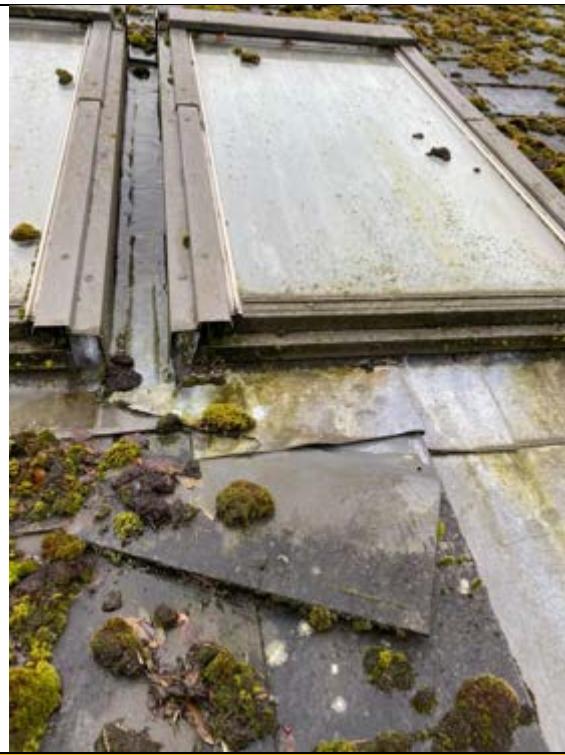
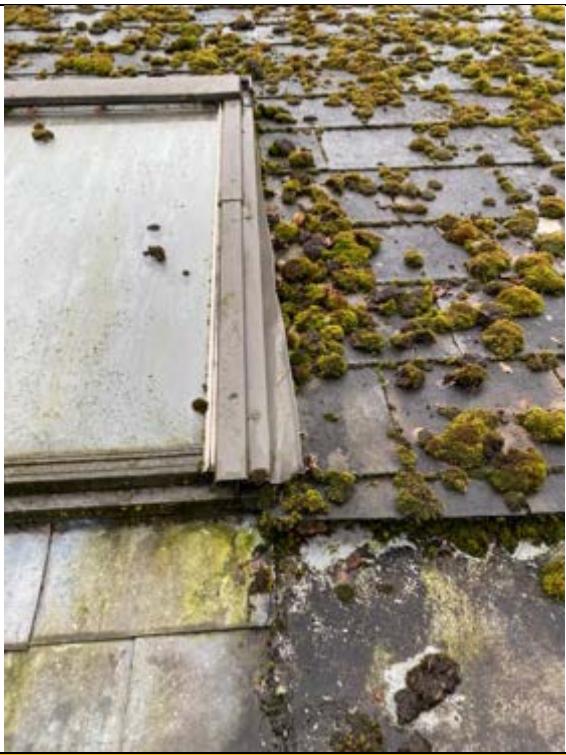
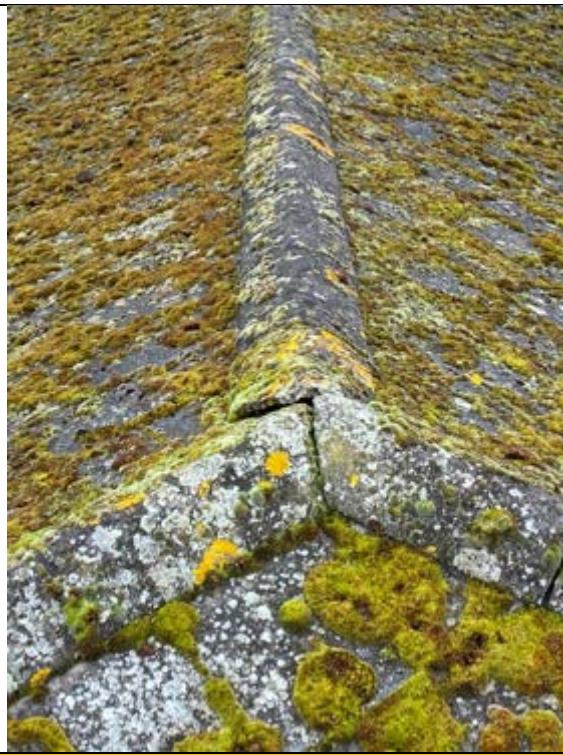
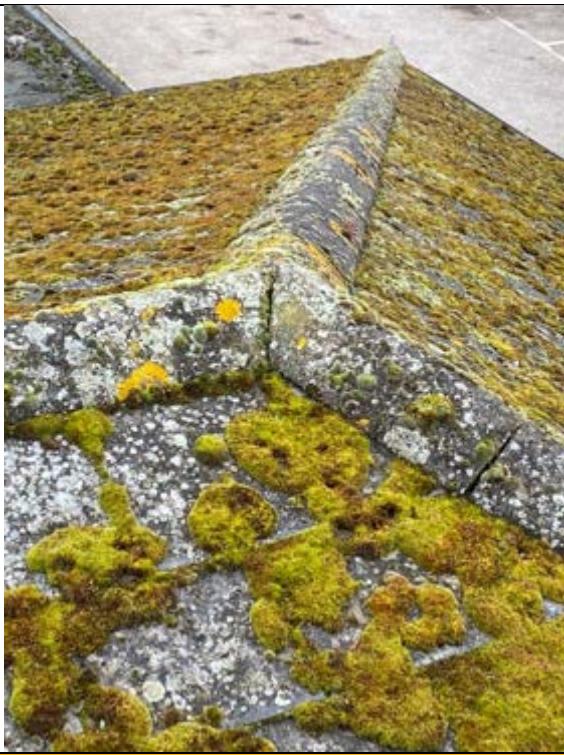
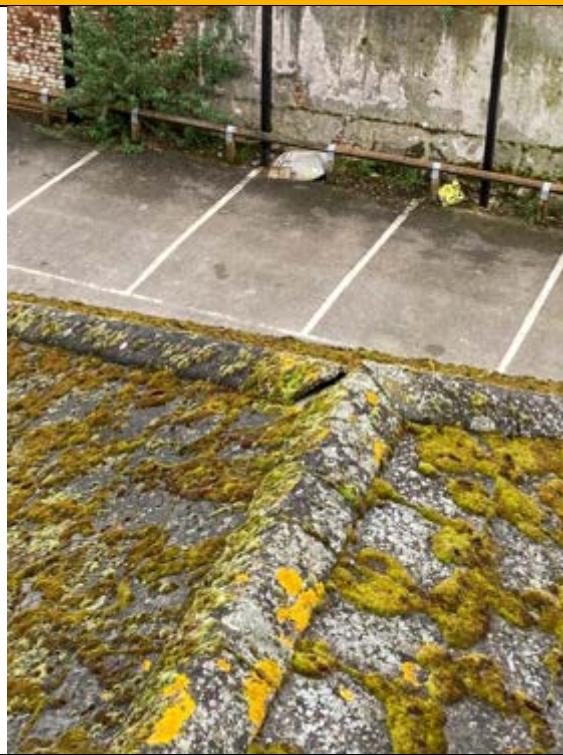
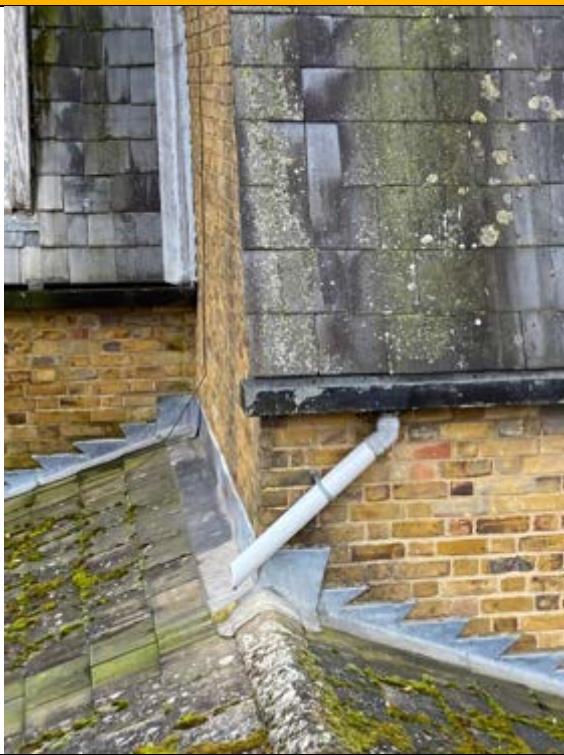
10.	<p>Slate Roof 07:</p> <p>There is extensive moss build up resulting in difficulty inspecting the slates for damage. This will have to be reinspected once moss is cleared to assess remedial works for the slates.</p> <p>Despite the presence of moss there are some visibly damaged and slipped slates that will need to be addressed.</p> <p>The guttering requires replacing due to damage as a result of the weight of the moss and debris currently in the guttering.</p>	111 - 123

<p>All of the fascia boards and soffits need to be removed and replaced with new due to degradation and compete failure in some parts and mortar underneath the eaves repointed.</p> <p>The lead and metal flashings around the two skylights to be replaced although consideration should be given to simply replace the skylights with new during roofing works.</p> <p>The lead gully between this roof and Slate roof 03 requires attention as mentioned in section 6.</p> <p>There are a number of hip slates and ridges that appear to have slipped/moved where the ridge meets the hip and further inspection is required once moss is removed from all areas.</p> <p>The lead flashing adjacent to the mansard roof appears in good condition except at the junction of the ridge where it appears the mortar has become loose next to the downpipe.</p>

10.	<p>Slate Roof 07:</p> <p>Allow to fully clean down the roof slates and hip/ridge slates and reinspect when clear to determine which slates require replacement, refixing or realignment.</p> <p>Allow to replace all broken slates and inspect the sarking felt and baton underneath to determine if they also need to be stripped back and replaced due to damage from ingress.</p> <p>Allow to strip off the fascias and soffits on all sides and replace with new and replace all guttering.</p> <p>Allow to fully overhaul the masonry supporting the eaves leading onto the flat roof and replace if necessary during roofing works.</p> <p>Allow to replace or repair the lead flashing into the mansard roof at the ridge.</p>

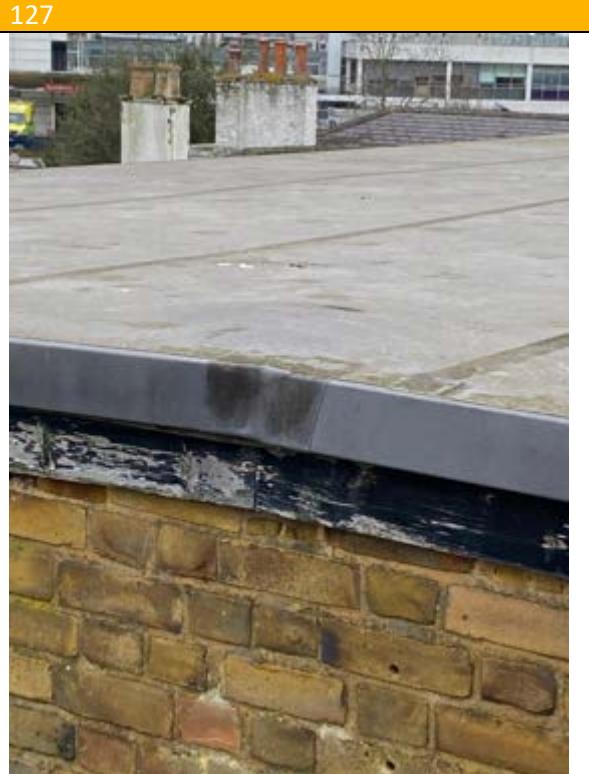
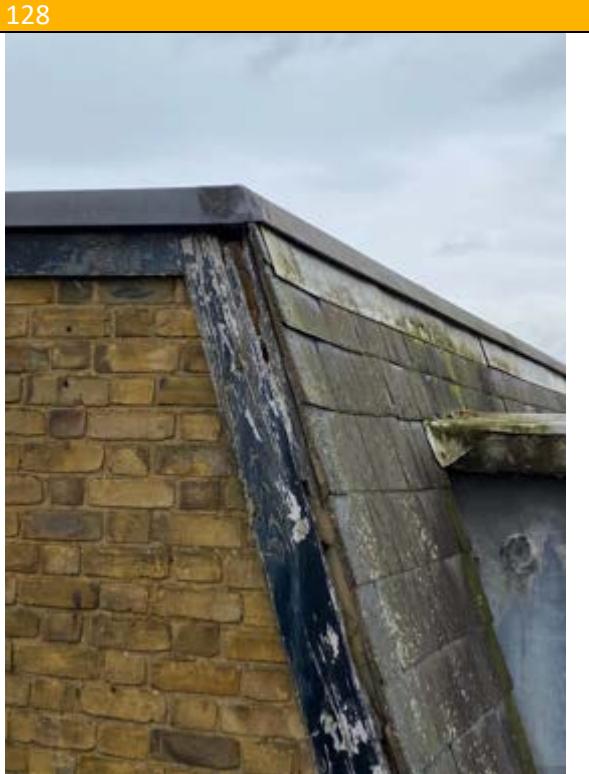
11.	<p>Flat Roof 03A:</p> <p>The flat roof is covered with a reinforced single ply membrane with what appears to be pvc metal coated trims onto the verge/slate.</p> <p>The flat roof has a central high point on the ridge falling away to either side allowing rainwater to drain away however it is minimal, there are no outlets situated on the flat roof.</p> <p>There is ponding water towards the mansard at the edges suggesting that the substrate underneath has become sunk preventing the water from flowing freely down the slates and into the guttering below.</p> <p>The guttering is metal and is full of debris on both sides.</p> <p>The timber fascias have completely failed and need replaced.</p>	124 - 129

11.	<p>Flat Roof 03A:</p> <p>Allow to strip off and replace flat roof ensuring an adequate fall is installed into the roof either through timber firrings or ctf insulation allowing for rainwater drainage onto the mansard.</p>

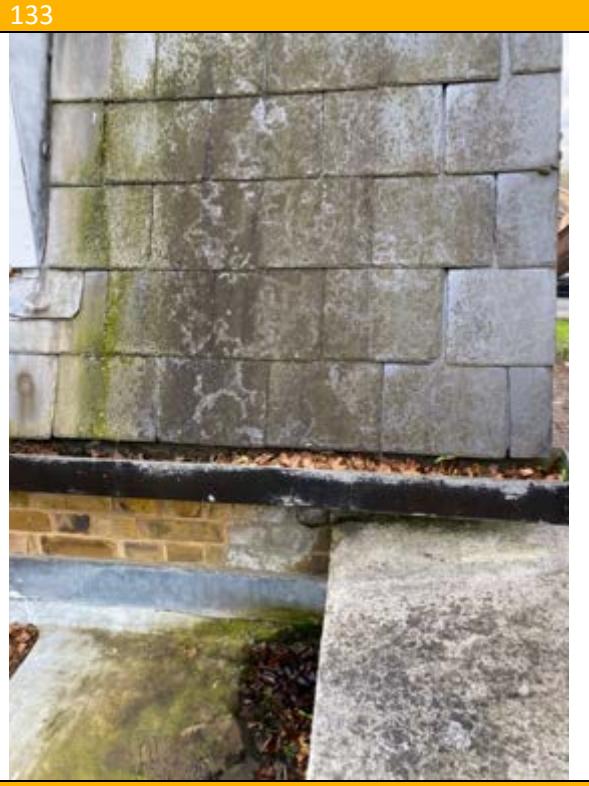
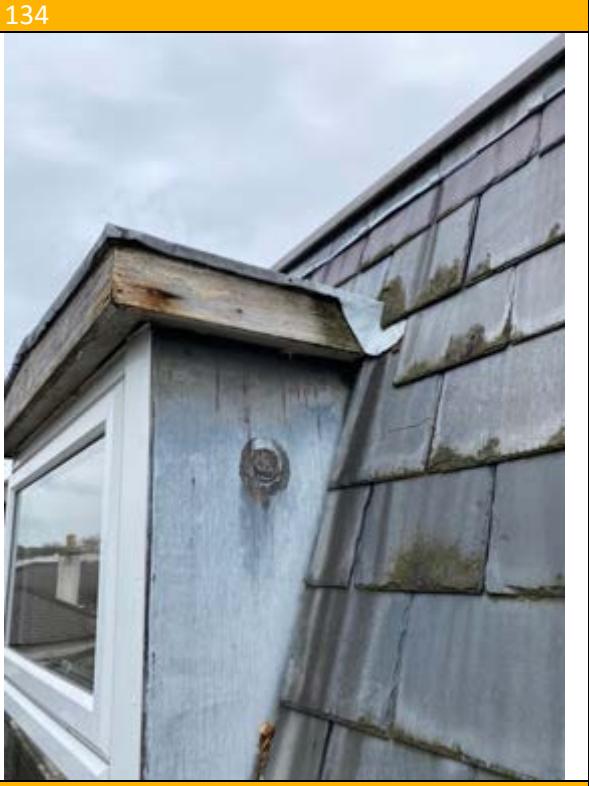
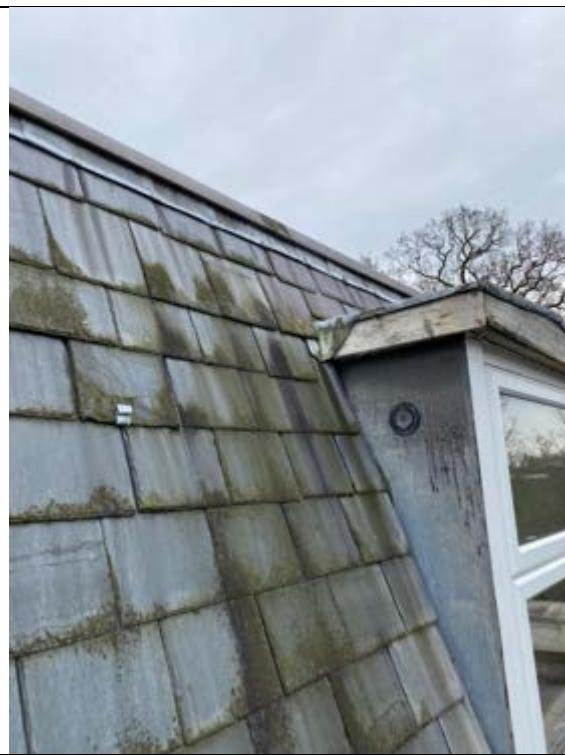
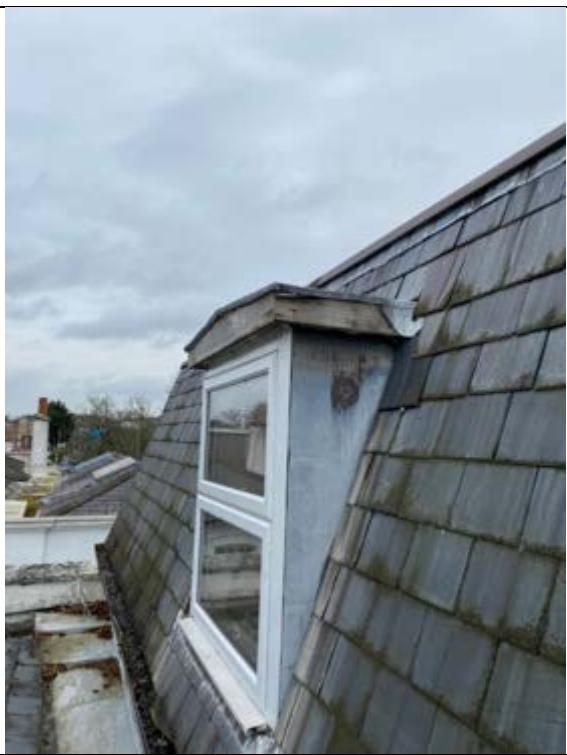
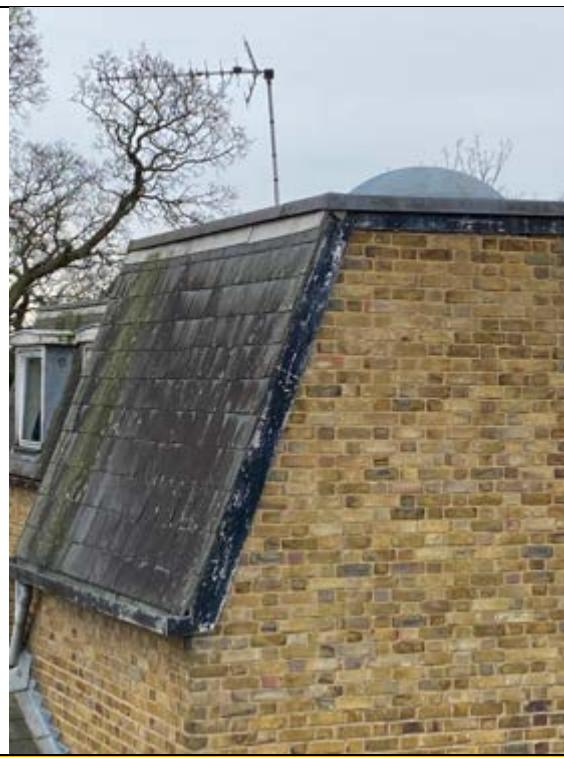
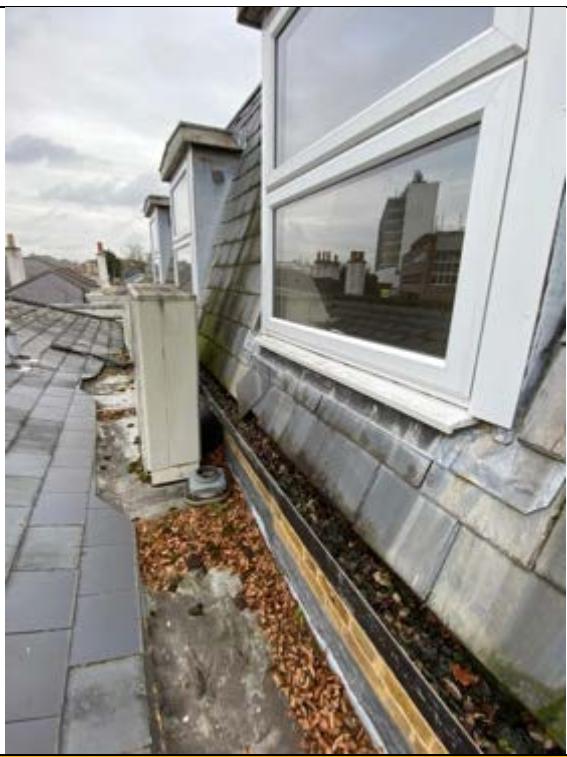
12.	<p>Slate Mansard Roof 01B:</p> <p>There are a number of slates that have become dislodged and broken.</p> <p>There is severe degradation of the facias and timber around the top of the window frames and these are covered with a lead flashing.</p> <p>The windows have been replaced in the past however it appears the window surrounds were not due to visible ageing.</p> <p>The metal guttering is full of debris and requires further inspection once cleared to assess base corrosion.</p> <p>Slate Mansard Roof 02B:</p> <p>There are a number of slates that have become dislodged and broken.</p>	130 - 143

<p>There is severe degradation of the facias and timber around the top of the window frames and these are covered with a lead flashing.</p> <p>The windows have been replaced in the past however it appears the window surrounds were not due to visible ageing.</p> <p>The metal guttering is full of debris and requires further inspection once cleared to assess base corrosion. There are also service cables from Slate Roof 09-10-11 in the guttering.</p> <p>The mansard roof is bordered with Slate Roof 08 with lead flashings, the lead flashings appear in good order. Slate Mansard Roof 03B:</p> <p>There are a few slates that have become dislodged.</p> <p>The metal guttering is full of debris and requires further inspection once cleared to assess base corrosion.</p> <p>The fascia boards are badly degraded and require replacement on both sides.</p>

12.	<p>Slate Mansard Roof 01B/02B/03B:</p> <p>Allow to replace all broken/damaged slates and inspect the sarking felt and baton underneath to determine if they also need to be stripped back and replaced due to damage from ingress.</p> <p>Allow to strip off the fascias at the top of the window frames and replace with new.</p> <p>Allow to remove and replace guttering with new on all sides.</p> <p>Allow to inspect the mortar around the lead abutment from roof 01B to 03B and replace/renew where necessary.</p> <p>Allow to secure service cables away from the rainwater goods or remove if redundant.</p>

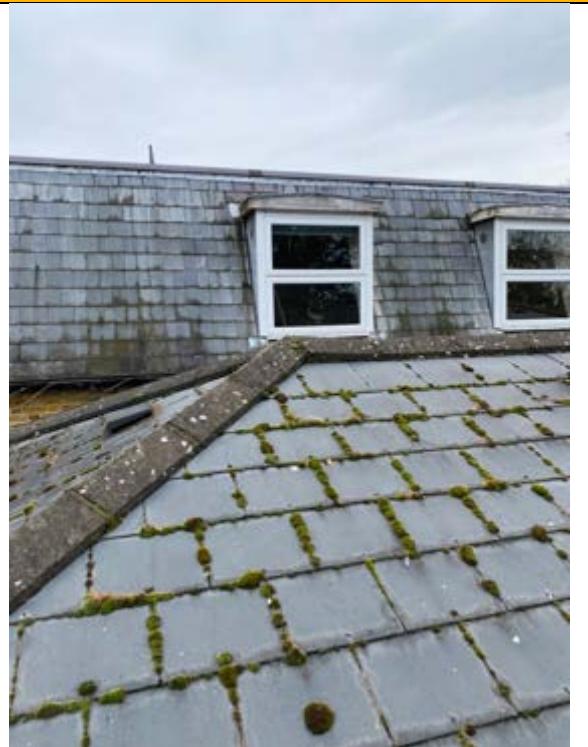
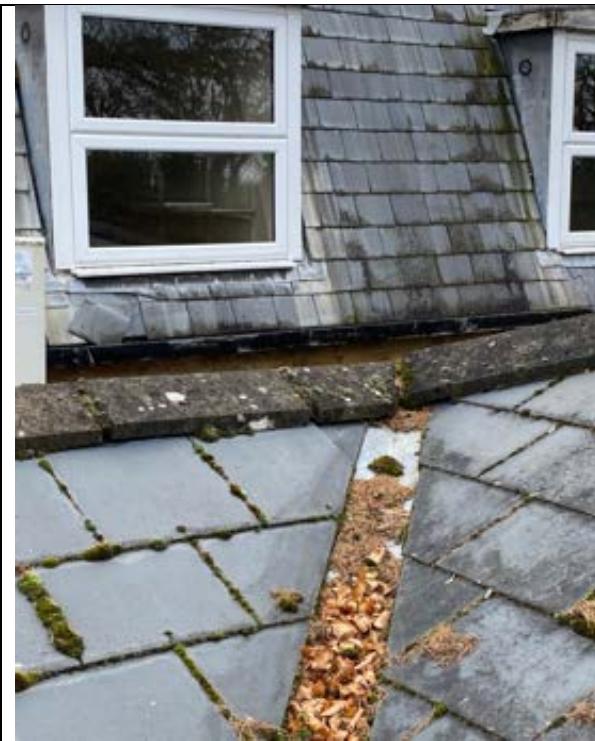
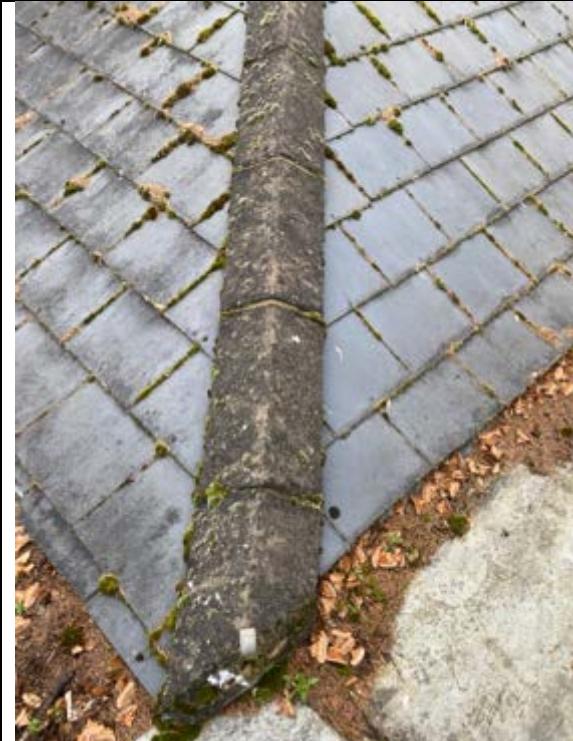
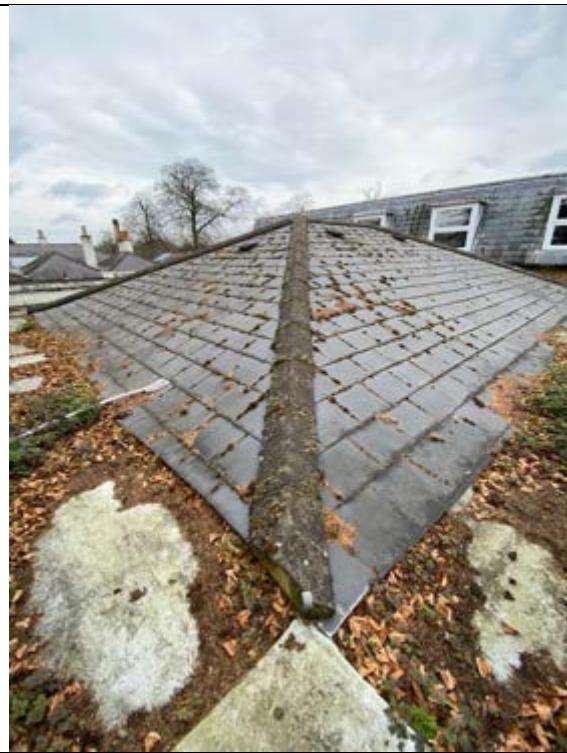
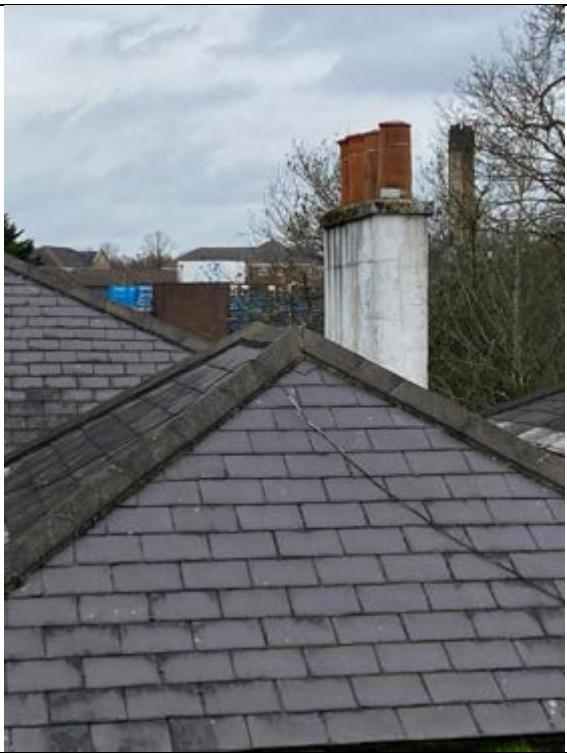
13.	<p>Slate Roof 08:</p> <p>There have been repairs over time to the slates, the upstands onto the parapet, the parapet themselves and also the perimeter which frames the slate roof down onto the parapet.</p> <p>The ridge and hip slates appear to be in reasonable condition however there are a number of slates that require replacing or repositioning and when this is undertaken further inspection should be given to the ridge and hips whilst on the roof.</p> <p>The perimeter and upstands onto the coping have been historically coated with a liquid membrane. The perimeter appears to be in a reasonable condition however there is a large amount of fallen leaves, moss and debris around the perimeter preventing further inspection.</p> <p>The lead flashing on the abutment to the mansard roof appears to have been replaced or repaired in the past and is in good condition.</p> <p>The lead flashing from the ridge down to the perimeter at the hip slates appears to be in reasonable condition and there is no sign of ingress.</p>	144 - 155

13.	<p>Slate Roof 08:</p> <p>Allow to fully clean down the roof slates and hip/ridge slates and reinspect when clear to determine which slates require replacement, refixing or realignment.</p> <p>Allow to replace all broken slates and inspect the sarking felt and baton underneath to determine if they also need to be stripped back and replaced due to damage from ingress.</p> <p>Allow to strip perimeter of slate roof back to original substrate and treat with a compatible waterproof membrane in line with listed building regulations. Allow to treat upstands of perimeter to coping stones to allow a watertight gully for rainwater to flow freely to external drainage and hoppers.</p> <p>Allow to repair or where necessary replace, the external cast hoppers and downpipes on all elevations in line with listed building status guidelines.</p> <p>Allow to remove redundant plant.</p>

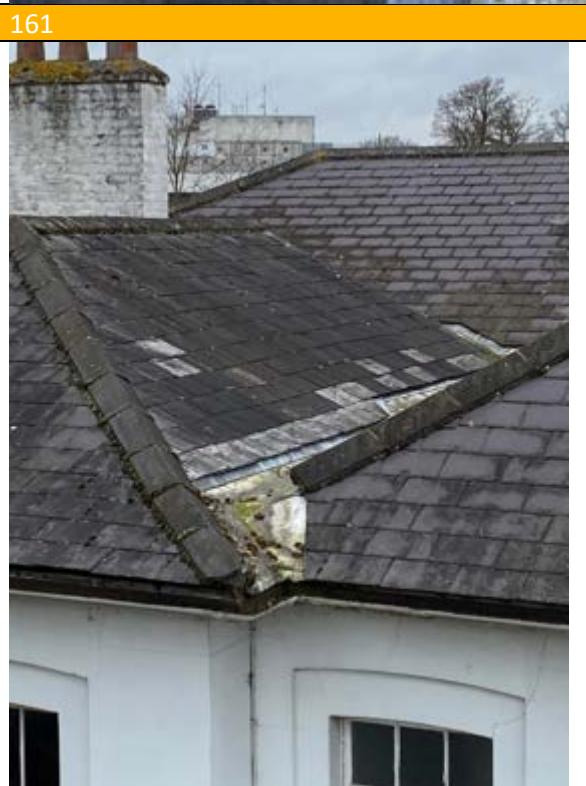
14.	<p>Slate Roof 09:</p> <p>The two chimney stacks on this roof have been treated in the past with liquid repairs to the upstands and around the flashing onto the adjoining slate roofs.</p> <p>The rear chimney shows signs of severe intervention lending to the possibility of historic failure at a significant</p>	156 - 169

<p>level causing ingress. The masonry has multiple cracks visible.</p> <p>The guttering around the rear stack shows signs on internal corrosion and appears to have become dislodged from their supports along to adjoining roof 10.</p> <p>There have been extensive repairs over time to the slates and the flashing leading to the gully between roof 09 and roof 10.</p> <p>The ridge and hip slates appear to be in good order.</p> <p>There is an access door to the rear of roof 09 that has become broken leaving the roof space completely open to the elements, this rear elevation onto Slate roof 01 has also been treated with a form of liquid membrane repair however due to extensive build up of moss and debris onto that area it cannot be fully inspected.</p> <p><b>Slate Roof 10:</b></p> <p>This central slate roof has been subject to repairs to the slates and perimeter over time.</p> <p>The perimeter appears to have been heavily treated with liquid membrane and there is evidence of supposed ingress at the base as most of the slates on either side of the roof have been replaced at the point the slate roof meets the gully.</p> <p>The ridge and hip slates appear to be in good order.</p> <p>The guttering at the rear is corroded and have become dislodged from their supports and requires attention.</p> <p><b>Slate Roof 11:</b></p> <p>The chimney stack in the gully has been heavily treated with liquid around the base and it has failed and is cracking to the point some masonry is becoming cracked and broken.</p> <p>This roof has been subject to repairs to the slates and perimeter over time.</p> <p>The perimeter appears to have been heavily treated with liquid membrane and there is evidence of supposed ingress at the base as most of the slates on either side of the roof have been replaced at the point the slate roof meets the gully into the adjoining roof 10 and adjoining roof 05.</p> <p>The ridge and hip slates appear to be in good order.</p> <p>The guttering at the rear is corroded and have become dislodged from their supports and requires attention.</p>

14.	<p>Slate Roof 09:</p> <p>Allow to fully clean down the roof slates and hip/ridge slates and reinspect when clear to determine which slates require replacement, refixing or realignment.</p> <p>Allow to replace all broken slates and inspect the sarking felt and baton underneath to determine if they also need to be stripped back and replaced due to damage from ingress.</p> <p>Allow to strip back the base of both chimney stacks and refurbish the termination between the chimney stacks and the flat roof area gullies.</p> <p>Allow to replace the access hatch into the roof space bordering slate roof 01 in line with listed building status guidelines.</p> <p>Slate Roof 10:</p> <p>Allow to fully clean down the roof slates and hip/ridge slates and reinspect when clear to determine which slates require replacement, refixing or realignment.</p> <p>Allow to replace all broken slates and inspect the sarking felt and baton underneath to determine if they also need to be stripped back and replaced due to damage from ingress.</p> <p>Slate Roof 11:</p> <p>Allow to fully clean down the roof slates and hip/ridge slates and reinspect when clear to determine which slates require replacement, refixing or realignment.</p> <p>Allow to replace all broken slates and inspect the sarking felt and baton underneath to determine if they also need to be stripped back and replaced due to damage from ingress.</p> <p>Allow to strip back the base of the chimney stack and refurbish the termination between the chimney and the flat roof area gullies. If necessary, allow to strip back slates, lead flashings and broken mortar around the base of the chimney stack and replace with new.</p> <p>Allow to strip perimeter of slate roofs 09-10-11 back to original substrate and treat with a compatible waterproof membrane in line with listed building regulations.</p>
