Reference No: PS - 1381

Roof Condition Report

The Furze – Internal

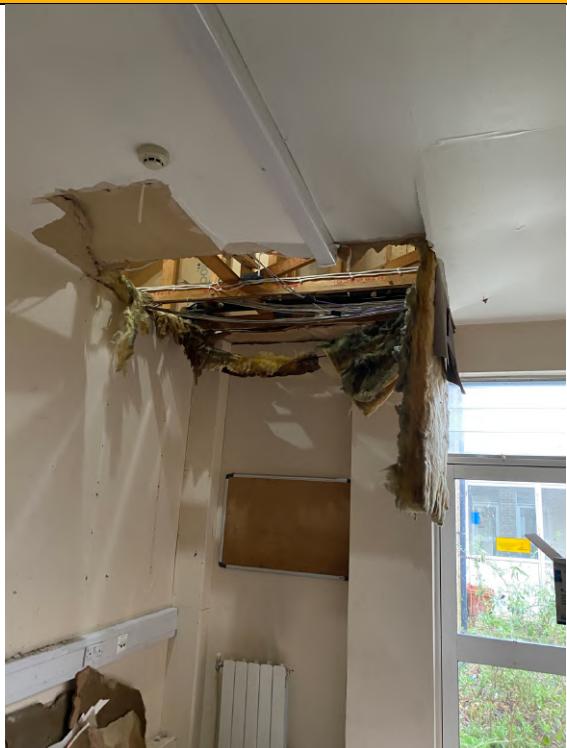
2 – Slate Roof 07 Room 10.5

Number	Action/Cause	Appendix B
1.	<p><u>Ground Floor Level:</u></p> <p>Slate Roof 07 –</p> <p>Damage above Room 10.5 caused by damaged valve on water pipe above as shown.</p> <p>Higher levels of light penetration than one would expect links in with external images showing dilapidated timber fascia's surrounding Slate roof 07. Roof is otherwise dry.</p> <p>Slate Roof 03 –</p> <p>Roof above Audiology suite difficult access to reach eaves however exploratory hatch shows pitched slate roof installed straight onto existing flat roof build up, no visible sign of ingress from hatch joists appear in fair condition.</p> <p>Courtyard –</p> <p>Poor detailing on fascia boards and damp visible on lintel above window of 19.3 due to detailing. Loose slates and poor allowance for pipework to enter adjacent roof will all contribute to ingress in adverse weather conditions.</p>	1 – 6 7 – 14 15 – 21 22 – 24

The defect found above room 10.5 from the internal pipework failure is indicative of other services viewed and it is advisable to undertake a full mechanical and electrical survey of existing services to include all internal plumbing.

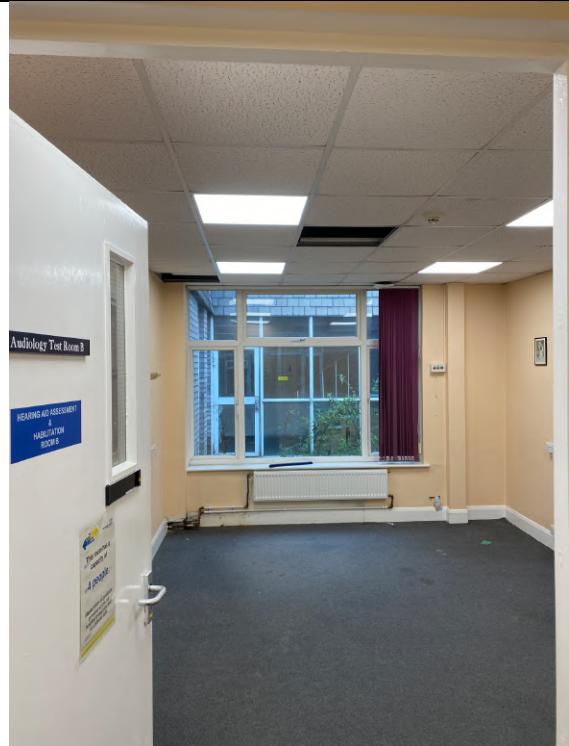
15 – 19.3 Hatch

The Courtyard defects will be addressed within the external roofing works, however if future consideration is given to replacing the windows in room 19.3 the lintel should be inspected to determine if any damage has been caused by the poor external detailing.

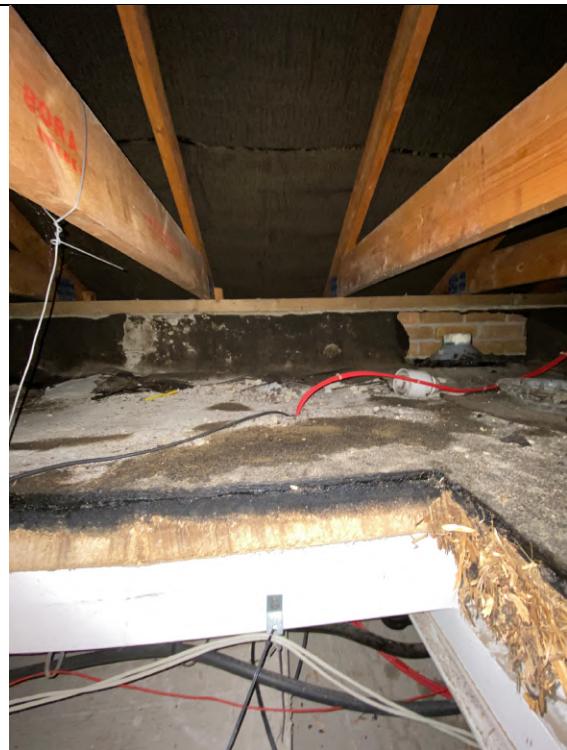
17 – Slate Roof 03 Audiology Suite

The pitched Slate Roof 03 has been installed directly above an existing bituminous flat roof build up, this is assumed a continuation of the Flat Roof 02A which was overclad. As a result, it is inconclusive to determine any ingress into the system above the audiology suite and the eaves are not visible. Consideration should be given to address the junction of the existing Flat Roof 02A onto the Slate Roof 03 to ensure that any historic ingress or

moisture is not trapped within the system and able to travel across the substrate under both roof areas.

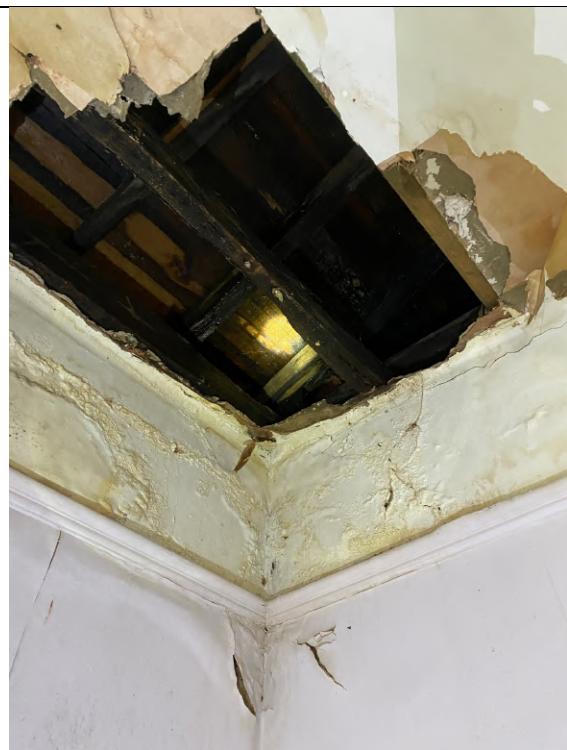
25 - First Floor 40.0

2.	<p><u>First Floor Level:</u></p> <p>Room 40.0 –</p> <p>Historic ingress from Slate Roof 01 present in room 40.0, exposed panel shows damage to beams and substrate of this section. Consistent with images from Slate Roof 01 of patch repair. Ingress damage extends to corner of roof above room 11.5.</p> <p>Room 29.5 –</p> <p>Hatch shows chimney stack above to centre of Slate Roof 01, appears to be in reasonable condition and the ceiling above room 29.5 has been completed replaced, no information has been given for this.</p> <p>Office 9.4 –</p> <p>Extensive water damage to ceiling consistent with upstand detailing on Flat roof 01A, no panel exposure available to view substrate.</p>	25 – 38 39 – 41 42 – 43

The historic ingress caused by the defects on Slate Roof 01 has resulted in extensive internal damage to the ceiling and substrate above room 40.0. As this appears to have been poorly repaired externally there is evidence that it remains an ongoing point of ingress which has resulted in damage over a significant period of time to the substrate of the Slate Roof, the beams underneath the ingress and the ceiling below. Assumption of damage to the floor of room 40 under the ingress point is assumed due to the time elapsed however due to a lack of intrusive works this cannot be confirmed.

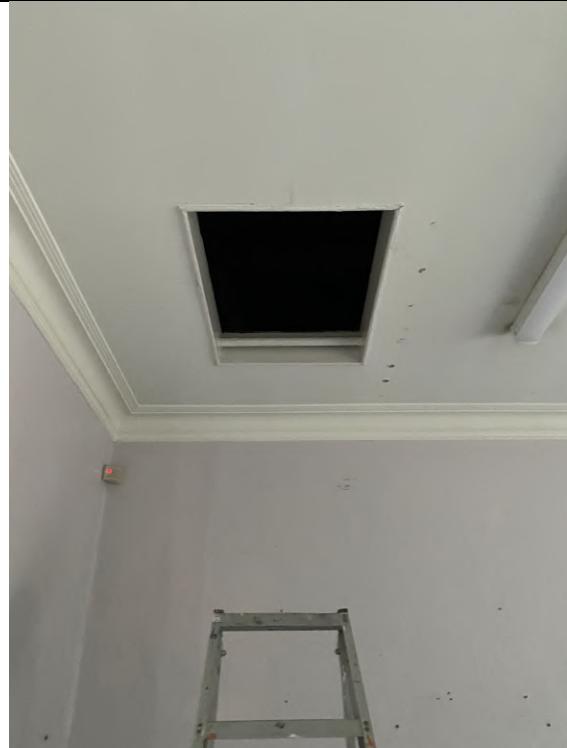
39 – 29.5 Hatch

Consideration should be given where ingress has occurred in the roof space resulting in water damage to insulation and ceiling substrate, due to non-intrusive survey, none were visible from the hatches, however due to the presence of visible condensation, mould and in some areas collapsing ceilings, it must be assumed that there has been damage to these. Areas should be removed and replaced in conjunction with external/internal works as has been historically performed in room 29.5.

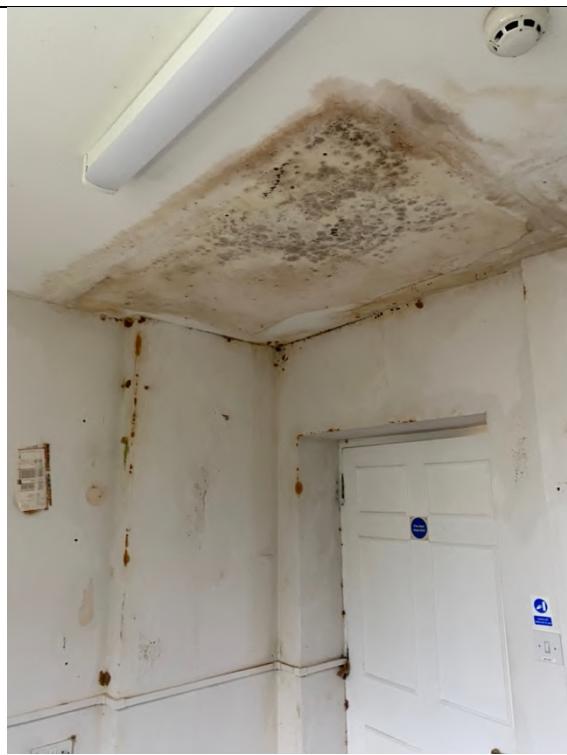
42 – Flat Roof 01A 9.4

Flat Roof 01A has visible ceiling damage consistent with the upstand defects on the roof above, a number of repairs have been conducted over the years to the upstands and the detail areas of Flat Roof 01A, it is unclear whether the ingress is ongoing or the patch repairs have prevented any ongoing ingress.
