Schedule of condition

**The Furze, Hillingdon
Hospital, Pield Heath
Road, Hillingdon UB8 3NN**

Prepared for: Northmores
Prepared by: Chris Baker BSc (Hons) MRICS
Date: 18 September 2023
Reference: 120937-100/MET/CBk

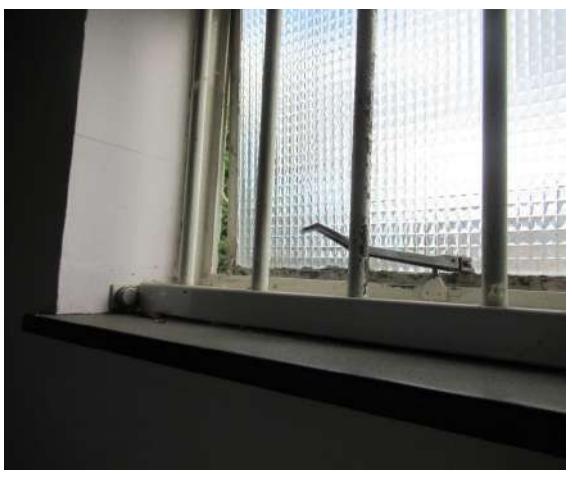
7.	Location: Ground Floor – East elevation Description: Steel frame Crittall window with single glazing and paint finish.	Element: External window 00-02
	Condition: Poor. Decay to the entire timber sill. Defective sealant. Poor paint finish.

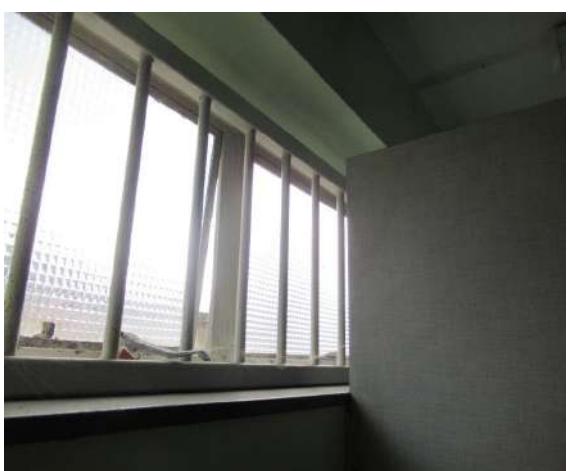
9.	Location: Ground Floor – East elevation Description: Steel frame Crittall window with single glazing and paint finish.	Element: Internal window 00-03
	Condition: Fair. Operational. Poor paint finish.

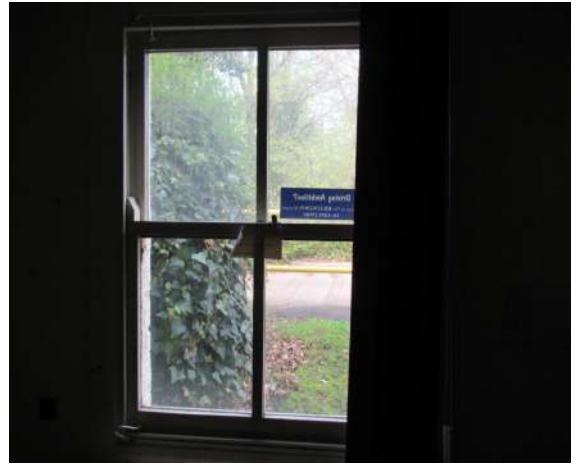
13.	<p>Location: Ground Floor – North elevation</p> <p>Description: Timber frame vertical sliding sash window with single glazing and paint finish.</p> <p>Condition: Fair. Operational.</p>	<p>Element: Internal window 00-04</p>

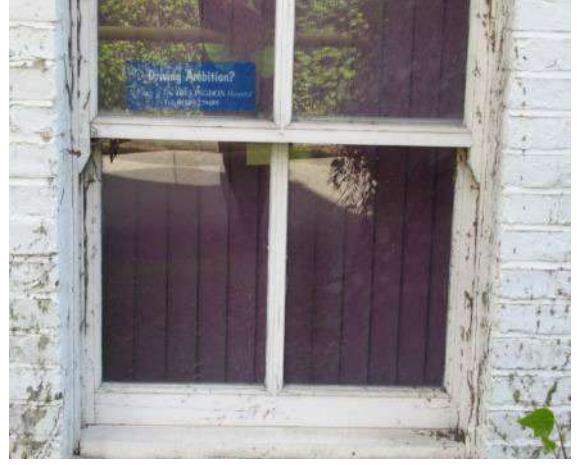
15.	<p>Location: Ground Floor – North elevation</p> <p>Description: Timber frame vertical sliding sash window with single glazing and paint finish.</p> <p>Condition: Fair. Poor paint finish.</p>	<p>Element: External window 00-04</p>

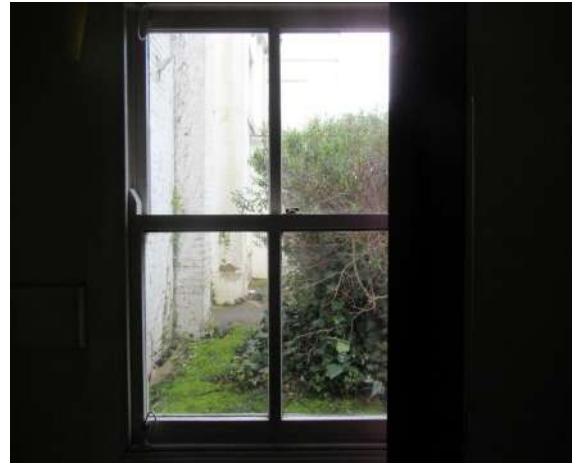
Condition: Fair. Locked shut.	
17.	Location: Ground Floor – North elevation	Element: Internal window 00-05
	Description: Timber frame vertical sliding sash window with single glazing and paint finish.

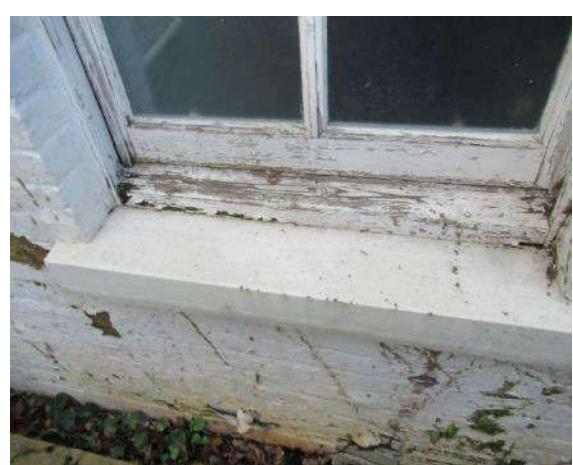
Condition: Poor. Decay to timber sill. Poor paint finish.	
24.	Location: Ground Floor – North elevation	Element: External window 00-06
	Description: Timber frame vertical sliding sash window with double glazing and paint finish.

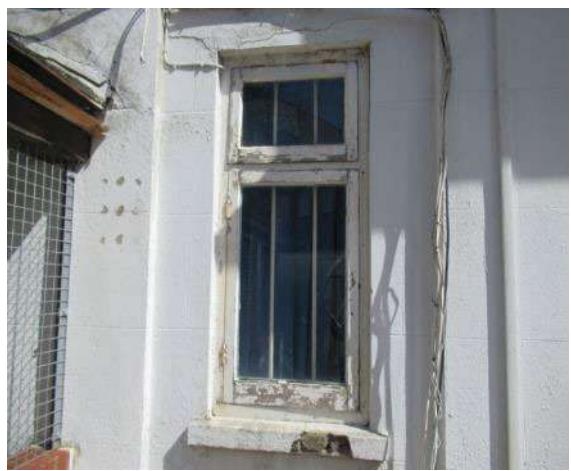
Condition: Poor. Poor paint finish.	
30.	Location: Ground Floor – West elevation	Element: External window 00-07
	Description: Timber frame side hung casement window with single glazing and paint finish.

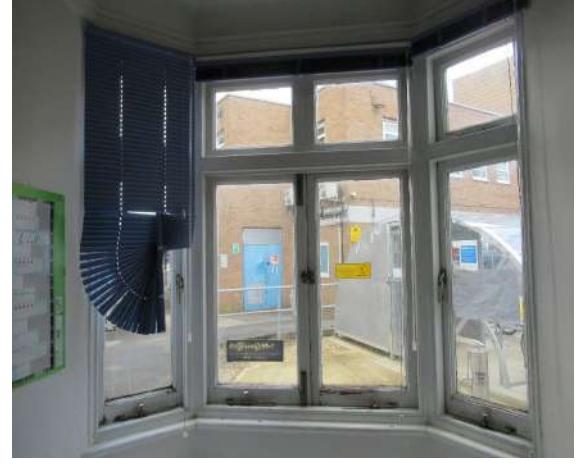
Condition: Poor. Operational. Fixings to top level restrictor missing. Decay to entire timber bottom rail. Poor paint finish	
38.	Location: Ground Floor – West elevation	Element: Internal window 00-09
	Description: Timber frame side hung casement window with single glazing and paint finish.

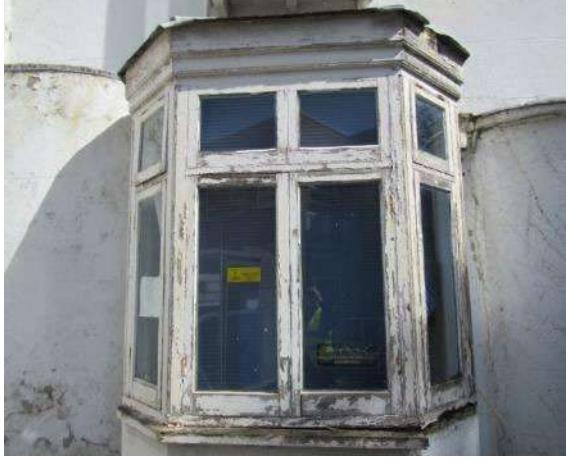
Condition: Poor. Missing and defective timber sill. Decay to sill. Defective and missing sealant. Poor paint finish.	
41.	Location: Ground Floor – West elevation	Element: External window 00-09
	Description: Timber frame side hung casement window with single glazing and paint finish.

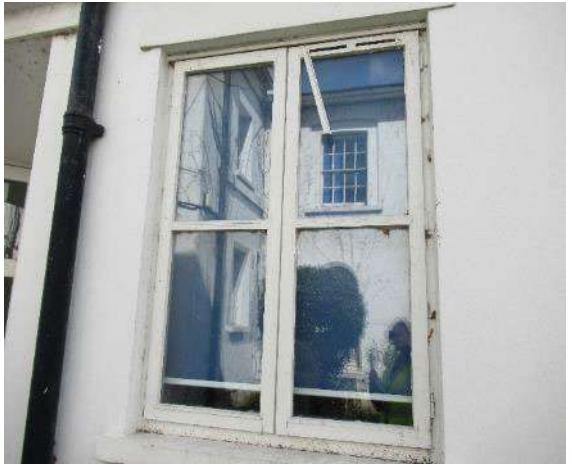
Condition: Poor. Broken vent cover to top rail. Poor paint finish.	
96.	Location: Ground Floor – West elevation	Element: External window 00-21
	Description: Timber side hung casement window with double glazing and a paint finish.

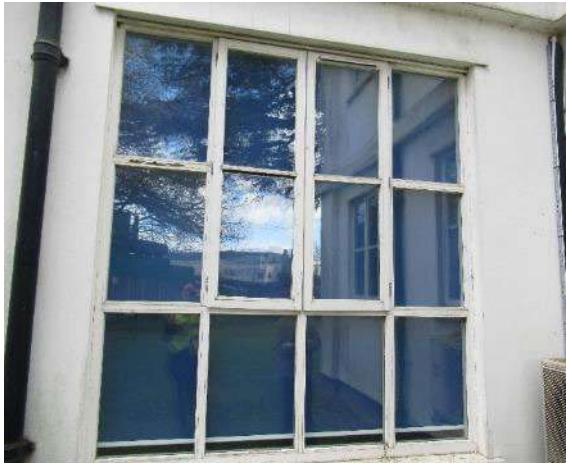
Condition: Poor. Missing timber to the sash bar. Decay to the timber bars throughout. Poor paint finish.	
104.	Location: Ground Floor – West elevation	Element: External window 00-23
	Description: Side hung timber casement window with double glazing and a paint finish.

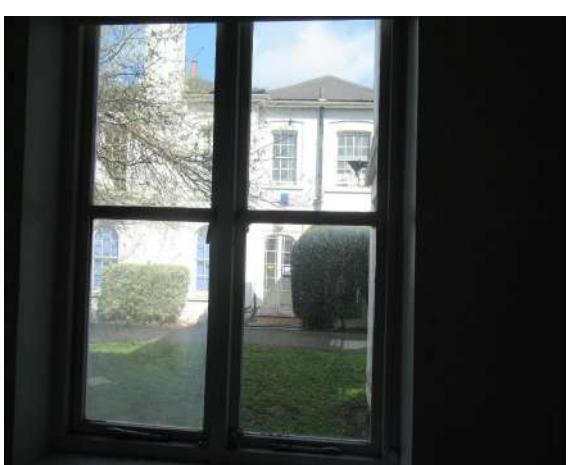
Condition: Fair. Operational. Missing lock fixing to bottom rail. Timber shrinkage causing splitting in the frame. Poor paint finish.

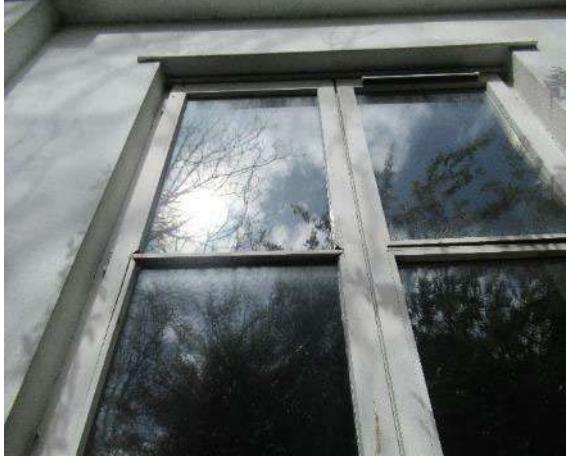
Condition: Poor. Missing timber to the left side mid rail. Decay to sill and bottom rail extending upwards along the stiles. Poor paint finish.	
125.	Location: Ground Floor – South elevation	Element: External window 00-28
	Description: Timber side hung casement window with double glazing and a paint finish

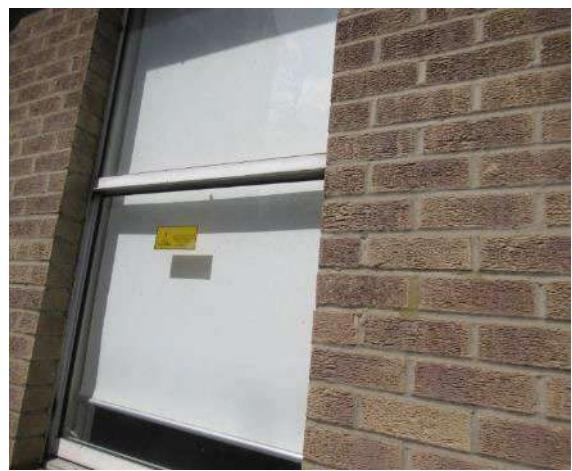
Condition: Fair. Defective sealant.	
141.	Location: Ground Floor – South elevation	Element: Internal window 00-32
	Description: Aluminium frame vertical sliding sash window with single glazing.

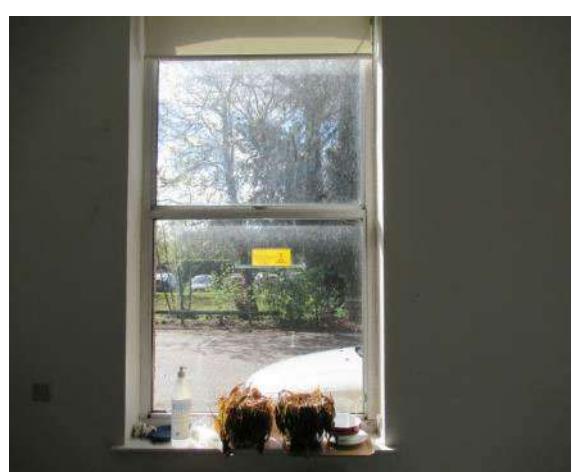
Condition: Fair. Operational. Unable to stay open. Poor paint finish to jambs and sill.

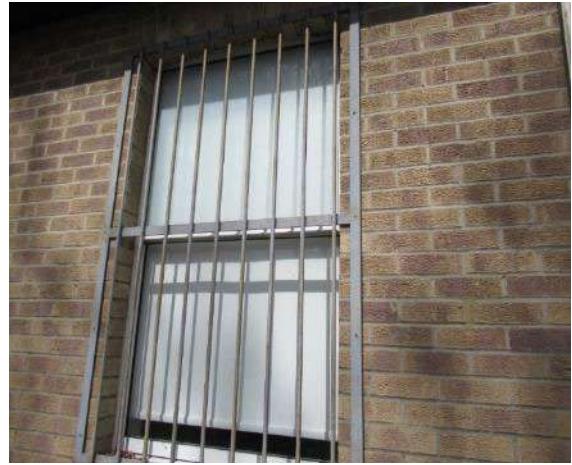
Condition: Fair. Defective and cracked sealant. Poor paint finish to security bars.	
149.	Location: Ground Floor – South elevation	Element: External window 00-34
	Description: Aluminium frame vertical sliding sash window with single glazing.

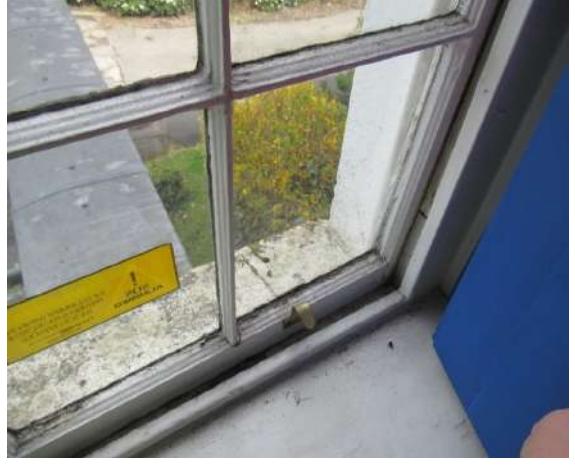
Condition: Poor. Inoperable. Stuck shut and out of alignment with frame. Poor paint finish.	
247.	Location: First Floor – North elevation	Element: Internal window 01-23
	Description: Timber frame vertical sliding sash window with single glazing and paint finish.

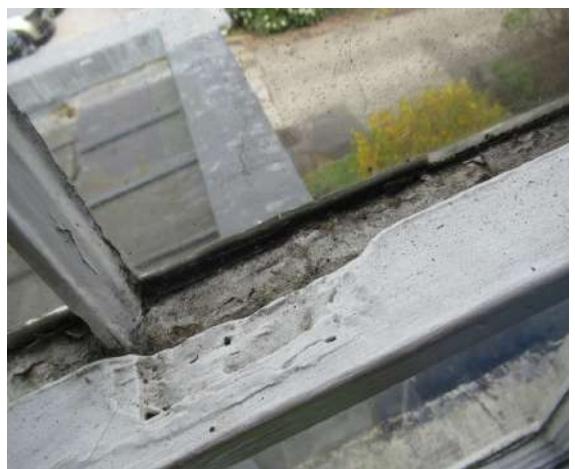
Condition: Poor. Inoperable. Stuck shut and out of frame. Poor paint finish.	
248.	Location: First Floor – North elevation	Element: External window 01-23
	Description: Timber frame vertical sliding sash window with single glazing and paint finish.

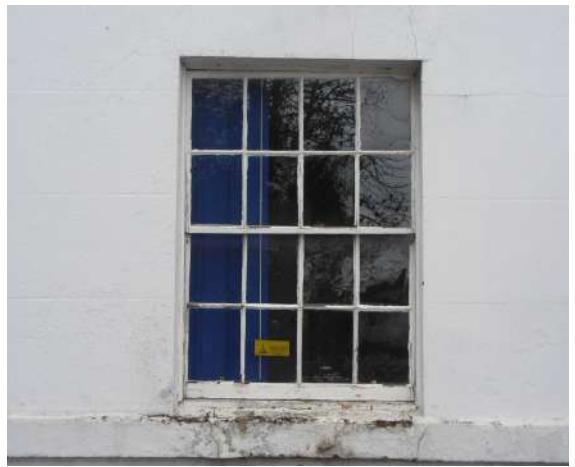
Condition: Poor. Decay to bottom rail. Poor paint finish.

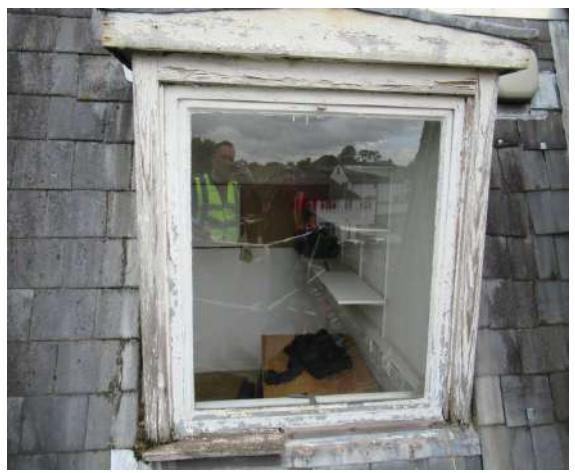
Condition: As above. Missing section of external timber cill.	
308.	Location: Second floor – east elevation	Element: External window 02-10
	Description: As above.

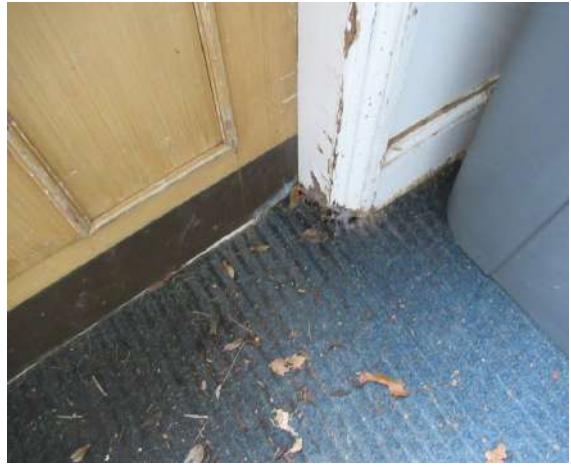
Condition: As above. Impact damage to internal frame.	
316.	Location: Ground floor – north elevation	Element: External door CA 00-01
	Description: Timber frame single glazed double doors with one openable sash. Paint finish internally and externally. Paint timber surround externally.

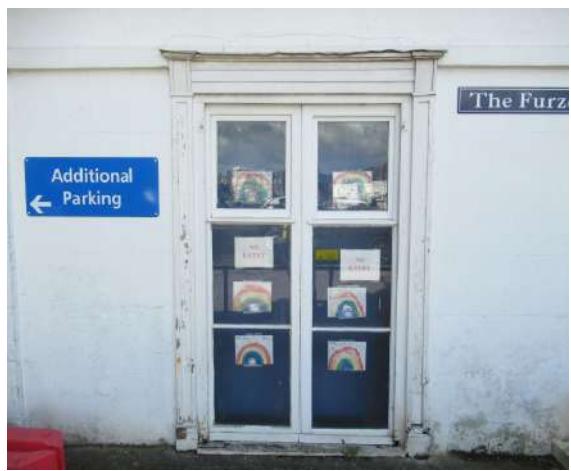
Condition: Poor. Timber decay to bottom rails on both doors and threshold. Poor paint finish. Poor quality previous repairs and decay evident to low level to the external surrounds to both sides.	
317.	Location: Ground floor – north elevation	Element: External door CA 00-01
	Description: As above.

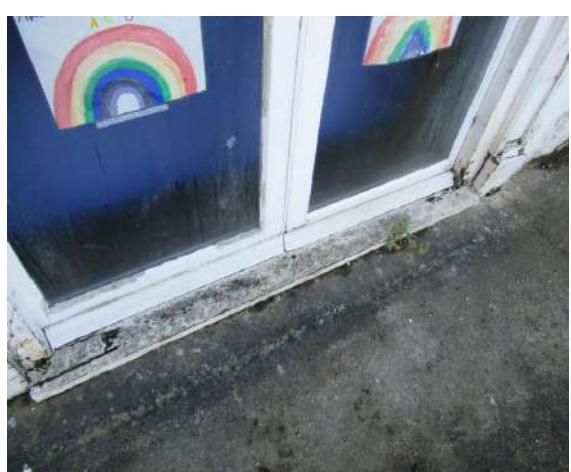
Condition: As above. Decay to bottom rails and threshold.

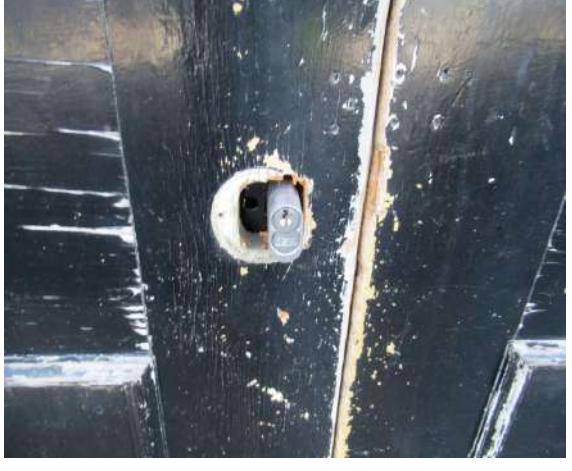
Condition: Poor. Missing cover plate to lock.	
322.	Location: Ground floor – north elevation	Element: External door CA 00-02
	Description: As above.

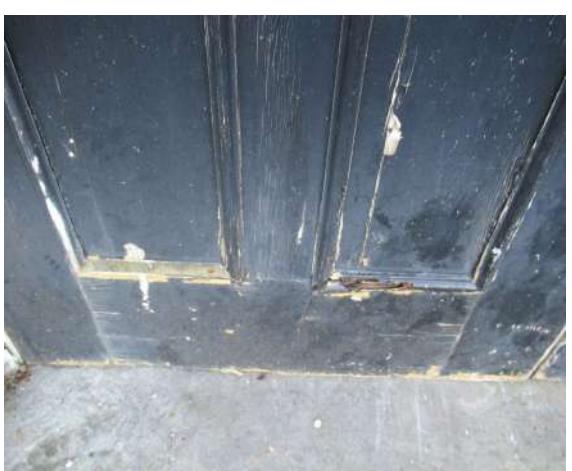
Condition: Poor. Missing and decayed sections of mouldings to lower panels	
323.	Location: Ground floor – north elevation	Element: External door CA 00-02
	Description: As above.

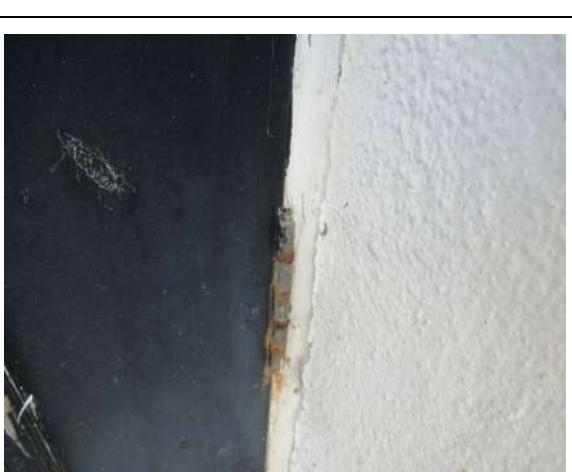
Condition: Poor. Corrosion staining to hinges.

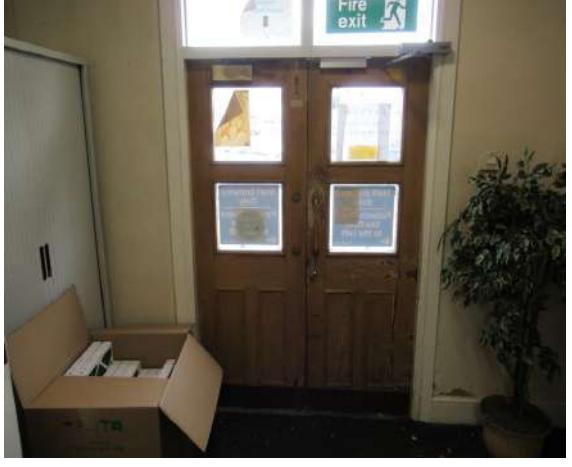
Condition: Poor. Poor quality internal finish and missing sections of moulding to low level.	
325.	Location: Ground floor – north elevation	Element: Internal door CA 00-02
	Description: As above.

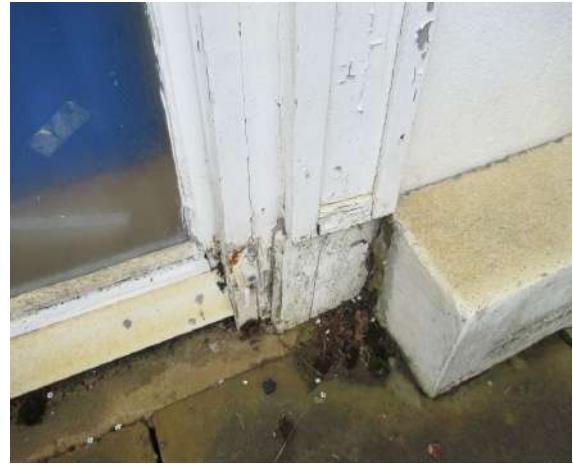
Condition: As above. Poor quality previous repairs and decay evident to low level to the external surrounds to both sides.	
331.	Location: Ground floor – west elevation	Element: External door CA 00-04
	Description: Timber frame single glazed double doors with fixed fan light above. Paint finish internally and externally. Paint timber surround externally.

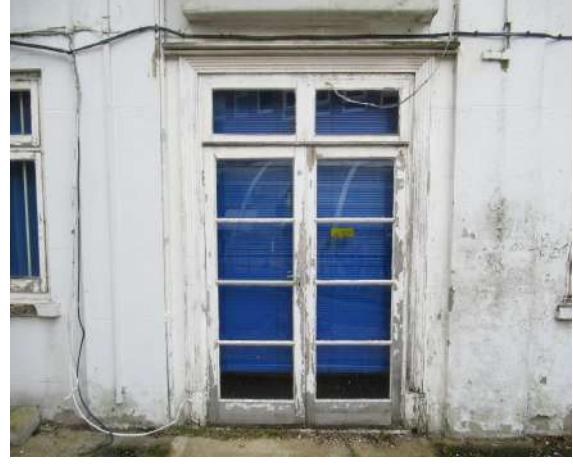
Condition: Poor. Timber decay to threshold. Poor quality previous repair to lower 400mm of LHS side rail. Poor paint finish. Poor quality previous repairs to side mouldings.	
332.	Location: Ground floor – west elevation	Element: External door CA 00-04
	Description: As above.

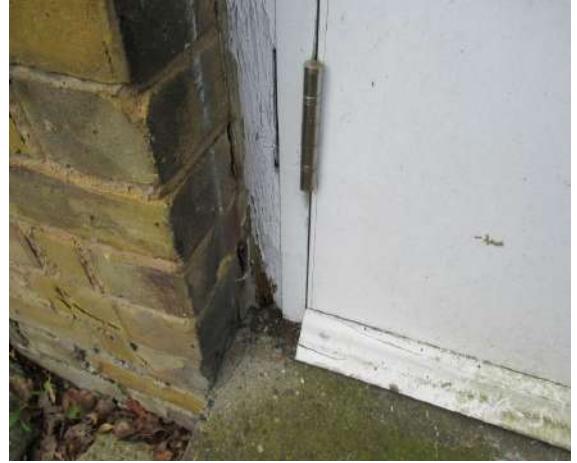
Condition: As above. Localised decay to lower 100mm of door frame to both sides.	
349.	Location: Ground floor – east elevation	Element: External door H 00-01
	Description: As above.

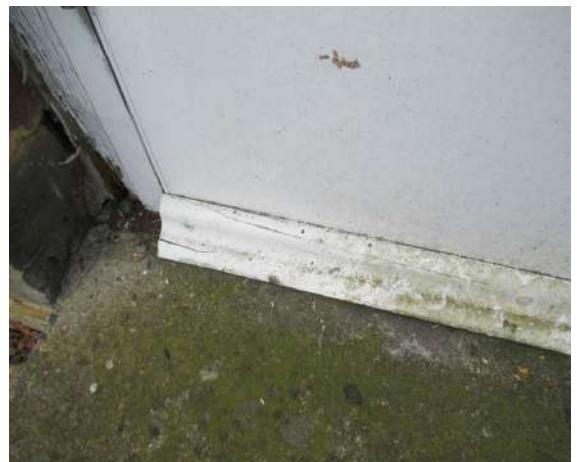
Condition: As above. Split timber weather bar	
350.	Location: Ground floor – south elevation	Element: External door H 00-03
	Description: Factory finished metal frame single glazed door with matching side cheek.

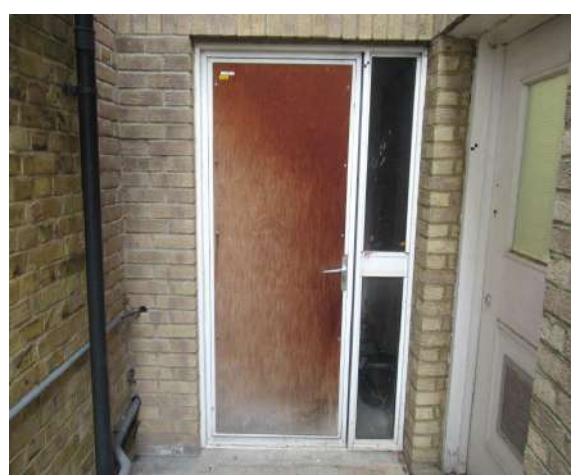
Condition: Fair. The glass panel has been overclad with timber.

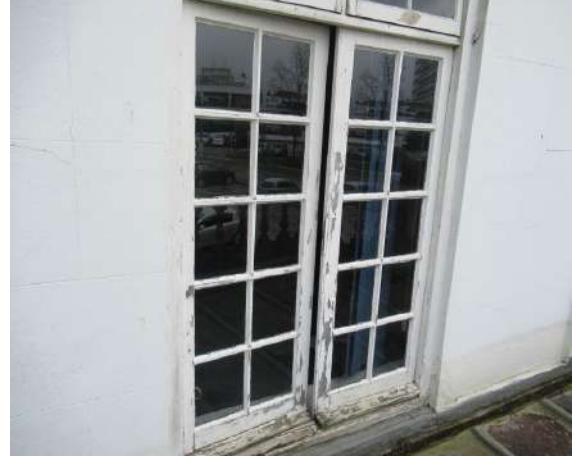
Condition: Poor. Fan light sashes do not close. Poor paint finish. Cover strip fitted to threshold.	
361.	Location: First floor – north elevation	Element: External door CA 01-02
	Description: As above.

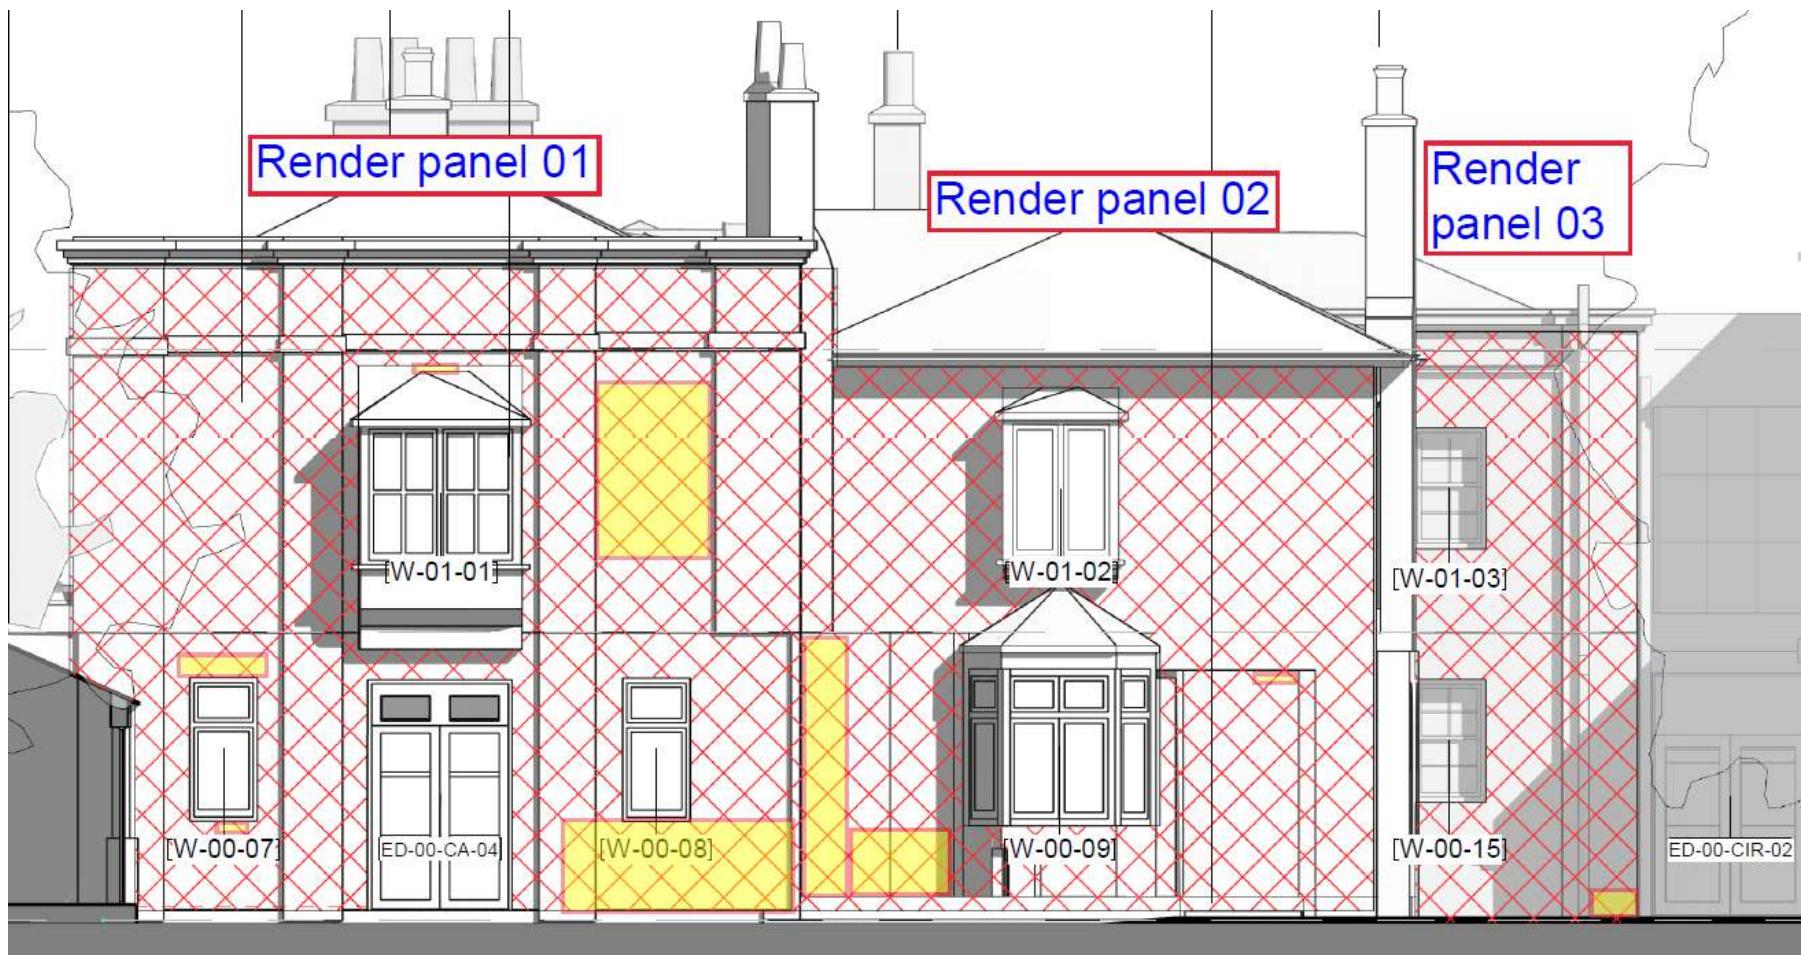
Denotes areas requiring renewal.
