# Former Randall's Department Store, Uxbridge

## Fire Station Structural Assessment

Project No. 113780

April 2018

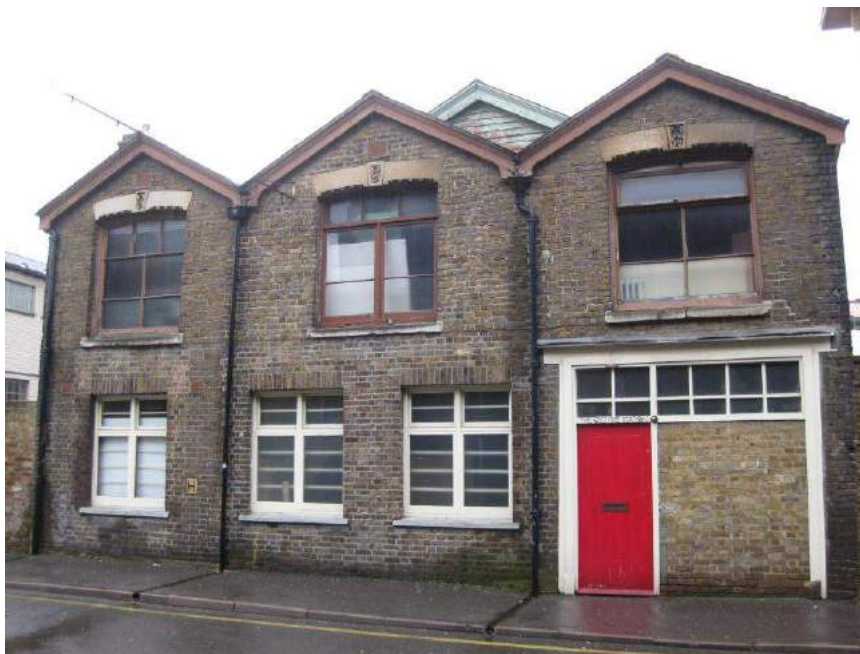
The front elevation has been heavily altered at ground floor level. The large bay doors have been infilled and the end door way removed. Refer to figures 2 and 3.

*Figure 3: Current configuration of the fire station facade*

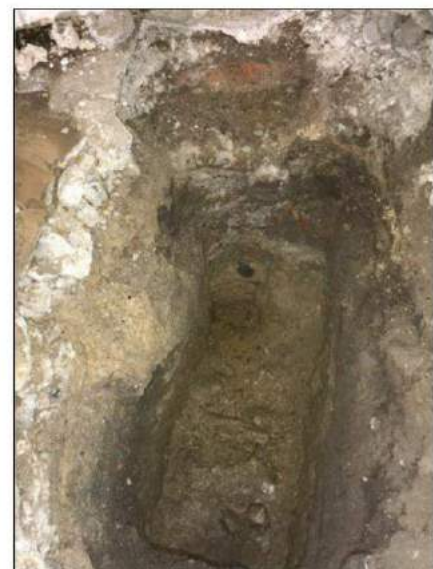
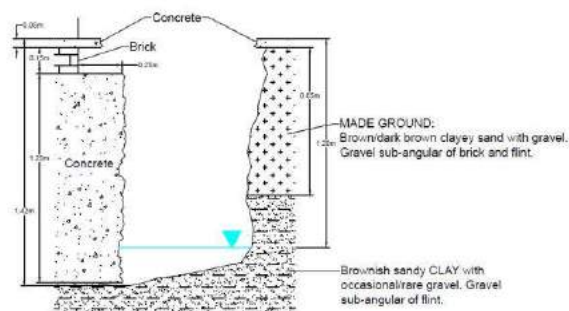
Figure 6: Trial Pit G (TPG)

Two trial pits were undertaken to determine the foundations. A concrete foundation was present below the masonry wall at location TPG. At TPH a deep masonry footing was present (see figures 5 to 7).

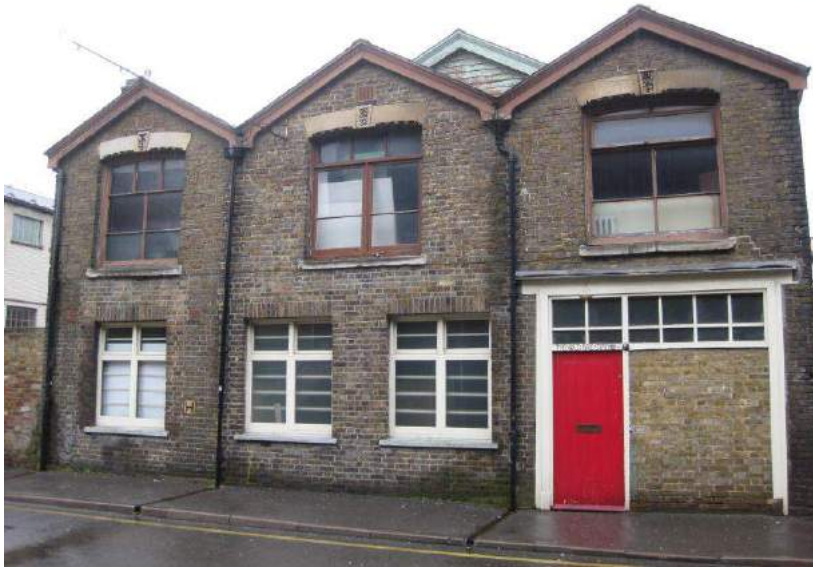
*Figure 9: Front elevation. The ground floor elevation has been heavily modified since the building was first constructed.*

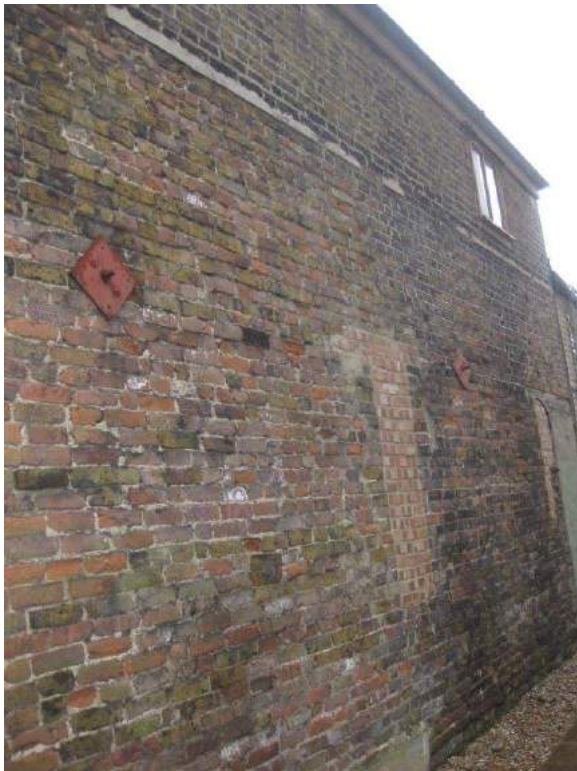
The southern wall next to Beaufort House is in poor condition and has shows evidence of bowing. The wall requires lateral restraint.

*Figure 10: Side elevation next to Beaufort House. Historic infilling of openings present. Ends plates of tie rods visible.*

The wall in poor condition on the southern side of the building is to be restrained by an internal steel frame which is bolted through the masonry wall. The proposed frame is shown in appendix C.

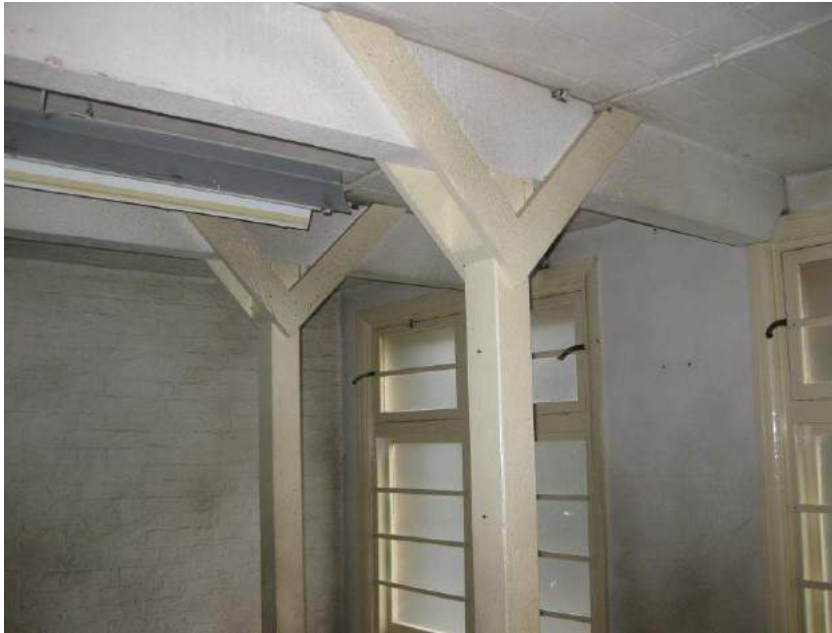
The first floor level floor structure behind the front elevation to the central and southernmost bays is a modern alteration of poor quality. In the central bay the floor is supported off timber posts that are a modern alteration. The floor structure here is to be replaced with a new floor to provide a robust and durable floor and to allow the timber posts at ground floor level to be removed.

*Figure 11: Support of the first floor structure behind the central bay. This structure is a poor quality modern alteration.*

The first floor structure is in poor condition and is to be replaced with a new timber joisted floor.

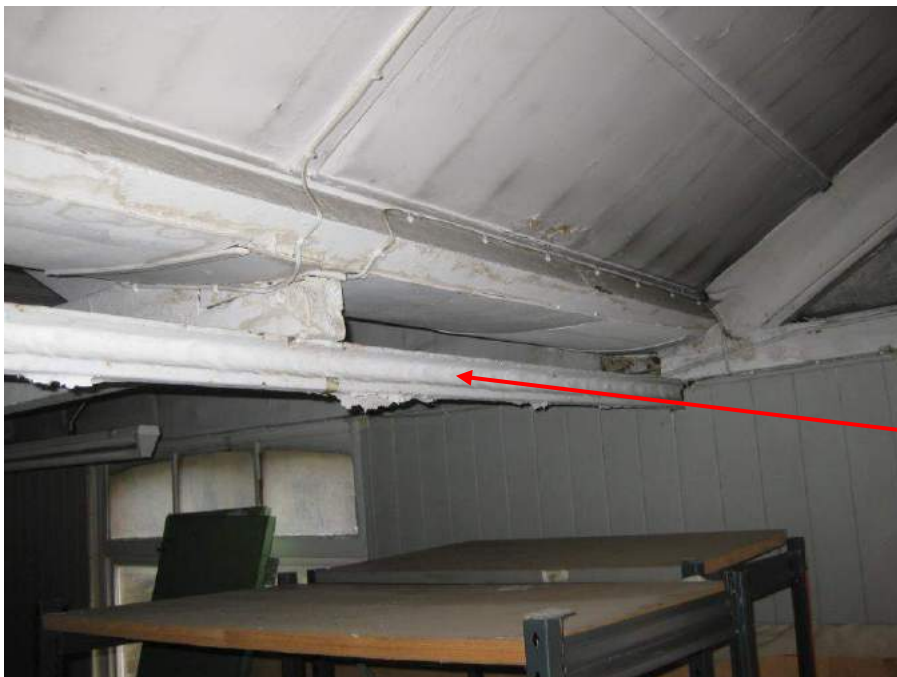
The roof to the front of the building is formed of three pitched roofs. The structure is primarily formed of timber roof trusses, with some unorthodox alterations including the use of a train track rail for supporting the ends of timber trusses. The structure to the front area of roof shows signs of water ingress which is likely to have caused material degradation. The structure supporting these roofs is in poor condition and has been subject to a number of poor quality alterations. The structure here is to be replaced.

Beam supporting roof is a modern alteration and is formed of a train track rail

*Figure 12: Poor quality roof structure to the front of the building*

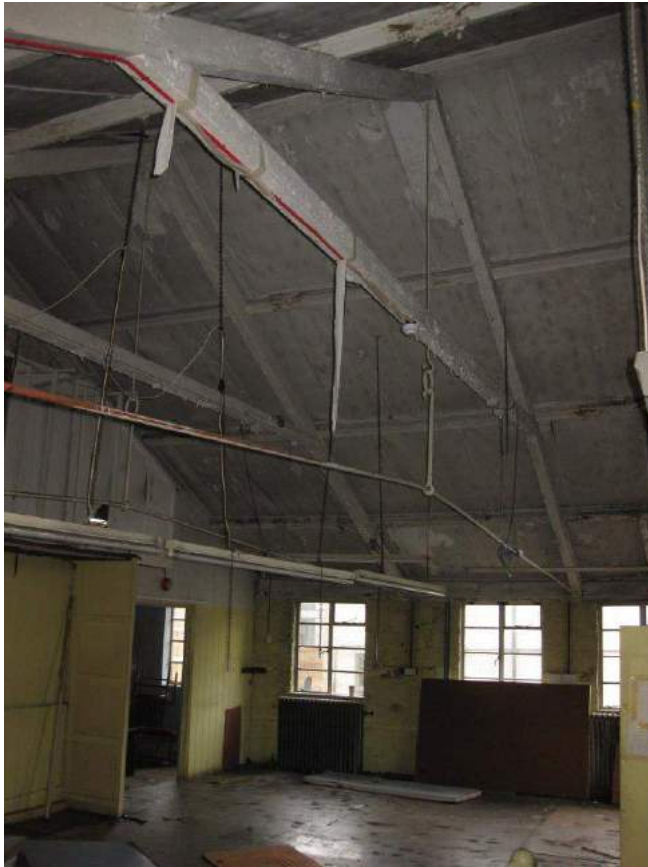
*Figure 13: Tied timber trusses forming the roof structure to the rear of the building.*

The large pitched roof to the rear of the building is supported by tied timber trusses in poor condition which are to be removed and replaced with new timber trusses.

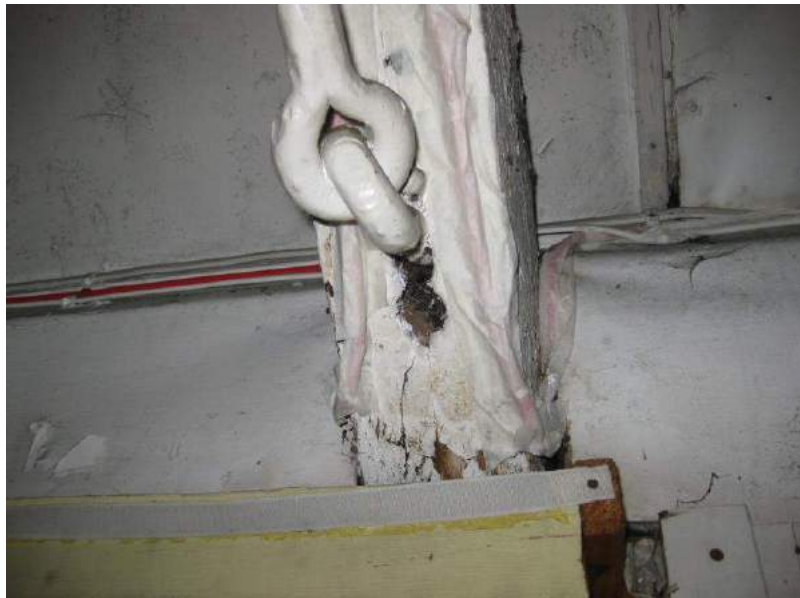
A double pitched roof is present to the rear of the building which is supported by tied timber trusses. From visual inspection where the tie rod connects to the ends of the rafter, the bolted connection shows evidence of rotating, slipping and failing the timber in bearing. This may have been exacerbated by the timber becoming wet. The existing tied timber trusses cannot be retained due to their poor condition. These will be replaced with new softwood trusses as shown on drawing 113780-RVS-FH-Z3-03-DR-S-4005. Timber purlins to this area of the roof are to be replaced.

*Figure 14: Detail of the steel tie fixing into the end of the timber rafter. The bolted connection shows evidence of rotating, slipping and failing the timber in bearing. This may have been exacerbated by the timber becoming wet.*

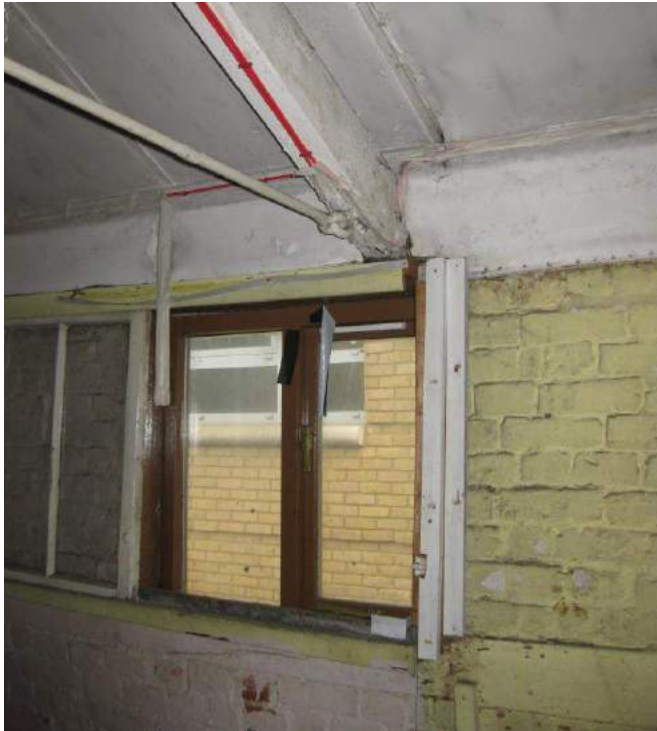
*Figure 15: End of timber truss supported by a beam over an opening. Opening up works are required to determine the type and condition of the beam. The connection of the truss end to this beam is to be determined following opening works.*

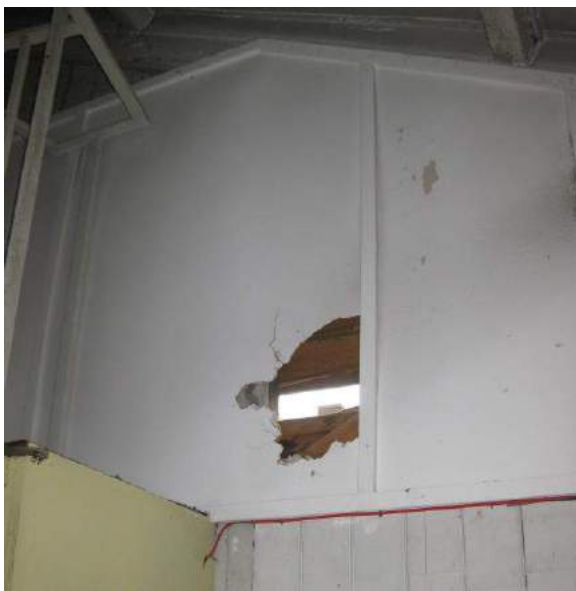
*Figure 16: Hole present through roof gable. The roof covering is likely to be in a poor condition and require replacement. The hole will have let water into the structure.*

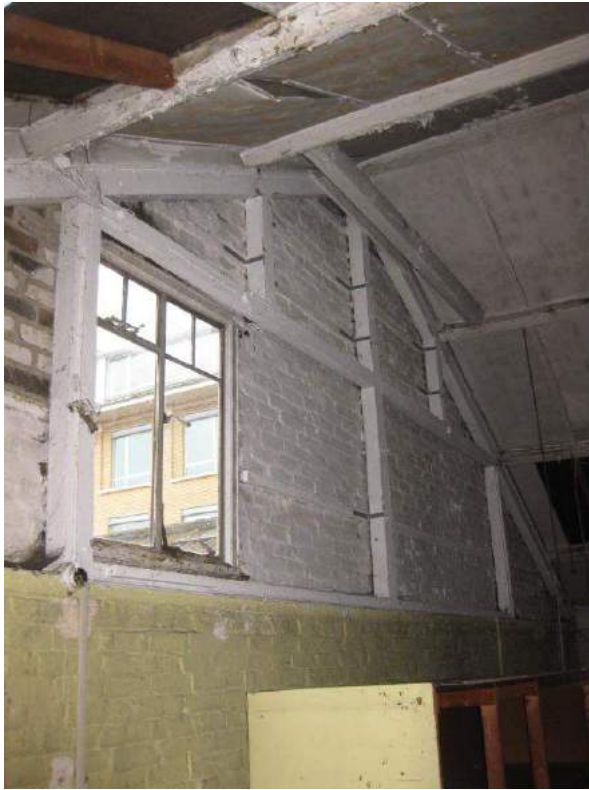
*Figure 17: Roof gable next to the 1960s warehouse. At high level the thickness of the wall reduces to half a brick thick which is very thin. It appears that the timber frame on the inside face provides lateral restraint to the wall.*

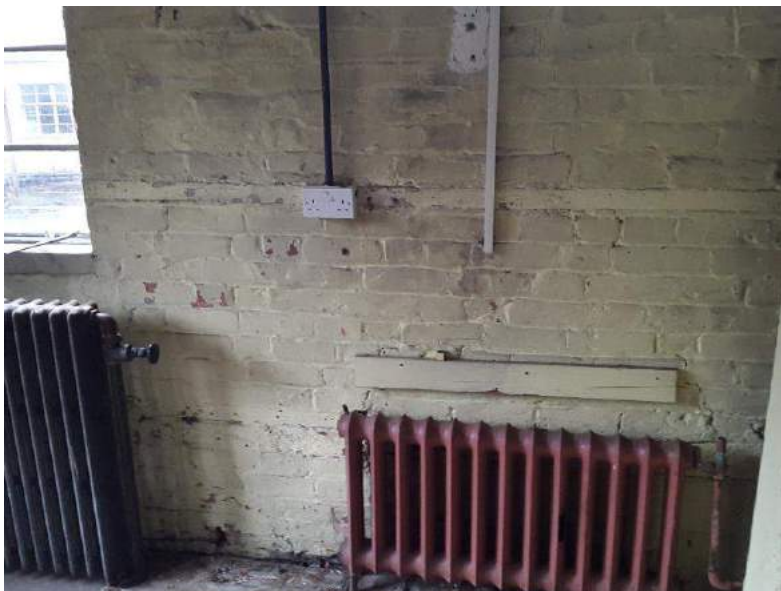
In a number of areas timber is embedded into the masonry wall construction. The timber is to be cut out and replaced with masonry for long term durability.

*Figure 18: Timber is embedded into a number of masonry walls. It is recommended that the timber be removed and replaced with masonry to provide long term durability.*

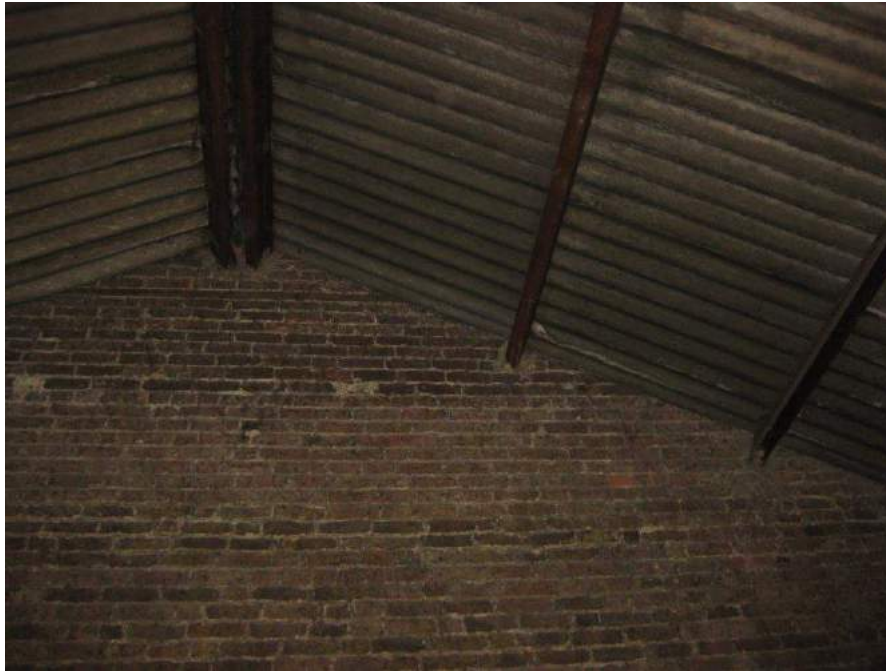
*Figure 19: The rear wall of the fire station building at the interface with the 1960s warehouse. The warehouse roof purlins bear onto the fire station masonry wall.*

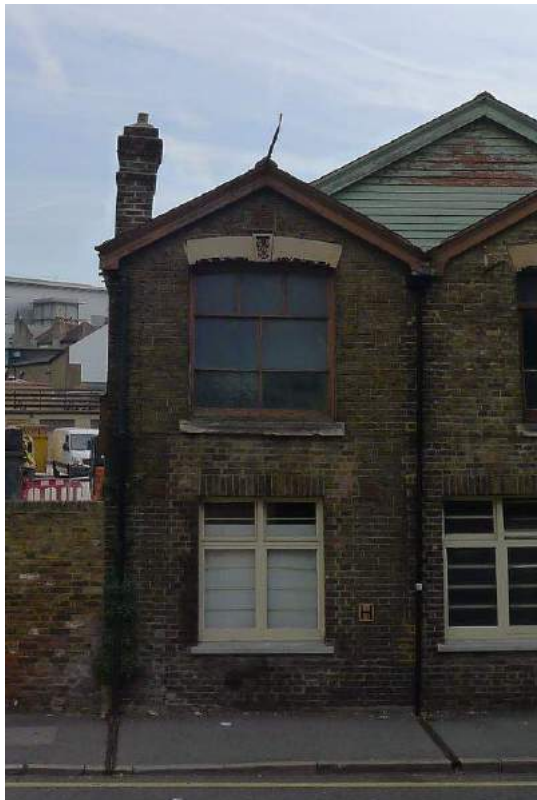
*Figure 20: The chimney stack is leaning and potentially unstable.*

EXISTING CHIMNEY MAY  
REQUIRE REBUILDING.  
SUBJECT TO INSPECTION

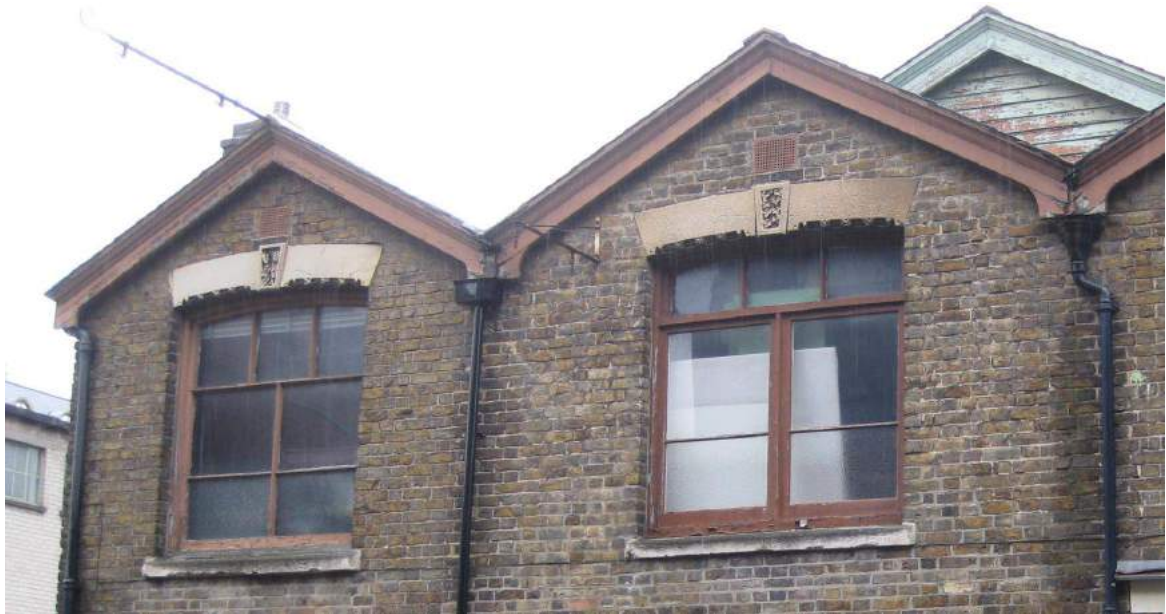
*Figure 21: Lintels to the front façade have dropped slightly and are to be made good.*

Existing timber lintels in poor condition are to be replaced. Where a timber lintel is present over an opening that has been infilled, the lintel is to be replaced with masonry for long term durability.

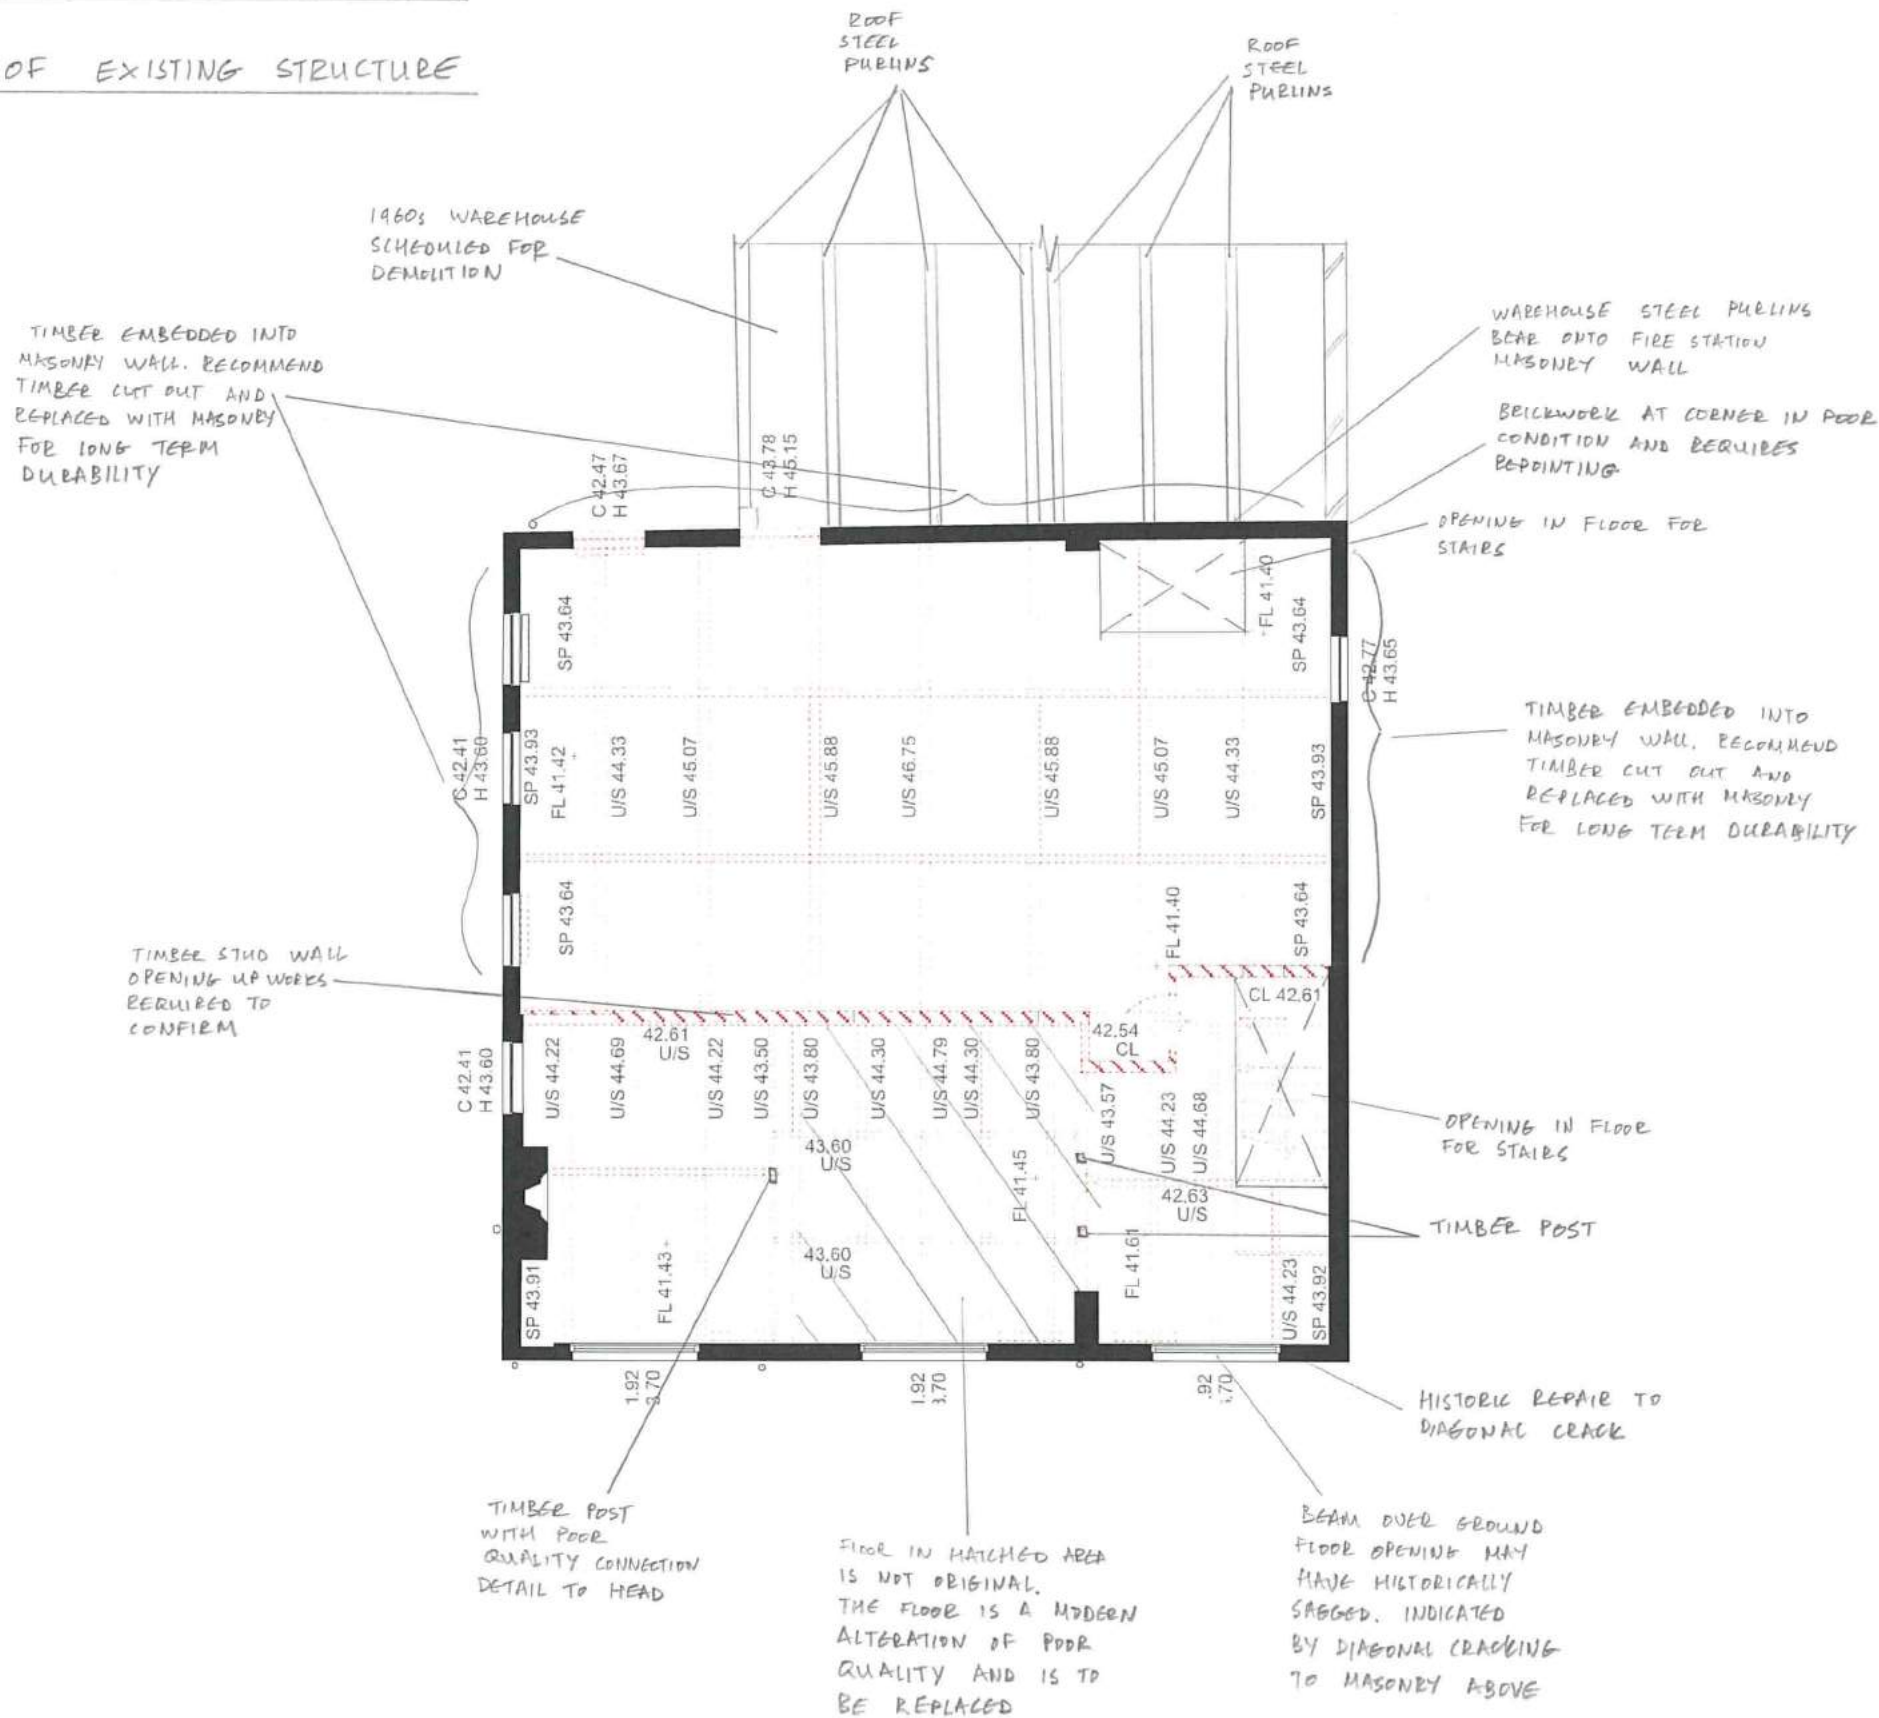
# FIRE STATION FIRST FLOOR

HOLE PRESENT THROUGH  
ROOF GABLE. THE HOLE  
WILL HAVE LET WATER  
INTO THE STRUCTURE,  
POSSIBLY CAUSING ROT  
TO OCCUR.

TIMBER  
ROOF STRUCTURE IN HATCHED  
AREA IS IN POOR CONDITION AND  
HAS BEEN SUBJECT TO A NUMBER  
OF MODERN ALTERATIONS OF  
POOR QUALITY. ROOF STRUCTURE  
TO BE REPLACED.

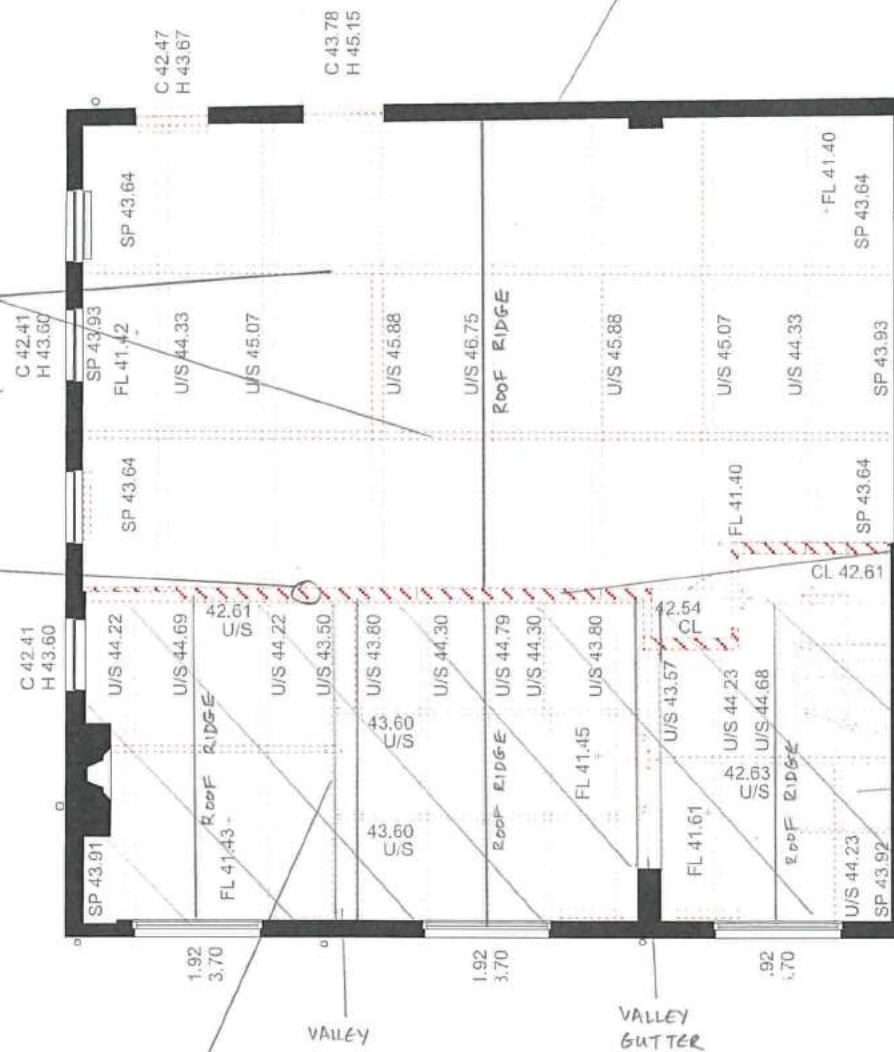
RAIL TRACK  
FORMS VALLEY  
BEAM, AND  
SUPPORTS  
TIMBER ROOF  
TRUSSES

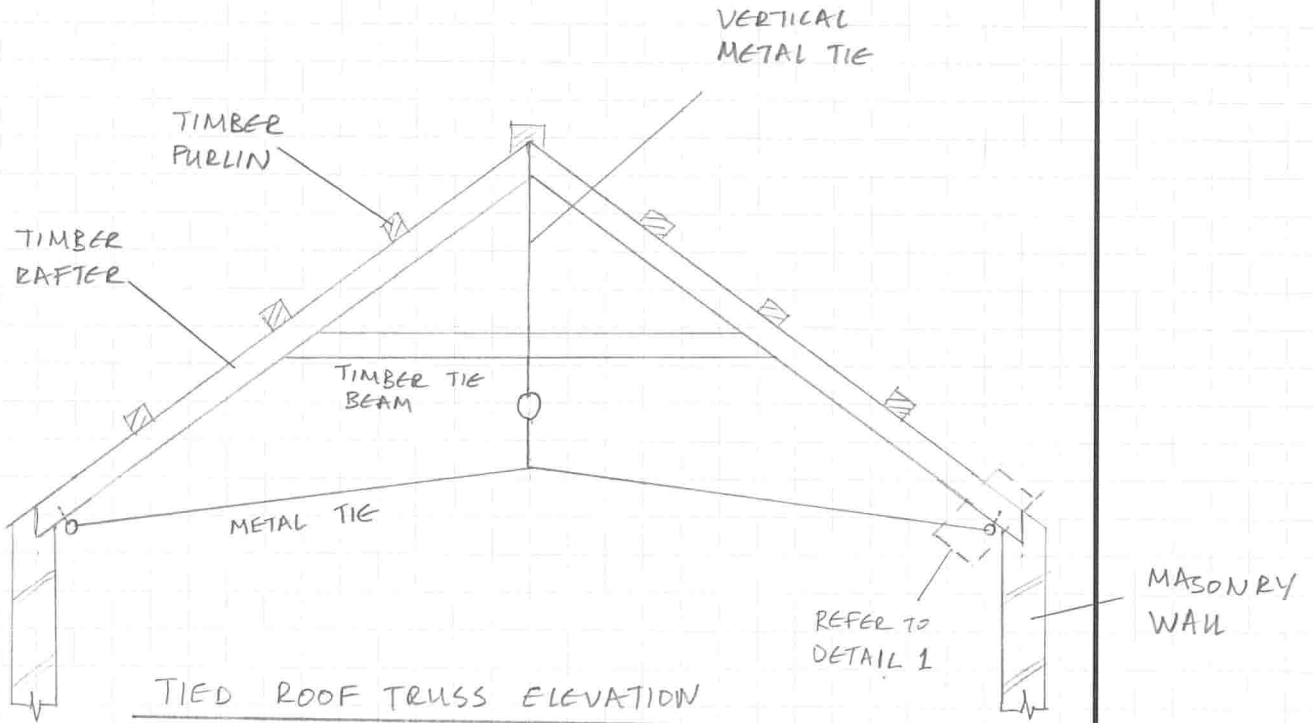
TENSION IN METAL  
TIE LOOKS TO  
HAVE CAUSED  
MOVEMENT OF  
BOLT

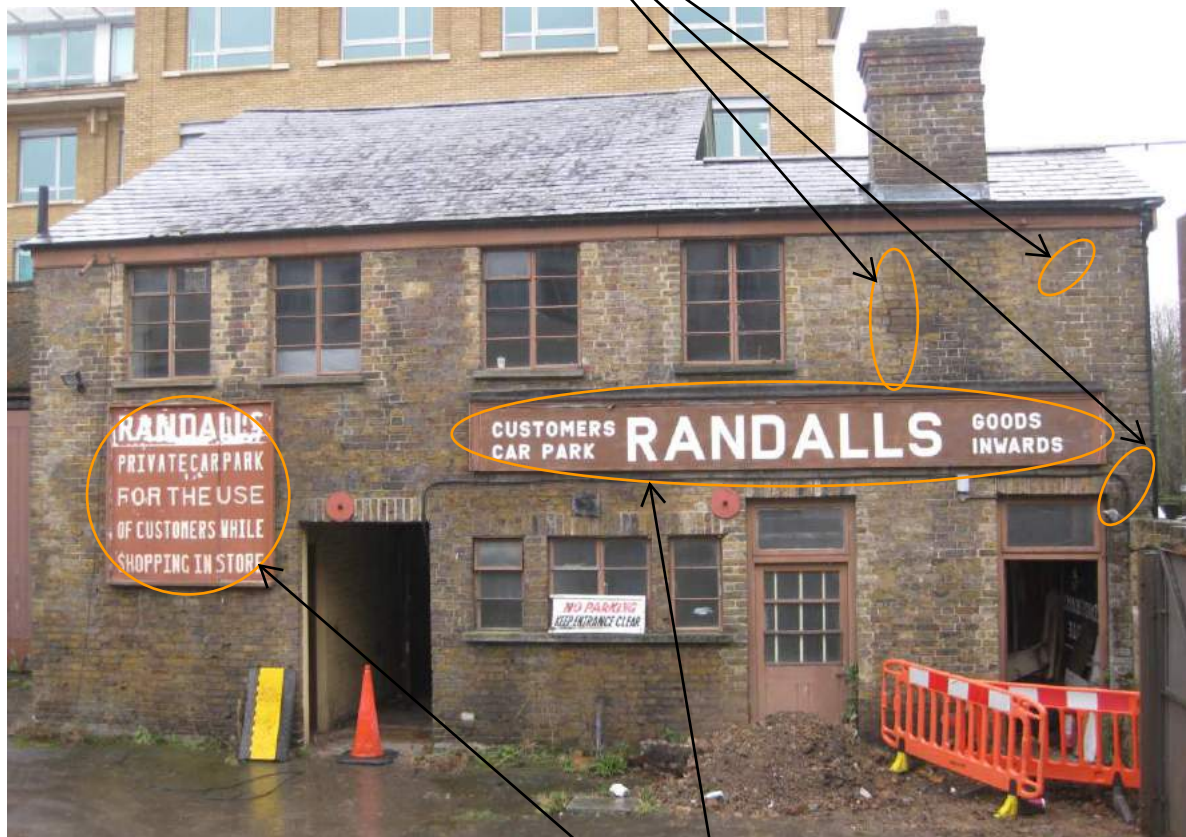
Existing signage board to be removed to identify if masonry cracking present. Cracks to be repaired.

Where crack repairs identified these are to be repaired with Helifix crack stitching (or equally approved product).

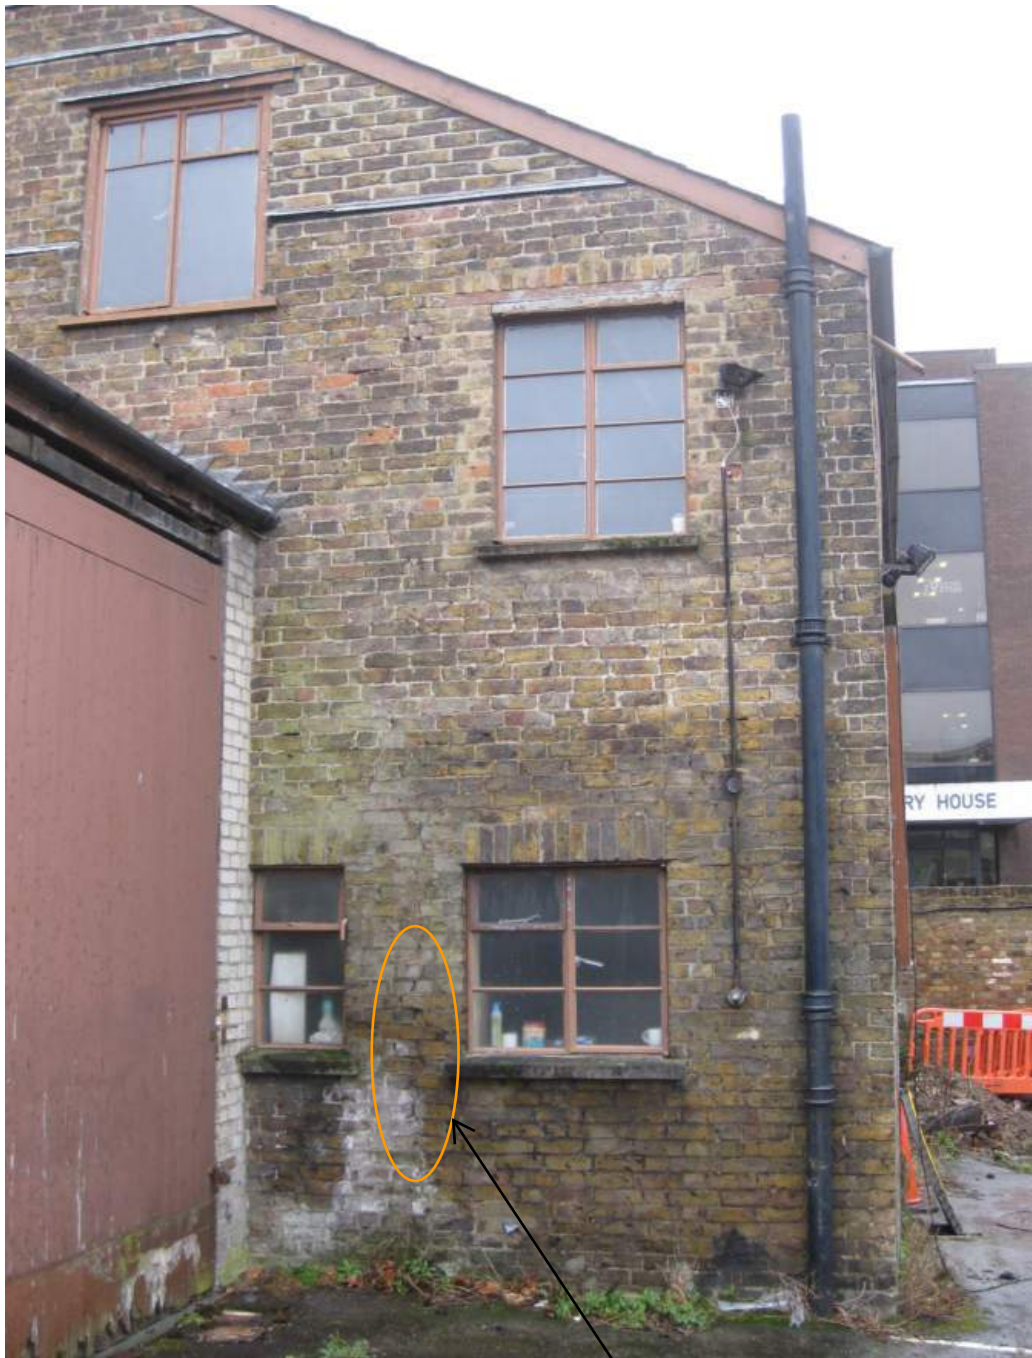
Cracks to be repaired.

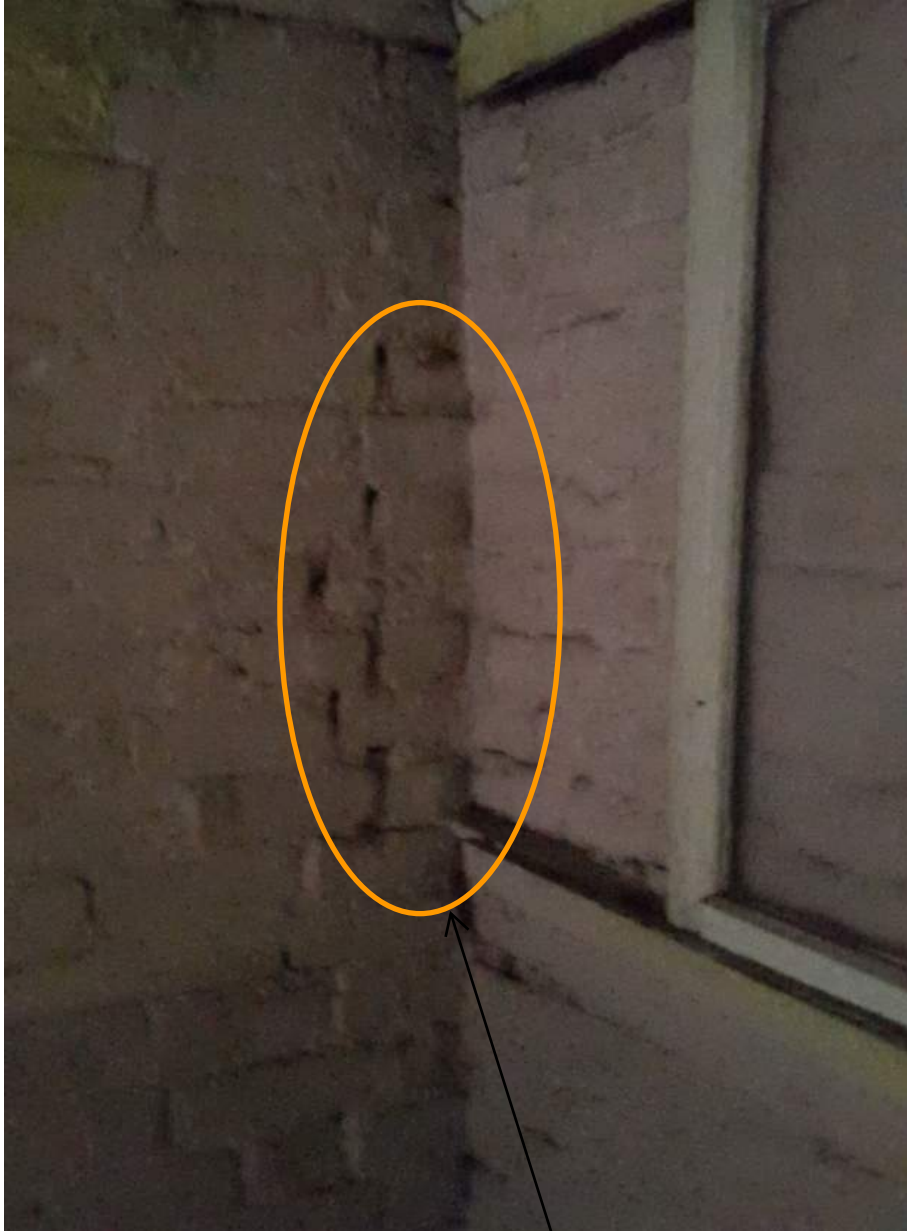
Internal view at south-east corner of building  
at first floor level

Cracks to be repaired.
