ADDENDUM TECHNICAL REPORT  
Retained

| DATE OF ISSUE: | 4 <sup>th</sup> March 2019 |
| [REDACTED] | Mr and Mrs Robinson<br>24 Nicholas Way<br>Northwood<br>HA6 2TS |

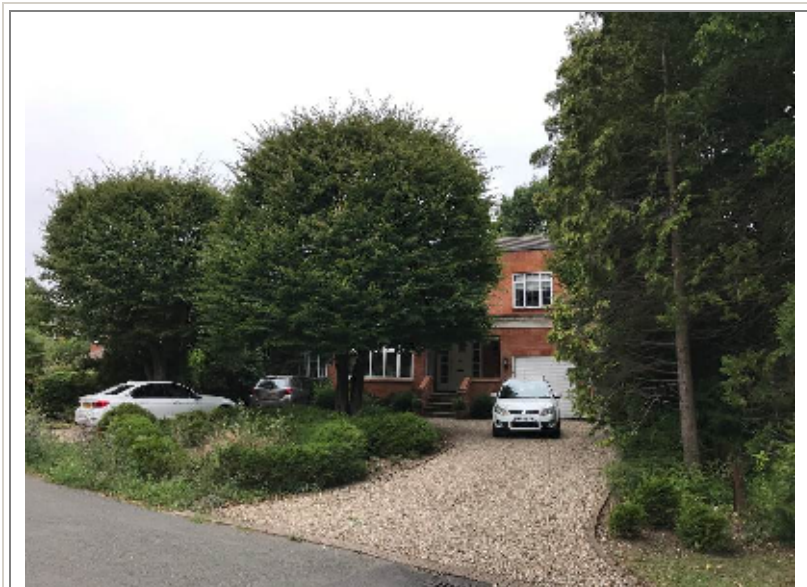
General view of property
