# Arboricultural Appraisal Report

## Subsidence Damage Investigation at:

24 Nicholas Way  
Northwood  
HA6 2TS

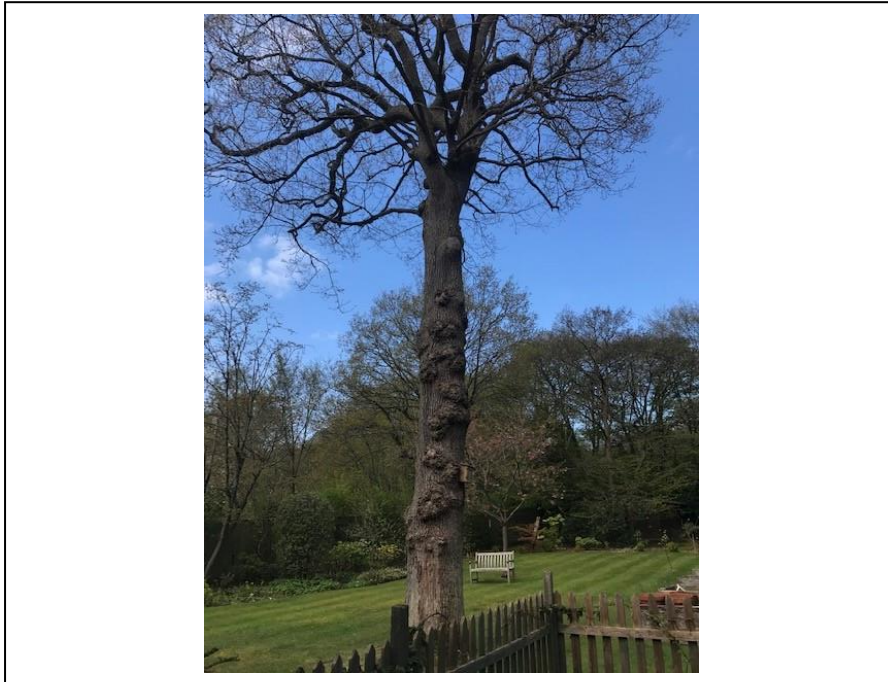
Roots were observed to a depth of 2000mm bgl in TP/BH1 and recovered samples have been positively identified (using anatomical analysis) as *Quercus* sp., the origin of which will be T1 confirming its influence on the soils below the foundations.

Based on the technical reports currently available, engineering opinion, the history of damage and our own site assessment we conclude the damage is consistent with shrinkage of the clay subsoil related to moisture abstraction by vegetation. Having considered the information currently available, it is our opinion that T1 is the principal cause of or is materially contributing to the current subsidence damage.

View of T1 Oak, current claim.

If an arboricultural solution is to be implemented to mitigate the influence of the implicated tree we recommend that T1 is removed.

| Tree No. | Species | Ht (m) | Dia (mm) | Crown Spread (m) | Dist. to building (m) | Age Classification | Ownership |
|---|---|---|---|---|---|---|---|
| Recommendation | | Remove (fell) to near ground level. Owner to physically remove any regrowth (no chemical treatment due to translocation risk). | | | | | |

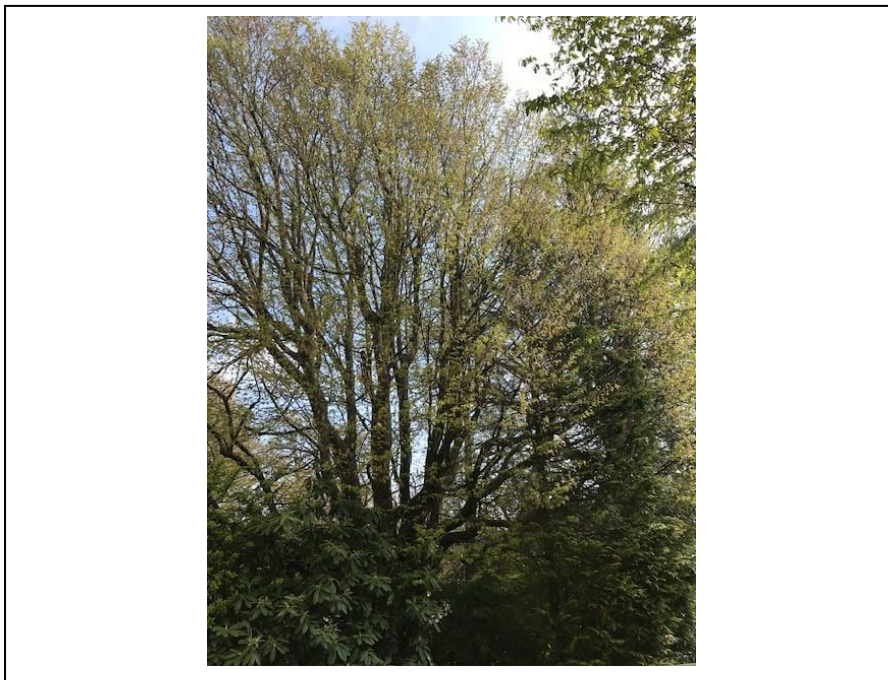
View of TG2 Hornbeam, future risk.

| Tree No. | Species | Ht (m) | Dia (mm) | Crown Spread (m) | Dist. to building (m) | Age Classification | Ownership |
|---|---|---|---|---|---|---|---|
| Recommendation | | Prune on a triennial cycle to maintain at broadly no more than current dimensions. | | | | | |

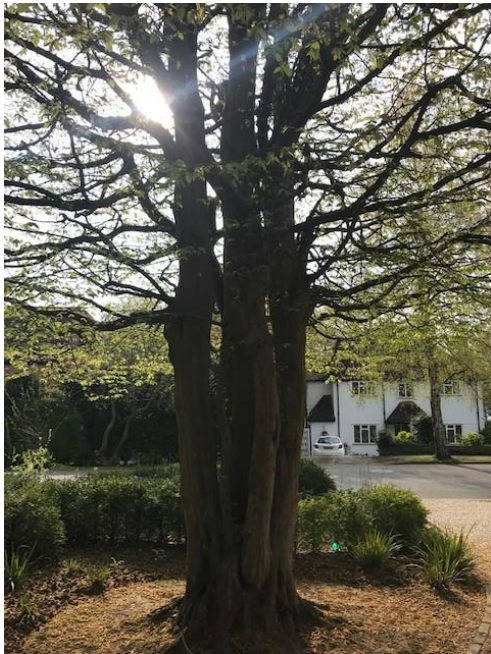
View of T5 Hornbeam, future risk.

| Tree No. | Species | Ht (m) | Dia (mm) | Crown Spread (m) | Dist. to building (m) | Age Classification | Ownership |
|---|---|---|---|---|---|---|---|
| Recommendation | | Prune on a triennial cycle to maintain at broadly no more than current dimensions. | | | | | |

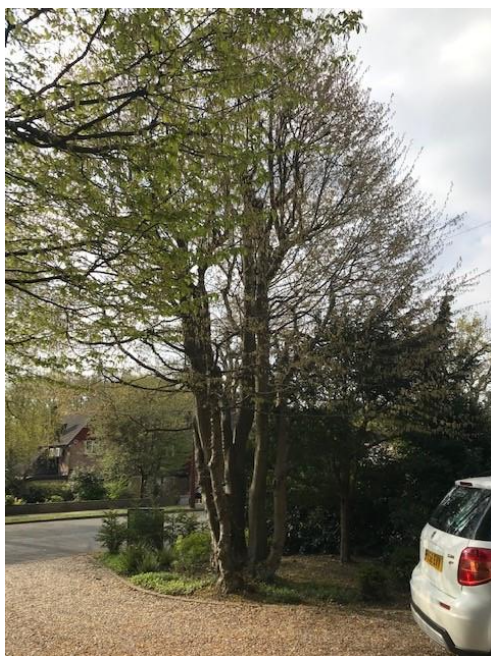
View of T6 Hornbeam, future risk.

| Tree No. | Species | Ht (m) | Dia (mm) | Crown Spread (m) | Dist. to building (m) | Age Classification | Ownership |
|---|---|---|---|---|---|---|---|
| Recommendation | | Prune on a triennial cycle to maintain at broadly no more than current dimensions. | | | | | |
