# NCP Flightpath Heathrow Phase 1 Desk Study Report

*Aprirose Real Estate Investment*

Date: 6 July 2022

Doc ref: 23795-HYD-XX-XX-RP-GE-1000

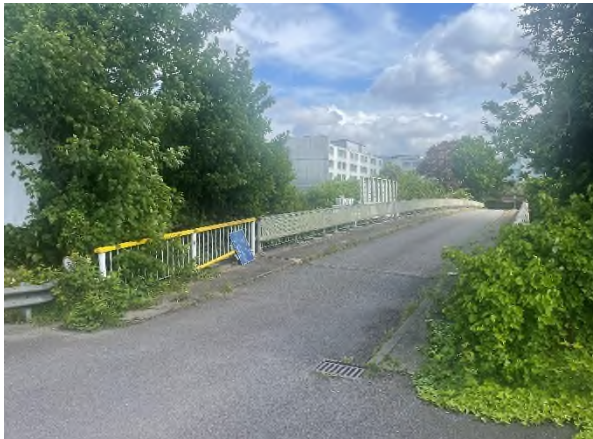
Figure 2.3: The entrance of the site as seen from the eastern site boundary. A bridge leading to the neighbouring hotel crosses the underlying Tunnel Road East. This is the main accessway to the site.

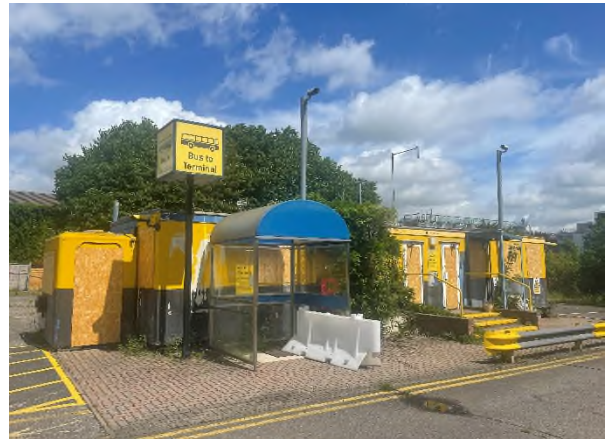
Figure 2.4: Customer Service cabin and bus stop towards the north of the site. Services including street lighting, an aerial, outdoor plug sockets and CCTV can be seen around the structure. It is unknown if services are live.

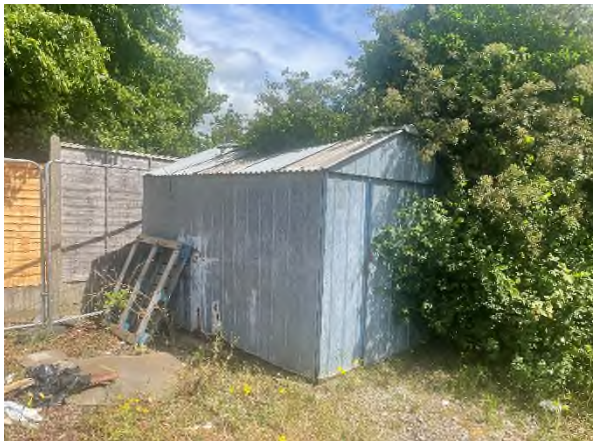
Figure 2.5: Disused metal shed at the north-east corner of the site.

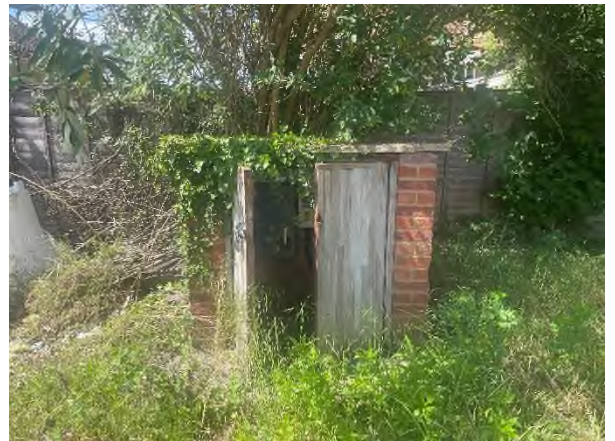
Figure 2.6: Brick structure containing electrical equipment along the western site boundary.

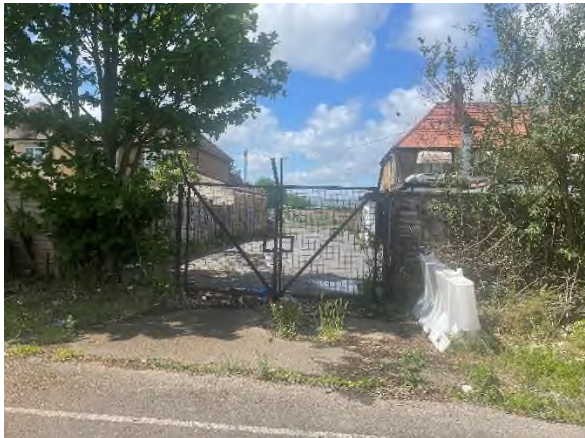
Figure 2.7: Locked secondary access gate along the western site boundary.

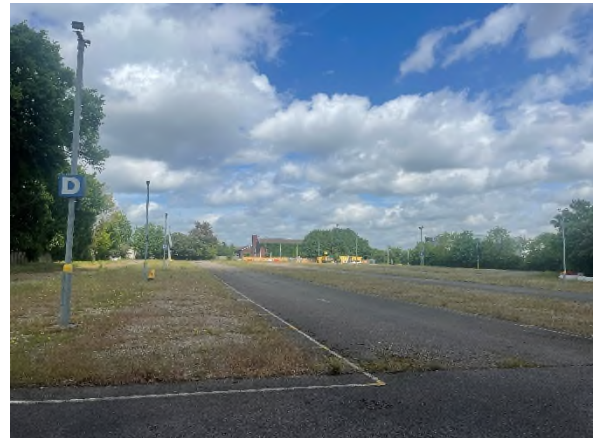
Figure 2.8: Car parking area viewed from the south-west corner of the site. Parking bays with an aggregate surface are overgrown with weeds and grass. Asphalt roads provide an accessway to the parking bays. Street lighting and CCTV facilitate the car park.

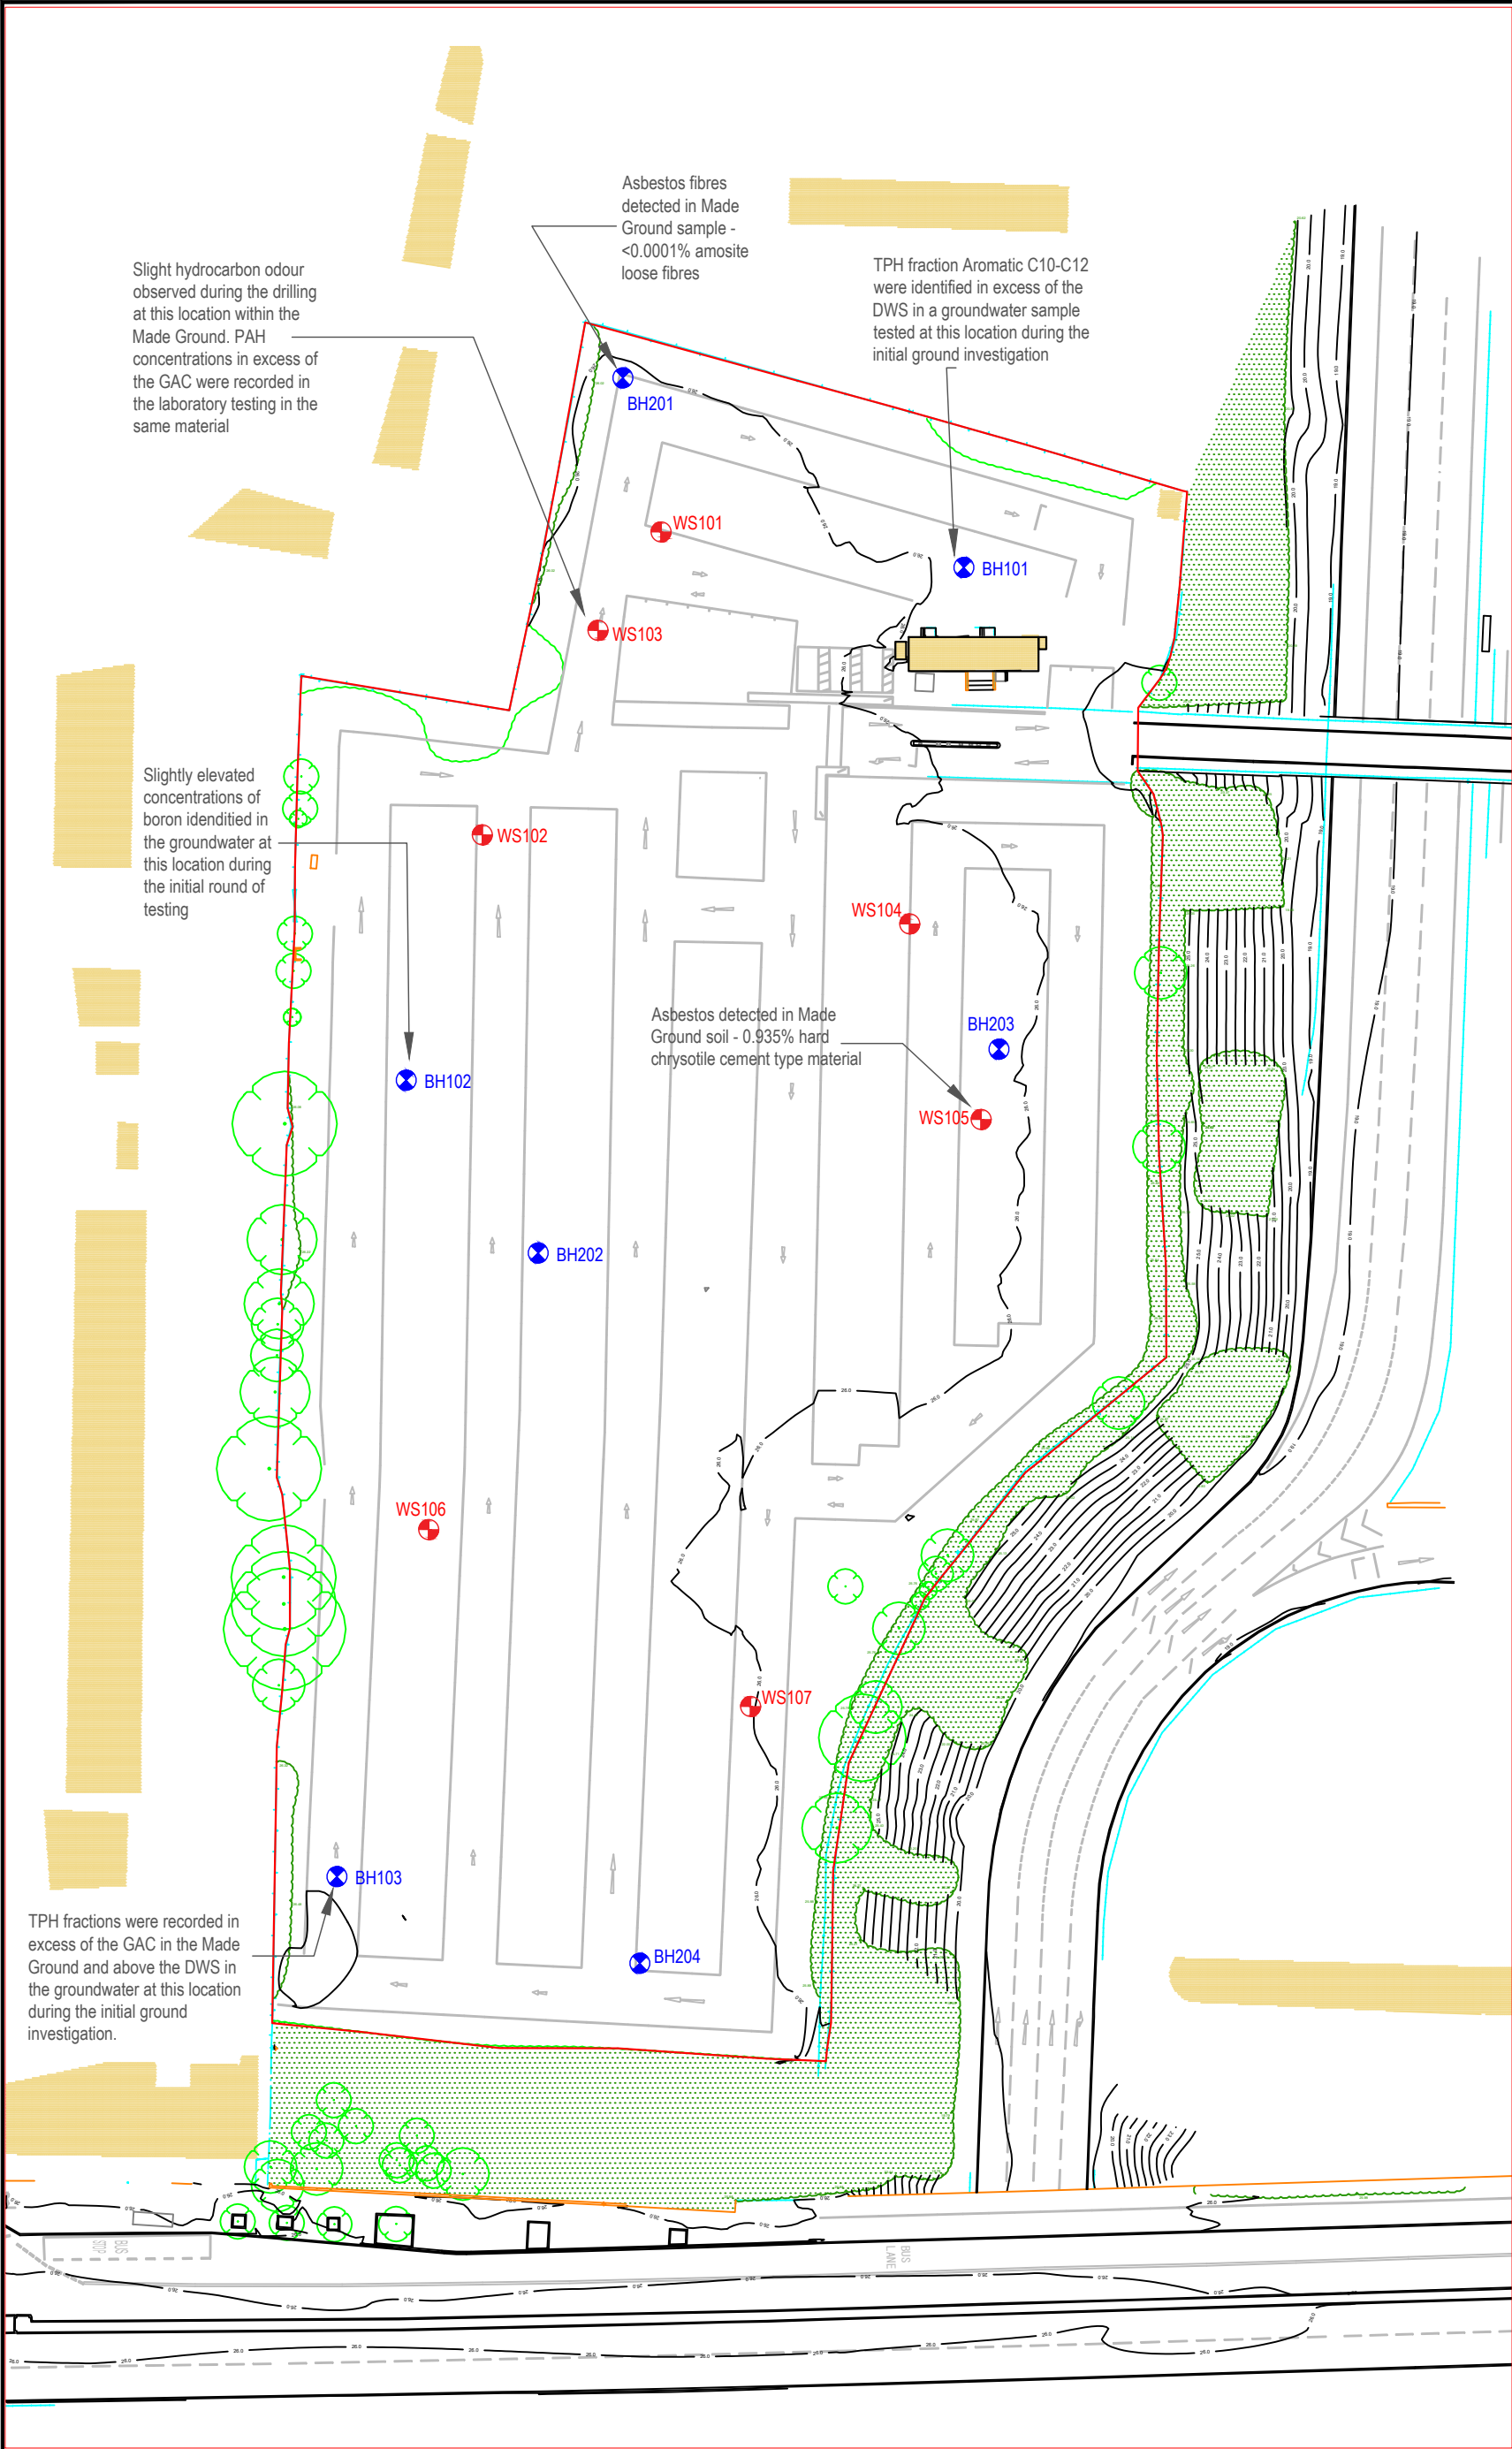
Notes:  
Groundwater contamination was discounted and attributed to unsuitable groundwater sampling techniques by TRC. A second round of sampling was undertaken which encountered no hydrocarbon concentrations in exceedance of the DWS. Further monitoring and sampling was recommended.
