Drainage Investigation Report

102230.2.RTN

Auger were commissioned by Sedgwick International UK to undertake drainage investigations following the customer reporting cracking to the building / subsidence at the property. The issue was noted to be external at the property.

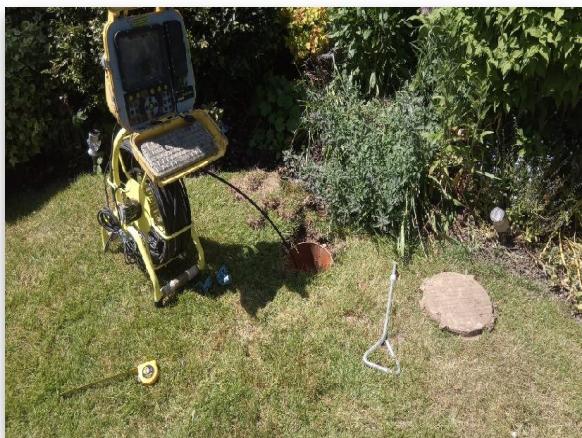
Fig 2.1: Buried IC2
