75 Ladygate Lane
RUISLIP
Middlesex
HA4 7QX

INSURANCE CLAIM

CONCERNING SUBSIDENCE DAMAGE

ENGINEERING APPRAISAL REPORT

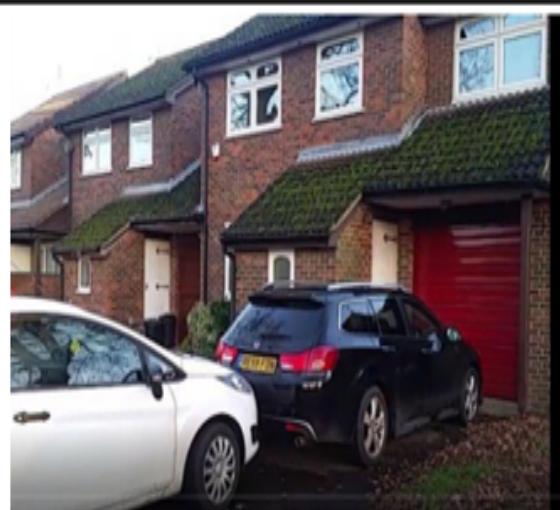
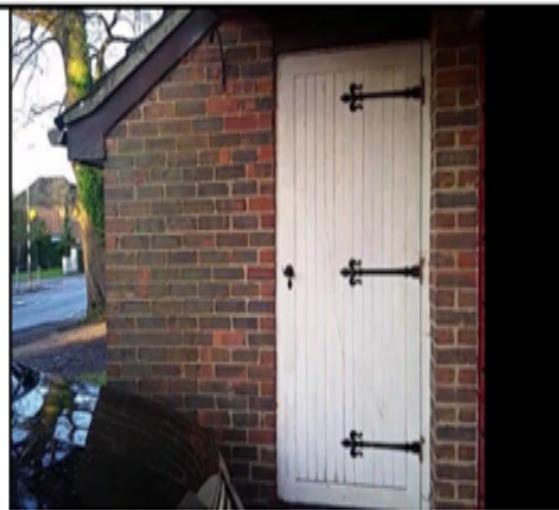
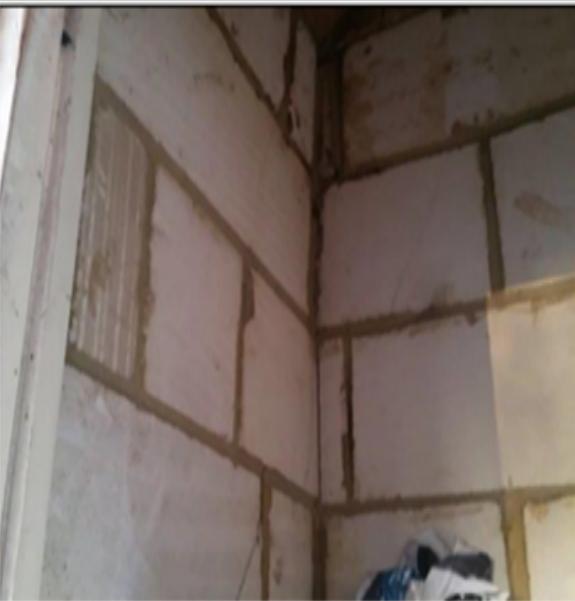
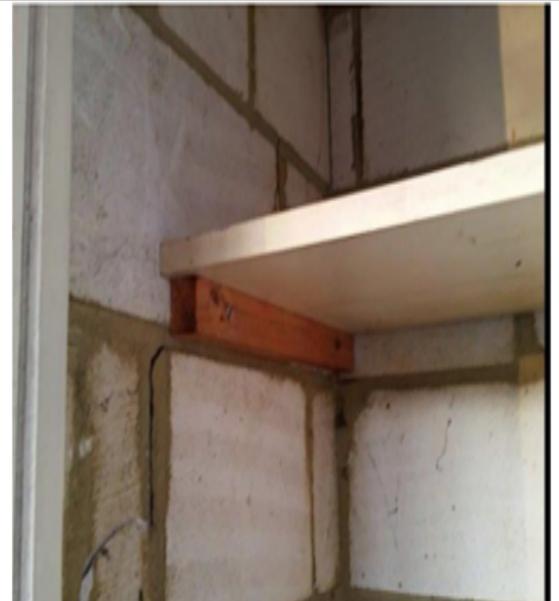
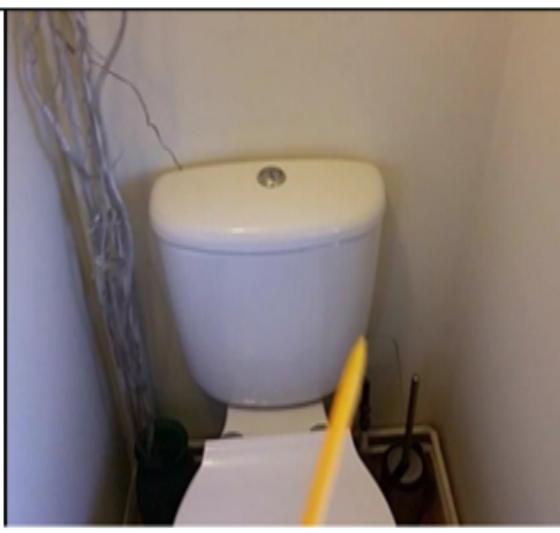
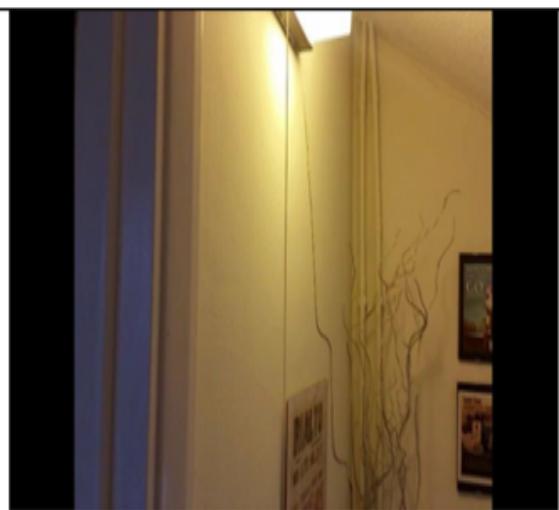
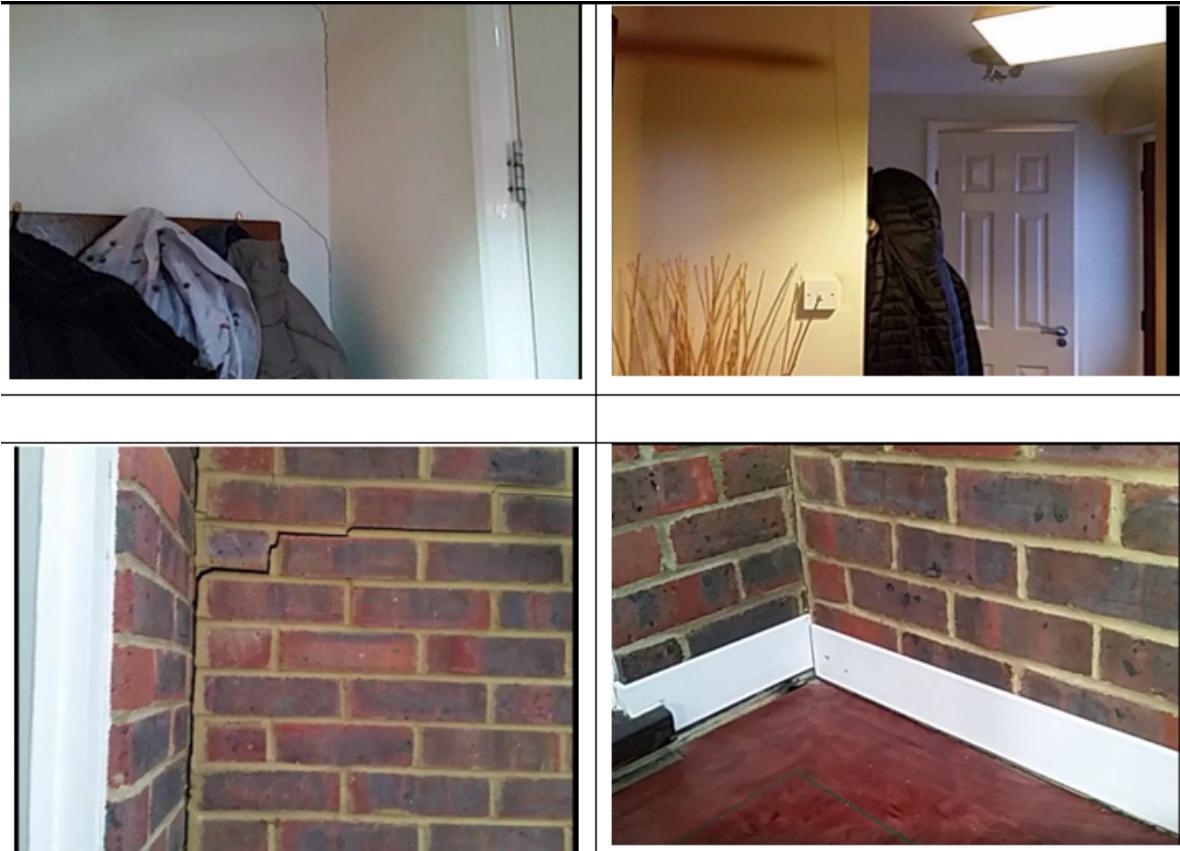
The main areas of damage is to the front outrigger & rear conservatory and takes the form of tapering external and internal cracks. The conservatory also has a sloping concrete floor.

This pattern of damage indicates a mechanism of rotational downwards movement to the front and rear of the property.

The level of damage is moderate, and is classified as category 3 in accordance with BRE Digest 251 - Assessment of damage in low-rise buildings.

If the Oak trees are removed then we consider that works including structural crack repair and redecoration at an approximate cost of £10,000.00 will be appropriate in order to repair the damage in this case.

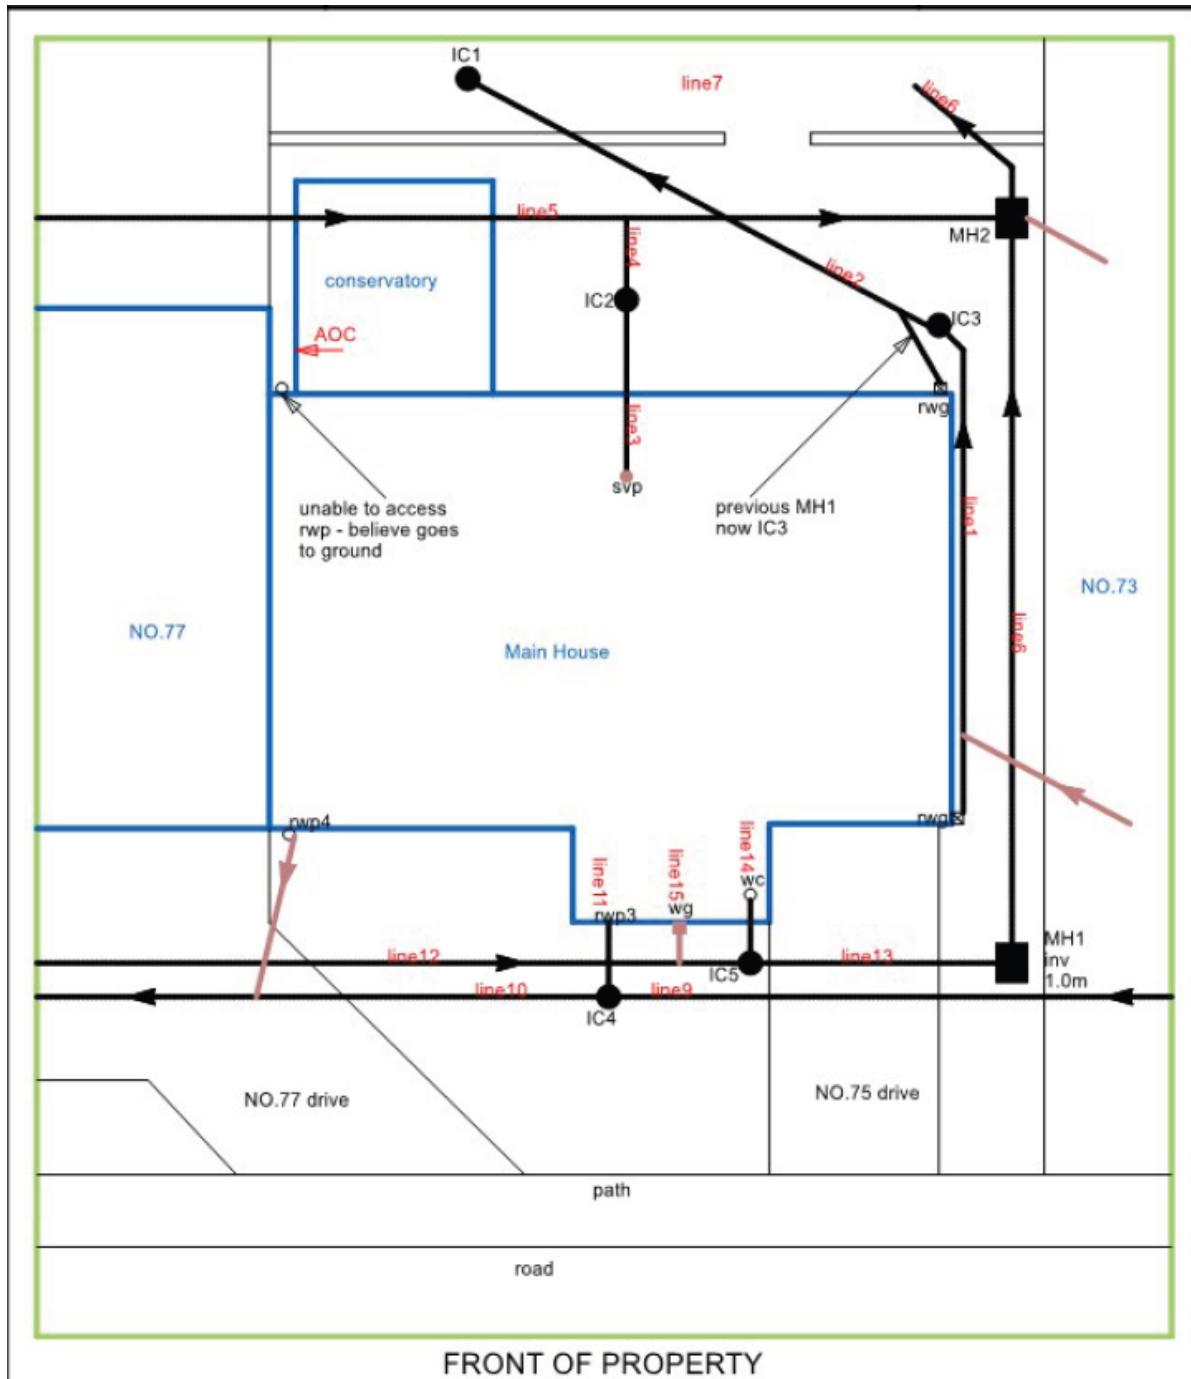
Extract from Auger drainage report

A comprehensive CCTV survey of the drains was undertaken but no defects were found which would lead to an escape of water into the soil.

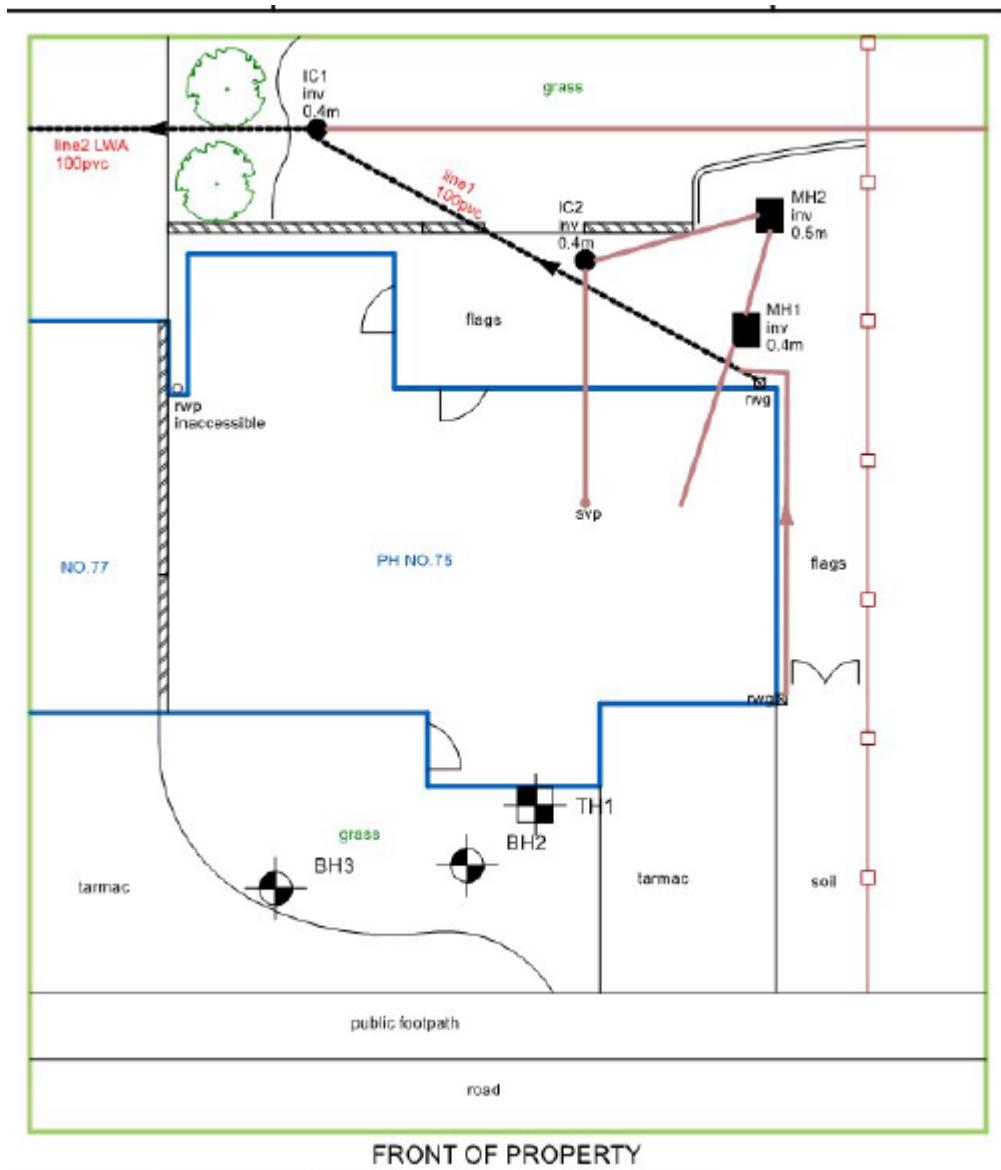
Extract from Auger July 2020 report showing location of trial hole and remote boreholes to front of property.

Trial pit 1 was excavated at the front of the outrigger and revealed a concrete foundation bearing at a depth of 700mm below external ground level on to brown silty clay. The trial hole and remote boreholes were terminated at a depth of 1.1m due to encountering solid ground and was unable to penetrate further.

Roots were observed in the trial pit.

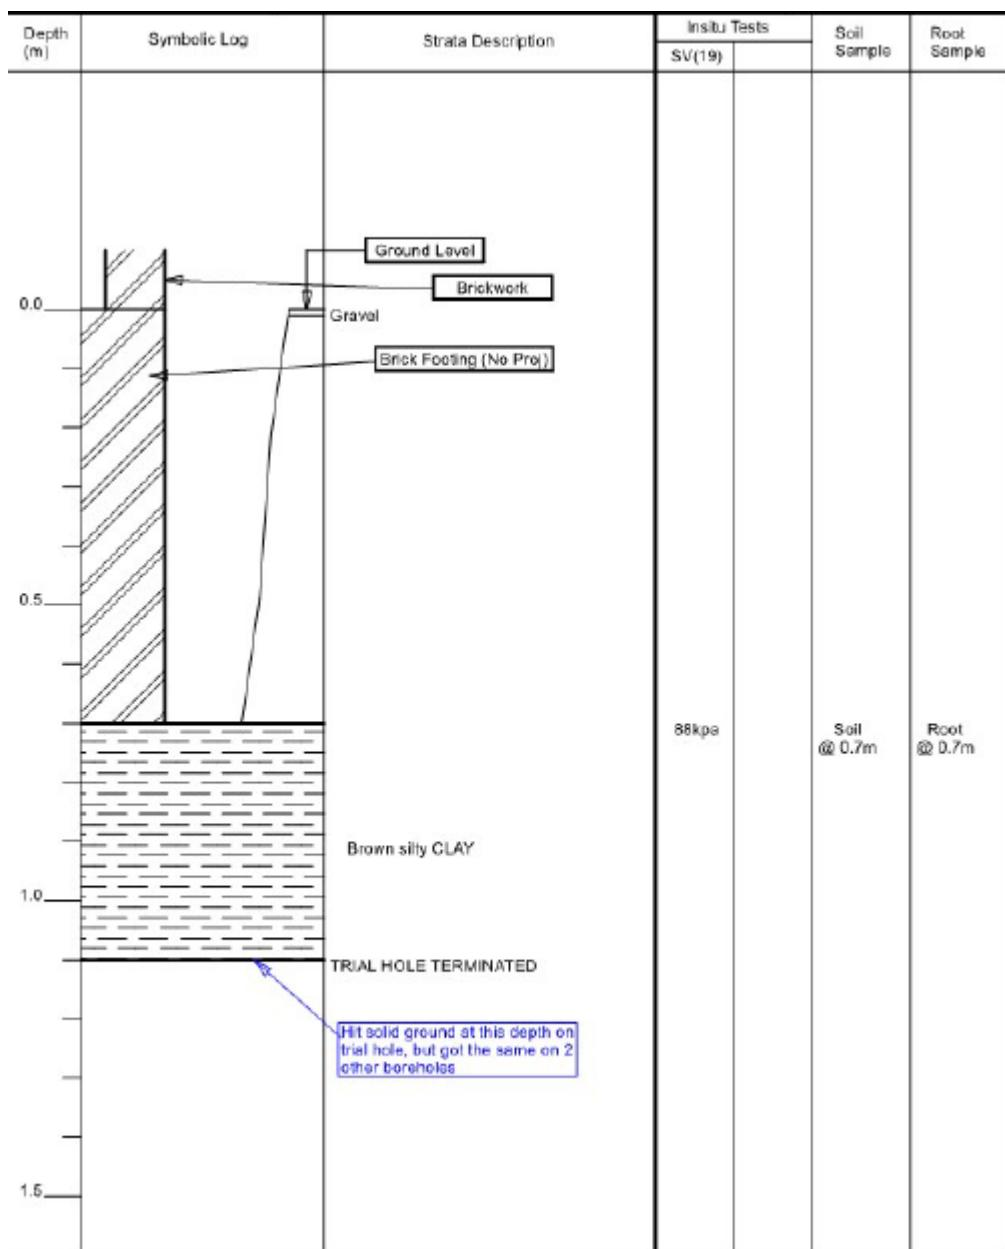
Extracts from Auger July 2020 report showing trial pit 1 details and soil descriptions

In trial pit/borehole 1 (front elevation) the moisture content tests indicate that the clay is desiccated down to 3500mm, as confirmed by moisture content values being less than 0.4 x liquid limit. The soil suction test values are high and indicate severe desiccation in the soil.

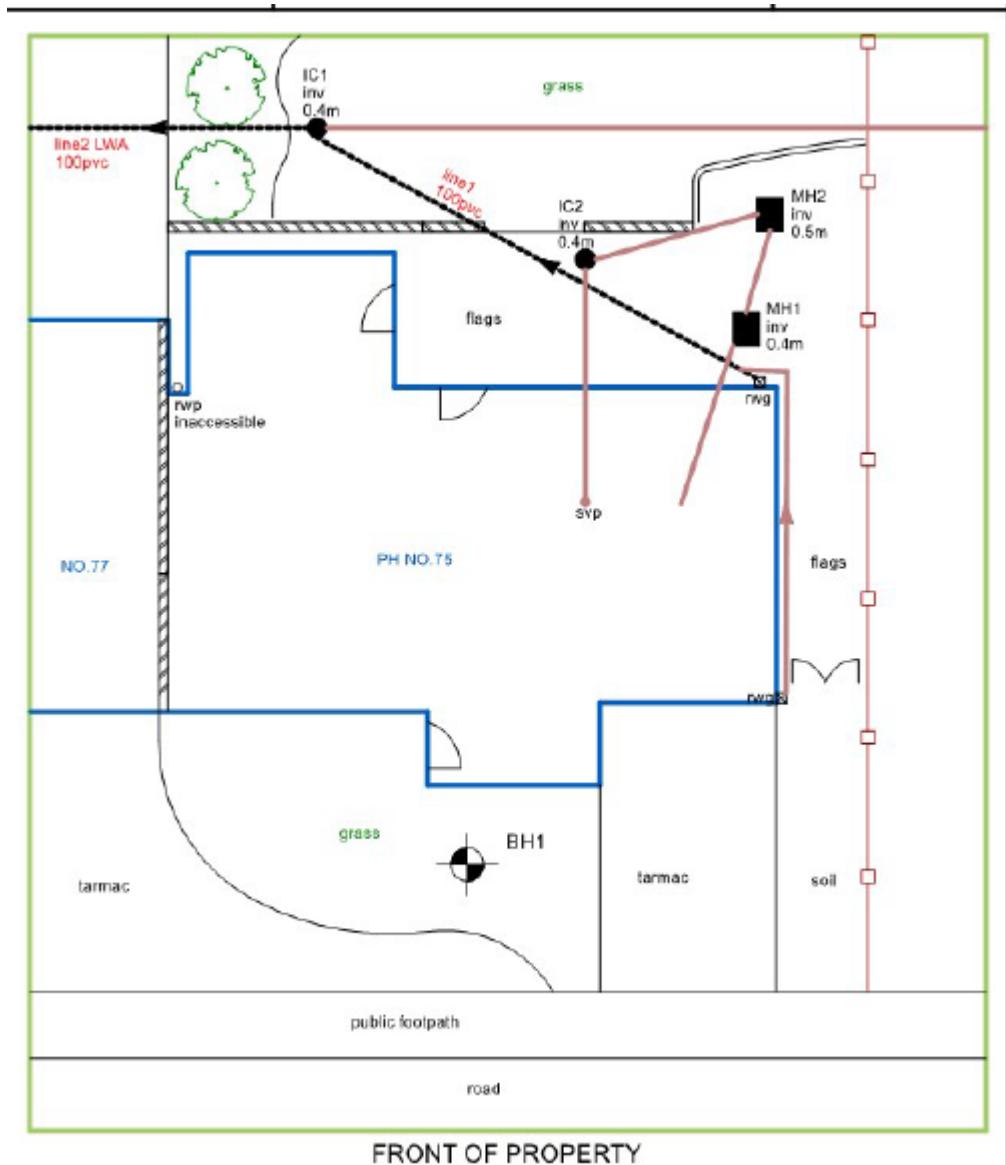
Extract from Auger December 2020 report showing location of remote borehole.

Roots were also observed in this borehole.

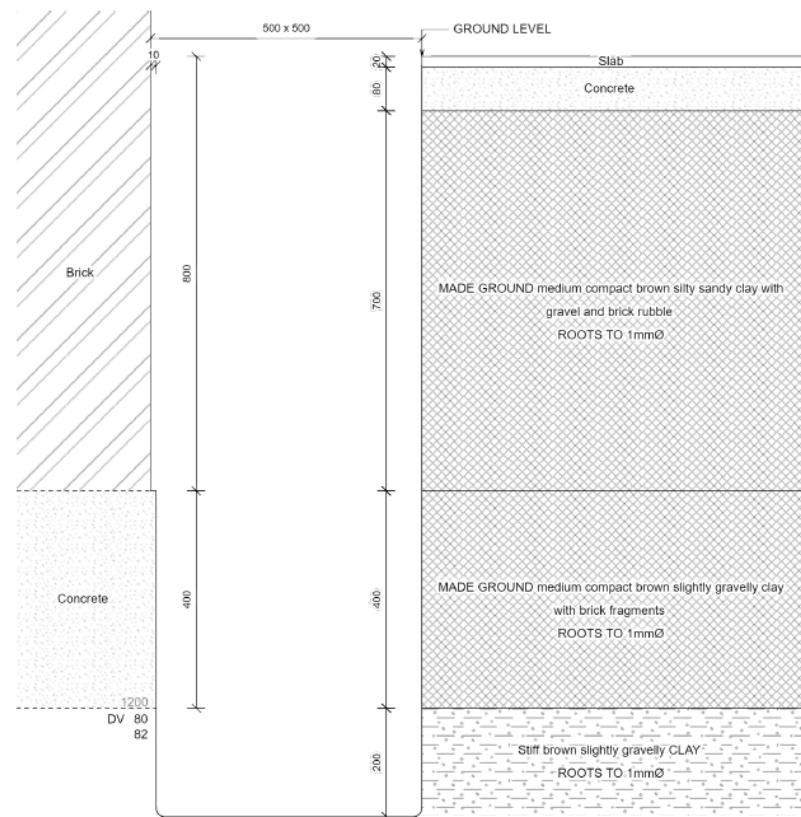
Extract from CET's report showing trial pit 2 details- Main House

Main House: A concrete foundation bearing at a depth of 1200mm below external ground level on to stiff brown slightly gravelly clay.

Roots were observed in the trial pit.

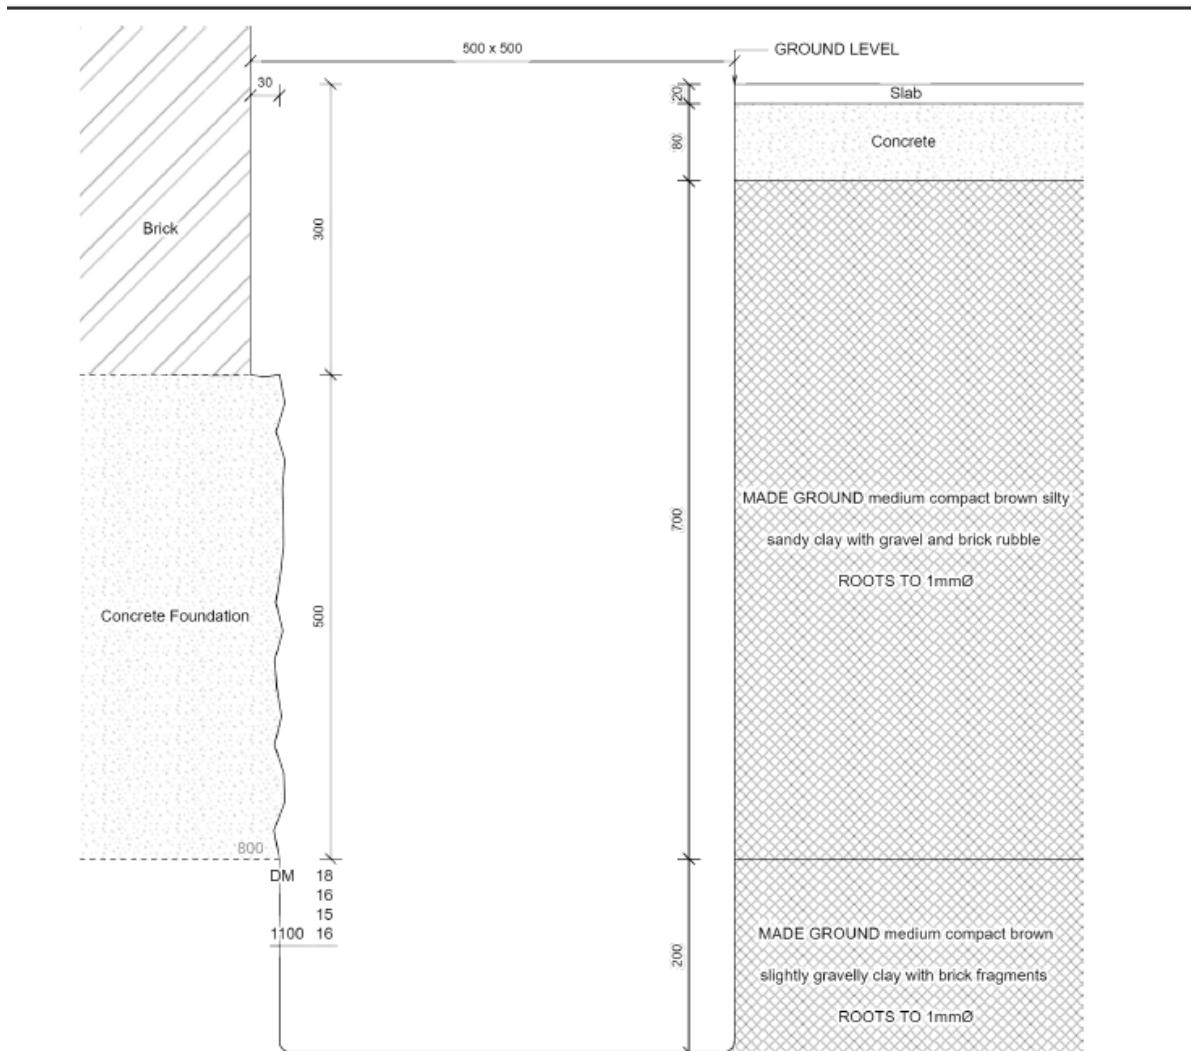
Extract from CET's report showing trial pit 2 details- Conservatory

Conservatory: A concrete foundation bearing at a depth of 800mm below external ground level on to made ground: medium compact brown slightly gravelly clay with brick fragments.

Roots were observed in the trial pit.

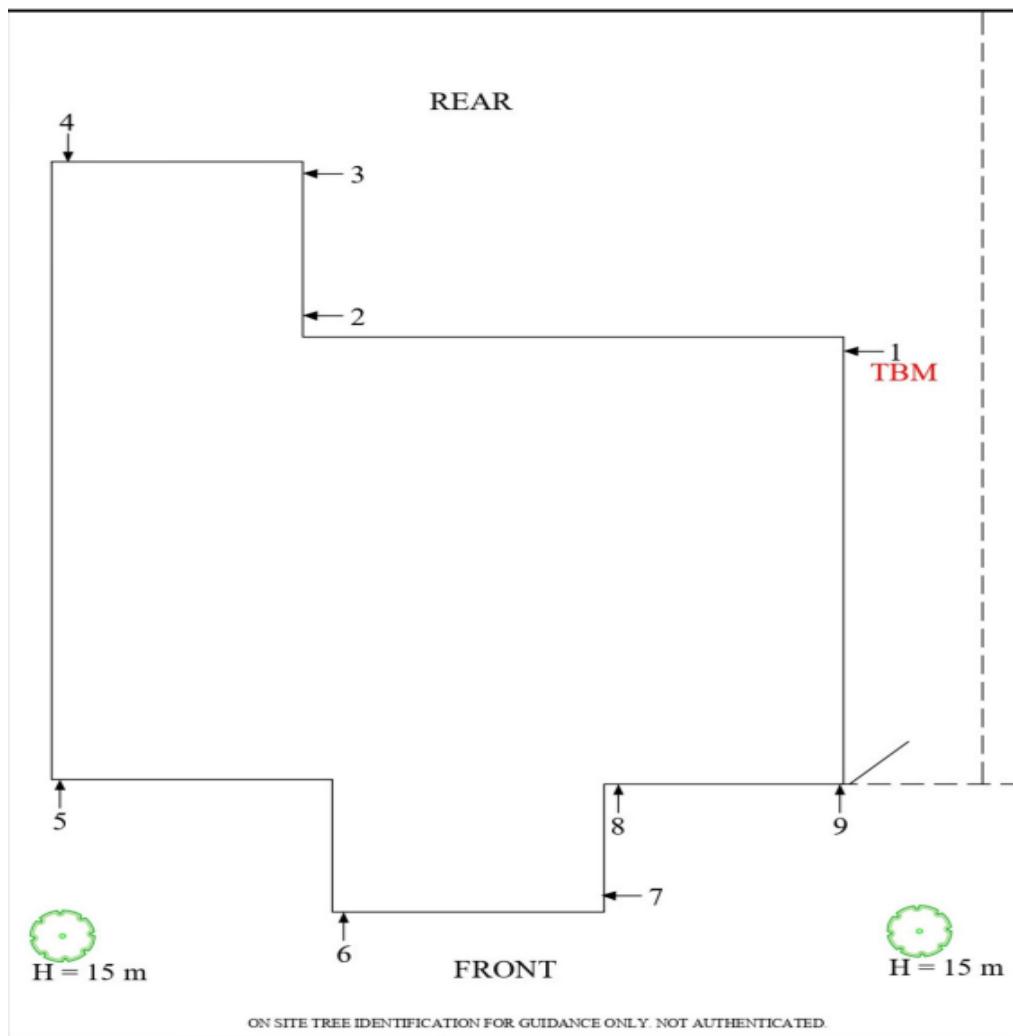
Extract from My Home Needs report showing location of monitoring stations

Stations 5, 6, 7, 8 and 9 are located on the front elevation where maximum damage has occurred.

Stations 1, 2, 3 and 4 are located on the rear wall of the rear elevation wall and conservatory where further damage has occurred. Stations 2, 3 and 4 are located around the conservatory which is the main area of concern to the rear.

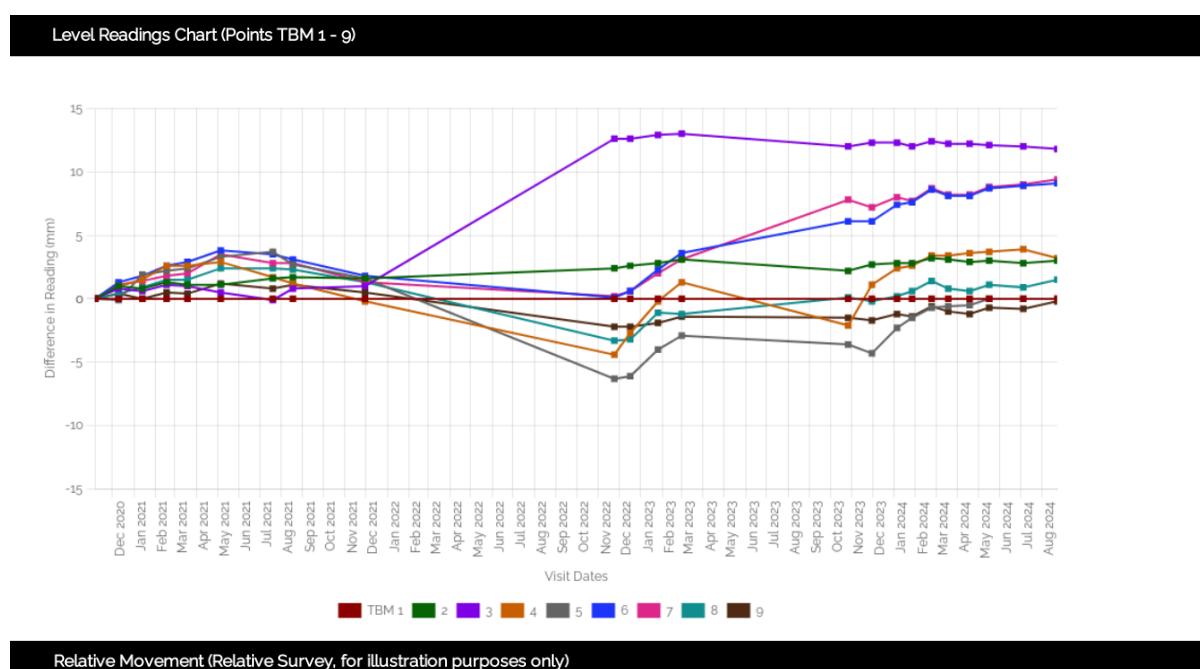
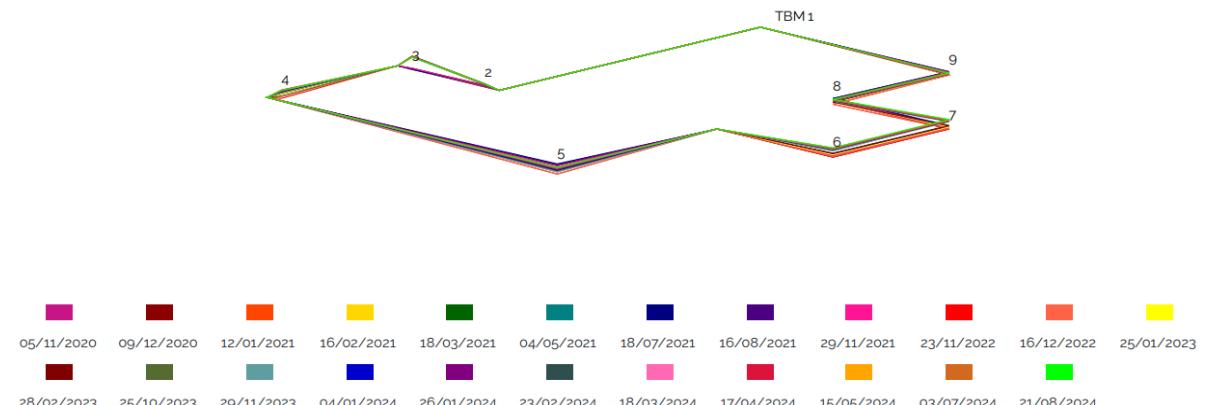
The level monitoring shows a cyclical pattern of downward movement during the drier summer months when the trees are in leaf, and subsequent upward movement during the wetter winter months when the trees have dropped leaf and are dormant. This pattern of movement is consistent with clay shrinkage subsidence.

The maximum movement is noted to the front left hand corner of the property and indicates a downward movement of 10mm between July 2021 and November 2022

The maximum movement noted to the rear left hand corner of the conservatory and indicates a significant rotational downward movement of 7.3mm between May 2021 and November 2022.

Full recovery was not achieved until March 2023.

It's worth noting that Geopolymer treatment works were completed in September 2022 and again retreated in October 2023 due to its failure. Although this has provided a degree of stabilisation borne out in the monitoring readings following the retreatment works its effectiveness has not yet been fully verified.
