# ARBORICULTURAL ASSESSMENT REPORT

For:	Client:	Sedgwick International UK
	Insurer:	[REDACTED]
Site:	Policyholder:	[REDACTED]
	Risk Address:	75 Ladygate Lane, Ruislip, HA4 7QX
Refs:	PRI Ref:	170183
	Client Ref:	9083963
	Insurer Ref:	[REDACTED]

Arborist Name:	Will Hinde	Date:	11/11/2020
QC:	Margaret MacQueen	Date:	19/11/2020

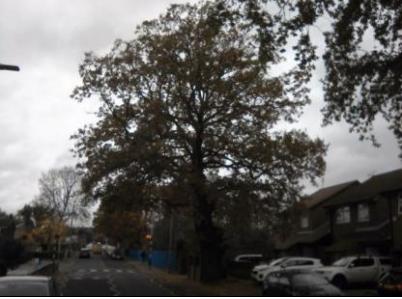
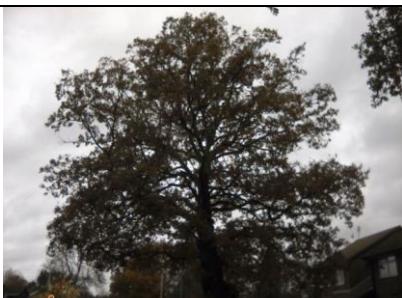
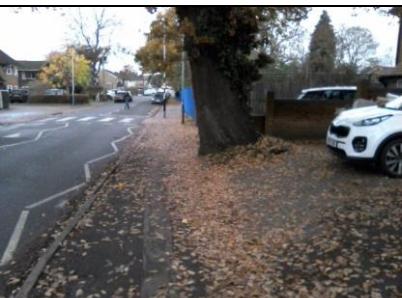
SG1 - Mixed species shrubs	T1 - Oak

T1 - Oak	T1 - Oak

Tree No:	Species	Works Required
T1	Oak	Fell and treat stump (deciduous).
T2	Oak	Fell and treat stump (deciduous).

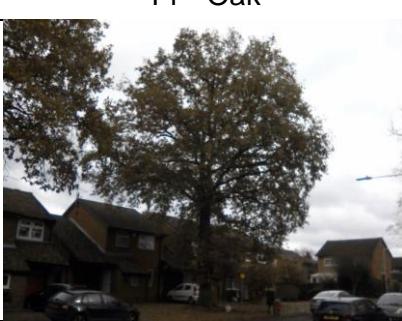
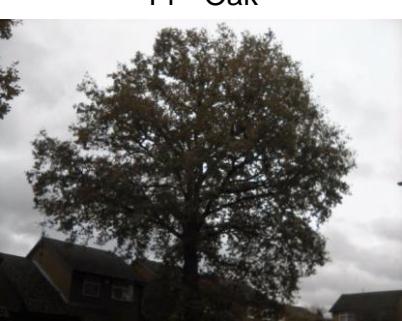
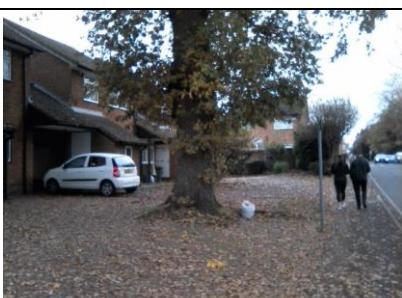
T2 - Oak	T2 - Oak

T2 - Oak	T3 - Poplar
