Site Investigation Report

102230.4.TSI

Client	Sedgwick International UK
Client ref	8767150
Visit date	09/07/2020
Report date	09/07/2020

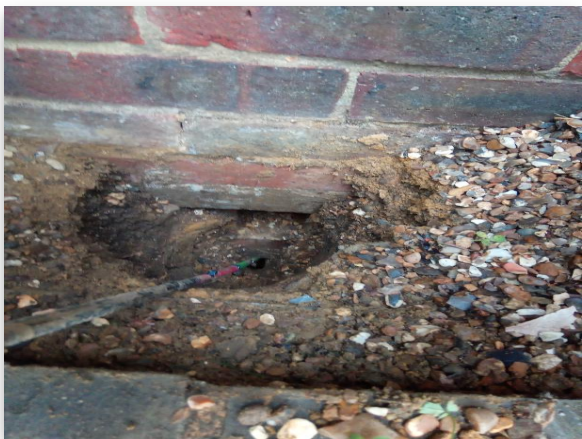
Fig 1.2: Trial Hole 1 Footing

We were unable to reach the required depth on TH1 because solid ground was encountered at a depth of 1.1 meters, we carried out a further two remote boreholes and encountered the same issue at the depth of a meter.

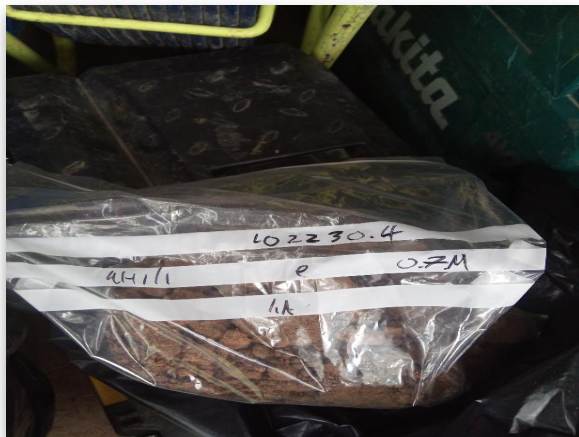
Fig 7.3: Soil Sample Taken

We were unable to collect all soil samples from TH1 due to not being able to reach the required depth, only one soil sample has been taken.

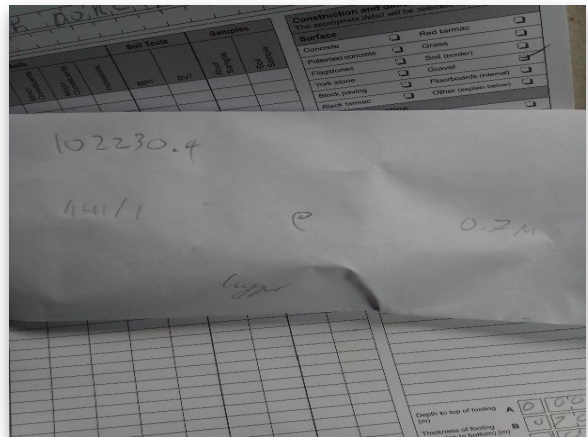
Fig 7.4: Root Sample Taken

We took one root sample in TH1 that we found before encountering solid ground.

TH1, 0.7m		
9 no.	Examined root: QUERCUS (Oak).	Alive, recently*.
2 no.	Both pieces of BARK only - insufficient material for recognition.	
3 no.	Unfortunately all with insufficient cells for identification.
