## Addendum Arboricultural Report

### Subsidence Damage Investigation at:

Flats 1 & 3 Uplands Court  
19 Frithwood Avenue  
Northwood  
HA6 3LY

| MWA REF: | SUB200116-6580 REV01 |

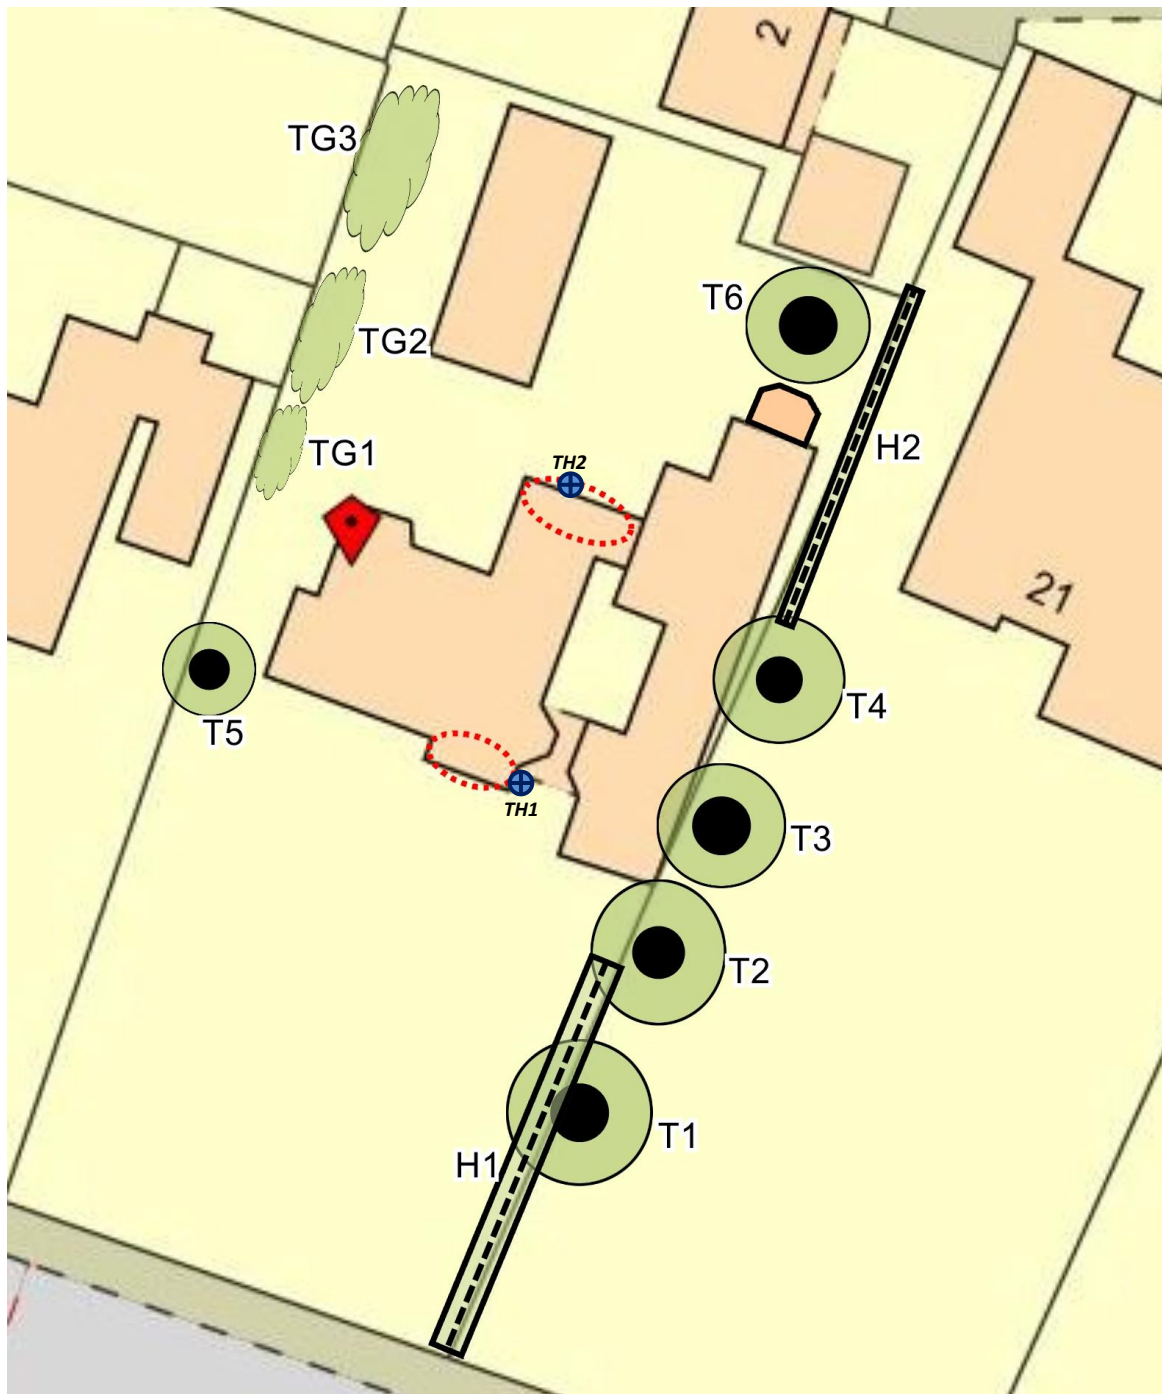
Approximate areas of damage

If an arboricultural solution is to be implemented to mitigate the influence of the implicated trees we now recommend that T2, T5 and TG2 are removed and T1 reduced.

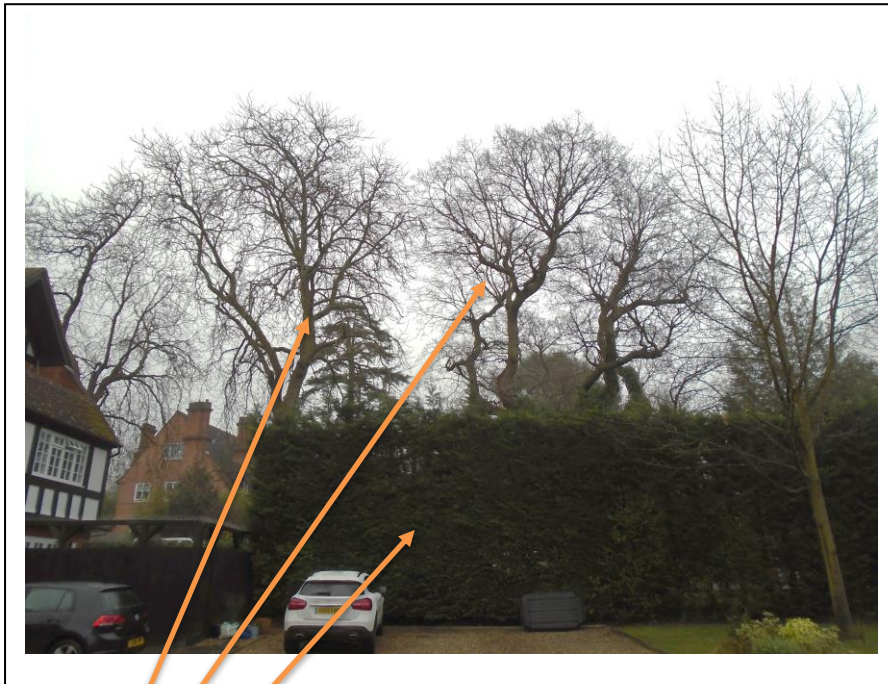
Our initial report noted that despite no positive identification of roots from T2, due to its size and proximity to the area of damage, its roots were also likely to be present below foundation level in proximity to the area of movement/damage and influencing soil moisture and volumes.

The oak roots recovered in the second site investigation will originate from T1. This tree was originally recommended for reduction as a future risk. In view of the positive root identification works to this tree are now moved to current claim works.

| Tree No. | Species | Ht (m) | Dia (mm) | Crown Spread (m) | Dist. to building (m) | Age Classification | Ownership |
|---|---|---|---|---|---|---|---|
| T1 | Oak | 15.5 * | 1000 * | 11 * | 15 * | Older than Property | Third Party<br>21 Frithwood Ave<br>HA6 3LY |
| T2 | Horse Chestnut | 15 | 750 | 12 * | 5 | Older than extension | Third Party<br>21 Frithwood Ave<br>HA6 3LY |

| Tree No. | Species | Ht (m) | Dia (mm) | Crown Spread (m) | Dist. to building (m) | Age Classification | Ownership |
|---|---|---|---|---|---|---|---|
| H1 | Cypress | 4.25 | Ms | 2 | 5 | Younger than Property | Policy Holder |

View of T2, T1 and H1

| Tree No. | Species | Ht (m) | Dia (mm) | Crown Spread (m) | Dist. to building (m) | Age Classification | Ownership |
|---|---|---|---|---|---|---|---|
| Recommendation | | Reduce height by 1.5m and crown radius by 1m to previous pruning points. Prune on a triennial cycle to maintain at broadly reduced dimensions. | | | | | |
| Recommendation | | Remove (fell) to near ground level. Owner to physically remove any regrowth (no chemical treatment due to translocation risk). | | | | | |

| Tree No. | Species | Ht (m) | Dia (mm) | Crown Spread (m) | Dist. to building (m) | Age Classification | Ownership |
|---|---|---|---|---|---|---|---|
| Recommendation | | Maintain broadly at no more than current dimensions by periodic pruning. | | | | | |

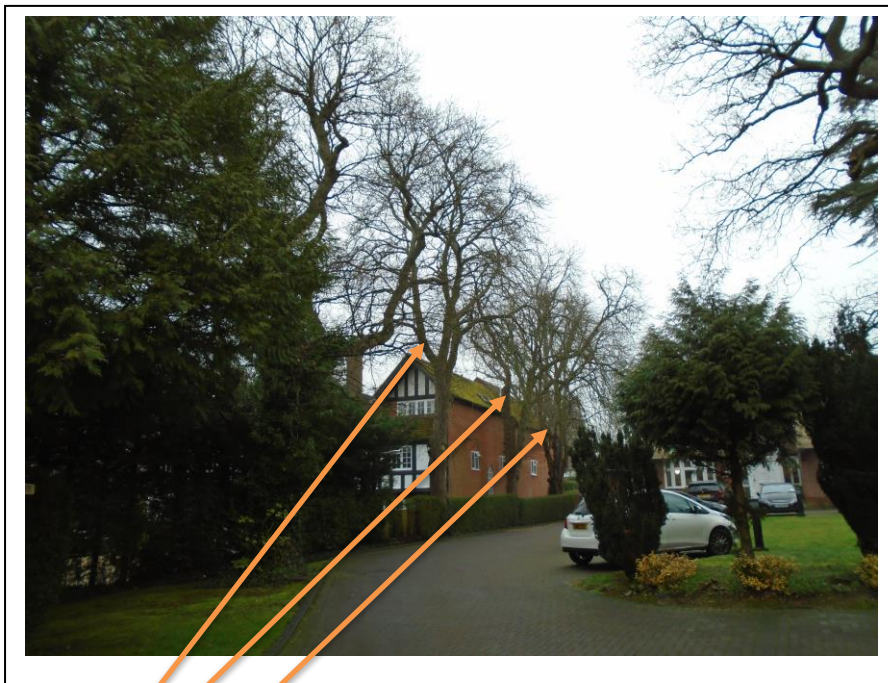
The second site investigation recovered Aesculus roots to 2.1m depth and whilst the borehole was slightly offset from the building, it is highly likely that the roots from this tree are present below the foundations.

Trees T3 and T4 (chestnut) are also within influencing distance of the original house and the Aesculus roots identified may originate from one or both these trees. However, on balance we consider it likely that T2 is the most significant of the chestnuts with respect to the damage at the front right of the original house.

| Tree No. | Species | Ht (m) | Dia (mm) | Crown Spread (m) | Dist. to building (m) | Age Classification | Ownership |
|---|---|---|---|---|---|---|---|
| T3 | Horse Chestnut | 12 * | 650 * | 11 * | 2.75 * | Older than extension | Third Party<br>21 Frithwood Ave<br>HA6 3LY |
| T4 | Horse Chestnut | 13 * | 750 * | 9 * | 3 * | Older than extension | Third Party<br>21 Frithwood Ave<br>HA6 3LY |

View of T2, T3 and T4

| Tree No. | Species | Ht (m) | Dia (mm) | Crown Spread (m) | Dist. to building (m) | Age Classification | Ownership |
|---|---|---|---|---|---|---|---|
| Recommendation | | Maintain broadly at no more than current dimensions | | | | | |

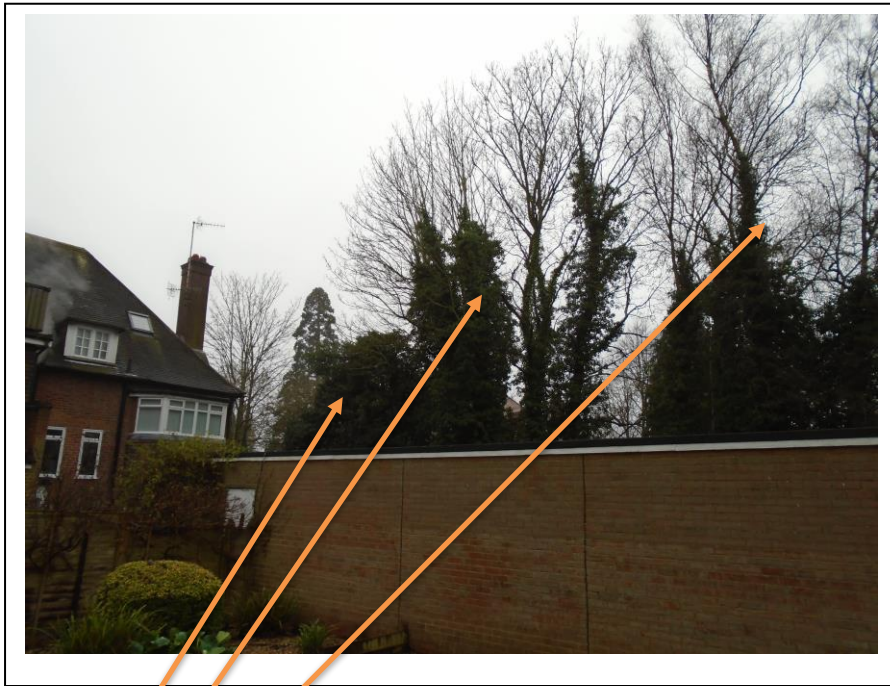
The Acer roots noted at a depth of 1m in TH2 (first site investigation) will originate from the trees within TG2.

| Tree No. | Species | Ht (m) | Dia (mm) | Crown Spread (m) | Dist. to building (m) | Age Classification | Ownership |
|---|---|---|---|---|---|---|---|
| TG2 | Sycamore | 12.5 * | Ms<br>300 * | 12 | 10 * | Younger than Property | Policy Holder |

| Tree No. | Species | Ht (m) | Dia (mm) | Crown Spread (m) | Dist. to building (m) | Age Classification | Ownership |
|---|---|---|---|---|---|---|---|
| TG1 | Prunus | 8 | Ms<br>250 * | 5 | 6.5 * | Younger than Property | Policy Holder |
| TG3 | Birch | 13 * | 250 * | 7 * | 14 * | Younger than Property | Policy Holder |

View of TG1, TG2 and TG3

| Tree No. | Species | Ht (m) | Dia (mm) | Crown Spread (m) | Dist. to building (m) | Age Classification | Ownership |
|---|---|---|---|---|---|---|---|
| Recommendation | | Remove (fell) to near ground level and treat stump to inhibit regrowth. | | | | | |

| Tree No. | Species | Ht (m) | Dia (mm) | Crown Spread (m) | Dist. to building (m) | Age Classification | Ownership |
|---|---|---|---|---|---|---|---|
| Recommendation | | Do not allow to exceed current dimensions. | | | | | |
| Recommendation | | None at present | | | | | |

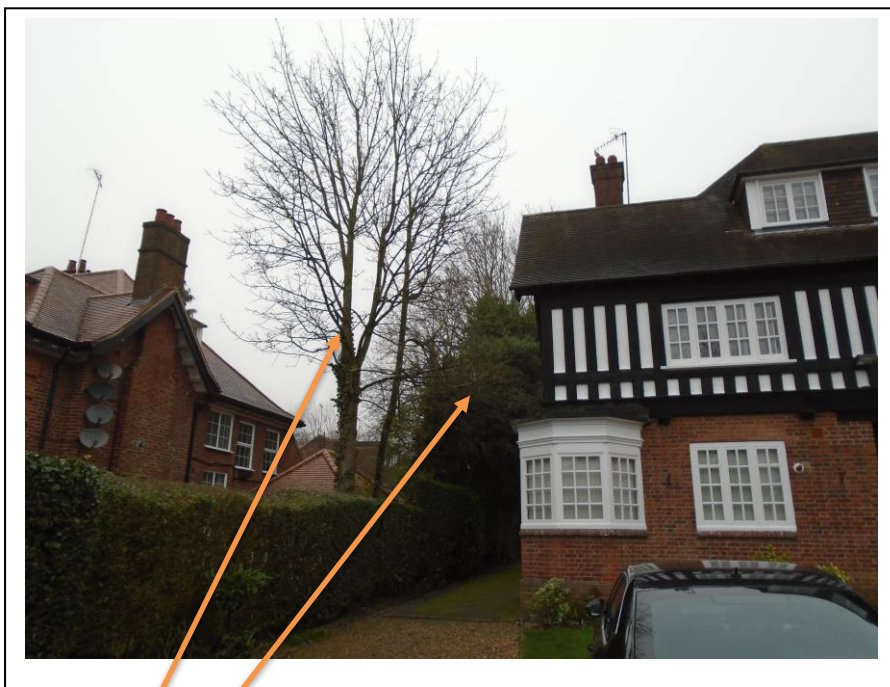
Level monitoring recorded significant downward movement during the summer of 2020 followed by uplift (recovery). This pattern of movement is consistent with the seasonal influence of vegetation on soil moisture and volumes. In view of the movement to the right of the original house the recommended removal of T5 is now moved to current claim works.

| Tree No. | Species | Ht (m) | Dia (mm) | Crown Spread (m) | Dist. to building (m) | Age Classification | Ownership |
|---|---|---|---|---|---|---|---|
| T5 | Sycamore | 11 * | Ms<br>250 * | 7 * | 3 | Younger than Property | Policy Holder |

View of T5 and TG1

| Tree No. | Species | Ht (m) | Dia (mm) | Crown Spread (m) | Dist. to building (m) | Age Classification | Ownership |
|---|---|---|---|---|---|---|---|
| Recommendation | | Remove (fell) to near ground level and treat stump to inhibit regrowth. | | | | | |
