Site Investigation Report

97316.1.USI

Auger were commissioned by Crawford & Co to undertake a site investigation and CCTV inspection of the underground drainage within the area of concern at the property.

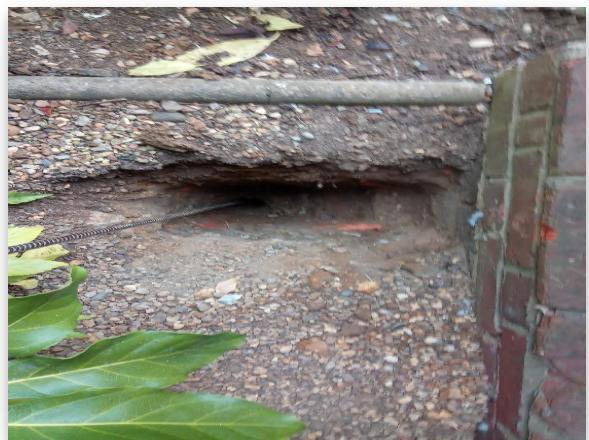
Fig 1.2: Trial Hole 1 Footing

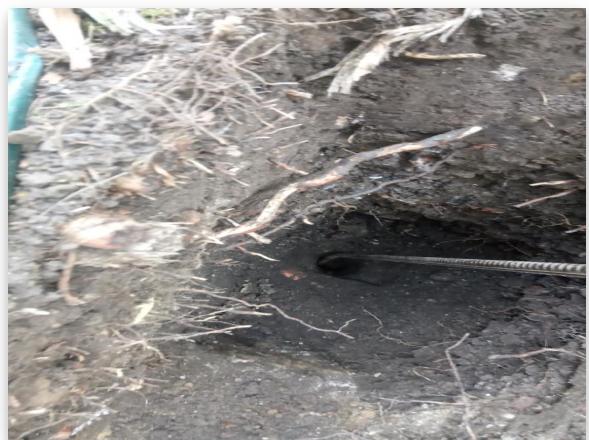
Fig 2.2: Trial Hole 2 Footing

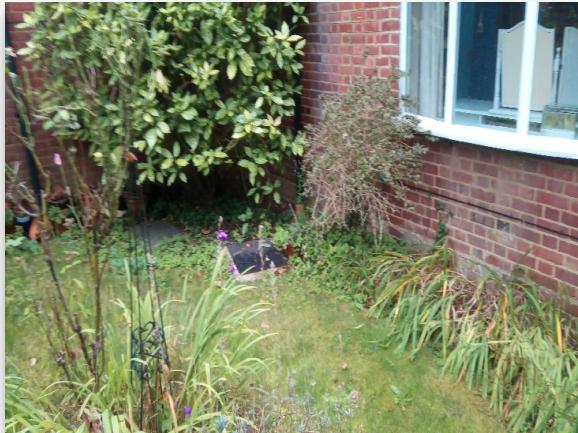
Fig 3.1: Location of manhole 3 (small tree in corner may need to be cut back)

Repairs	<p>We believe repairs are needed on lines 3 and 5.</p> <p>Please see the proposed layout below for details of our repair recommendations.</p> <p>PLEASE NOTE - The small tree located next to manhole 3 (please see Fig 3.1 below) may need to be cut back in order to facilitate access for the repair works.</p>
Maintain System	<p>We noted root ingress within the chambers of manhole 2 and manhole 3 (please see Fig 3.4 below). However, this is not currently affecting the function of the drains.</p> <p>We recommend that the customer undertakes regular inspections of all manholes and removes any roots which could potentially obstruct the flow of waste in the future. Please note that this is classed as a maintenance issue and would not normally be covered under policy terms.</p>
Water Retention on Line 3	<p>Please note that due to the relatively constant level of water retention on line 4, we believe that this could be the result of an underlying issue of poor fall in the pipework. Any works to resolve a falls issue would be classed as betterment and would not normally be covered under policy terms.</p> <p>The customer may wish to undertake private works to have the pipework on line 4 re-laid to try and achieve adequate fall. However, this issue does not currently appear to be affecting the function of the drain. Furthermore, since the line is holding water, it therefore cannot be escaping in the area of concern.</p>

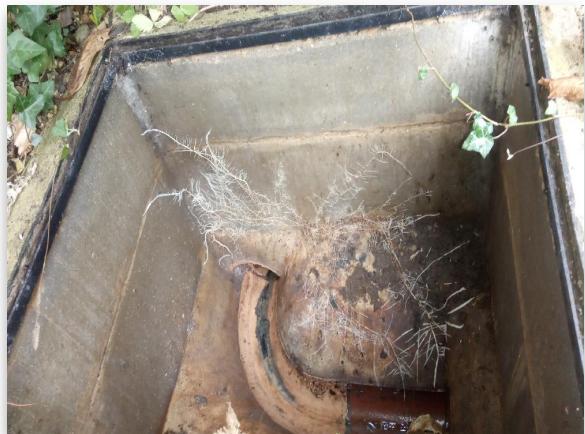
Fig 3.4: Manhole 3 (root ingress in chamber)

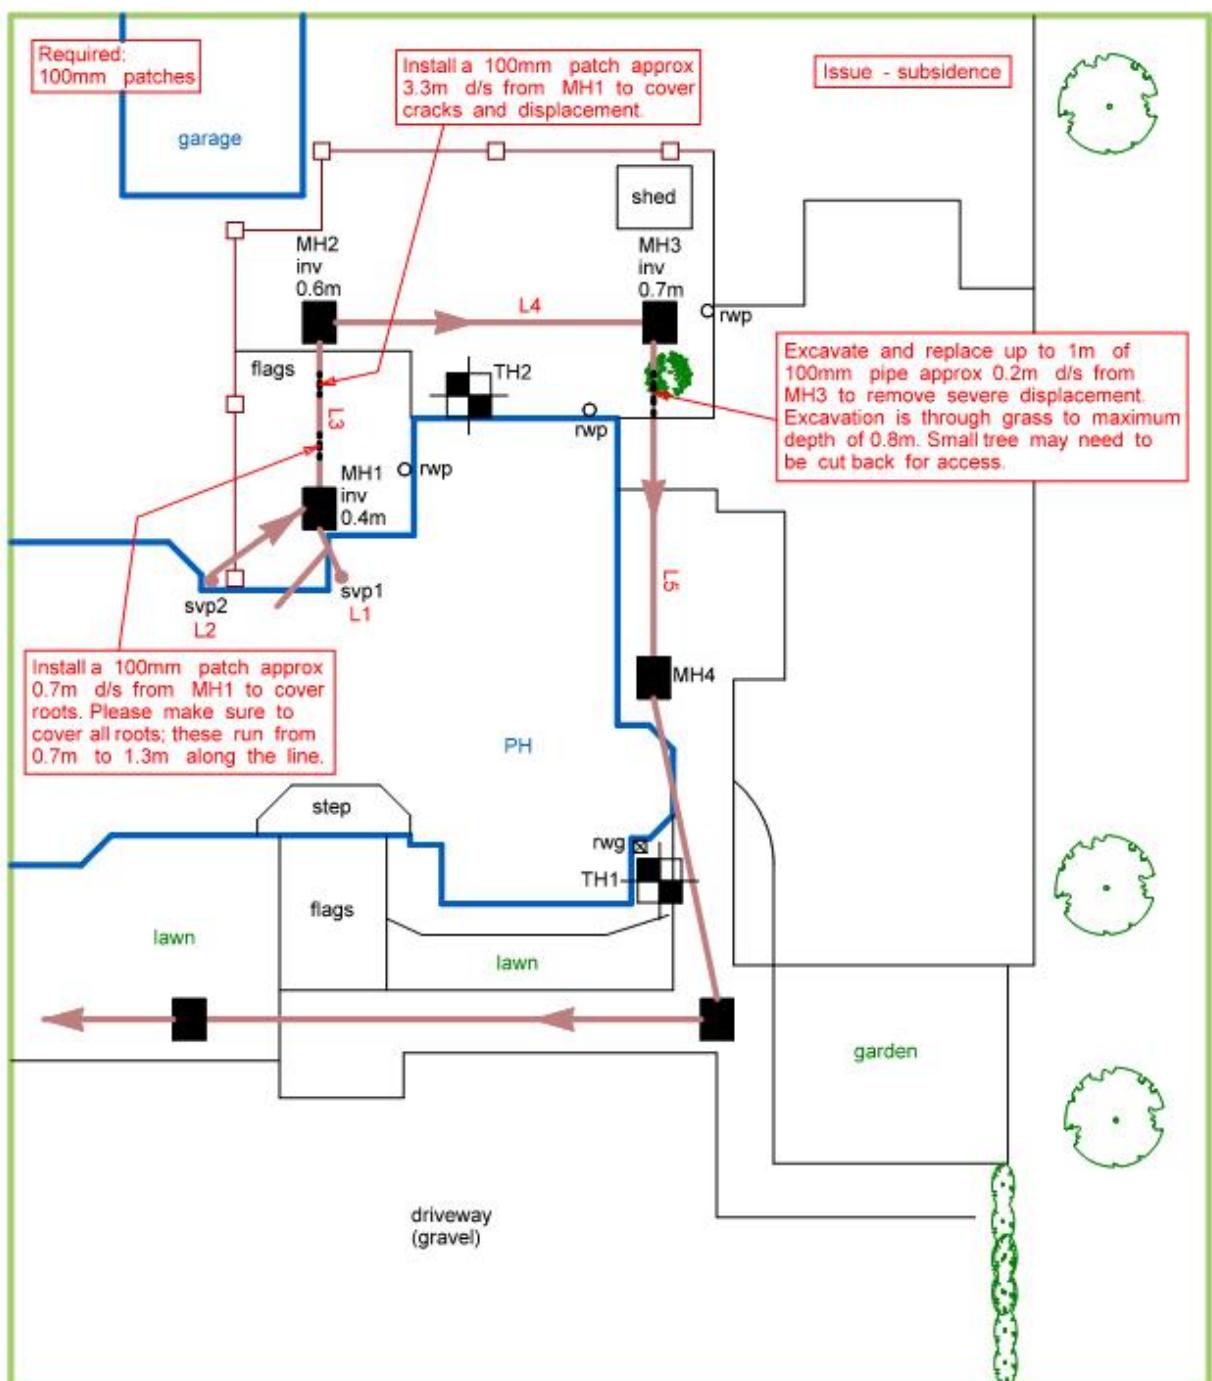
FRONT OF PROPERTY

Our survey revealed cracking and root ingress in the pipework.

Our survey revealed a severe joint displacement approximately 0.2m downstream from manhole 3.
