Site Investigation Report

97316.5.TSI

Client	Crawford & Co
Client ref	SU1903345
Visit date	26/03/2021
Report date	31/03/2021

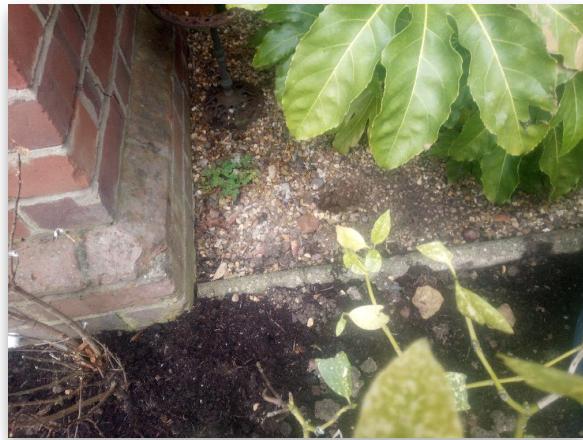
Fig 1.1: Trial Hole 1 Location - Next to original trial hole location
