## SITE INVESTIGATION FACTUAL REPORT

Report No: SI-494735

Site: 14 Watford Road  
Hillingdon

Date of Visit: 11/8/2022

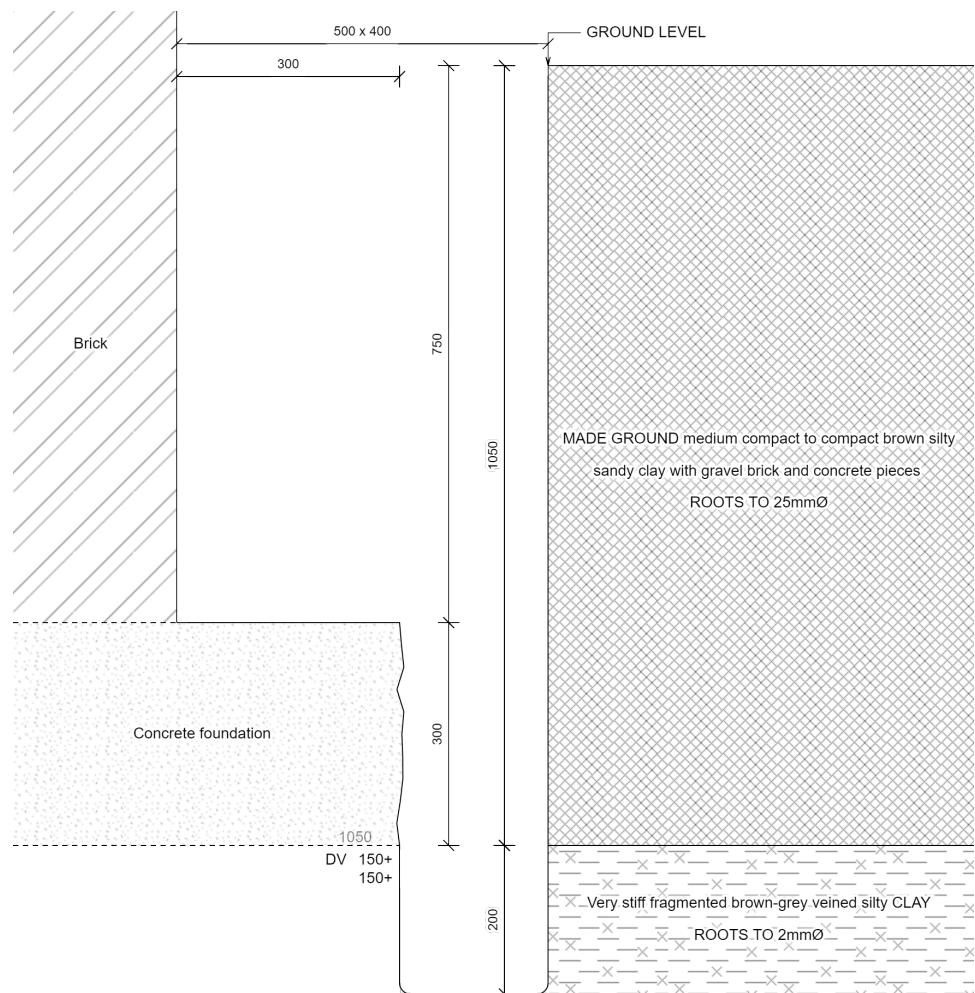
**TRIAL PIT REF:** TP1

House and bay have same foundation.

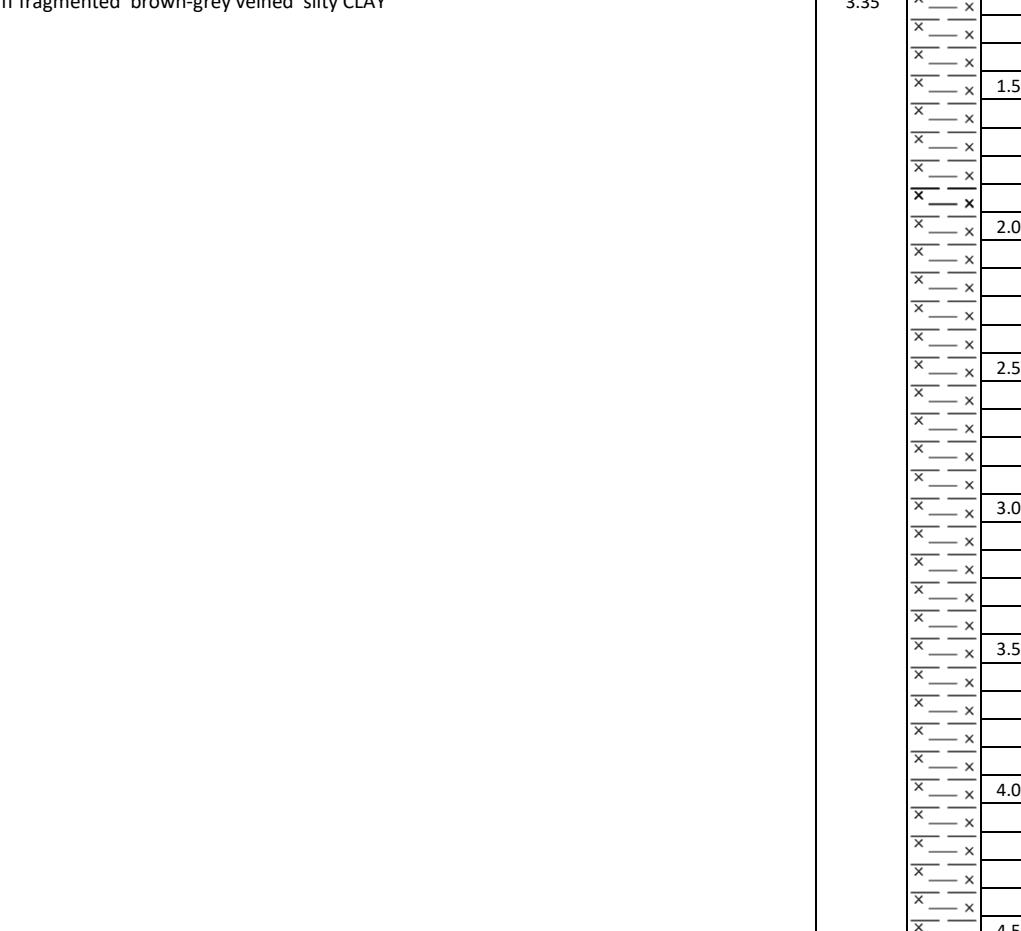
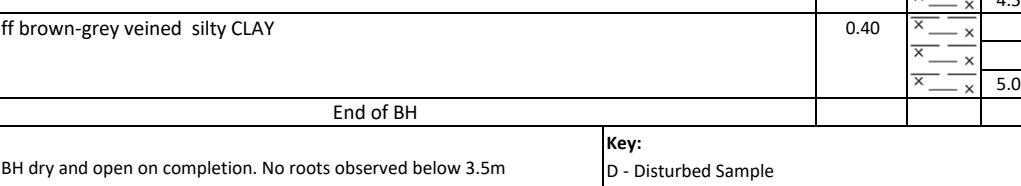
Borehole		1		Sheet:	1 of 1	Site:	14 WATFORD ROAD			
Boring Method:		Hand Auger		Ground Level:			SEDGWICK INTERNATIONAL UK			
Diameter (mm):		75	Weather:	dry						
Depth	Soil Description							Samples and Tests		
(m)								Thickness	Legend	
0.00	See Trial Pit							1.25		
1.25	Very stiff fragmented brown-grey veined silty CLAY							3.35

4.60	Very stiff brown-grey veined silty CLAY							0.40

5.00	End of BH									
Remarks: BH ends at 5.0m, BH dry and open on completion. No roots observed below 3.5m					<b>Key:</b> D - Disturbed Sample B - Bulk Sample W - Water Sample J - Jar Sample V - Pilcon Shear Vane (kPa) M - Mackintosh Probe TD - Too Dense To Drive			To Depth	Max Dia (m) (mm)	
								3.50	1	
					</
