ARBORICULTURAL ASSESSMENT REPORT

Risk Address: 14 Watford Road, Northwood, Middlesex, HA6 3NR

**PRI Ref:** 240503

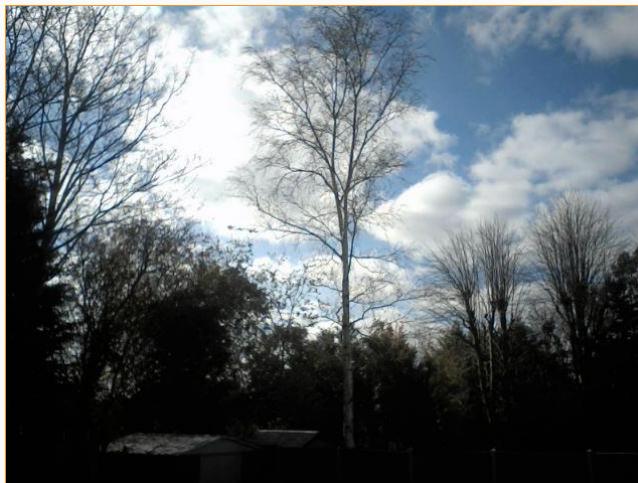
T1 - Birch

Tree No	Common Name	Age Class	Condition	Height (m)	Crown Spread (m)	Stem diam. (mm)	Dist to bldg. (m)	Roots Implicated	Pruning history	Recommendation	Tree work constraints	Notes	Owner address	Owner
T1	Birch	Mature	Fair	14.7	3.0*	250	11.5	N	Subject to past management.	No work required.		checked and agreed 16/9/22.	12 Watford Road Northwood Middlesex HA6 3NR	P3P
T2	Oak	Mature	Fair	17.3	14*	1080	16.1	Y	Subject to past management, but not been reduced as per 2019 recommendation. checked 16/9/22	Fell and treat stump.	TPO. parking on drive.	Oak roots implicated. influencing distance is between 13 and 30 metres. TPO tree. recommended 16/9/22	12 Watford Road Northwood Middlesex HA6 3NR	P3P
TG1	Mixed species group	Mature	Fair	13.6	3.50*	300	1*	N	Subject to recent management.	No work required.		Species include cypress, hawthorn, privet, holly, and beech. Checked and agreed 16/9/22	16 Watford Road Northwood Middlesex HA6 3NR	P3P

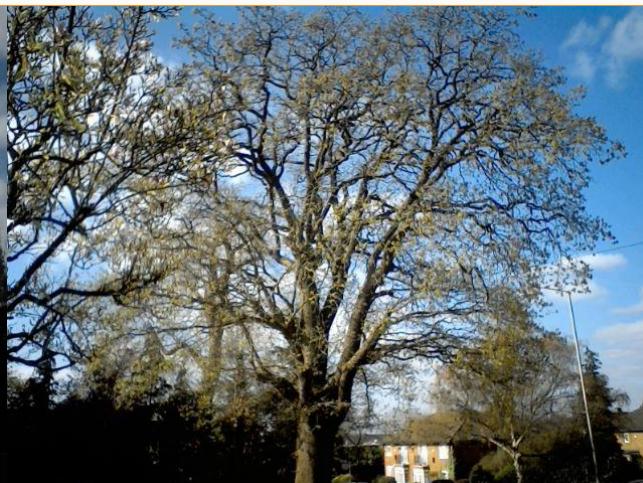
T2 - Oak

London borough Hillingdon council's website has confirmed that the implicated Oak vegetation is subject to a Tree Preservation Order and there are no Conservation Area controls.

Tree No:	Species	Works Required
T2	Oak	Fell and treat stump.

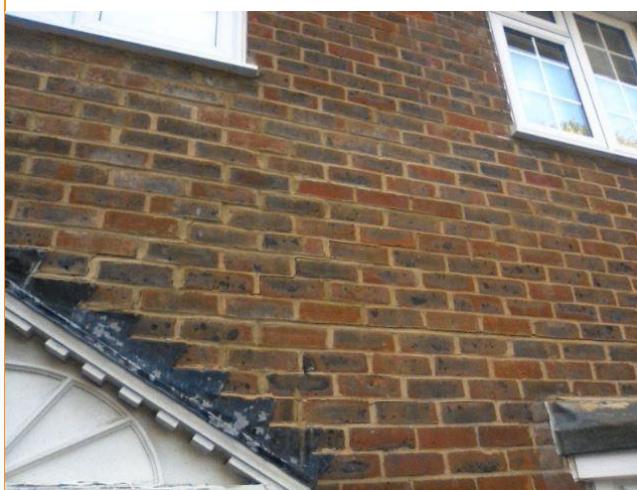
Return of damage - front elevation
