## Asbestos Survey: Refurbishment & Demolition

**Waterloo wharf.  
Uxbridge,  
UB8 2QX.**

**Howarth Homes.  
54 Oxford Road  
Uxbridge  
UB9 4DN**

**00522/DL  
3rd July 2017.  
5<sup>TH</sup> July 2017.**

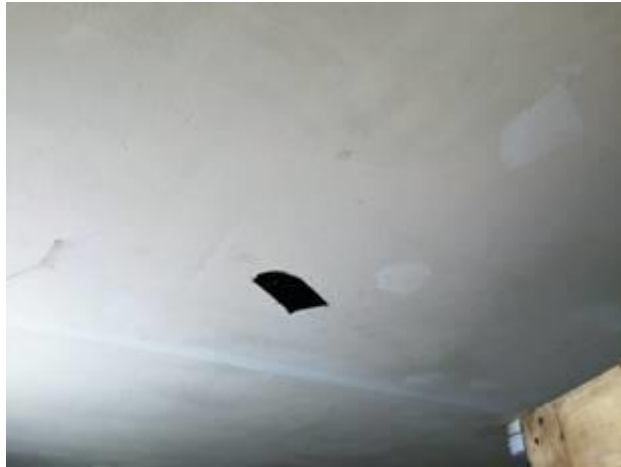
| Sample No. | 1 | Survey Type | Refurbishment/Demolition |

| Product | Ceiling panels | Product Type | AIB |
| Area | Basement ceiling | Damage | None |
| Floor | Basement | Asbestos Type | Chrysotile & Amosite |
| Room | Basement | Mat Risk Score | 8 |
| Asbestos? | Yes | Quantity | Throughout basement |

Action/Notes :Remove by licensed contractor

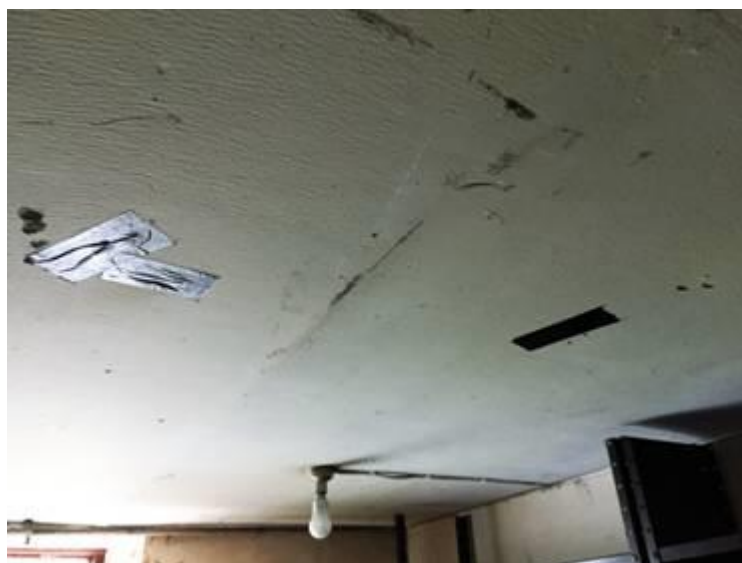
| Sample No. | 2 | Survey Type | Refurbishment/Demolition |

| Product | Ceiling panels | Product Type | AIB |
| Area | Basement ceiling | Damage | None |
| Floor | Basement | Asbestos Type | Chrysotile & Amosite |
| Room | Basement | Mat Risk Score | 8 |
| Asbestos? | Yes | Quantity | Throughout basement |

Action/Notes :Remove by licensed contractor

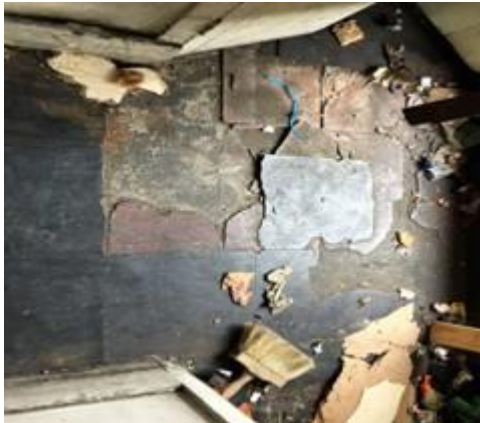
| Sample No. | 3 | Survey Type | Refurbishment/Demolition |

| Product | Floor tiles | Product Type | Asbestos composite |
| Area | Basement floor | Damage | None |
| Floor | Basement | Asbestos Type | Chrysotile |
| Room | Basement | Mat Risk Score | 3 |
| Asbestos? | Yes | Quantity | Throughout basement |

Action/Notes :Remove by competent person

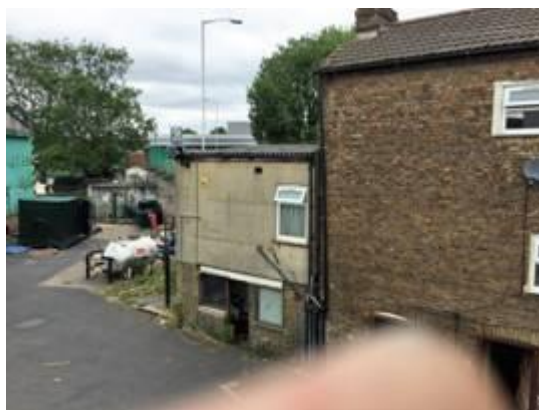
| Sample No. | NA | Survey Type | Refurbishment/Demolition |

| Product | Roof Sheets | Product Type | Asbestos cement |
| Area | Lodge roof | Damage | None |
| Floor | Roof | Asbestos Type | Chrysotile |
| Room | External | Mat Risk Score | 4 |
| Asbestos? | Yes | Quantity | 25m2 |

Action/Notes :Remove by competent persons
