Ground Investigation Factual Report

Site Address: 17-20 Meadway Gardens, Ruislip, Middlesex, HA4 7QP

Project No.: HH/24/70996

Issue Date: July 2024

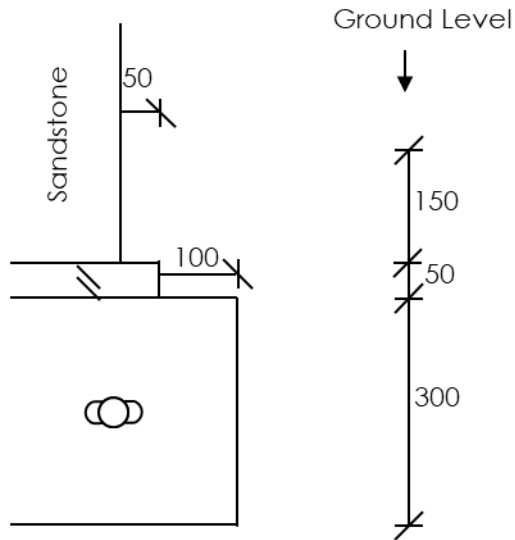
TP/BH1 Foundation Detail

For strata information, please refer to borehole log TPBH1.

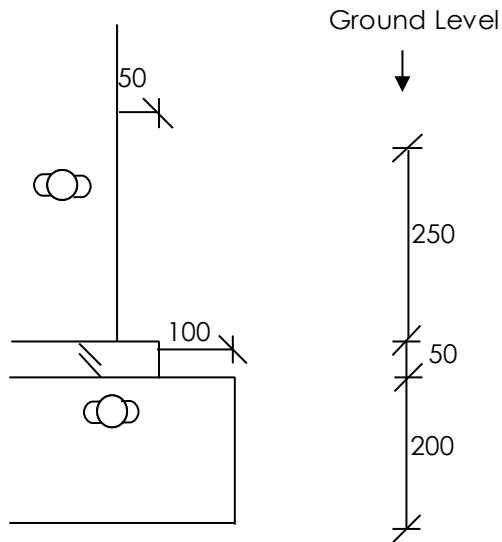
TP/BH2 Foundation Detail

For strata information, please refer to borehole log TPBH2.

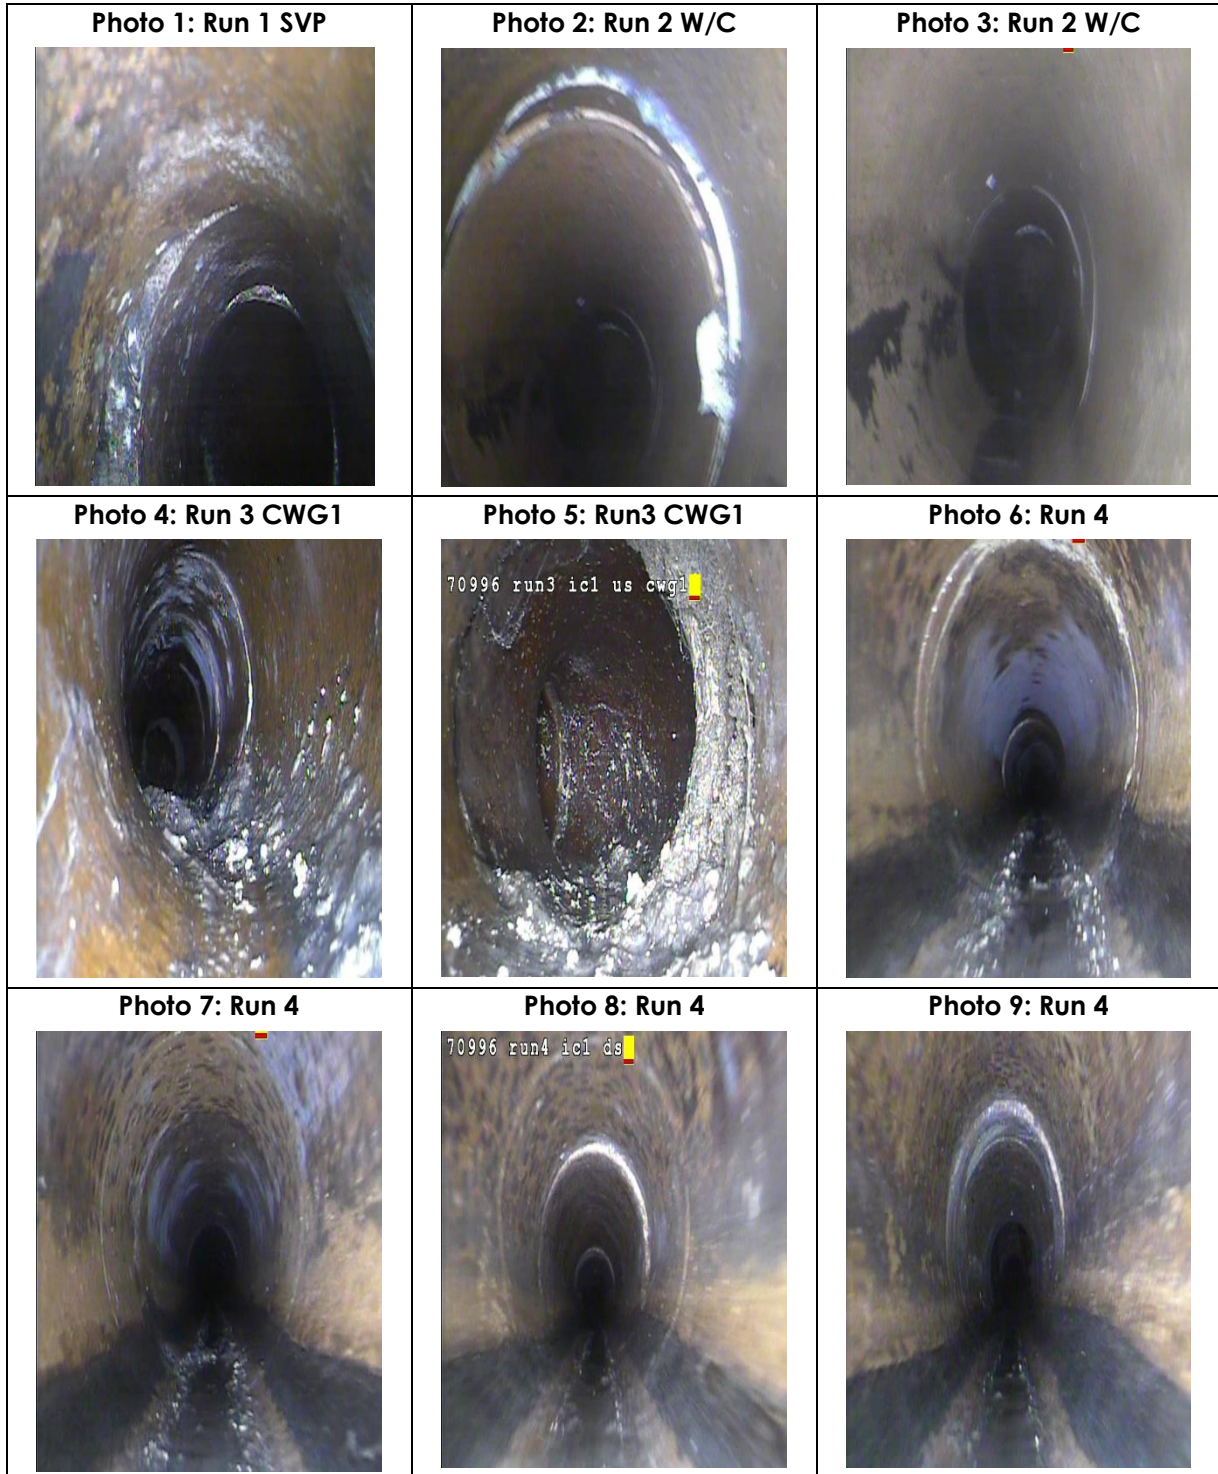
Photograph

The drain is made of V/C. Defects were identified within the drain run. Please refer to photo 1 within the report.

The drain is made of V/C. Defects were identified within the drain run. Please refer to photos 2 and 3 within the report.

The drain is made of V/C. Defects were identified within the drain run which include root infiltration. Please refer to photos 4 and 5 within the report.

0.1	JDM:				Grade 2	Photo 1	
0.3	LU: 90°					Rest Bend	
0.3	FH:						
Run: 2	Dir: U/S	Pipe Dia(mm):	100	System:	F/W	Made Of:	V/C
From:	I/C 1	Inv(m):	0.5	To:	W/C	Inv(m):	Internal
Metres	Faults/Defects				Internal Condition Grading	Remarks	
0	ST:						
0	WL: 0%						
0	LL: Slow 15° Bend

0.48	FC: 11 o'clock to 5 o'clock				Grade 3	Photo 2	
0.75	FC: 11 o'clock to 5 o'clock				Grade 3	Photo 3	
1.18	LU: 90°					Rest Bend	
1.5	FH:					Top of the Rest Bend	
Run: 3	Dir: U/S	Pipe Dia(mm):	100	System:	C/W	Made Of:	V/C
From:	I/C 1	Inv(m):	0.5	To:	CWG 1	Inv(m):	0.3
Metres	Faults/Defects				Internal Condition Grading	Remarks	
0	ST:						
0	WL: 0%

0.2	FC: 12 o'clock to 4 o'clock				Grade 3	Photo 4	
0.9	RM: 20%					Photo 5	
1.1	LL: 45°						
1.4	FH:					CWG 1	
Run: 4	Dir: D/S	Pipe Dia(mm):	100	System:	C/W	Made Of:	V/C
From:	I/C 1	Inv(m):	0.5	To:	I/C 2	Inv(m):	Neighbour's land. Unable to confirm invert depth
Metres	Faults/Defects				Internal Condition Grading	Remarks	
0	ST:						
0	WL: 0%

Install a patch repair using the small pencil packer to seal the defects within the drain run.

Install a patch repair to seal the defects within the drain run.

Undertake root cutting using the mechanical cutting machine.
