Crack and Level Monitoring

Provider Name: My Home Needs

Address: Flat 19, 17 - 20 Meadway Gardens, Ruislip, HA4 7QP

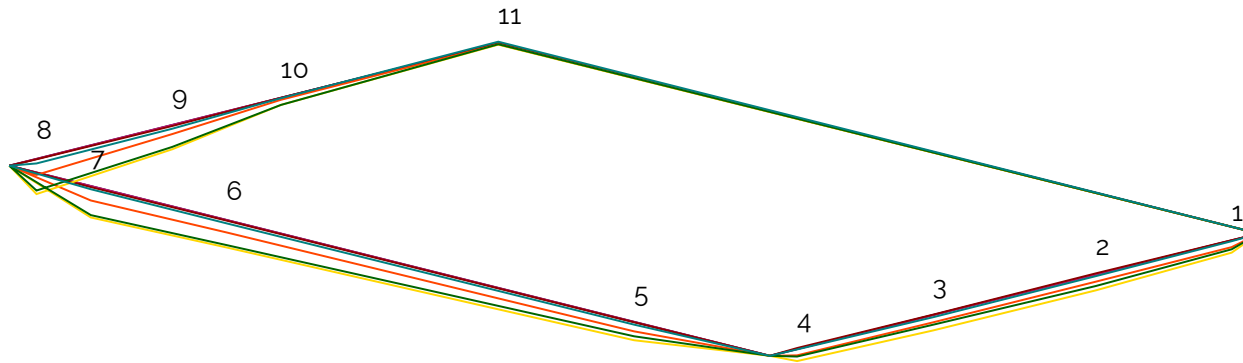
Relative Movement (Relative Survey, for illustration purposes only)

Level Movement (Displayed in Millimeters)

Visit 1	Visit 2	Visit 3	Visit 4	Visit 5	Visit 6	Visit 7	Visit 8
	28/02/25	09/05/25	08/07/25	09/09/25	10/11/25	20/01/26		
1	0	+0.1	-3.4	-6.2	-4.5	-0.4		
2	0	+0.5	-3.7	-8.1	-5.9	-0.9		
3	0	+0.2	-3.7	-7.8	-4.9	-1.1		
4	0	+0.5	-3.2	-6.1	-3.8	-0.2		
5	0	-0.2	-4.8	-9.3	-7.3	-1.4		
6	0	-0.3	-6.3	-13.9	-12.7	-1.7		
7	0	-0.5	-7.3	-15.9	-14.7	-1.6		
8	0	-0.2	-8.1	-17.8	-16	-2.3

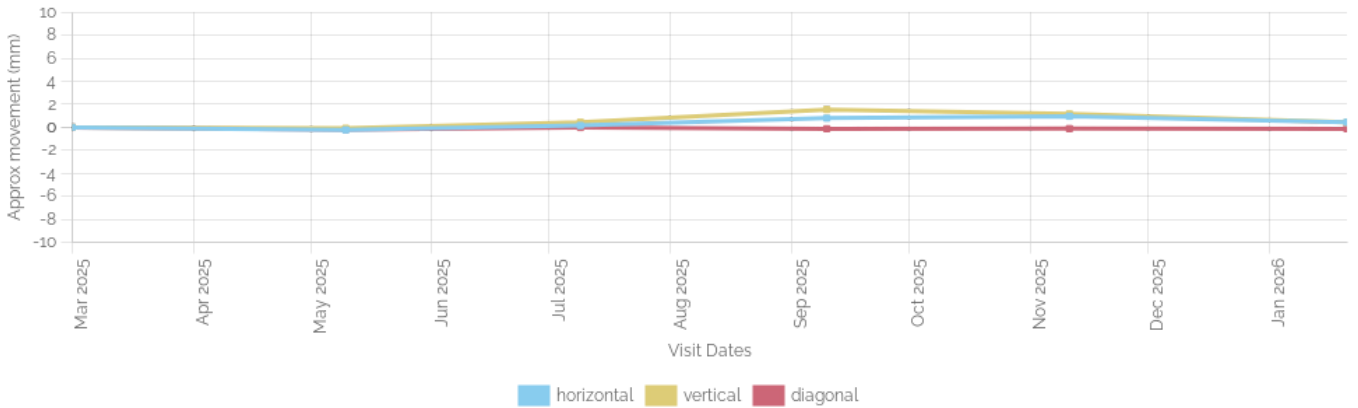
(External) front elevation under left hand side of left hand ground floor window - Crack Readings Differences (Displayed in Millimetres)

Visit 1	Visit 2	Visit 3	Visit 4	Visit 5	Visit 6	Visit 7	Visit 8
	28/02/25	09/05/25	08/07/25	09/09/25	10/11/25	20/01/26		
H	0	-0.22	0.16	0.8	0.96	0.44		
V	0	-0.08	0.44	1.55	1.16	0.43		
D	0	-0.18	-0.01	-0.12	-0.11	-0.12

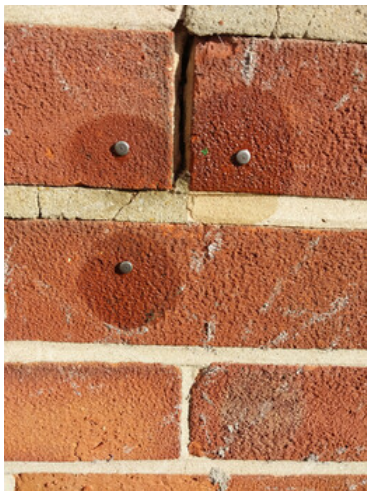
(External) front elevation under left hand side of left hand ground floor window - Visit #1

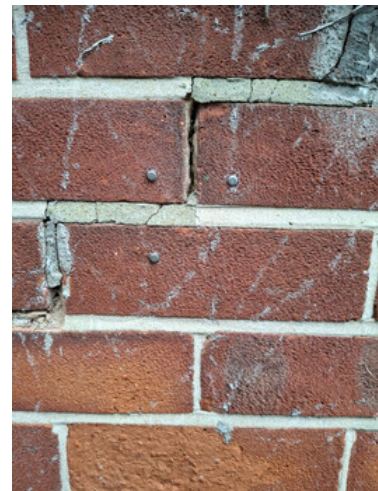
(External) front elevation under left hand side of left hand ground floor window - Visit #6

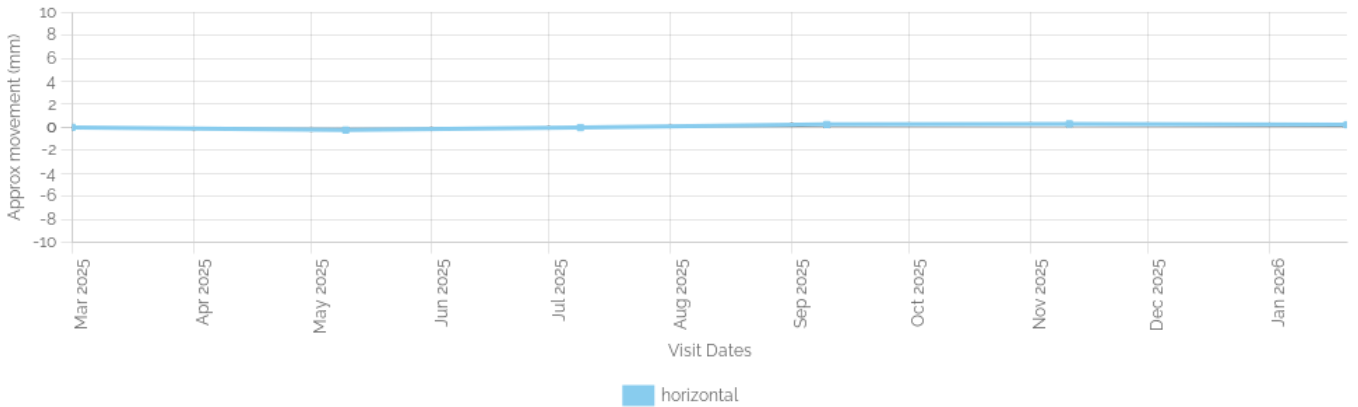
(External) front elevation above right hand side of right hand ground floor window - Crack Readings Differences (Displayed in Millimetres)

Visit 1	Visit 2	Visit 3	Visit 4	Visit 5	Visit 6	Visit 7	Visit 8
	28/02/25	09/05/25	08/07/25	09/09/25	10/11/25	20/01/26		
H	0	-0.24	-0.02	0.25	0.3	0.23

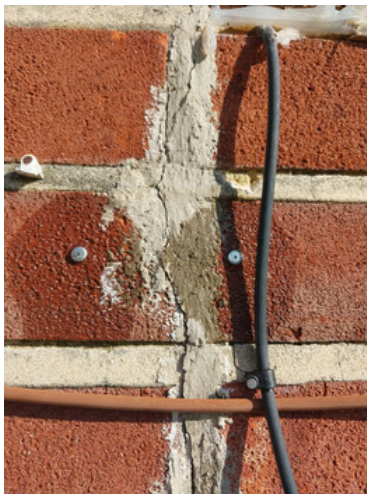
(External) front elevation above right hand side of right hand ground floor window - Visit #1

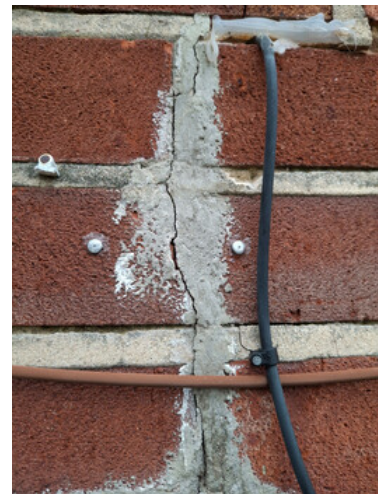
(External) front elevation above right hand side of right hand ground floor window - Visit #6

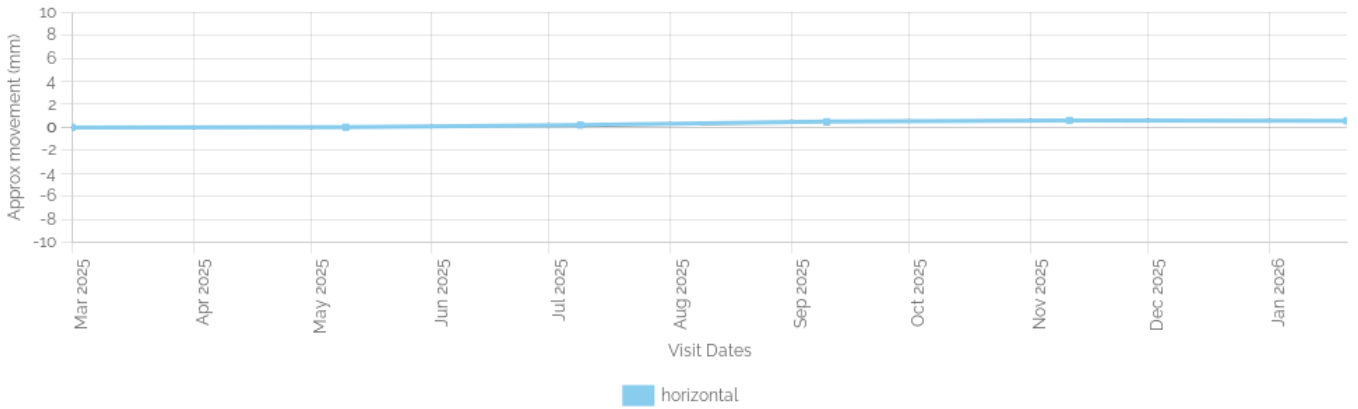
(External) right hand side of flat 20 door low level - Crack Readings Differences (Displayed in Millimetres)

Visit 1	Visit 2	Visit 3	Visit 4	Visit 5	Visit 6	Visit 7	Visit 8
	28/02/25	09/05/25	08/07/25	09/09/25	10/11/25	20/01/26		
H	0	0.01	0.2	0.49	0.6	0.57

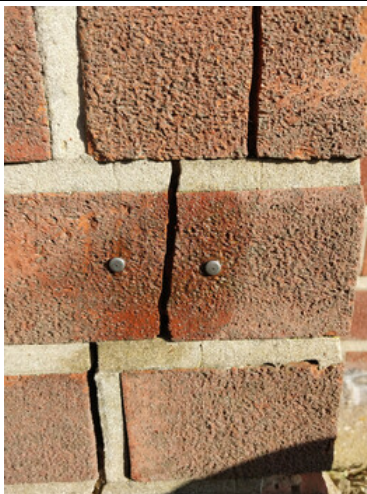
(External) right hand side of flat 20 door low level - Visit #1

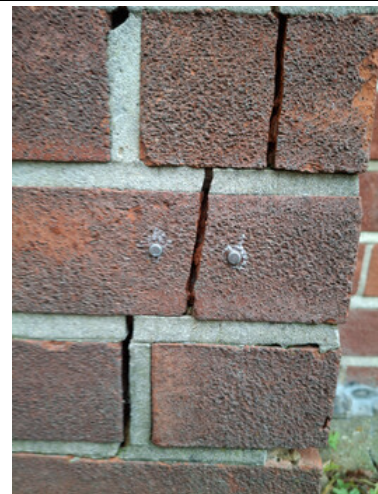
(External) right hand side of flat 20 door low level - Visit #6

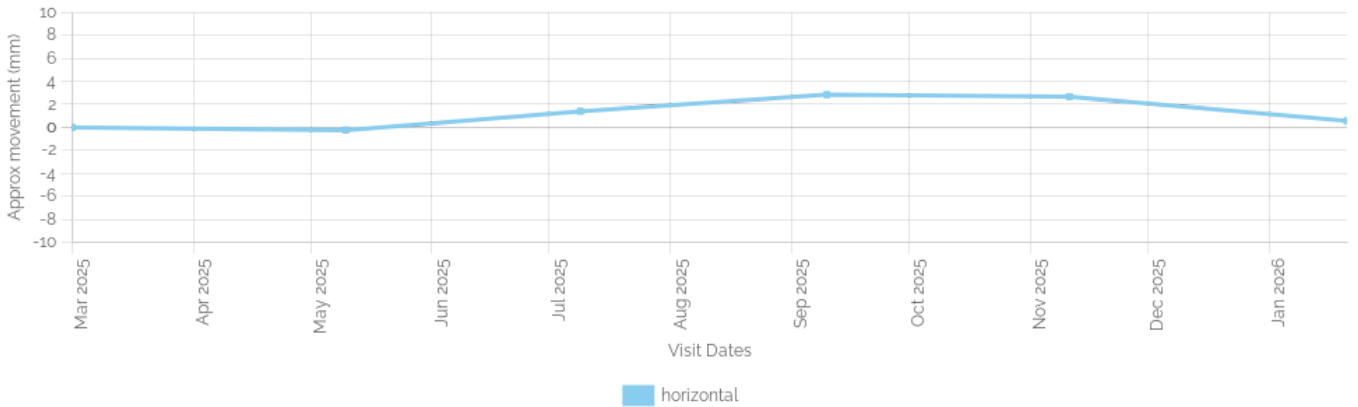
(External) rear elevation below first floor left hand window - Crack Readings Differences (Displayed in Millimetres)

Visit 1	Visit 2	Visit 3	Visit 4	Visit 5	Visit 6	Visit 7	Visit 8
	28/02/25	09/05/25	08/07/25	09/09/25	10/11/25	20/01/26		
H	0	-0.24	1.4	2.84	2.67	0.56

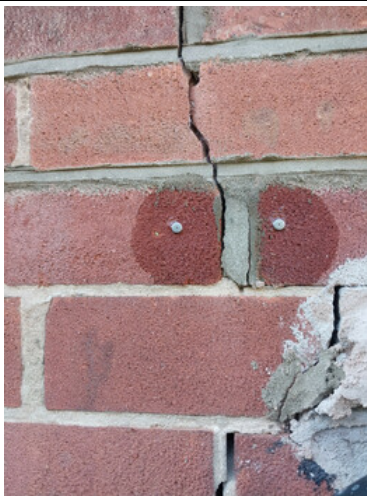
(External) rear elevation below first floor left hand window - Visit #1

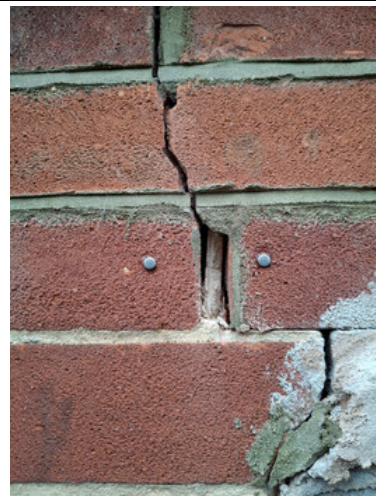
(External) rear elevation below first floor left hand window - Visit #6

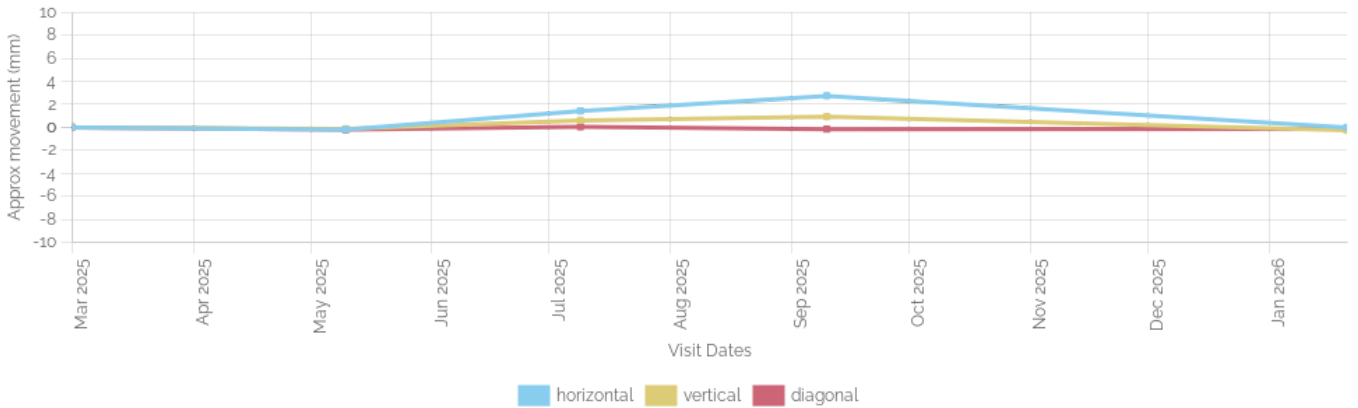
(External) rear elevation below first floor middle window - Crack Readings Differences (Displayed in Millimetres)

Visit 1	Visit 2	Visit 3	Visit 4	Visit 5	Visit 6	Visit 7	Visit 8
	28/02/25	09/05/25	08/07/25	09/09/25	10/11/25	20/01/26		
H	0	-0.18	1.43	2.74		0		
V	0	-0.12	0.61	0.93		-0.26		
D	0	-0.2	0.05	-0.15		-0.13

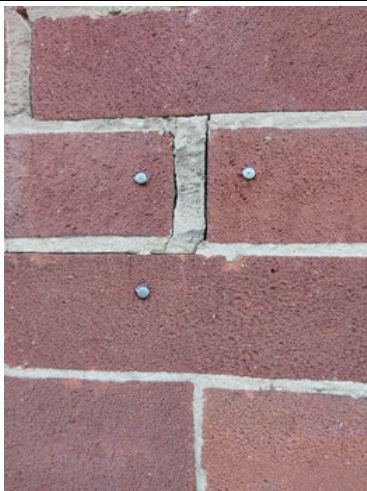
(External) rear elevation below first floor middle window - Visit #1

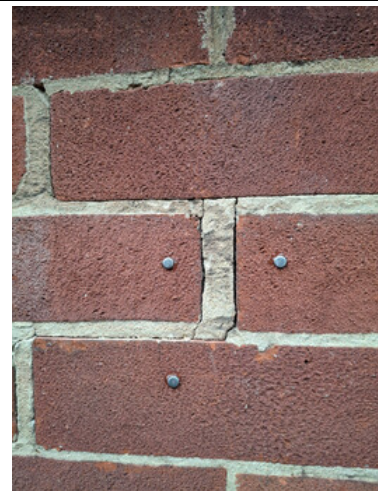
(External) rear elevation below first floor middle window - Visit #6
