Initial Subsidence Report

17-20 Meadway Gardens,

Ruislip, Middlesex

Date of Report: 20th March 2024

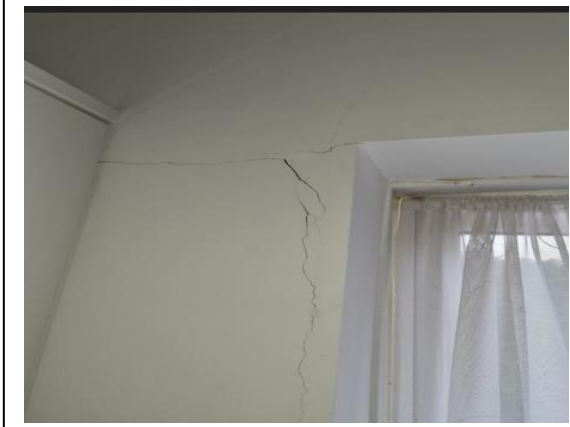
Location	Description of Damage	Category (BRE 251):
Flat 20		
Kitchen	<ul style="list-style-type: none">- Tapering diagonal & horizontal cracking is evident radiating from the top left corner of the rear window towards the rear corner. Slight vertical cracking is evident radiating from the top left corner of the rear window.- Slight diagonal cracking is evident radiating from the top right hand corner of the air vent to the left elevation extending up to the ceiling and to radiating from the top left hand corner of the air vent which radiates down towards the extractor hood.- <1mm diagonal tapering crack is evident radiating from the top left hand corner of the front kitchen cupboard door up to the ceiling line.	2
Landing & Stairs	<ul style="list-style-type: none">- Circa 1mm diagonal tapering crack is evident to the left hand elevation radiating from ceiling wall junction and extending down to the junction of the front left division wall over the staircase and then extending vertically down to the junction of the division wall and left elevation.- The cracking then continues along the junction of the coving and left elevation towards the rear of the landing.- Slight diagonal cracking is evident above the rear right hand bedroom door extending up to the ceiling.- A crack was noted to the landing ceiling which radiates from the left hand side across to the loft hatch.	2

Photo 2: Flat 20 – Kitchen - Cracking to LHS of Window

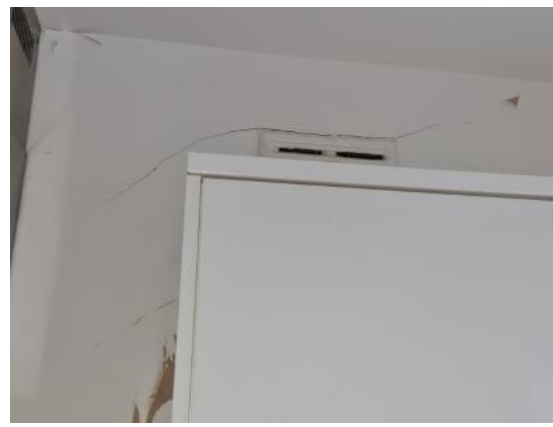
Photo 3: Flat 20 – Kitchen - Cracking to Left Elevation

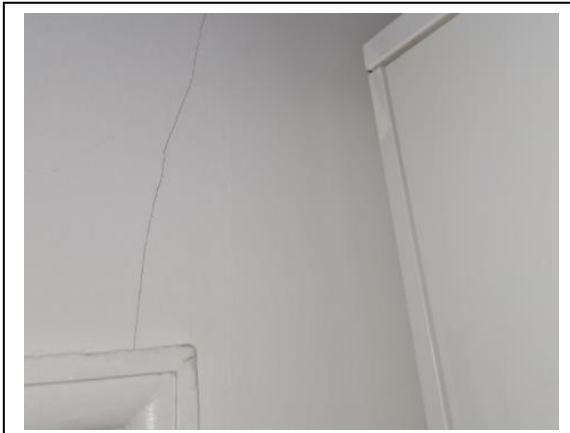
Photo 4: Flat 20 – Kitchen - Cracking above cupboard door

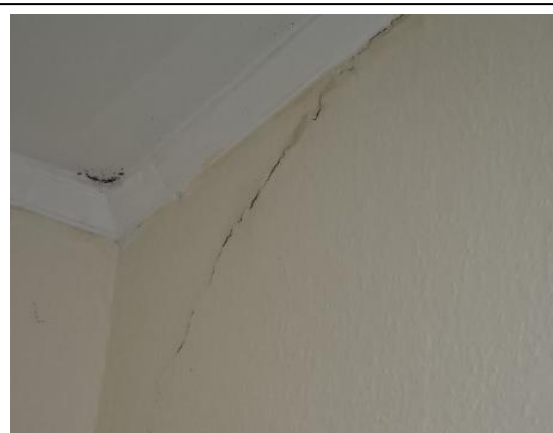
Photo 5: Flat 20 – Stairs - Cracking to Left Elevation

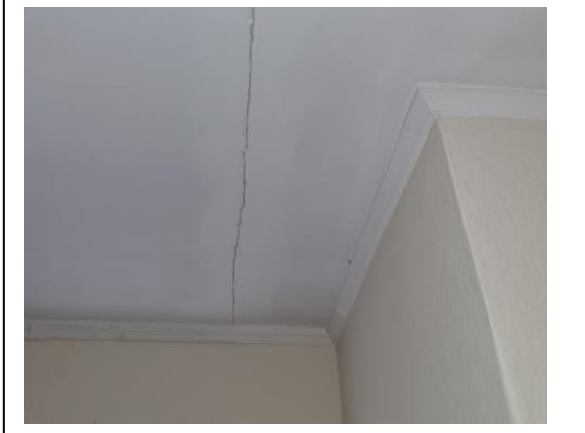
Photo 6: Flat 20 – Landing - Cracking to Ceiling

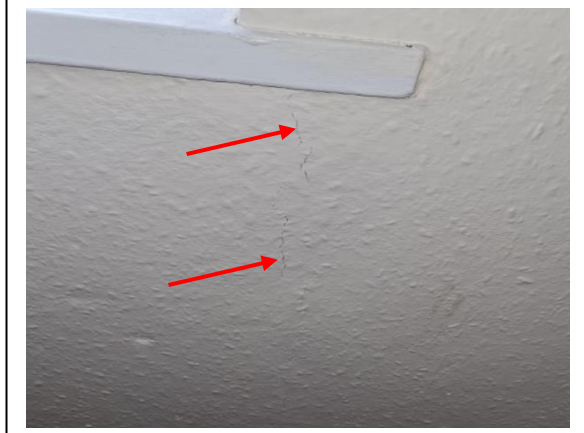
Front Left Hand Bedroom	<ul style="list-style-type: none">- Circa 1mm vertical tapering crack is evident radiating from the bottom left hand corner of the front elevation window cill extending down to skirting level.	2

Photo 7: Flat 20 – Front Left Bedroom - Cracking Below LHS of Window

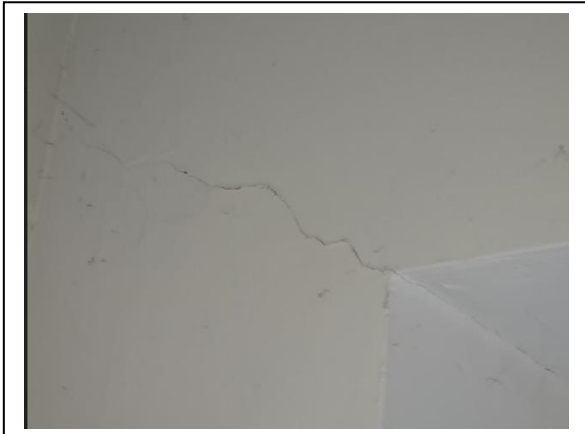
Bathroom	<ul style="list-style-type: none"> - Slight diagonal cracking is evident to the top left hand corner of the rear elevation window and to the bottom right hand corner of the window which extends to the skirting. - To the right hand division wall slight diagonal cracking was noted radiating from the rear elevation up to the ceiling extending for approximately 1m from the rear elevation. 	2
Rear Right Hand Bedroom	<ul style="list-style-type: none"> - Circa 1mm diagonal crack was evident radiating from the top right hand corner of the bedroom door extending up to ceiling level. Radiating off this crack was a further slight diagonal crack which radiates up to the ceiling level and then a crack continues across the ceiling from the left to right hand side. - A circa 1mm diagonal crack is evident to the front left corner of the room which extends below the ceiling line on the front division wall and extends diagonally to the left division wall above the landing door. - Cracking was also noted following the ceiling board joints to the room. 	2

Photo 8: Flat 20 – Bathroom - Cracking Above LHS of Window

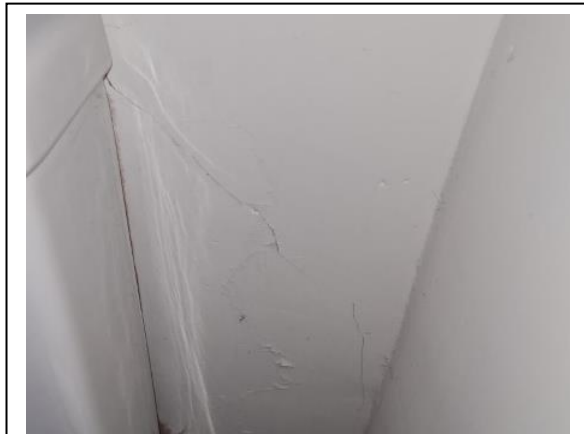
Photo 9: Flat 20 – Bathroom - Cracking Below RHS of Window

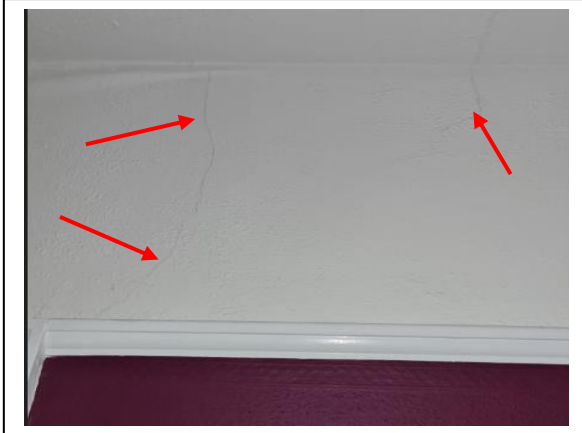
Photo 10: Flat 20 – Rear Right Bedroom - Cracking Above Door

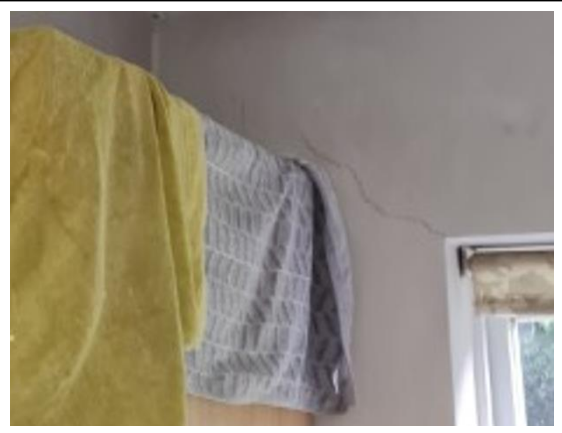
Flat 19		
Kitchen	<p>A 1mm diagonal tapering crack was noted radiating from the top left hand corner of the rear elevation window extending up to the top left hand corner of the room.</p> <p>Slight diagonal cracking was also evident to the left hand elevation extending from the ceiling down behind the wall units.</p>	2
Rear Right Bedroom	<p>Slight diagonal cracking was evident to the top left hand corner of the rear elevation window with the cracking continuing along the ceiling perimeter line to the left hand division wall.</p>	2
Front Right Hand Lounge	<p>Slight diagonal cracking was noted radiating from the top right hand corner and bottom left hand corner of the front elevation window.</p> <p>Slight diagonal cracking was evident above the top left hand corner of the hallway door.</p> <p>Cracking was also evident to the ceiling perimeter of the room.</p>	2
Front Left Hand Bedroom	<p>1mm diagonal cracking was evident radiating from the bottom left hand corner of the window cill down to skirting level.</p> <p>Hairline diagonal cracking was noted radiating from the top right hand corner of the front elevation window extending up to the right hand division wall.</p>	2

Photo 11: Flat 19 – Kitchen - Cracking Above LHS of Window

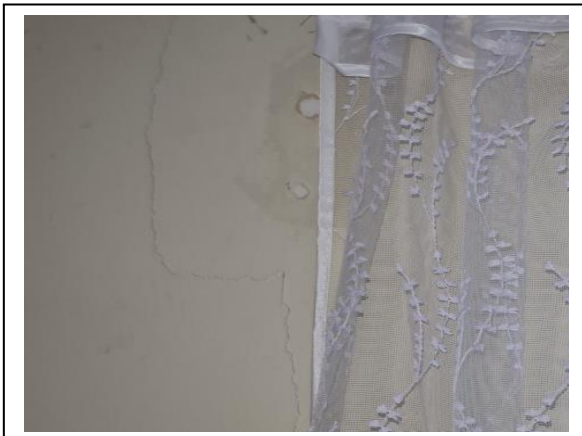
Photo 12: Flat 19 – Rear Left Bedroom - Cracking to LHS of Window

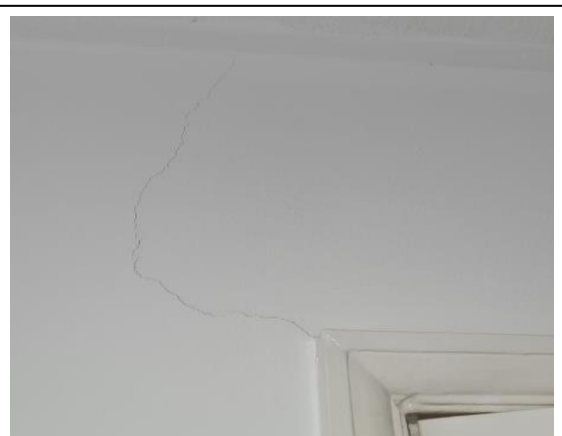
Photo 13: Flat 19 – Front Right Lounge- Cracking above door

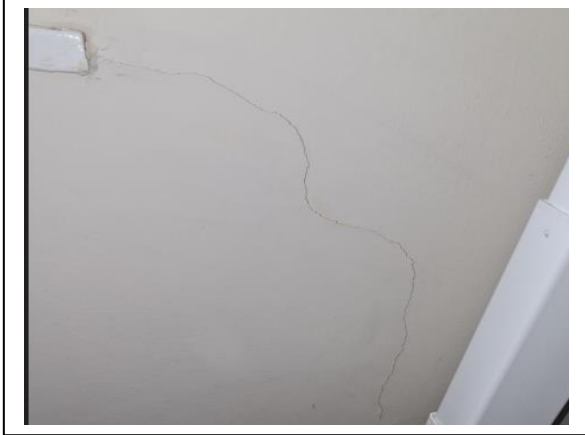
Photo 14: Flat 19 – Front Left Bedroom-
Cracking below window

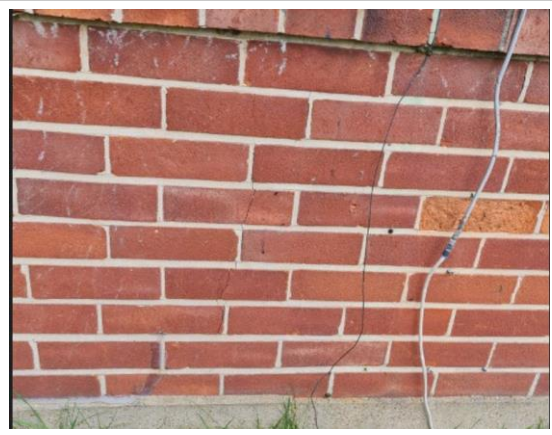
Vertical and diagonal cracking is evident radiating from the top left hand corner of the rear cupboard door.	
Front Elevation	<p>1mm stepped diagonal cracking is evident radiating from the bottom right hand corner of the ground floor left hand window running down to the concrete plinth and then runs along the plinth and continues through the plinth.</p> <p>1-2mm stepped diagonal cracking is evident radiating from the bottom left hand corner of the front elevation ground floor left hand window extending down to the plinth. There is evidence of previous repairs to the crack.</p> <p>2mm stepped diagonal cracking is noted to the left hand side of the front entrance to Flat 19 which extends from ground level up for approximately 6 courses.</p> <p>The rendered plinth to the left hand side of the front elevation has cracked and debonded from the brickwork and at some stage this has been filled with a silicon sealant.</p> <p>1mm stepped diagonal cracking is evident radiating from the head of the ground floor left hand window extending to the underside of the first floor left hand window cill.</p> <p>Circa 1mm diagonal crack was noted radiating from the top left hand and right hand corners of the first floor left hand window.</p> <p>Circa 1mm diagonal cracking is evident radiating from the top right hand corner of the ground floor window extending to the underside of the first floor right hand window cill.</p> <p>There is also evidence of a slight diagonal crack radiating from the top left hand corner of the first floor left hand window cill.</p>	2

Photo 15: Front Elevation – Cracking below
Ground Floor Left Window

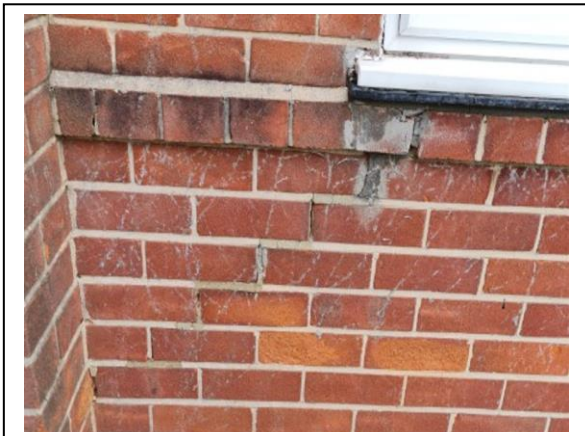
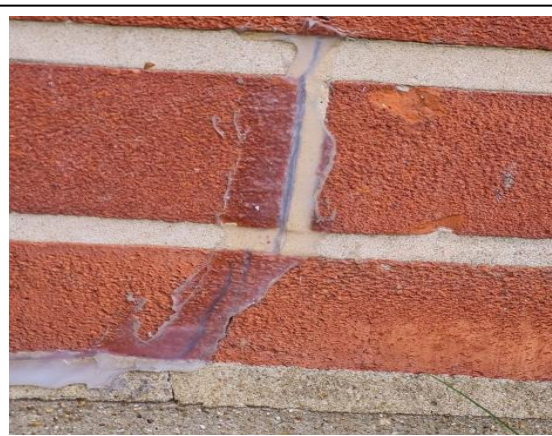
8.1 During our inspection we noted signs of previous repairs to the property on the front elevation and you may wish to make further enquiries regarding when these were undertaken.

Photo 16: Front Elevation – Cracking below
Ground Floor Left Window- Note evidence of
previous repairs

Photo 17: Front Elevation – Cracking below
Ground Floor Left Window- Note evidence of
previous repairs

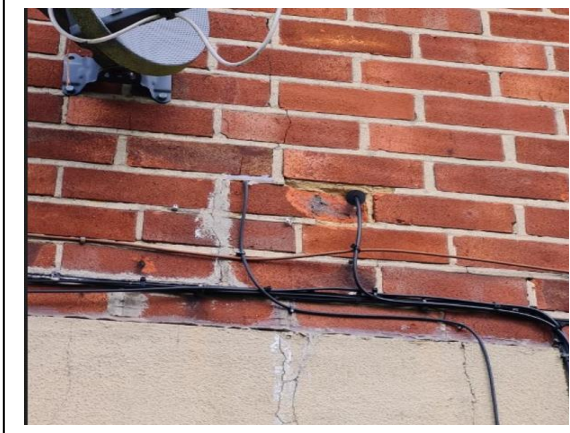
Photo 18: Front Elevation – Cracking above Ground Floor Right Window- Note evidence of previous repairs

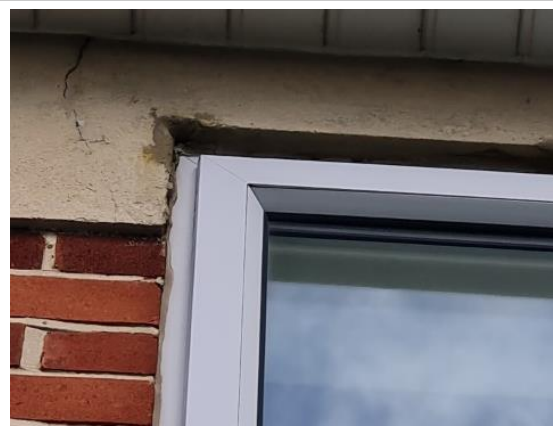
Photo 19: Cracking above First Floor Left Window

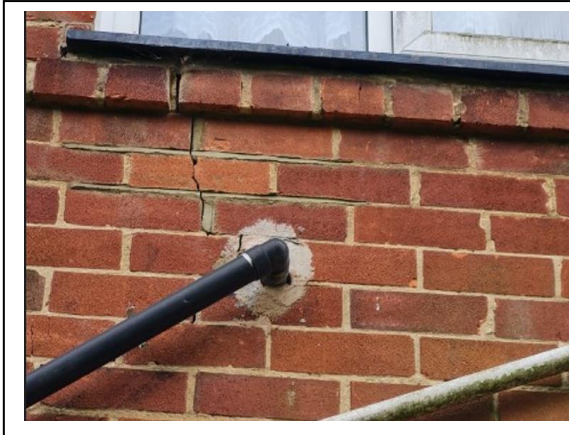
Rear Elevation	<p>There is a circa 2mm stepped diagonal crack radiating from the cill of the first floor left hand window extending down to the top left hand corner of the 1st floor middle window.</p> <p>There is evidence of a 1mm stepped diagonal crack radiating from the bottom left hand corner of the ground floor window extending to ground level.</p> <p>There is a 2mm diagonal crack radiating from the top left hand corner of the 1st floor left hand window extending up to the eaves level.</p> <p>There is a circa 1mm stepped diagonal crack evident radiating from the underside of the cill to the 1st floor middle window extending down to the top right hand corner of the ground floor middle window. There is evidence of previous repairs & possible presence of Helibars to this crack.</p>	2

Photo 20: Rear Elevation – Cracking below First Floor Middle Window- Note evidence of previous repairs & possible presence of Helibars

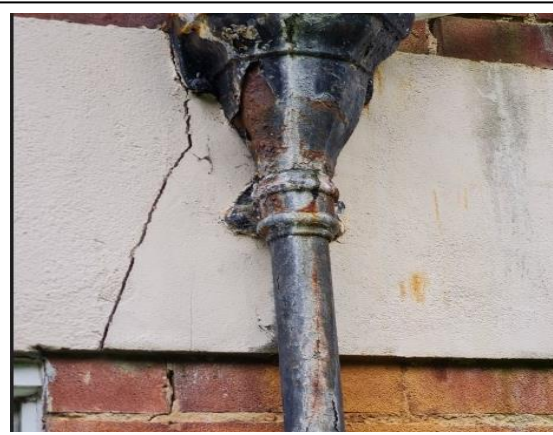
Photo 21: Rear Elevation – Cracking above Ground Floor Middle Window-

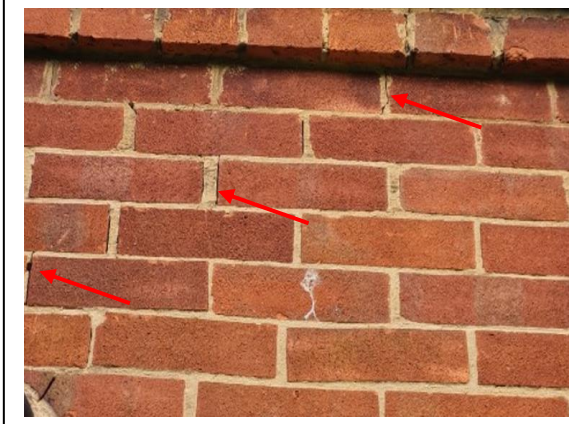
Photo 22: Rear Elevation – Cracking below First Floor Left Window

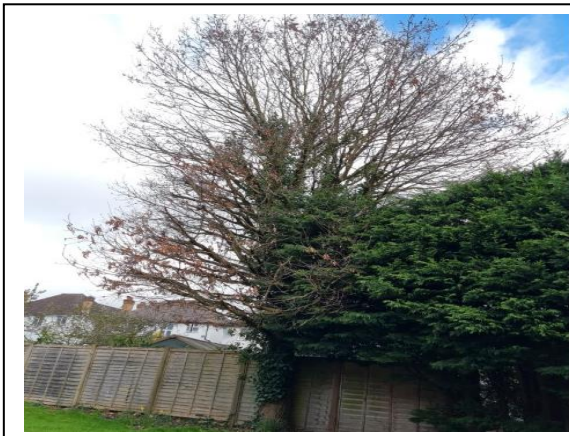
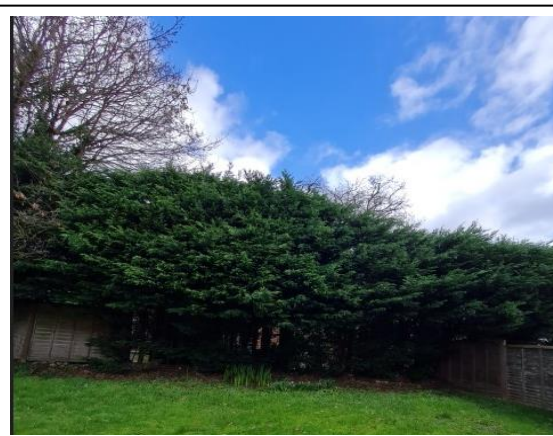
- 7.3 In this instance the trees and shrubs to the rear and right hand side of the property is likely to be the primary influence. In our opinion the removal of the trees within influencing distance of the property will alleviate any further movements. The clay sub-soil will then need to be allowed a period of recovery to enable rehydration. The subsequent swelling of the soil should lead to the crack widths reducing as the structure recovers. A short period of monitoring will assist in confirming when stability is regained.

Photo 24: Vegetation to Rear Elevation

Photo 25: Vegetation to Rear Elevation

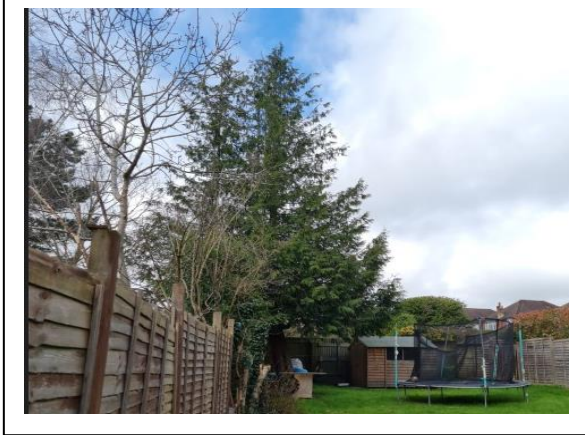
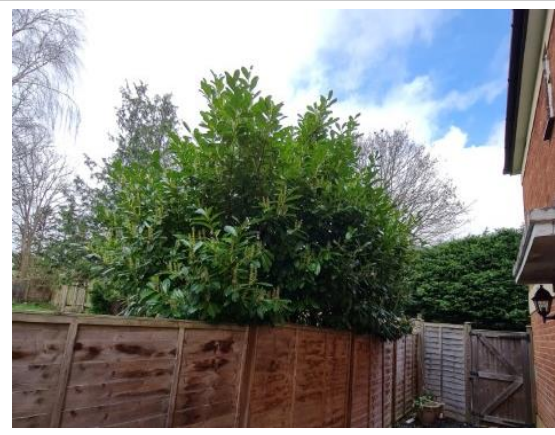
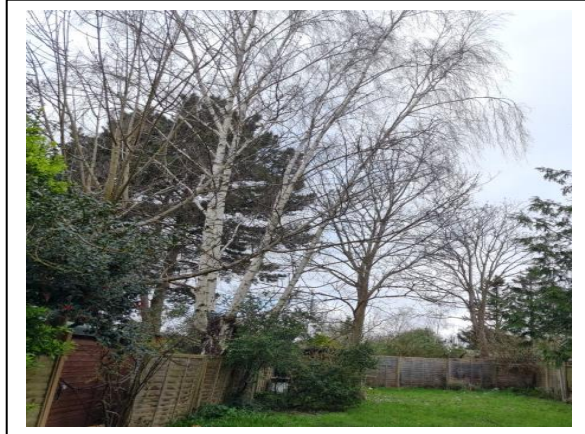
Photo 26: Vegetation to Left Elevation

Photo 27: Vegetation to Left Elevation

Photo 28: Vegetation to Left Elevation
