Arboricultural Appraisal Report

Subsidence Damage Investigation at:

17-20 Meadway Gardens
Ruislip
HA4 7QP

CLIENT: Meadow Chartered Surveyors
 CLIENT REF: 9440113P
 MWA REF: SUB240909-15618
 MWA CONSULTANT: Andy Clark
 REPORT DATE: 04/11/2024

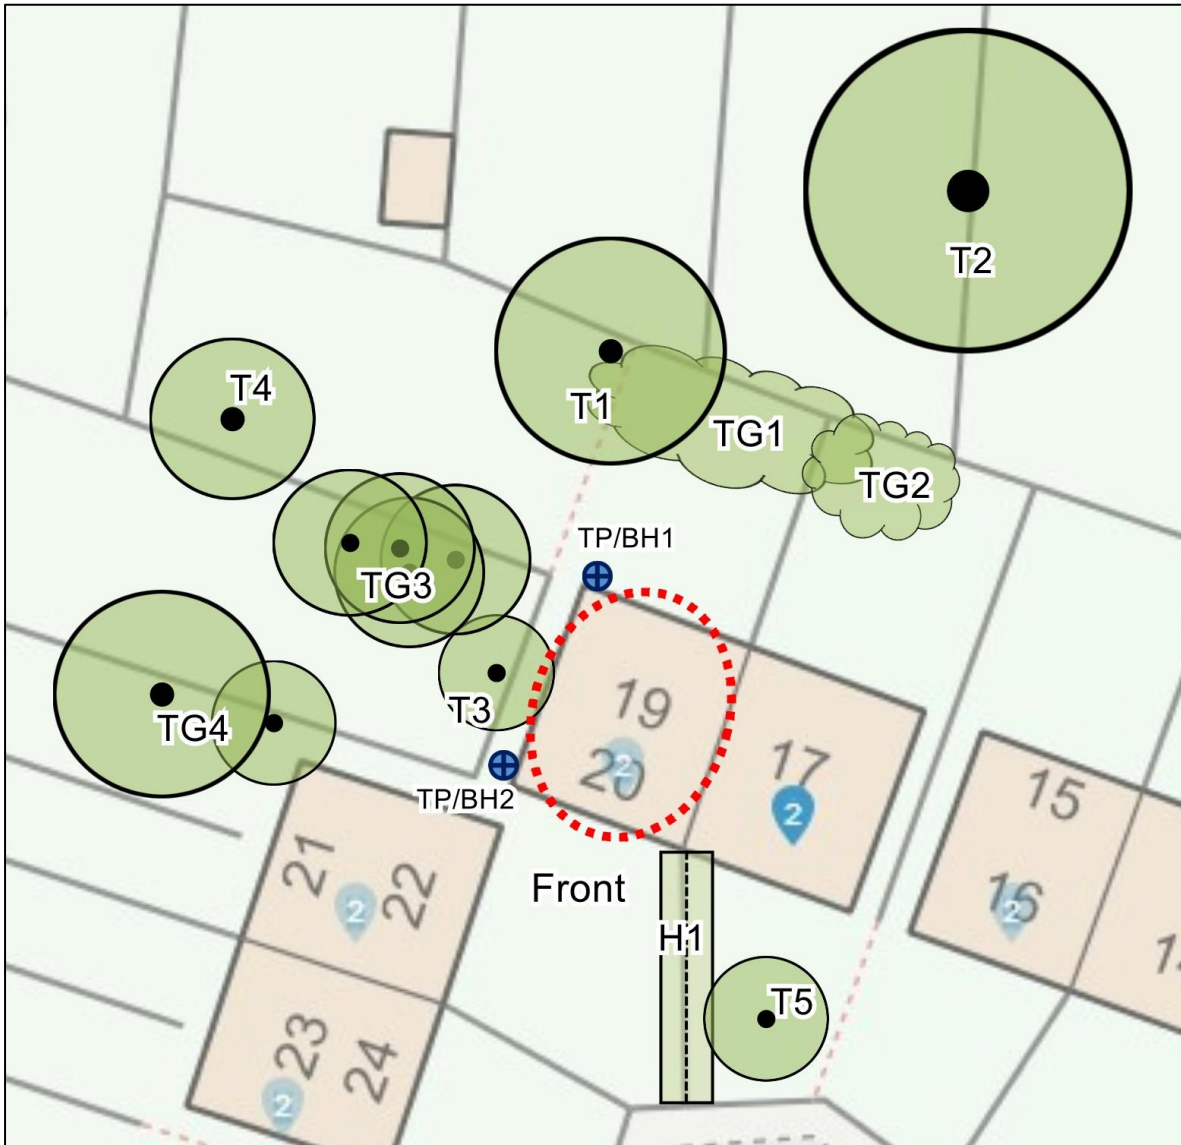
Site Plan

Approximate areas of damage

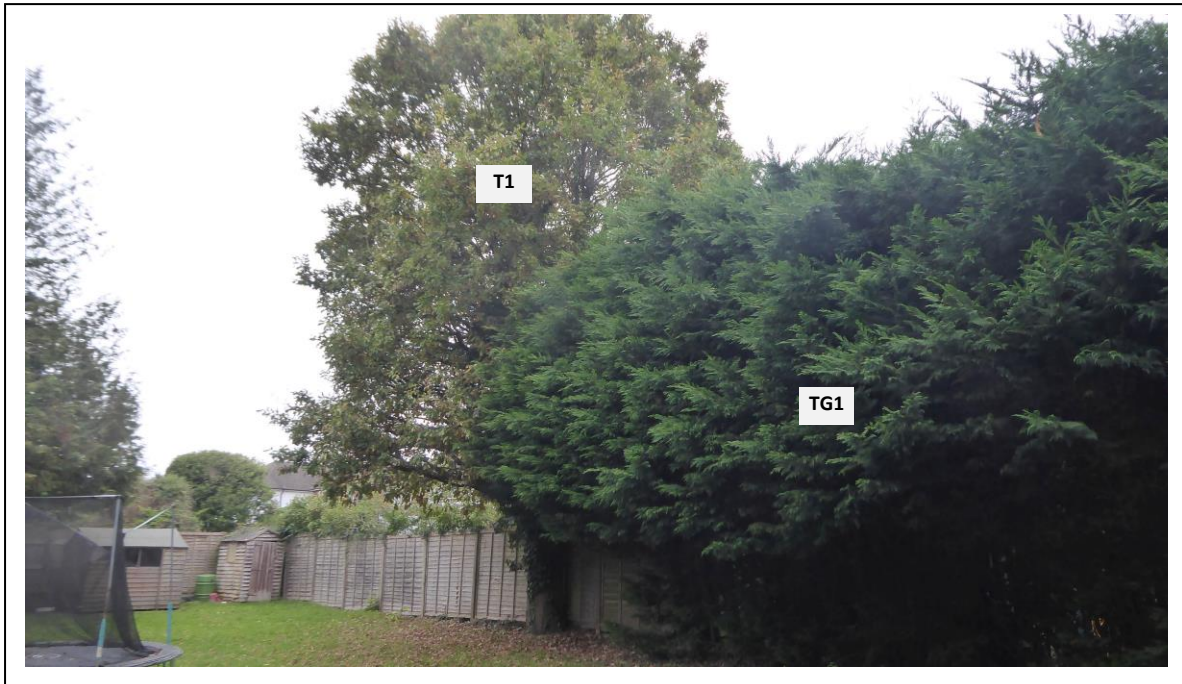
Roots were observed below foundation depth in TP/BH1 and recovered samples have been positively identified (using anatomical analysis) as *Quercus* spp., the most likely origin of which will be T1 Oak as the closest related tree to the TP/BH1 location, however the much larger but more distant T2 Oak is also within influencing distance of the building and may also be a source of the retrieved samples.

View of T1 Oak and TG1 Cypress group

If an arboricultural solution is to be implemented to mitigate the influence of the trees/vegetation considered to be responsible for the movement/damage, we recommend that T1 Oak and T3 Laurel are removed and TG1 and TG2 Cypress groups are reduced, combined with crown reduction of the more distant T2 Oak.

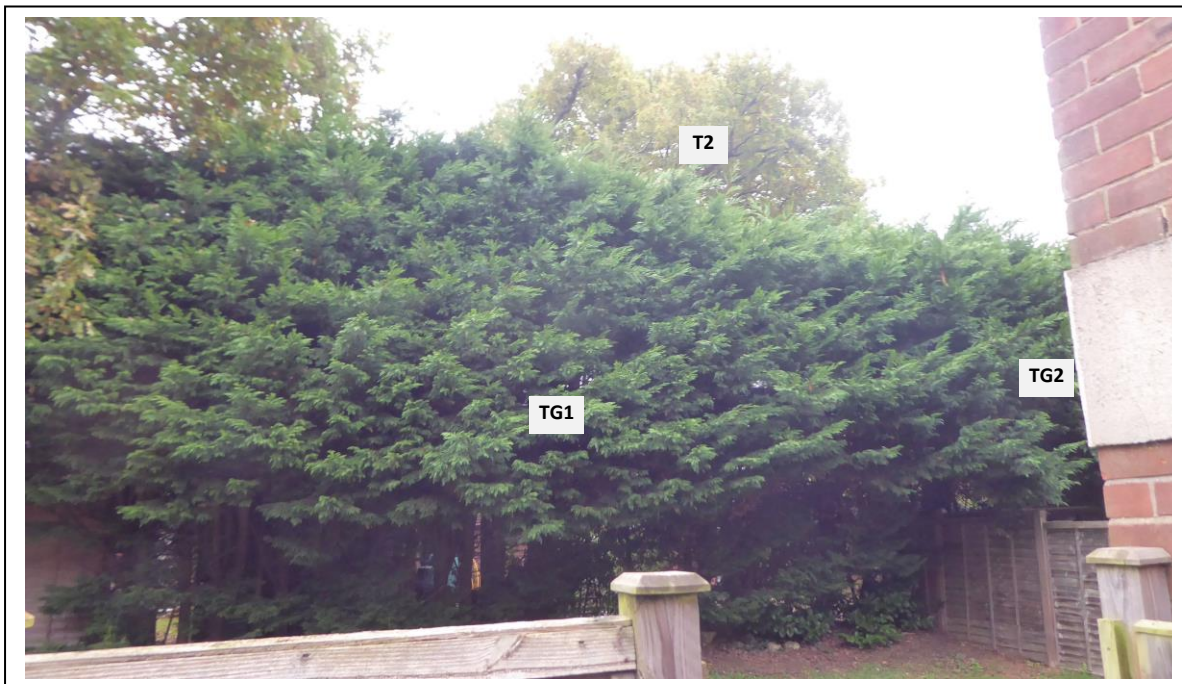
Irrespective of the identification of recovered root samples, the roots of the Cypresses of TG1 and TG2 groups are also likely to be present below foundation level in proximity to the area of movement/damage with the potential to influence soil moisture and volumes. T3 Laurel will also likely exert a localised contributory influence.

View of T2 Oak behind TG1 and TG2 Cypress groups

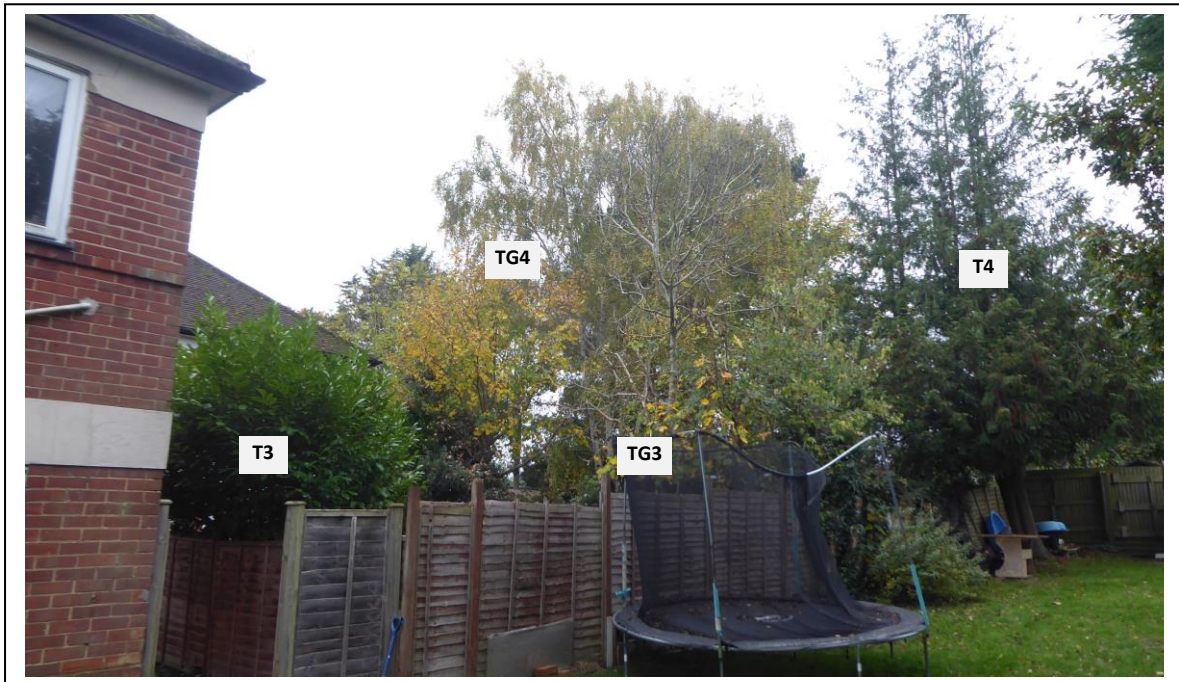
View of T3 Laurel, with TG3 group and T4 Western Red Cedar to left and TG4 group visible beyond

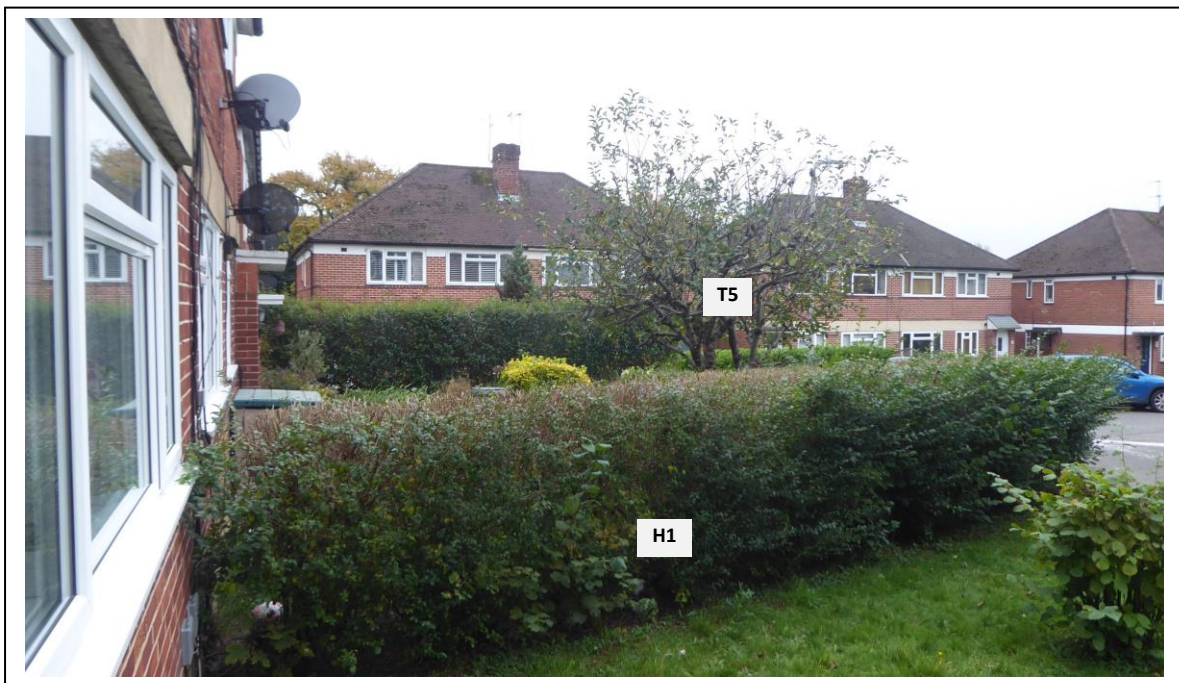
View of T5 Apple and H1 Privet and Hazel hedge

Tree No.	Species	Ht (m)	Dia (mm)	Crown Spread (m)	Dist. to building (m)	Age Classification	Ownership
H1	Privet and Hazel hedge	1.3	5	1.5	0.3	Younger than Property	Policy Holder
Management history		Subject to past management/pruning - very recently crown reduced/pruned.					
Recommendation		Cut-back sides hard to leave hedge no thicker than 0.5m. Trim thereafter on an annual cycle to maintain at broadly reduced dimensions.
