Demolition / Refurbishment Asbestos Survey Report

Weir House

50 Riverside Way

9th Aug 2023

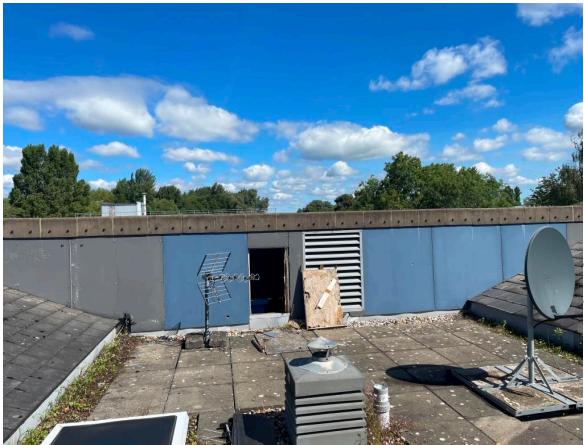
Sample Ref: B01

Location: Plant room

Material Sampled: External panels

No Asbestos Detected

Material Assessment Score: **0**

Remarks / Recommendations: N/A

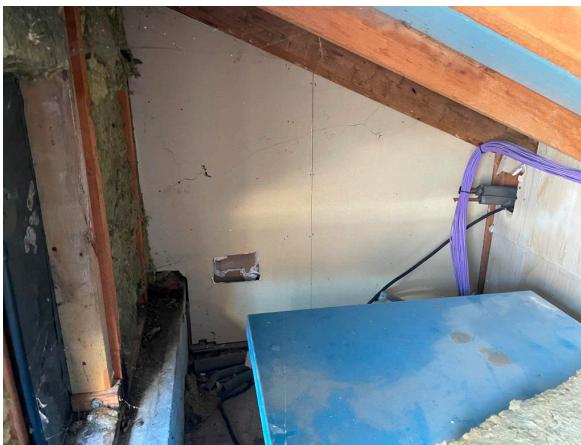
Sample Ref: B02

Location: Plant room

Material Sampled: Internal panels

No Asbestos Detected

Material Assessment Score: **0**

Remarks / Recommendations: N/A

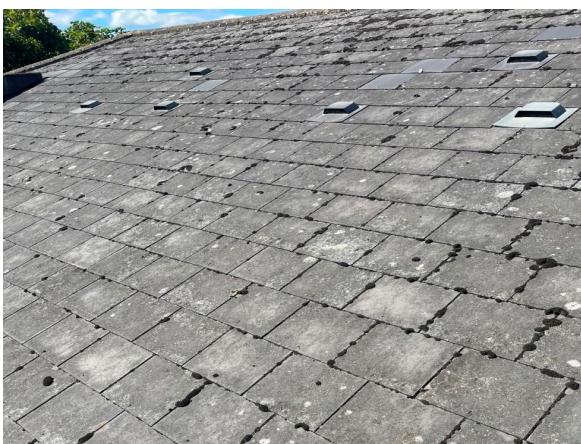
Sample Ref: B03

Location: Roof

Material Sampled: New fibre roof tiles

No Asbestos Detected

Material Assessment Score: **0**

Remarks / Recommendations: N/A
