## 7.2 Photographs

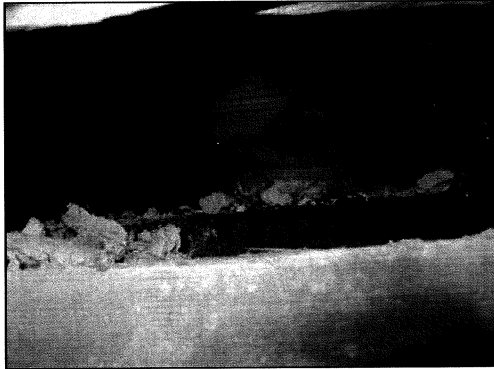
**Lounge, Room ID G03,  
Wall Intrusion  
(No Suspected Materials Seen)**

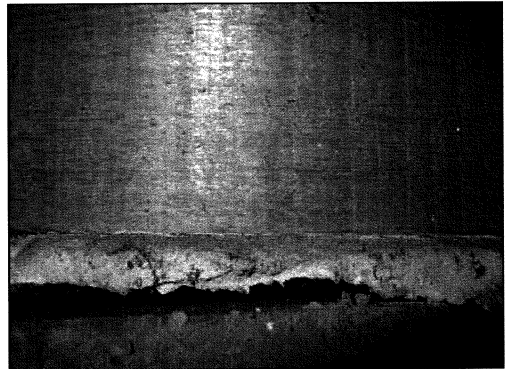
**Lounge, Room ID G03,  
Floor Intrusion  
(No Suspected Materials Seen)**

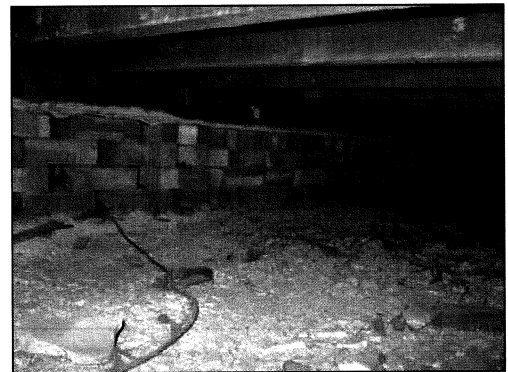
**Bedroom, Room ID G04,  
Floor Intrusion  
(No Suspected Materials Seen)**

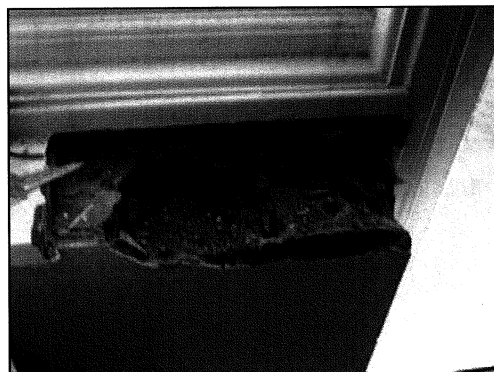
**Bedroom, Room ID G04,  
Wall Intrusion  
(No Suspected Materials Seen)**

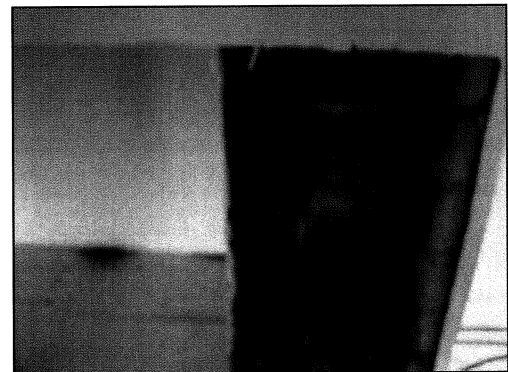
**Bedroom, Room ID G04,  
Chimney Intrusion  
(No Suspected Materials Seen)**
