**TECHNICAL REPORT ON A SUBSIDENCE CLAIM**

**Crawford Reference: SU1903746**

**5 Pine Trees Drive, Ickenham**

**SUBSIDENCE CLAIM**  
20<sup>th</sup> September 2019

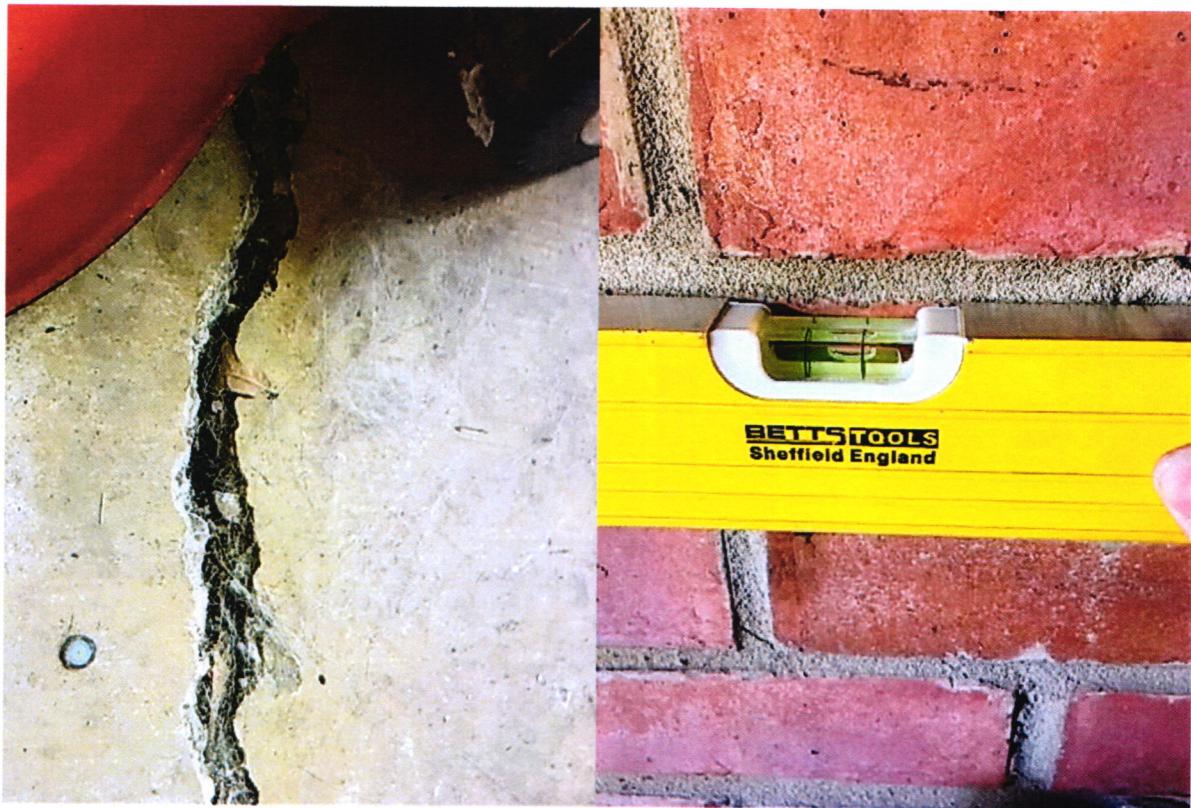
Fracturing to garage slab

Distortion to brickwork

To the rear of the garage there is a 24 mm fracture within the slab spanning from left to right. Further, the slab drops notably to the rear right corner. The remaining areas of the slab are relatively level albeit there is a 5 mm fracture adjacent to the door.

In terms of the structure, a spirit level assessment confirmed notable downward movement to the rear right corner with movement of 20mm over 1.8 m being recorded.

Movement has occurred adjacent to the access door resulting in high-level fracturing up to 20 mm in width. The frame of the door has displaced from the reveal resulting in a tapered vertical separation gap.

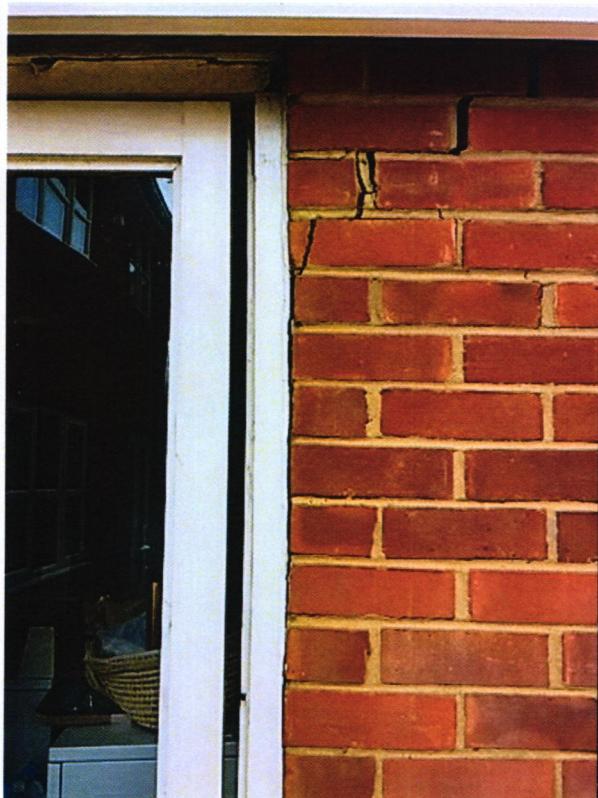
30mm gap between door and frame

On the right-hand flank there is a stepped crack up to 6mm width. This is present from circa 1 m above ground continuing down through the DPC course. The brickwork has also rotated to the right-hand side resulting in this protruding from the front section of garage by 7 mm. There is 15 mm cracking on the side of the access door and the frame has displaced by circa 30 mil in this location

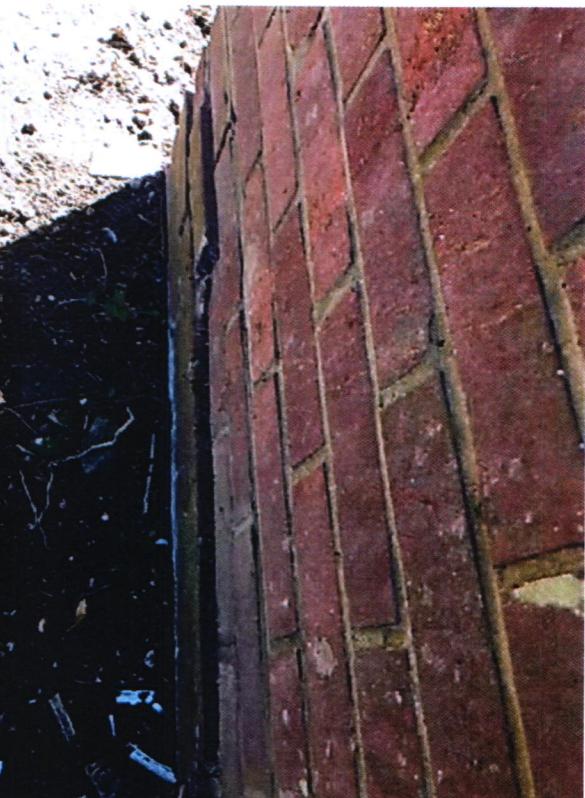
Lateral displacement of lower section of brickwork

The rear right corner has displaced at low-level resulting in lateral displacement in relation to the upper section of masonry. The lower section of brickwork now protrudes by 20mm. There is a stepped diagonal crack on the rear which is up to 2 mm in width and minor cracking on the damp proof course to the rear left

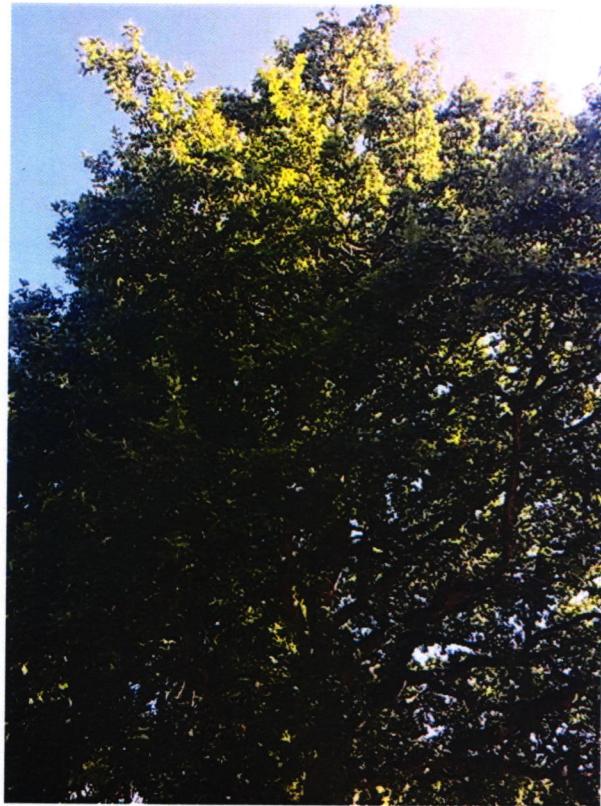
The timing of the event, the presence of shrinkable clay beneath the foundations and the proximity of vegetation where there is damage indicates the shrinkage to be root induced. This is a commonly encountered problem and probably accounts for around 70% of subsidence claims notified to insurers.

Oak tree in proximity to garage

Although the cause of the movement needs to be dealt with first, we have completed a soil risk analysis (VISCAT Assessment) which suggests a potential heave risk should the vegetation be removed. We are therefore arranging site investigations to quantify this risk in relation to the specific soil type at the property.
